Expertise

Protocol number: 46902085  
Order No. / Reference: 26755162  
Inspection date: 5 Aug 2026

Manufacturer: Volkswagen

Model: Tiguan Allspace 2.0 TSI OPF 4Motion DSG R-Line

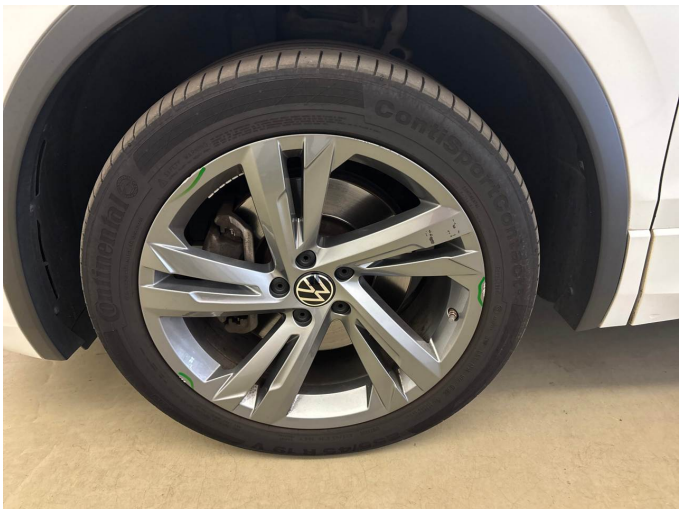
Figure 12: Mounted tyres

| # | Tyre size | Type of tyre | Manufacturer | Tread depth |
|---|---|---|---|---|
| 1) | 255/45 R19 100V | Summer tyres on Light alloy | Continental | 4mm / 4mm |
| 2) | 255/45 R19 100V | Summer tyres on Light alloy | Pirelli | 4mm / 4mm |

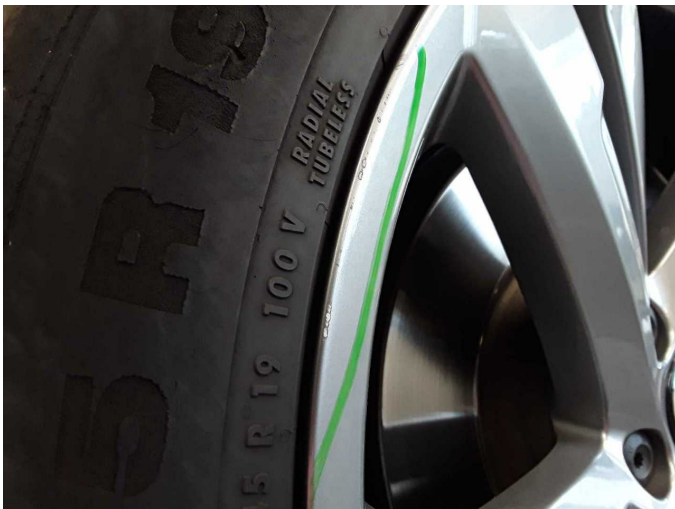
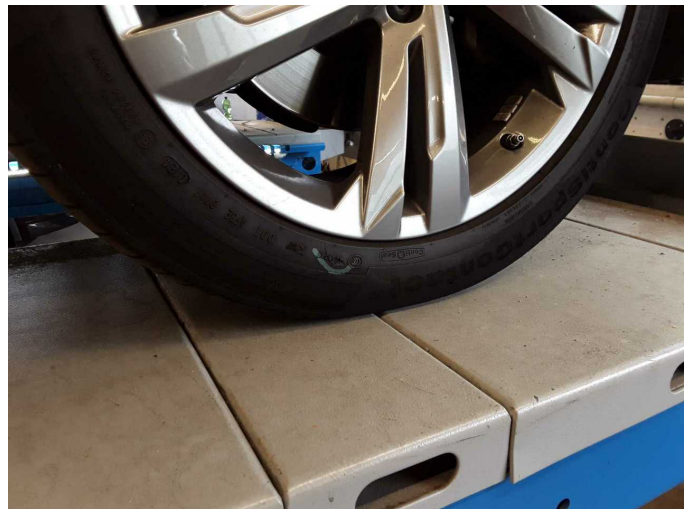
| No. | Component group | Description |
|---|---|---|
| 2 | Wheel / tyres | Alloy rim - front right side - Scratched - Smart repair |

**Damage 2:** Wheel / tyres: Alloy rim - front right side - Scratched - Smart repair

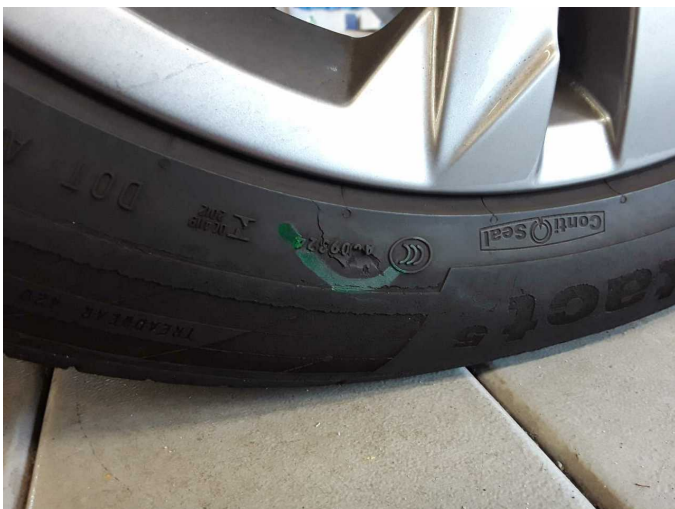
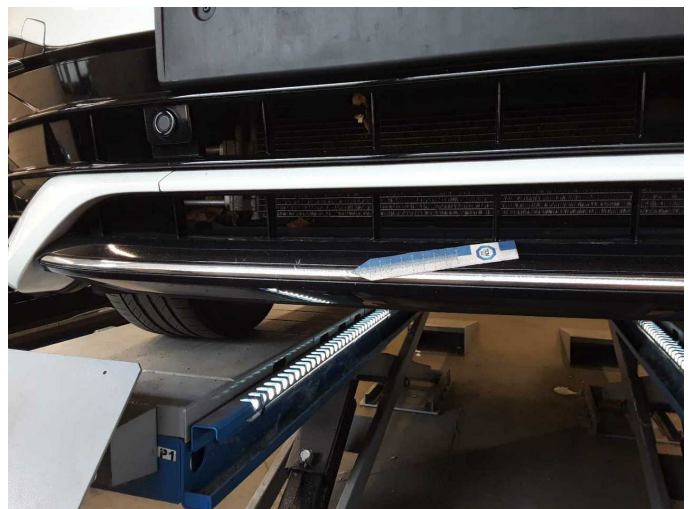
| No. | Component group | Description |
|---|---|---|
| 3 | Wheel / tyres | Tyre - front right side (nicht fahrbereit) - Damaged - Replace |

**Damage 3:** Wheel / tyres: Tyre - front right side (nicht fahrbereit) - Damaged - Replace

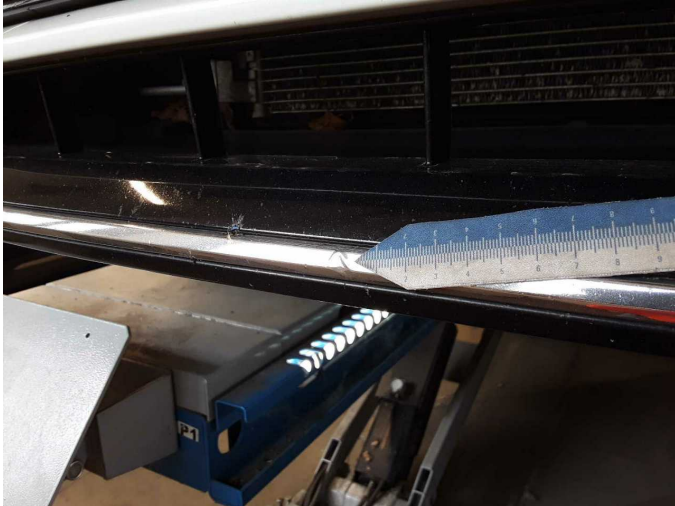
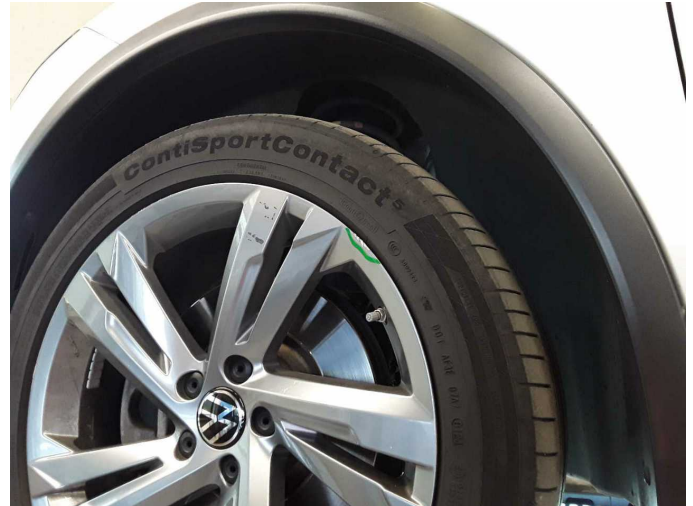
| No. | Component group | Description |
|---|---|---|
| 4 | Front bumper | Spoiler (Leiste) - Deformed - Replace |

**Damage 4:** Front bumper: Spoiler (Leiste) - Deformed - Replace

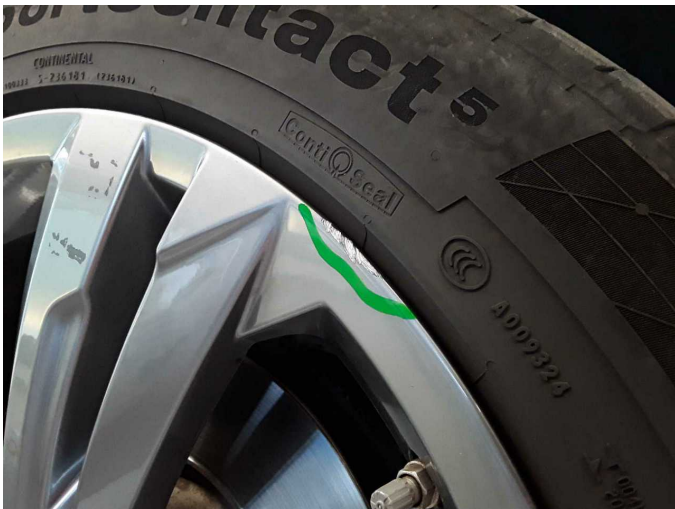
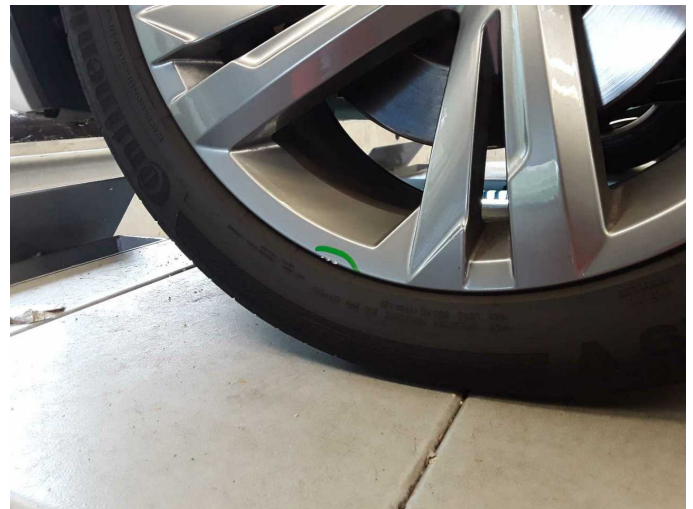
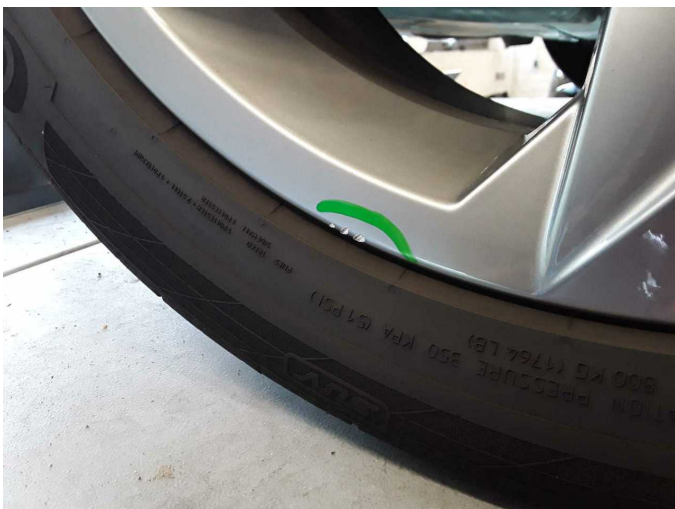
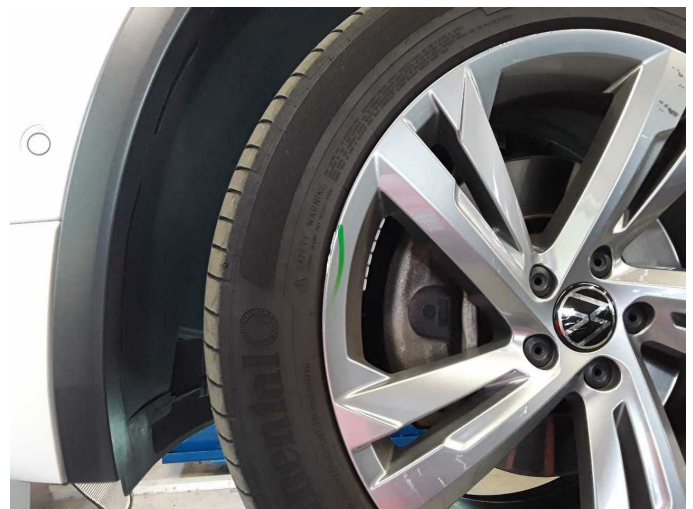
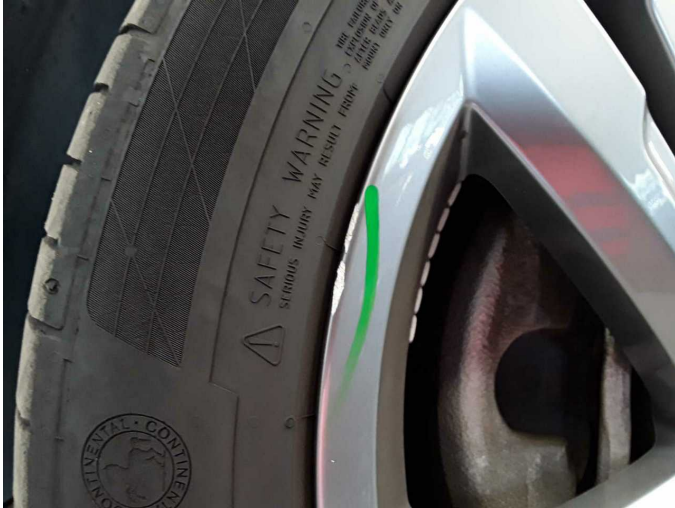
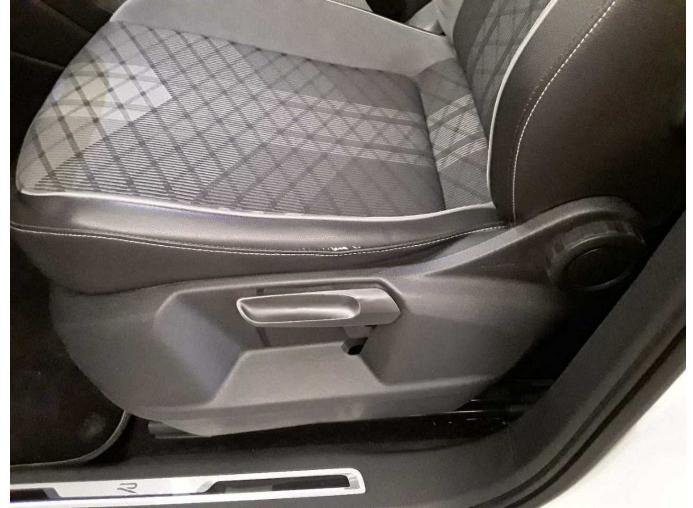
| No. | Component group | Description |
|---|---|---|
| 5 | Wheel / tyres | Alloy rim - front left side - Scratched - Loss in value |

**Damage 5:** Wheel / tyres: Alloy rim - front left side - Scratched - Loss in value

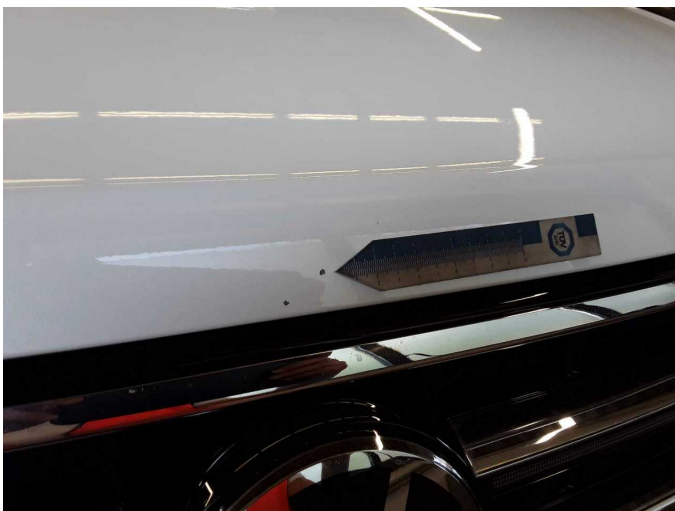
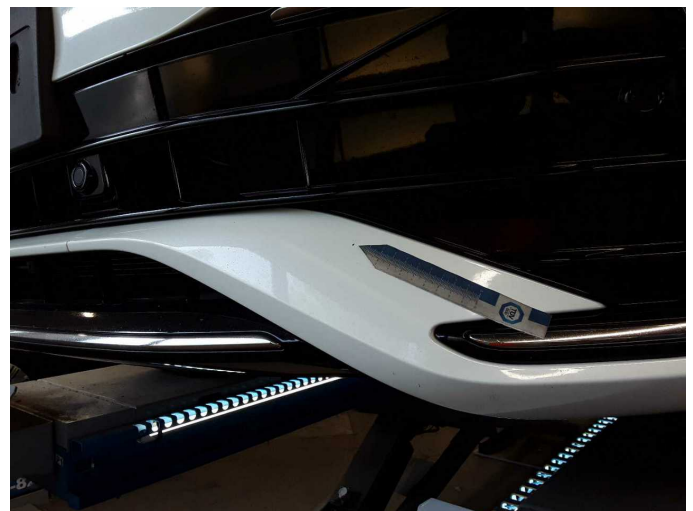
| No. | Component group | Description |
|---|---|---|
| 2 | Bonnet | Bonnet - Stone chips - No deduction |

**Wear and tear 2:** Bonnet: Bonnet - Stone chips - No deduction

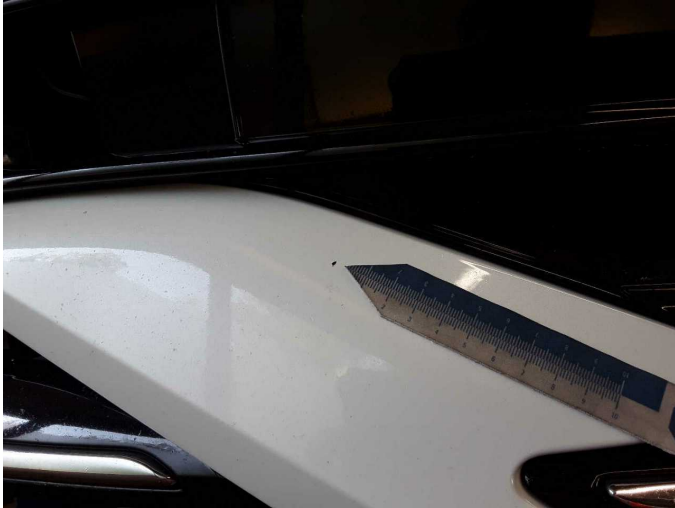
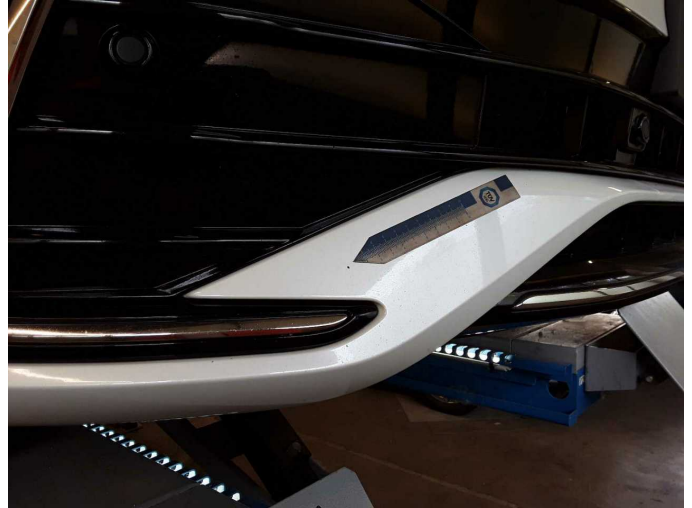
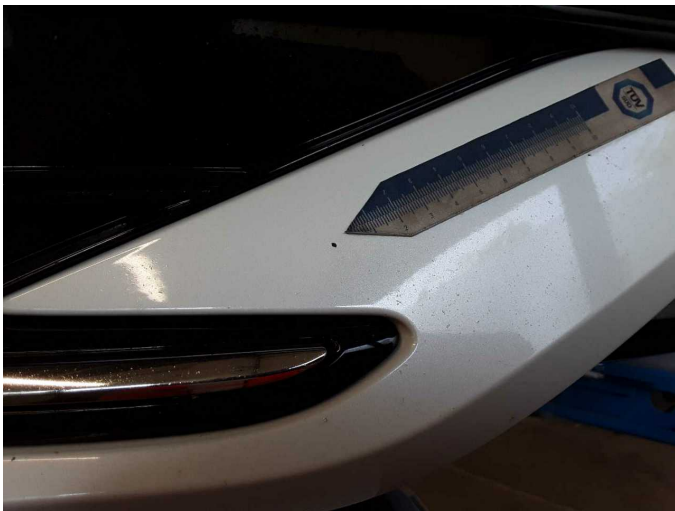
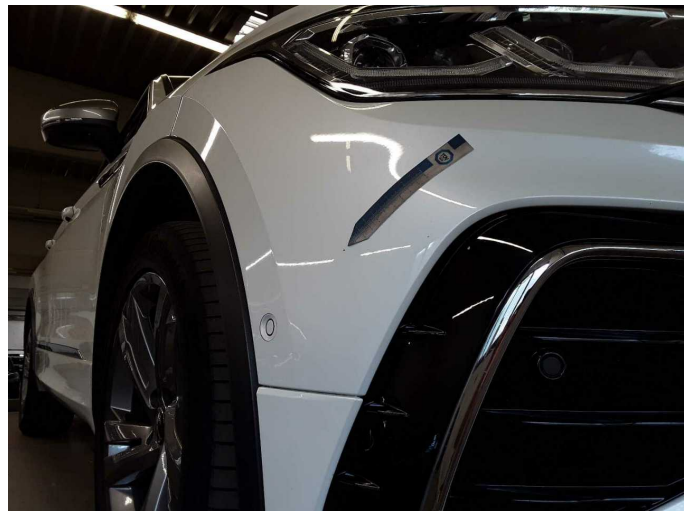
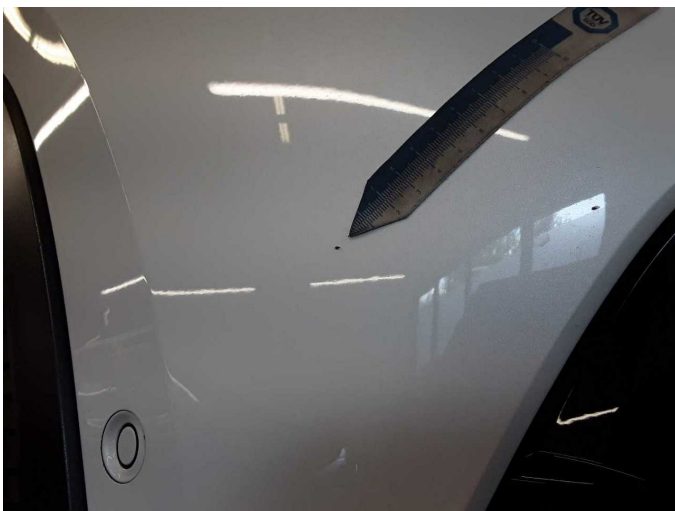
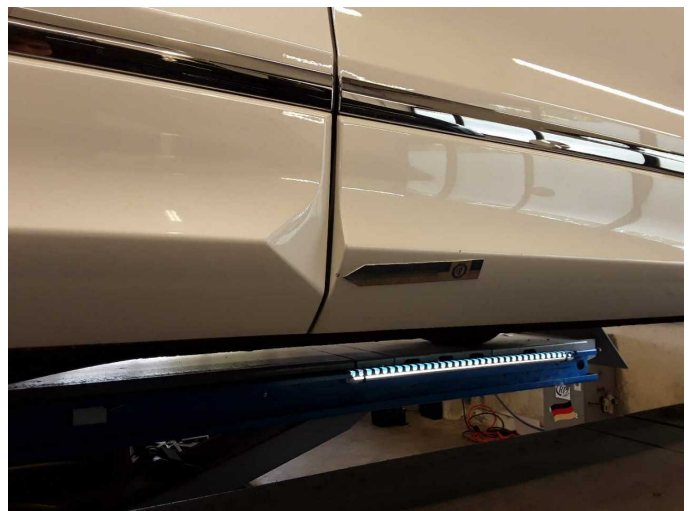
| No. | Component group | Description |
|---|---|---|
| 3 | Front bumper | Front bumper - Stone chips - No deduction |

**Wear and tear 3:** Front bumper: Front bumper - Stone chips - No deduction

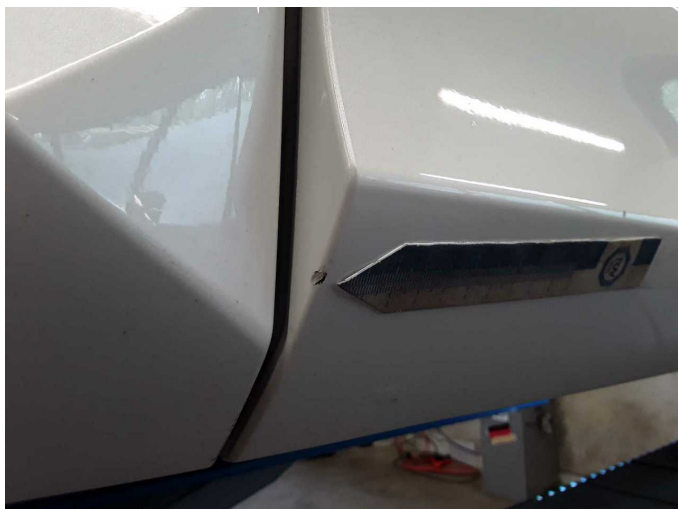
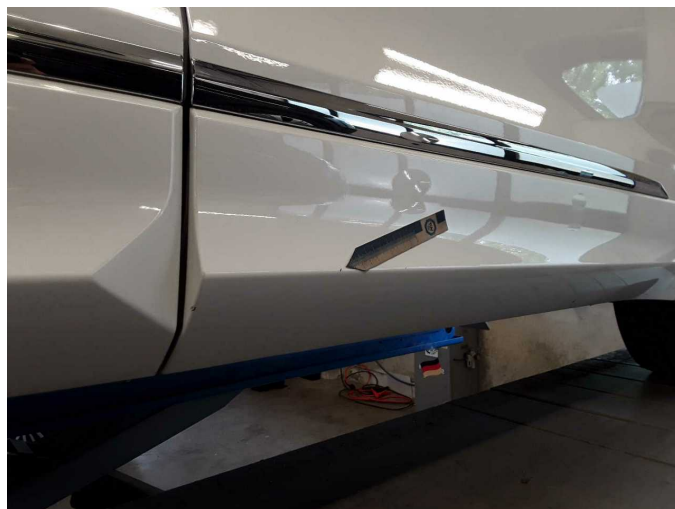
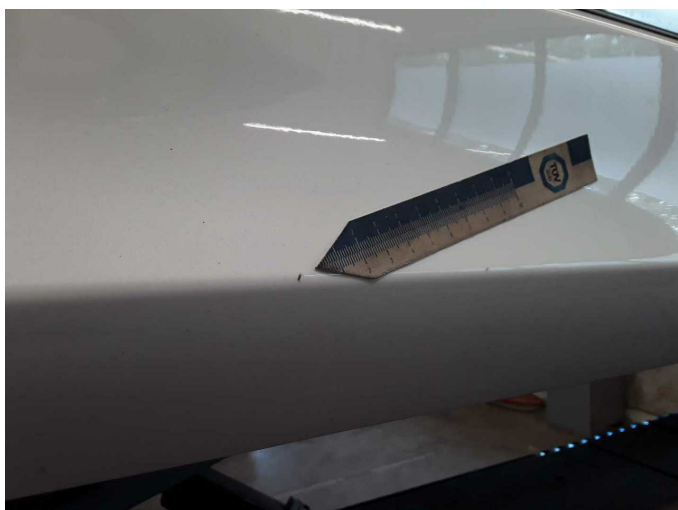
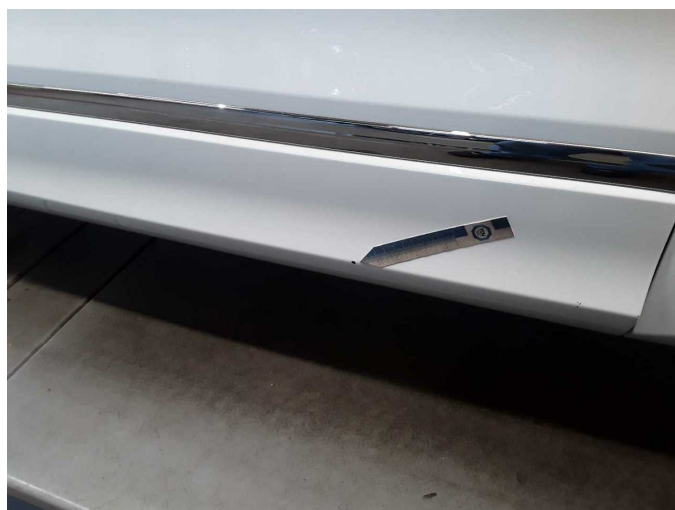
| No. | Component group | Description |
|---|---|---|
| 4 | Trim / covers | Door trim - front right side - Scratched - No deduction |

**Wear and tear 4:** Trim / covers: Door trim - front right side - Scratched - No deduction

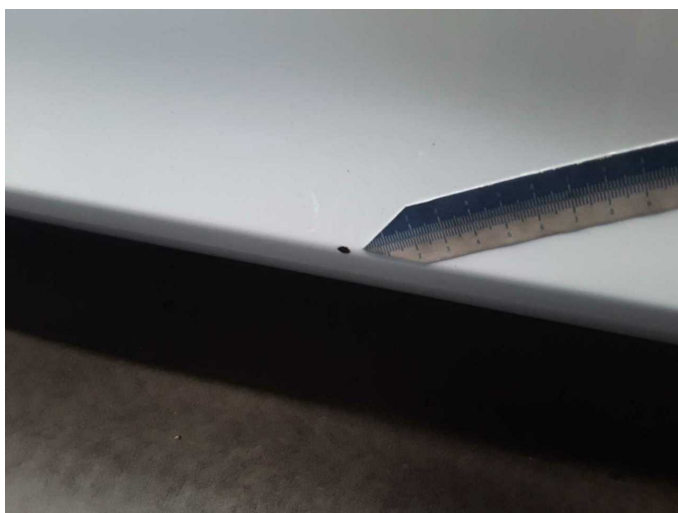
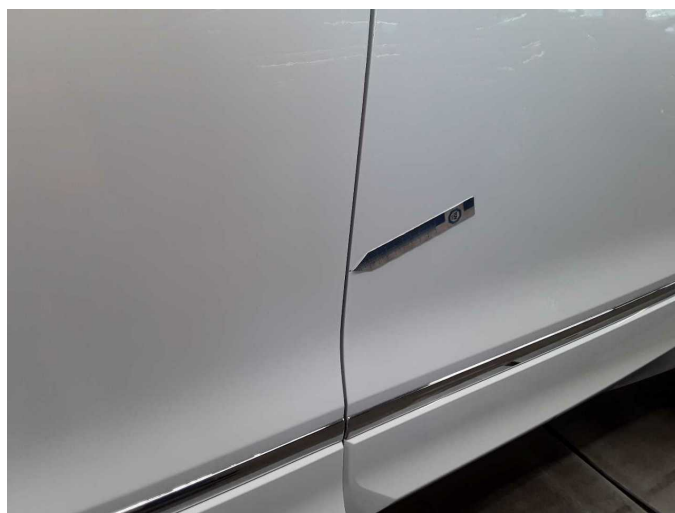
| No. | Component group | Description |
|---|---|---|
| 5 | Trim / covers | Door trim - front left side - Scratched - No deduction |

**Wear and tear 5:** Trim / covers: Door trim - front left side - Scratched - No deduction

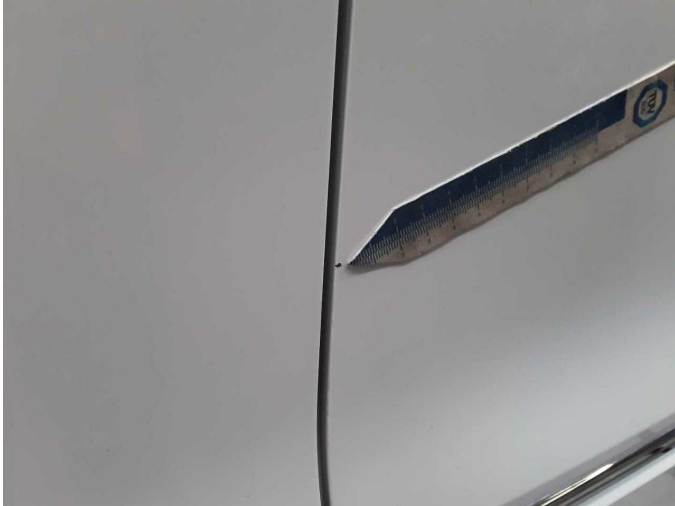
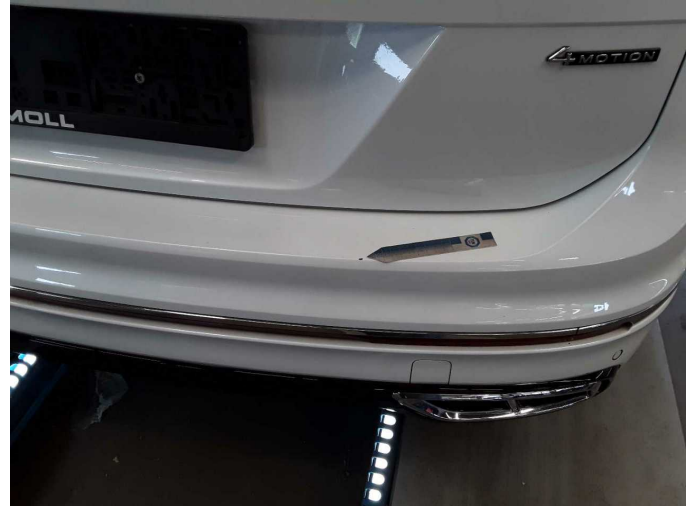
| No. | Component group | Description |
|---|---|---|
| 6 | Door - rear left side | Door - Stone chips - No deduction |

**Wear and tear 6:** Door - rear left side: Door - Stone chips - No deduction

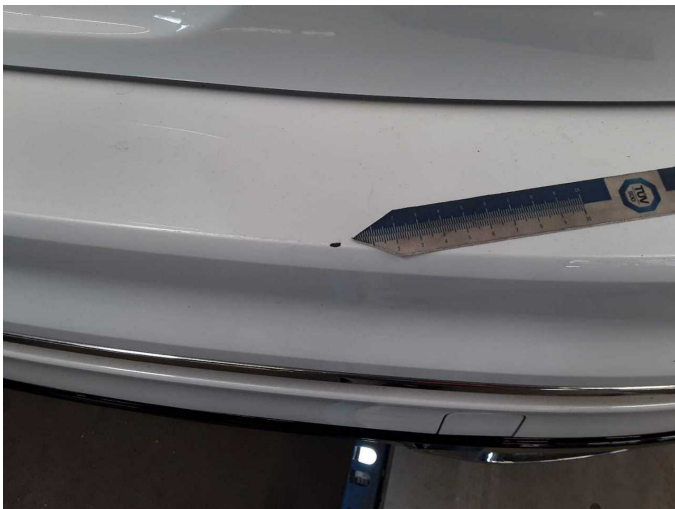
| No. | Component group | Description |
|---|---|---|
| 7 | Rear bumper | Rear bumper - Stone chips - No deduction |

**Wear and tear 7:** Rear bumper: Rear bumper - Stone chips - No deduction
