Expertise

Protocol number: 46679097  
Order No. / Reference: 26565870  
Inspection date: 15 Jul 2026

Manufacturer: Mercedes-Benz  
VIN: W1N4N1AB2RJ565083

Model: GLA 180 d 8G-DCT Entry

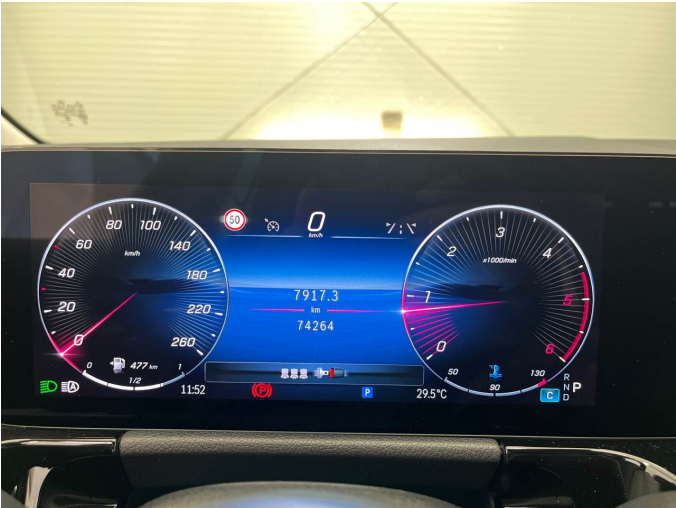
| Vehicle details | |
|---|---|
| Mileage (Read) | 74,264 km |

Figure 7: Instrument cluster

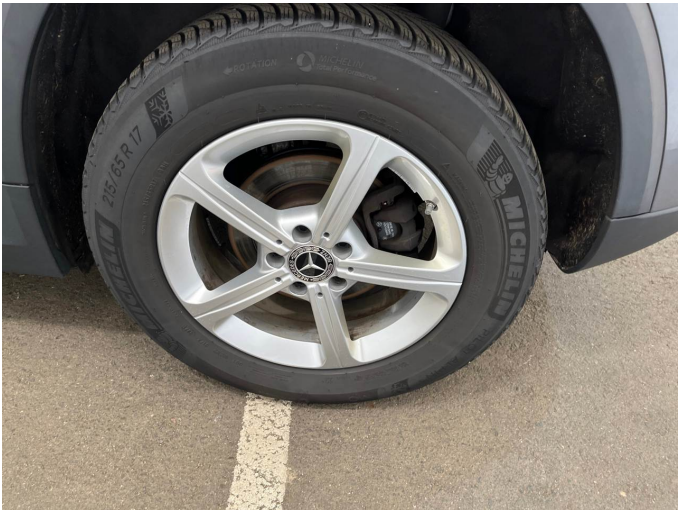
| # | Tyre size | Type of tyre | Manufacturer | Tread depth |
|---|---|---|---|---|
| 1) | 215/65 R17 99V | Summer tyres on Light alloy | Continental | 5mm / 5mm |
| 2) | 215/65 R17 99V | Summer tyres on Light alloy | Continental | 6mm / 6mm |

Figure 12: Mounted tyres

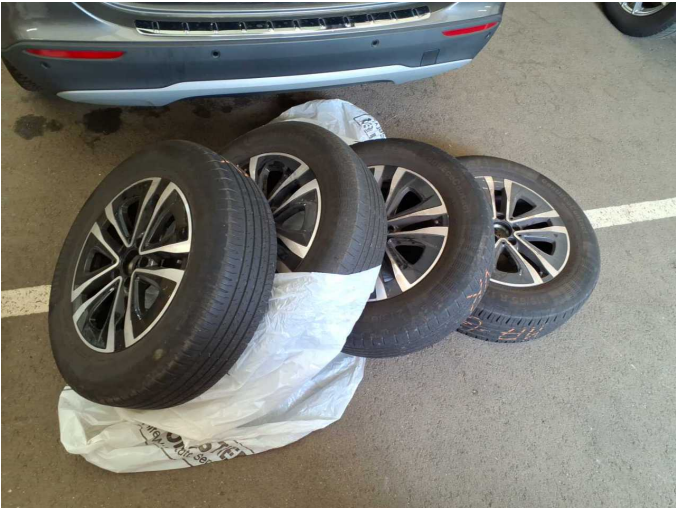
| # | Tyre size | Type of tyre | Manufacturer | Tread depth |
|---|---|---|---|---|
| 1) | 215/65 R17 99H | Winter tyres on Light alloy | Michelin | 6mm / 6mm |
| 2) | 215/65 R17 99H | Winter tyres on Light alloy | Michelin | 6mm / 6mm |

Figure 15: Additional tyres

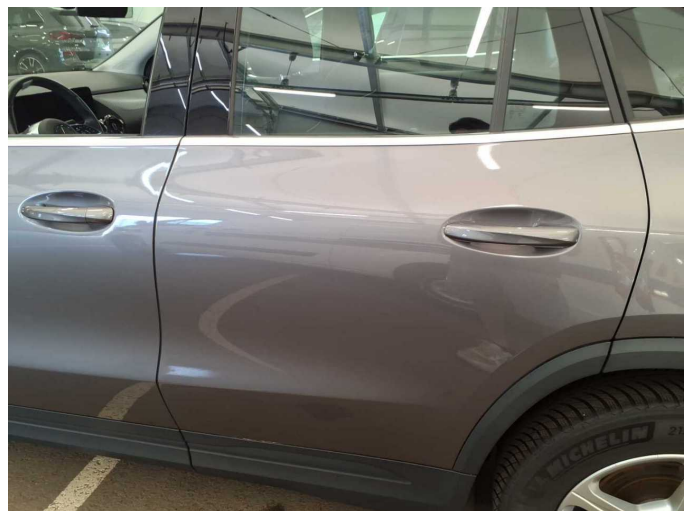
Damage 1: Door - rear left side: Door - Scratch(es) - Smart repair

| No. | Component group | Description |
|---|---|---|
| 1 | Door - rear left side | Door - Scratch(es) - Smart repair |

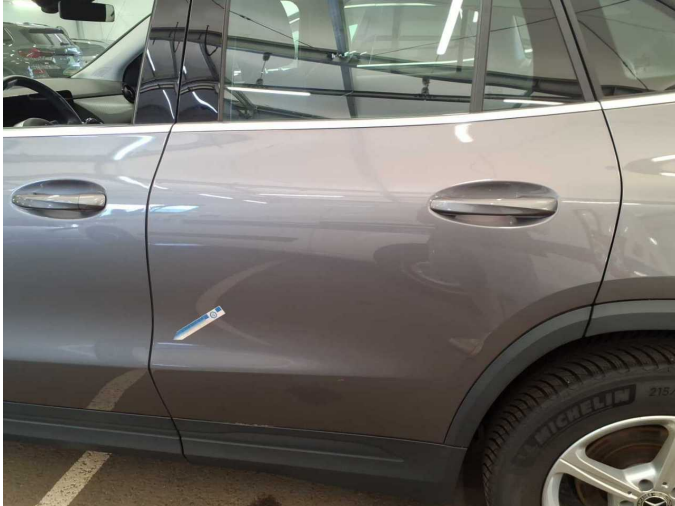
**Damage 1:** Door - rear left side: Door - Scratch(es) - Smart repair

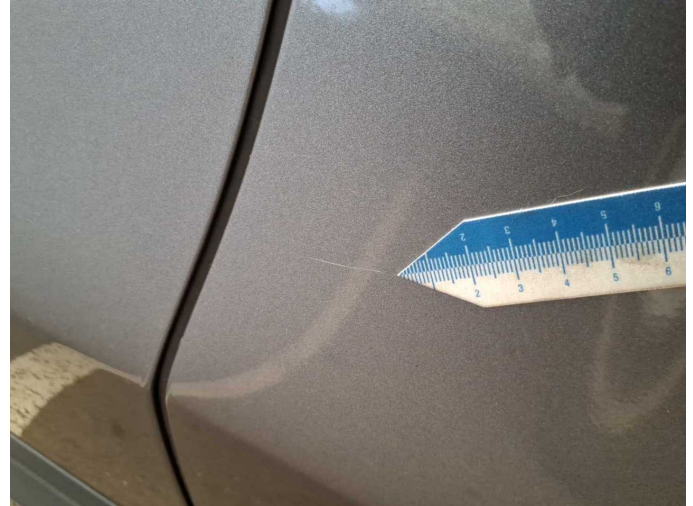
**Damage 1:** Door - rear left side: Door - Scratch(es) - Smart repair

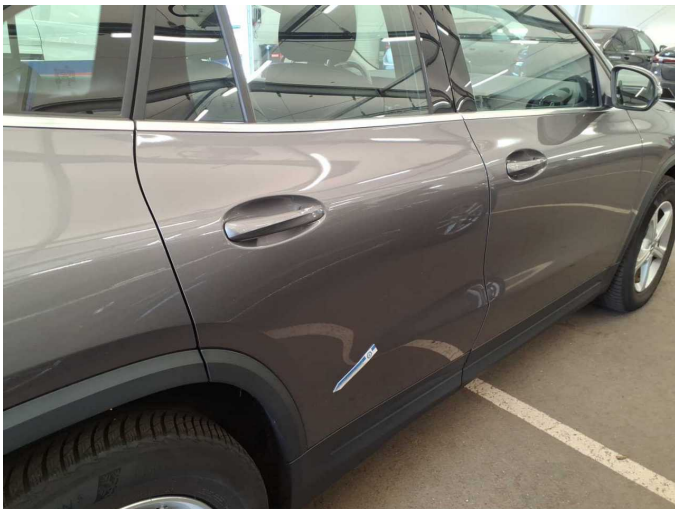
**Damage 2:** Door - rear right side: Door - Dent / paintcoat damage - Smart repair

| No. | Component group | Description |
|---|---|---|
| 2 | Door - rear right side | Door - Dent / paintcoat damage - Smart repair |

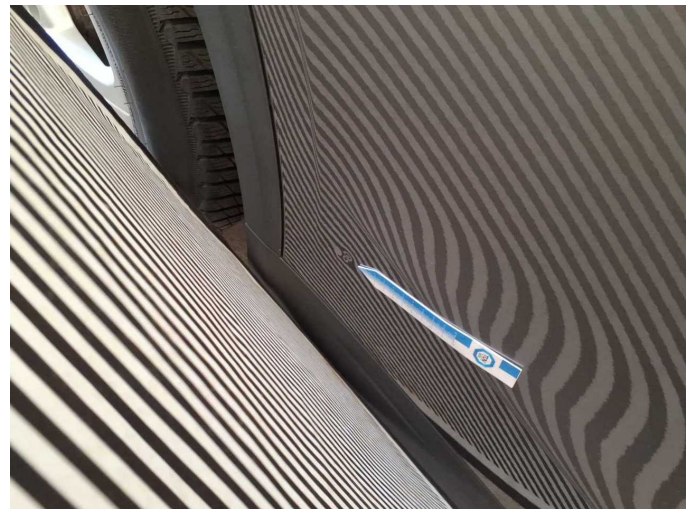
**Damage 2:** Door - rear right side: Door - Dent / paintcoat damage - Smart repair
