Expertise

Protocol number: 46055074
Order No. / Reference: 26528334
Inspection date: 17 Jun 2026

Manufacturer: Ford

Model: Focus 1.5 EcoBlue Start-Stopp-System Aut. TITANIUM X

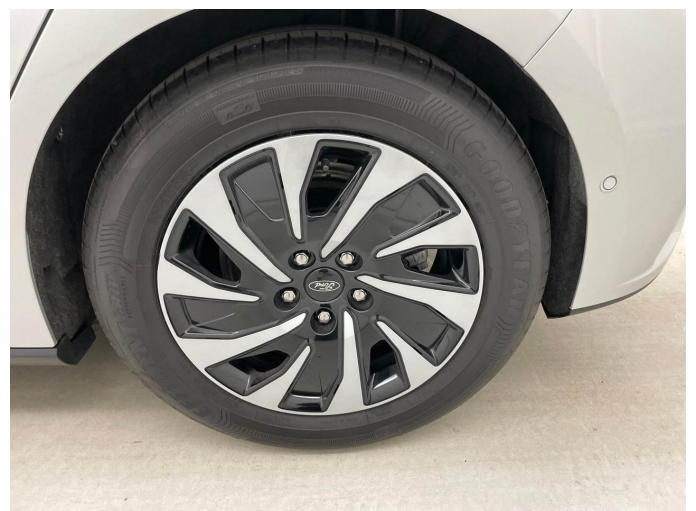
Figure 12: Mounted tyres

Mounted tyres				
#	Tyre size	Type of tyre	Manufacturer	Tread depth
1)	205/60 R16 92V	Summer tyres on Steel rim with wheel cover	Goodyear	6mm / 6mm
2)	205/60 R16 92V	Summer tyres on Steel rim with wheel cover	Goodyear	6mm / 6mm

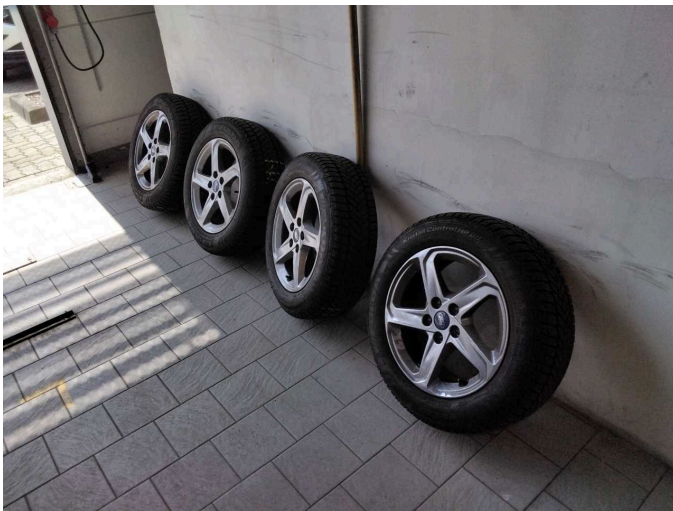
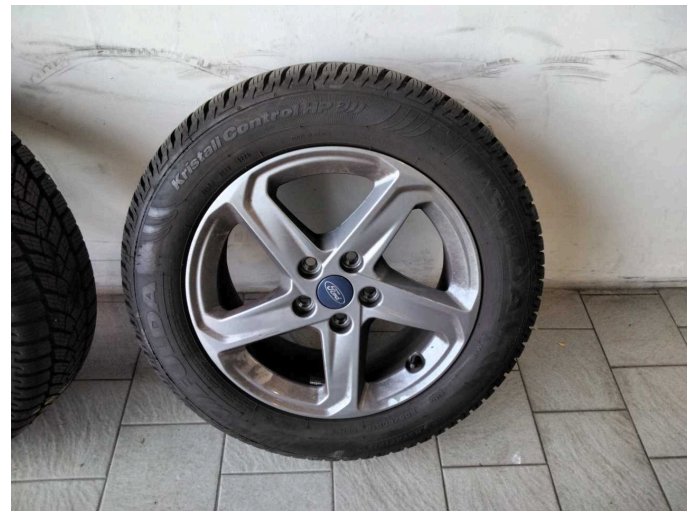
Figure 15: Additional tyres

Additional tyres				
#	Tyre size	Type of tyre	Manufacturer	Tread depth
1)	205/60 R16 92H	Winter tyres on Light alloy	Fulda	9mm / 9mm
2)	205/60 R16 92H	Winter tyres on Light alloy	Fulda	9mm / 9mm

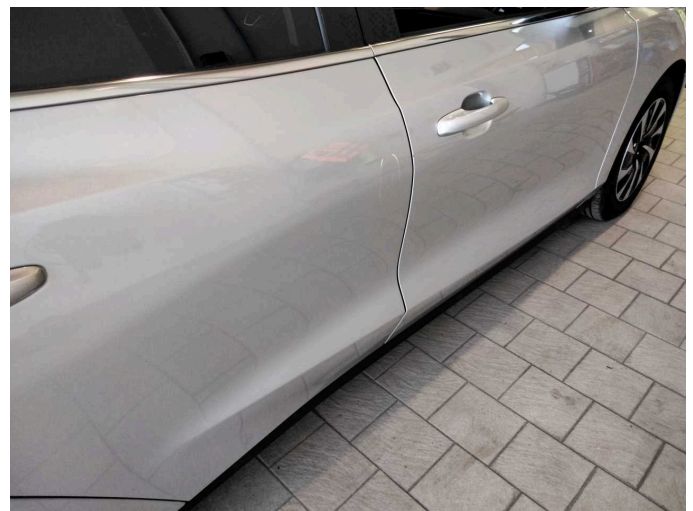
Damage 1: Door - rear right side: Door - dent(s) - Smart repair

No.	Component group	Description
1	Door - rear right side	Door - dent(s) - Smart repair

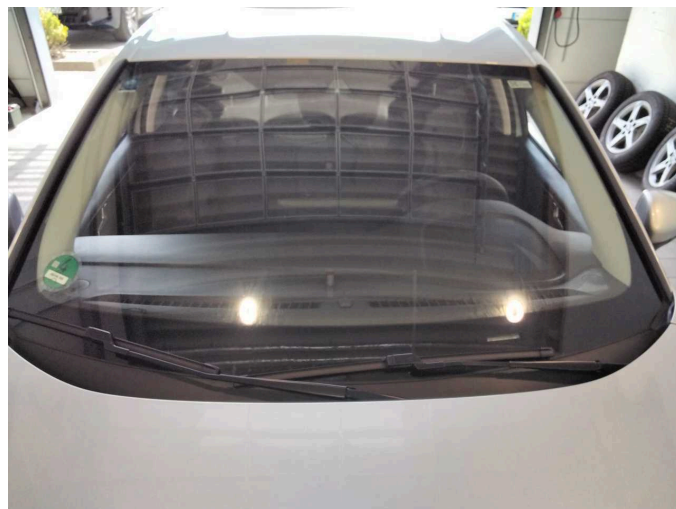
Wear and tear 1: Vehicle glazing: Windscreen - Stone chips - No deduction

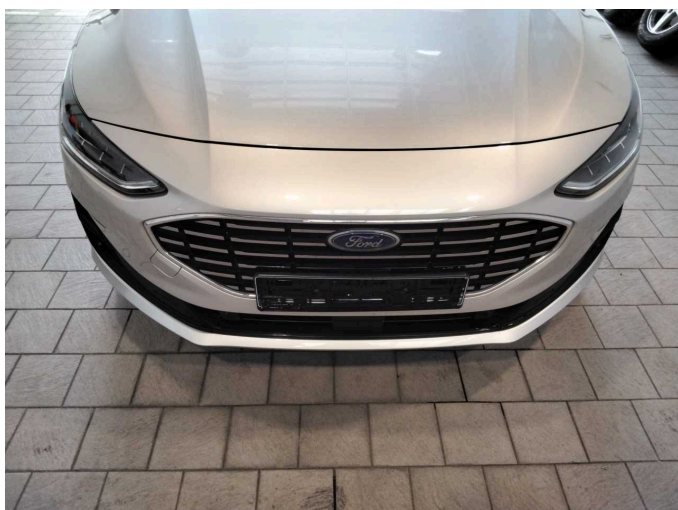
Wear and tear 3: Front bumper: Front bumper - Stone chips - No deduction

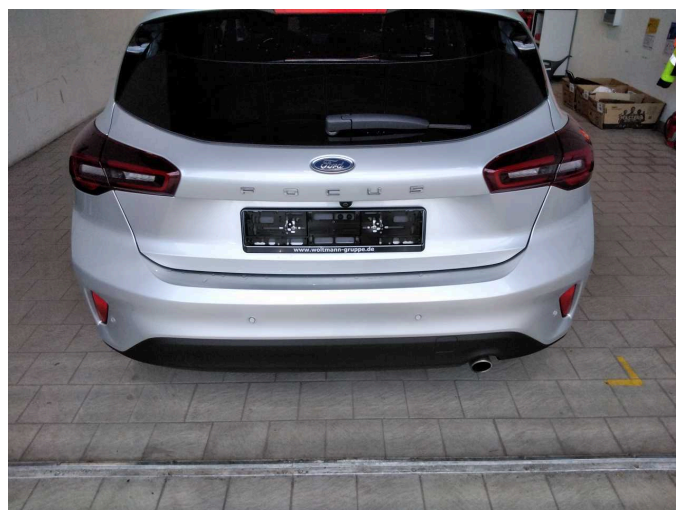
Wear and tear 4: Rear bumper: Rear bumper - Scratch(es) - No deduction
