Expertise

Protocol number: 46596625  
Order No. / Reference: 26631170  
Inspection date: 20 Jul 2026

Manufacturer: Audi  
VIN: WAUZZZF36P1012321

Model: Q3 35 TDI S tronic

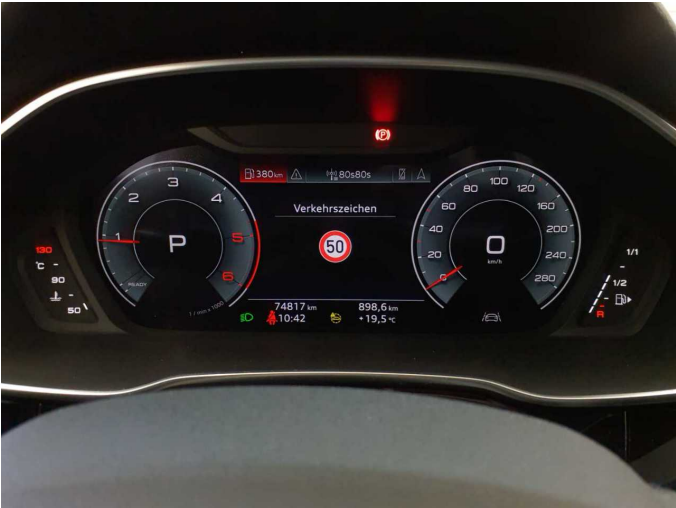
| Vehicle details | |
|---|---|
| Mileage (Read) | 74,817 km |

Figure 7: Instrument cluster

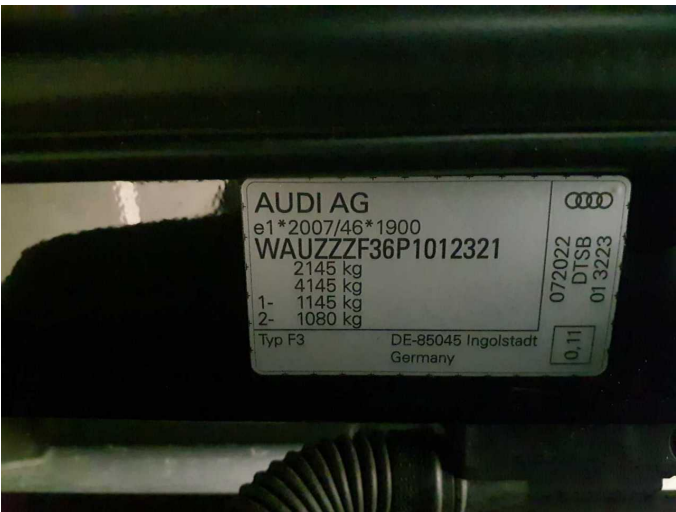
| VIN comparison | The vehicle identification number (VIN) was read from the vehicle and its conformity with the submitted documents was confirmed by the undersigned during the inspection. |

Figure 11: VIN

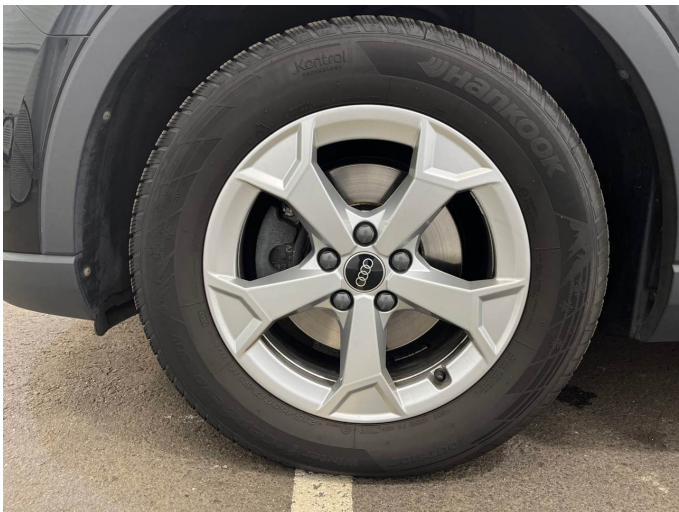
| # | Tyre size | Type of tyre | Manufacturer | Tread depth |
|---|---|---|---|---|
| 1) | 215/65 R17 99H | Winter tyres on Light alloy | Hankook | 5mm / 5mm |
| 2) | 215/65 R17 99H | Winter tyres on Light alloy | Hankook | 5mm / 5mm |

Figure 12: Mounted tyres

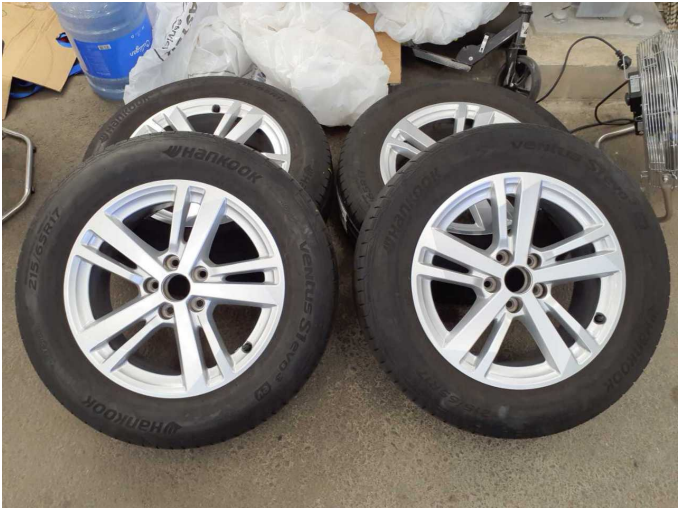
| # | Tyre size | Type of tyre | Manufacturer | Tread depth |
|---|---|---|---|---|
| 1) | 215/65 R17 99V | Summer tyres on Light alloy | Hankook | 4mm / 4mm |
| 2) | 215/65 R17 99V | Summer tyres on Light alloy | Hankook | 4mm / 4mm |

Figure 16: Additional tyres

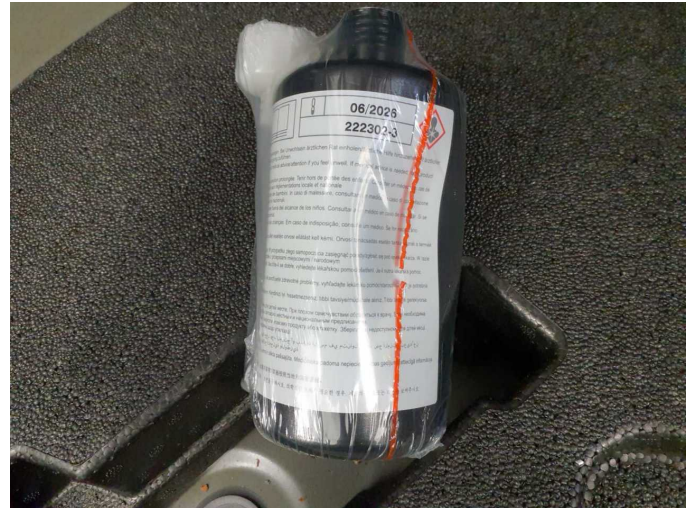
**Damage 1:** Equipment: Tirefit filler - Expired - Replace

| No. | Component group | Description |
|---|---|---|
| 1 | Equipment | Tirefit filler - Expired - Replace |

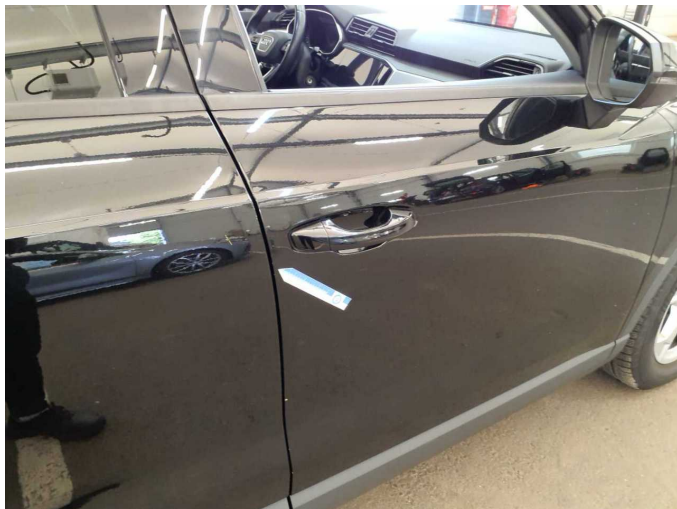
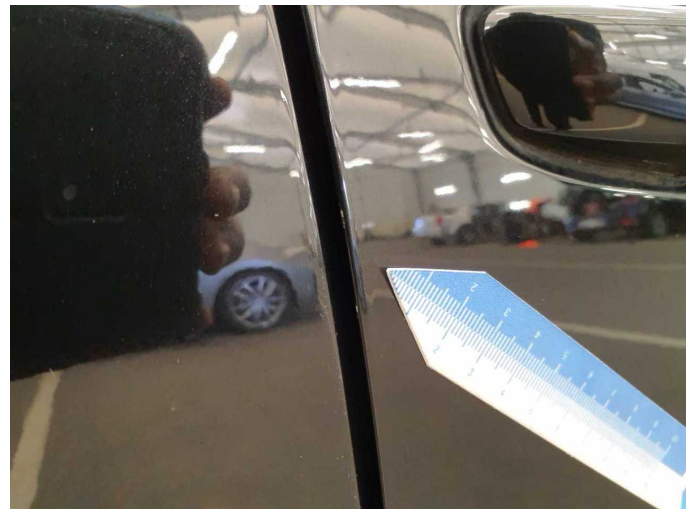
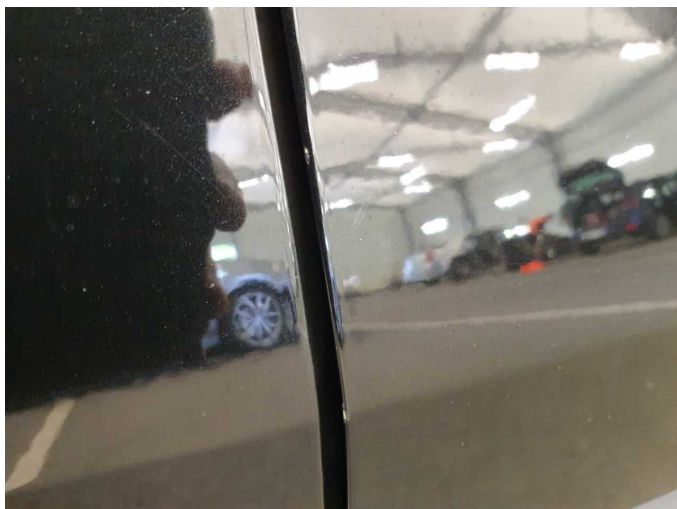
**Damage 2:** Door - front right side: Door edge - Scratch(es) - Smart repair

| No. | Component group | Description |
|---|---|---|
| 2 | Door - front right side | Door edge - Scratch(es) - Smart repair |

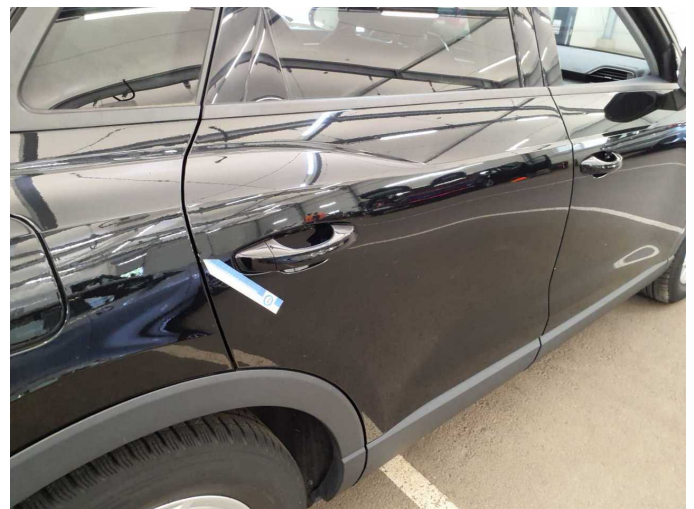
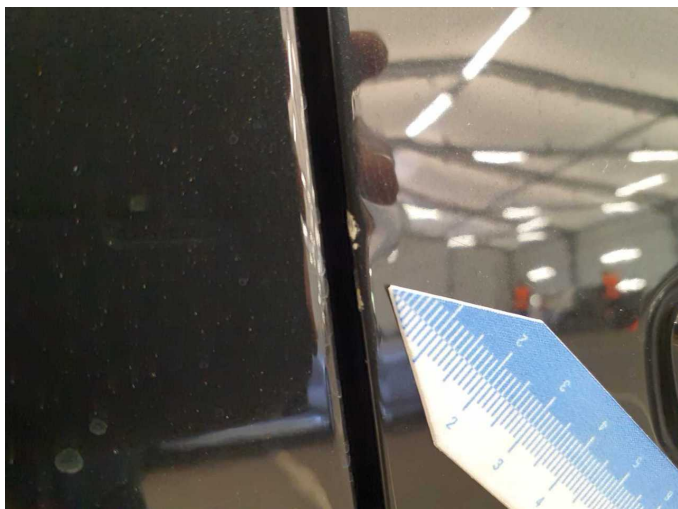
**Damage 3:** Door - rear right side: Door edge - Scratch(es) - Smart repair

| No. | Component group | Description |
|---|---|---|
| 3 | Door - rear right side | Door edge - Scratch(es) - Smart repair |

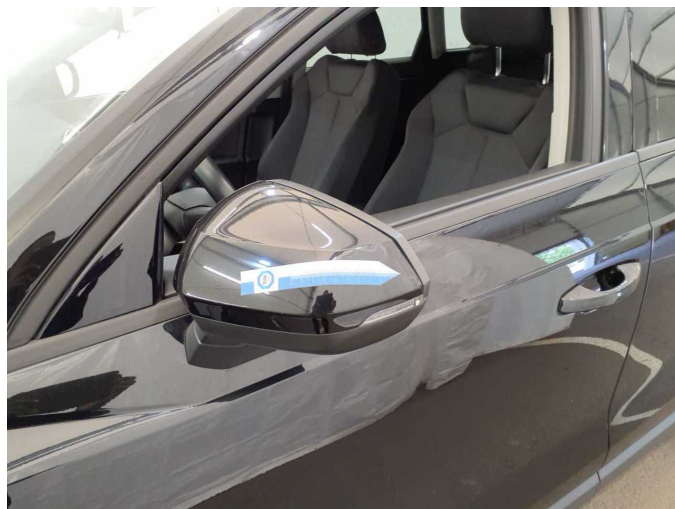
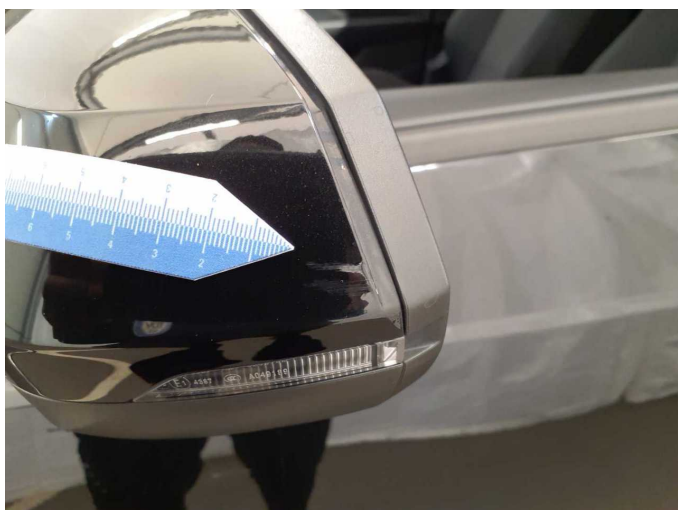
**Damage 4:** Wing mirror - left side: Cap - Scratch(es) - Smart repair

| No. | Component group | Description |
|---|---|---|
| 4 | Wing mirror - left side | Cap - Scratch(es) - Smart repair |

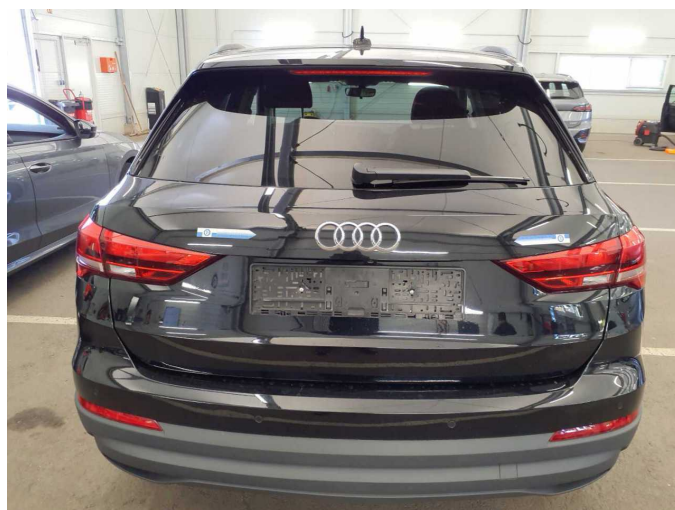
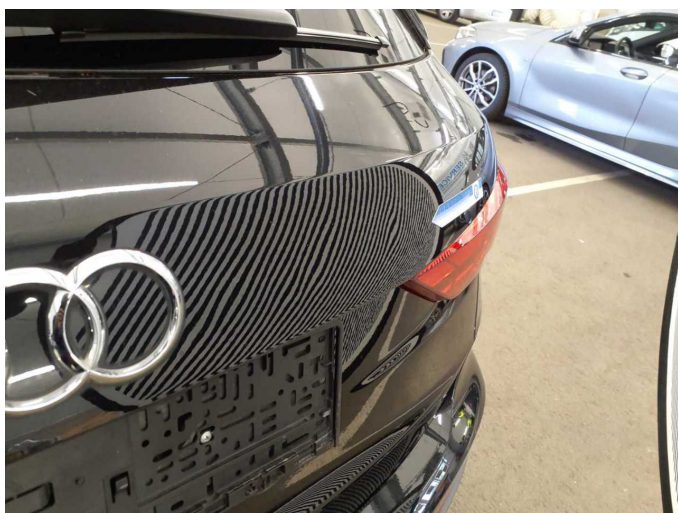
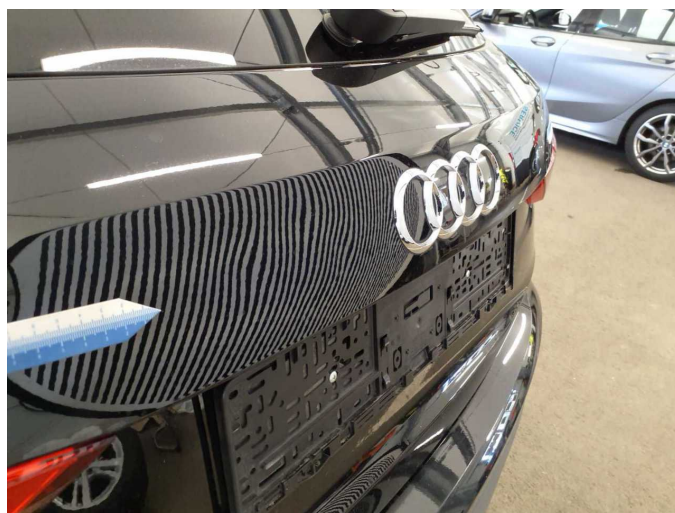
**Damage 5:** Boot lid / rear door: Boot lid - dent(s) - Smart repair

| No. | Component group | Description |
|---|---|---|
| 5 | Boot lid / rear door | Boot lid - dent(s) - Smart repair |

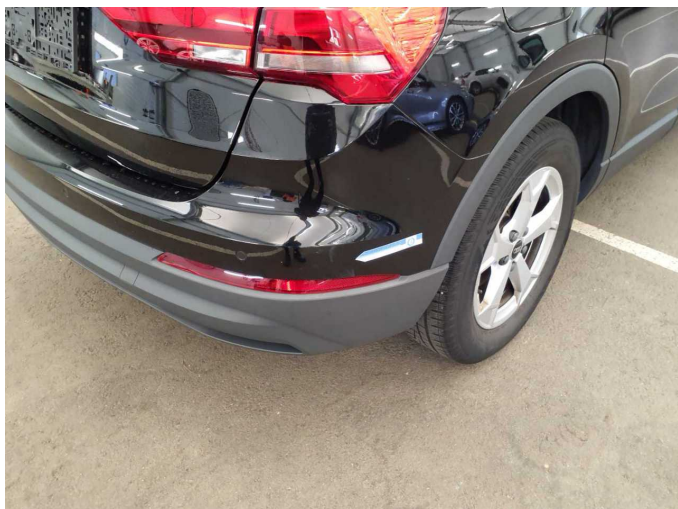
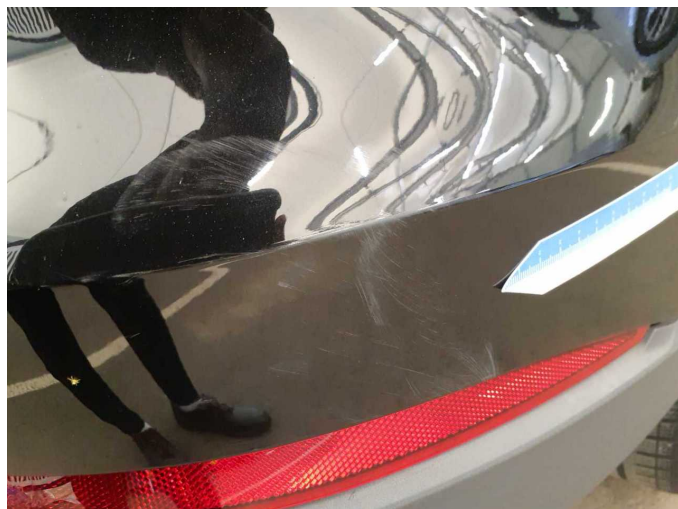
**Damage 6:** Rear bumper: Rear bumper - Scratch(es) - Paint

| No. | Component group | Description |
|---|---|---|
| 6 | Rear bumper | Rear bumper - Scratch(es) - Paint |
