Expertise

Protocol number: 46068725  
Order No. / Reference: 26528601  
Inspection date: 19 Jun 2026

Manufacturer: Volvo  
VIN: YV1UZZK5VDM1808904

Model: XC60 B4 D Geartronic RDesign

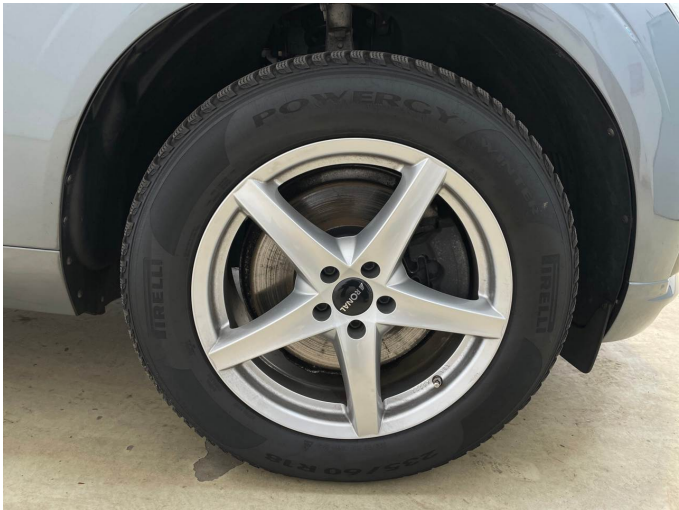
Figure 12: Mounted tyres

| Tyres | | | | |
|---|---|---|---|---|
| 1) | 235/60 R18 107H | Winter tyres on Light alloy | Pirelli | 5mm / 5mm |
| 2) | 235/60 R18 107H | Winter tyres on Light alloy | Pirelli | 7mm / 7mm |

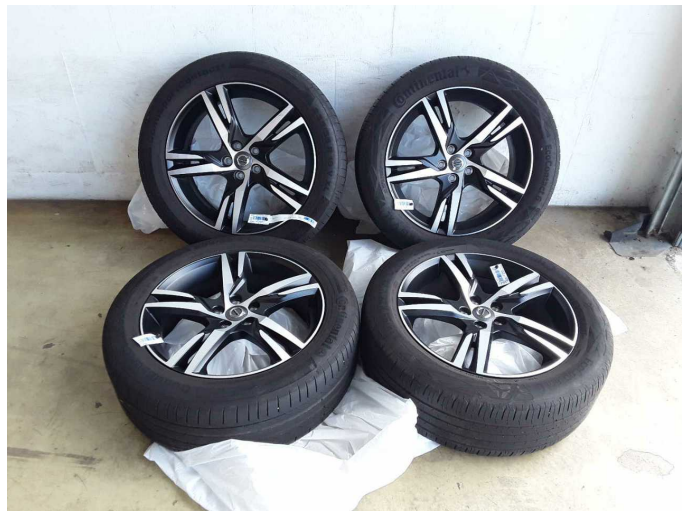
Figure 16: Additional tyres

| Tyres | | | | |
|---|---|---|---|---|
| 1) | 235/55 R19 105V | Summer tyres on Light alloy | Continental | 3mm / 3mm |
| 2) | 235/55 R19 105V | Summer tyres on Light alloy | Continental | 4mm / 4mm |

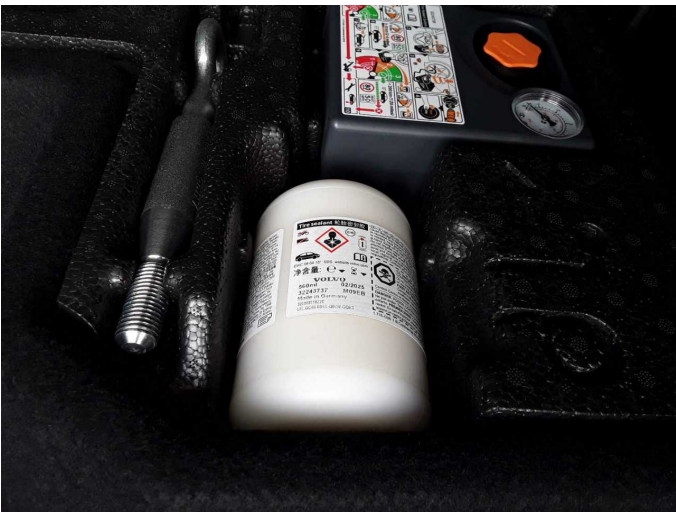
| No. | Component group | Description |
|---|---|---|
| 1 | Equipment | Tirefit filler - Expired - Replace |

Damage 1: Equipment: Tirefit filler - Expired - Replace

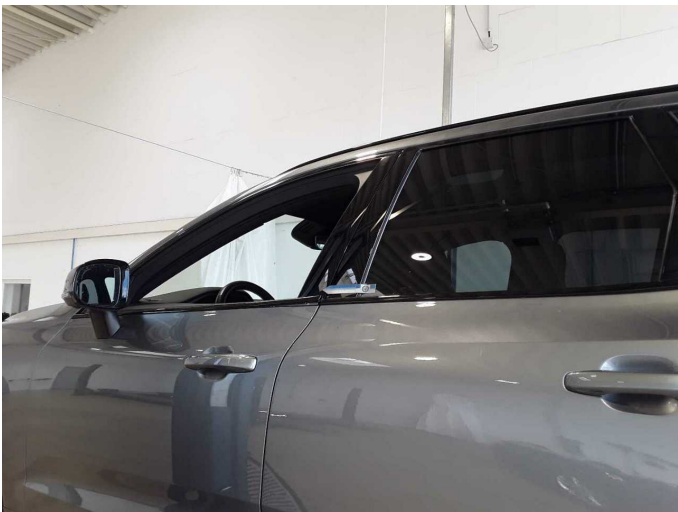
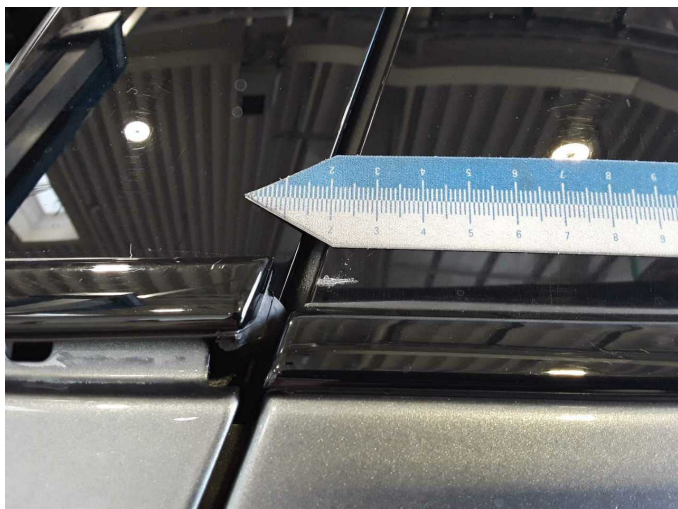
| No. | Component group | Description |
|---|---|---|
| 2 | Trim / covers | Brightware / decorative strip (Scheibe hinten links) - Scratch(es) - Replace |

Damage 2: Trim / covers: Brightware / decorative strip (Scheibe hinten links) - Scratch(es) - Replace

**Damage 2:** Trim / covers: Brightware / decorative strip (Scheibe hinten links) - Scratch(es) - Replace

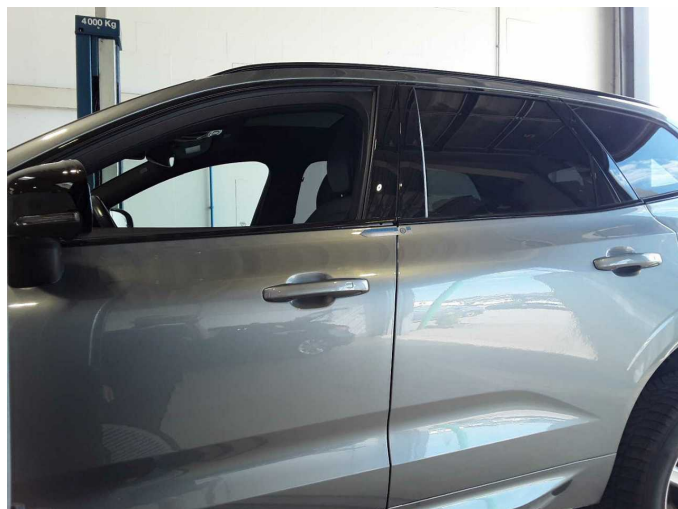
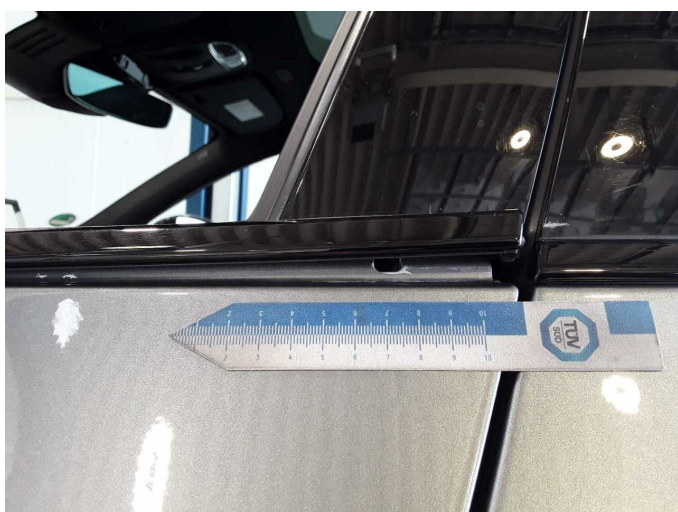
| No. | Component group | Description |
|---|---|---|
| 3 | Door - front left side | Strip - outer - Deformed - Replace |

**Damage 3:** Door - front left side: Strip - outer - Deformed - Replace

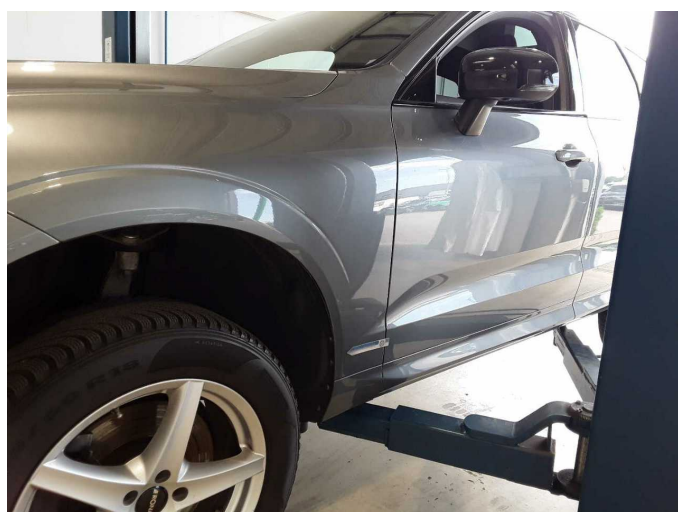
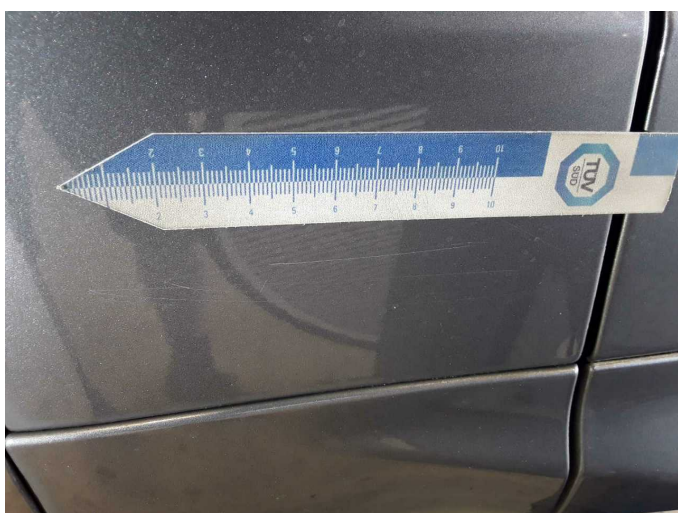
| No. | Component group | Description |
|---|---|---|
| 4 | Mudguard - left side | Mudguard - left side - Scratch(es) - Smart repair |

**Damage 4:** Mudguard - left side: Mudguard - left side - Scratch(es) - Smart repair

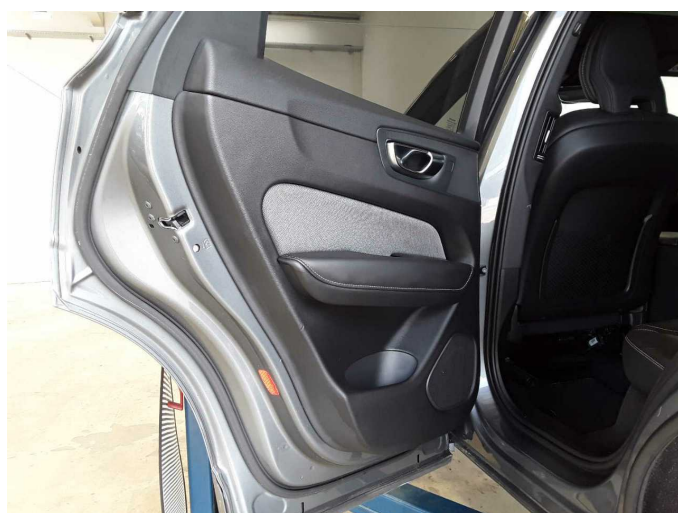
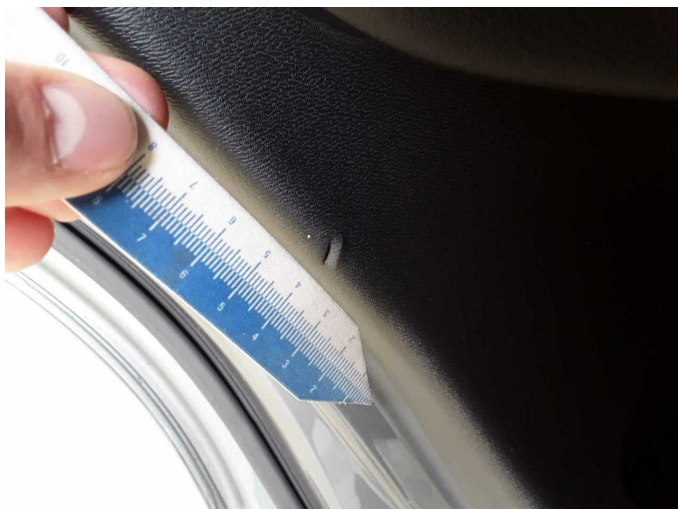
| No. | Component group | Description |
|---|---|---|
| 5 | Trim / covers | Door trim - rear left side - Loss in value |

**Damage 5:** Trim / covers: Door trim - rear left side - Loss in value

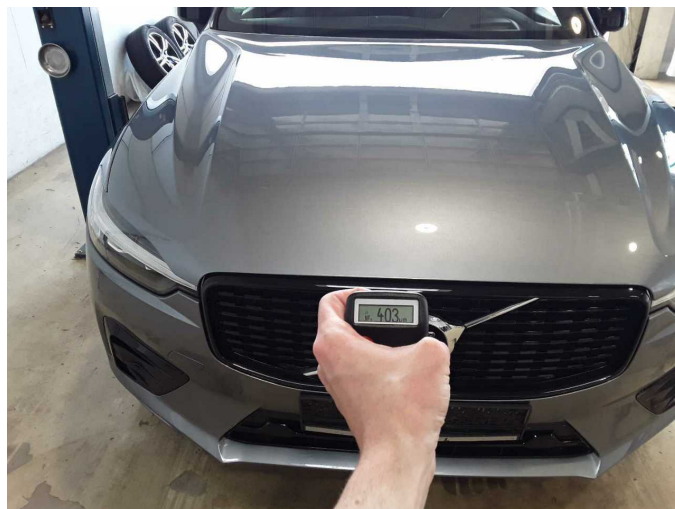
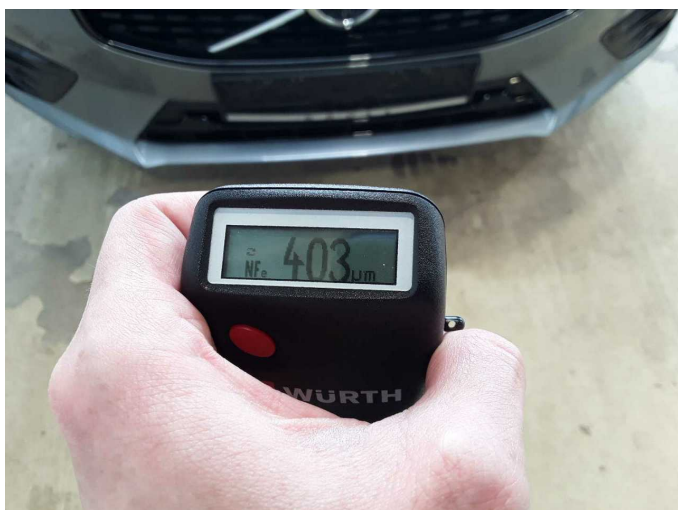
1 Bonnet, Professionally carried out, Invoice of repair done Non-existent

| Bonnet | 403 µm | Side panel - rear left side | 356 µm |

**Repainting 1:** Bonnet

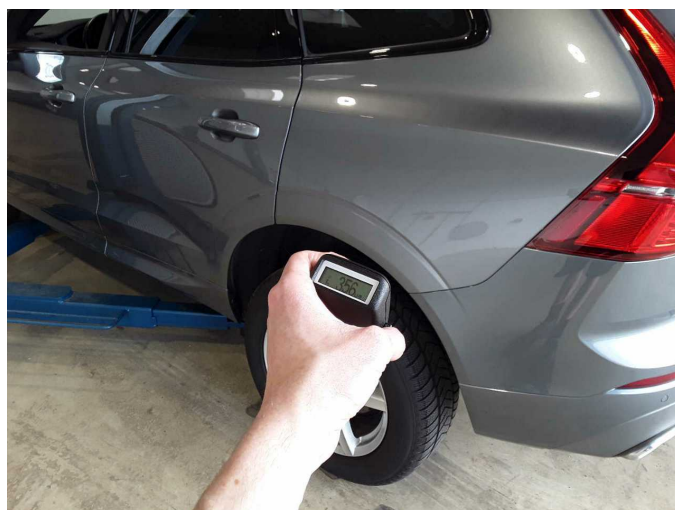
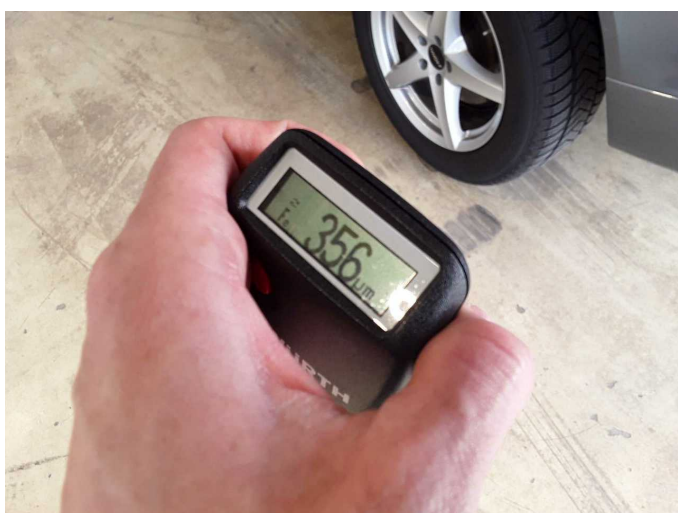
2 Side panel - rear left side, Professionally carried out, Invoice of repair done Non-existent

**Repainting 2:** Side panel - rear left side

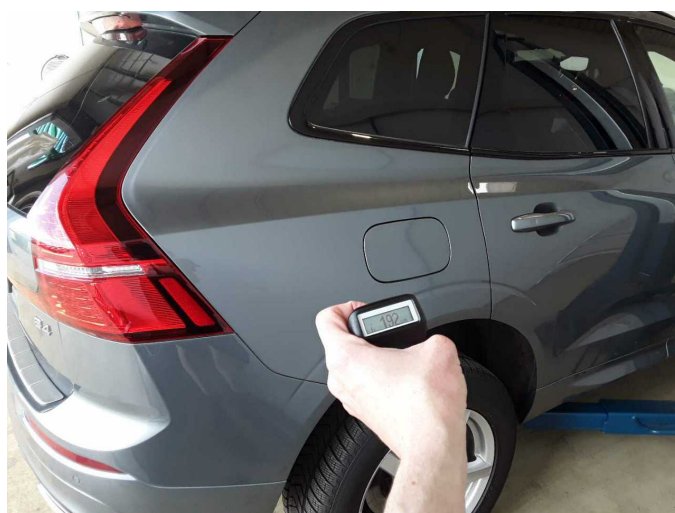
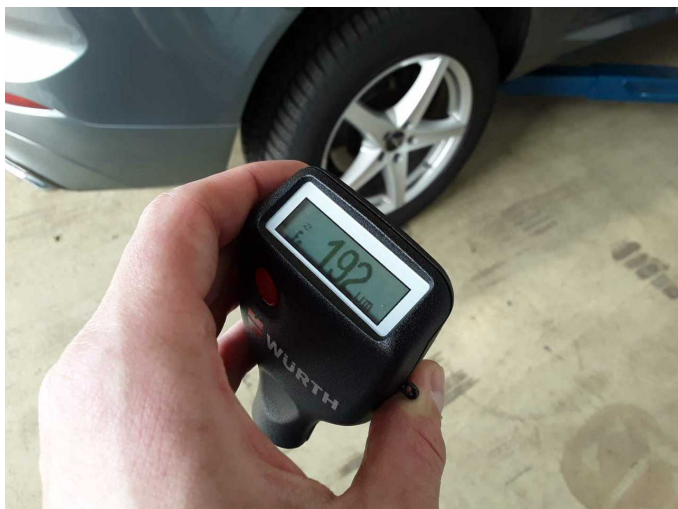
3 Side panel - rear right side, Professionally carried out, Invoice of repair done Non-existent

| Side panel - rear right side | 192 µm | Door - rear left side | 340 µm |

**Repainting 3:** Side panel - rear right side

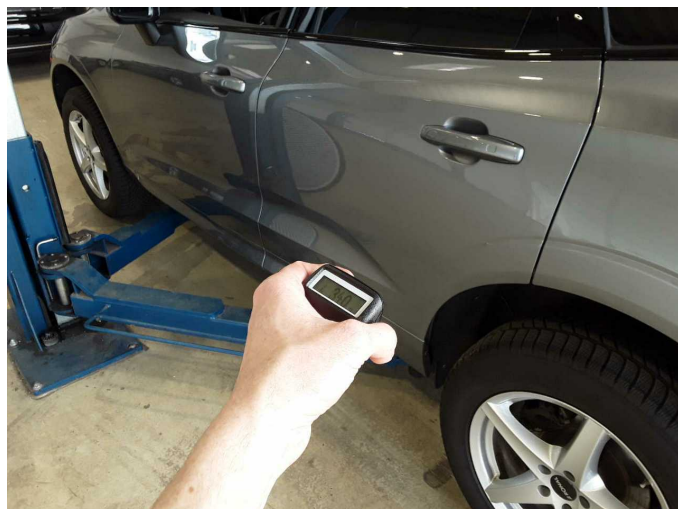
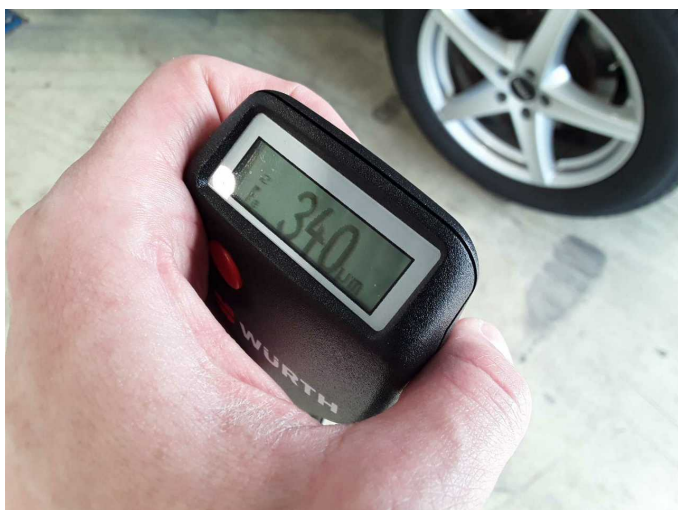
4 Door - rear left side, Professionally carried out, Invoice of repair done Non-existent

**Repainting 4:** Door - rear left side

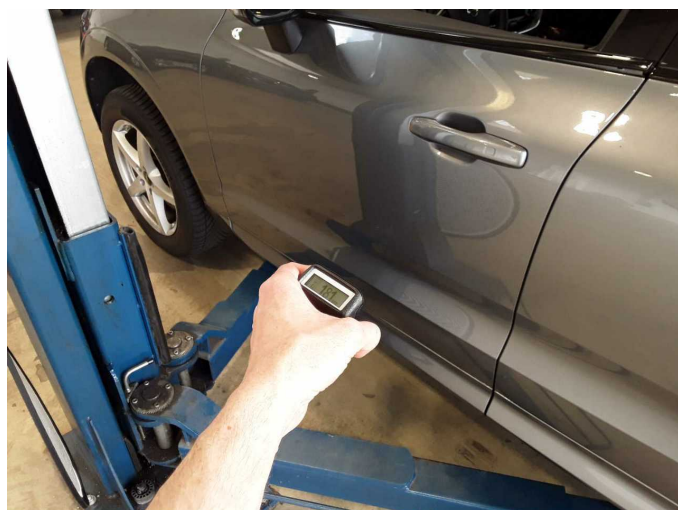
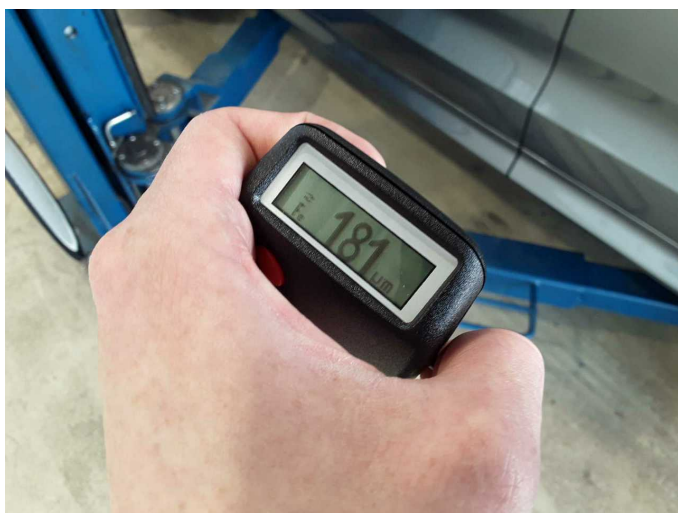
5 Door - front left side, Professionally carried out, Invoice of repair done Non-existent

| Door - front left side | 181 µm | | |

**Repainting 5:** Door - front left side
