Expertise

Protocol number: 46179753  
Order No. / Reference: 26562676  
Inspection date: 26 Jun 2026

| Manufacturer: Ford | Model: Focus Turnier 2.0 EcoBlue Start-Stopp-System Aut. ST-LINE |
| VIN: WF0PXXGCHPLY70933 | |

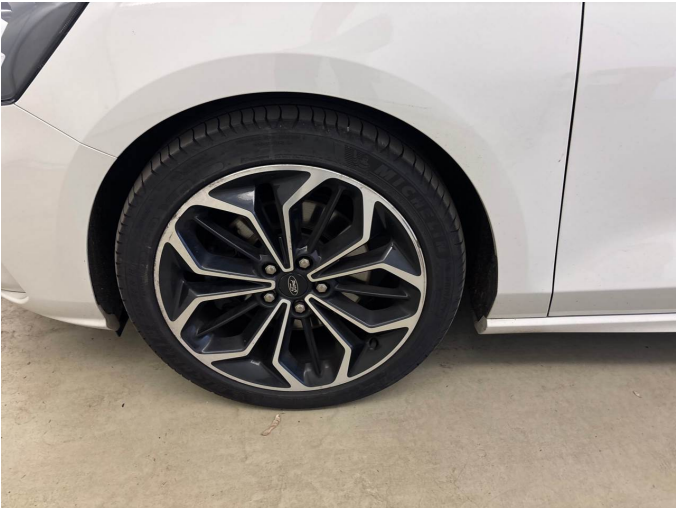
Figure 13: Mounted tyres

| # | Tyre size | Type of tyre | Manufacturer | Tread depth |
|---|---|---|---|---|
| 1) | 235/40 R18 95W | Summer tyres on Light alloy | Michelin | 4mm / 4mm |
| 2) | 235/40 R18 95W | Summer tyres on Light alloy | Michelin | 4mm / 4mm |

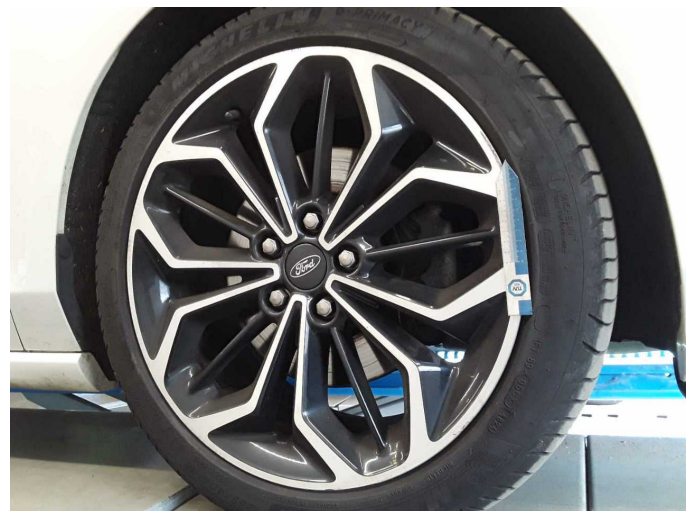
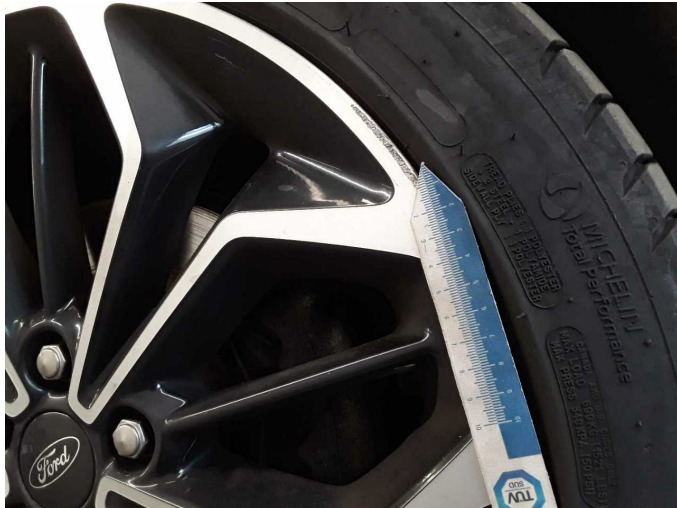
| No. | Component group | Description |
|---|---|---|
| 2 | Wheel / tyres | Alloy rim - front right side - Scratched - Loss in value |

**Damage 2:** Wheel / tyres: Alloy rim - front right side - Scratched - Loss in value

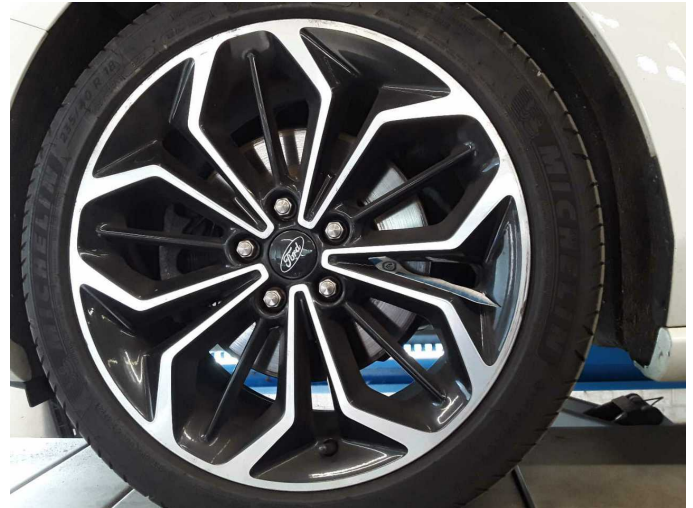
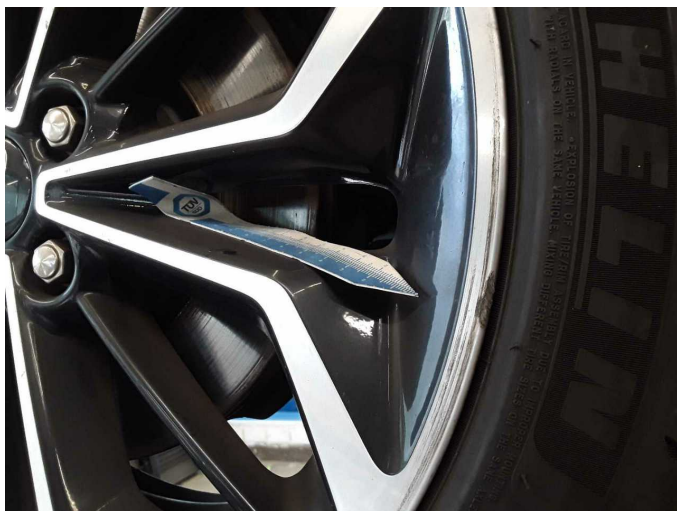
| No. | Component group | Description |
|---|---|---|
| 3 | Wheel / tyres | Alloy rim - front left side - Scratched - Loss in value |

**Damage 3:** Wheel / tyres: Alloy rim - front left side - Scratched - Loss in value

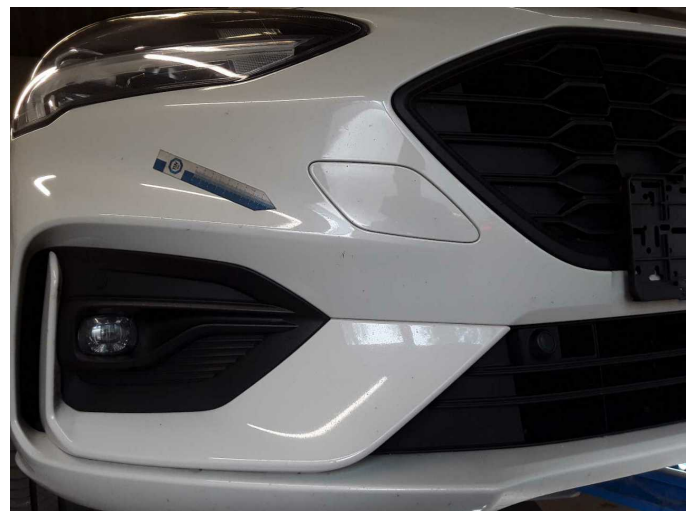
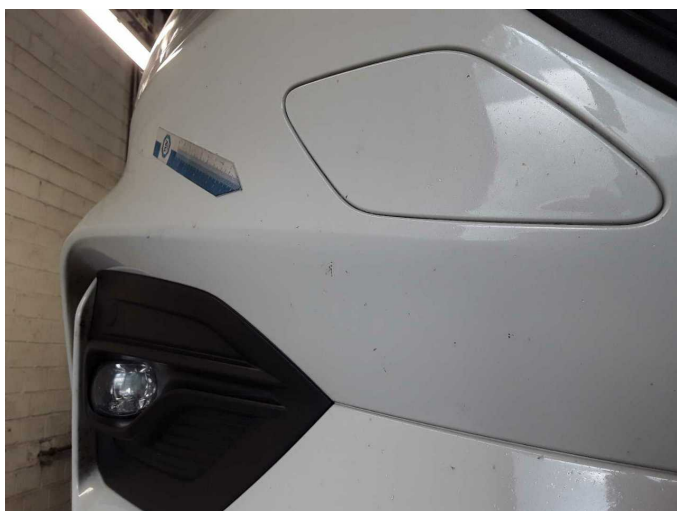
| No. | Component group | Description |
|---|---|---|
| 1 | Front bumper | Front bumper - Stone chips - No deduction |

**Wear and tear 1:** Front bumper: Front bumper - Stone chips - No deduction

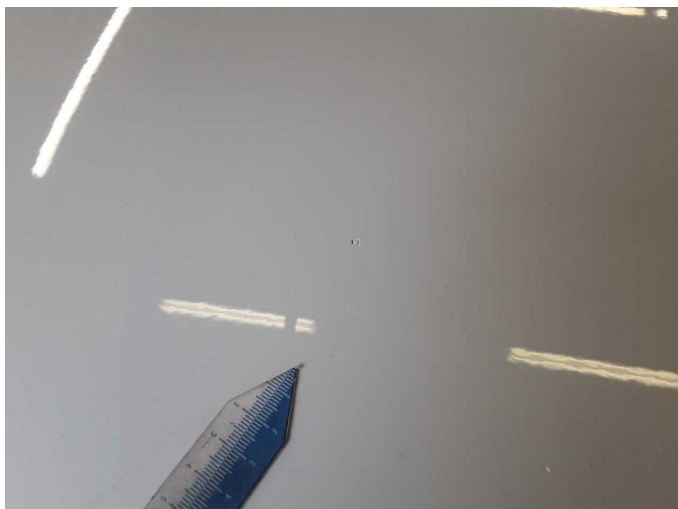
| No. | Component group | Description |
|---|---|---|
| 2 | Bonnet | Bonnet - Stone chips - No deduction |

**Wear and tear 2:** Bonnet: Bonnet - Stone chips - No deduction
