Expertise

Protocol number: 46044532
Order No. / Reference: 26518268
Inspection date: 19 Jun 2026

Model: Tarraco 2.0 TDI SCR DSG Xperience

VIN: VSSZZKN4PW000972

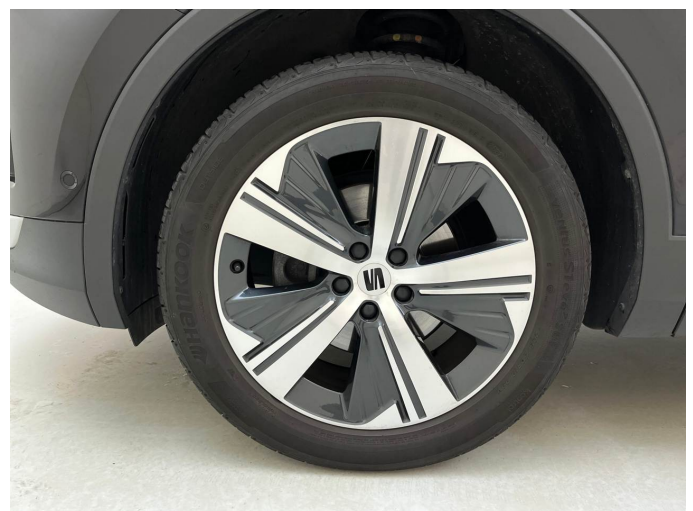
Figure 12: Mounted tyres

Mounted tyres				
#	Tyre size	Type of tyre	Manufacturer	Tread depth
1)	235/50 R19 99V	Summer tyres on Light alloy	Hankook	4mm / 4mm
2)	235/50 R19 99V	Summer tyres on Light alloy	Hankook	6mm / 6mm
Additional tyres				
#	Tyre size	Type of tyre	Manufacturer	Tread depth
1)	215/65 R17 103H	Winter tyres on Light alloy	Pirelli	7mm / 7mm
2)	215/65 R17 103H	Winter tyres on Light alloy	Pirelli	7mm / 7mm
Replacement				
Typ	Tyre size	Type of tyre	Manufacturer	Tread depth
N	145/85 R18 103M	Summer tyres on Steel	Sonstige	4 mm

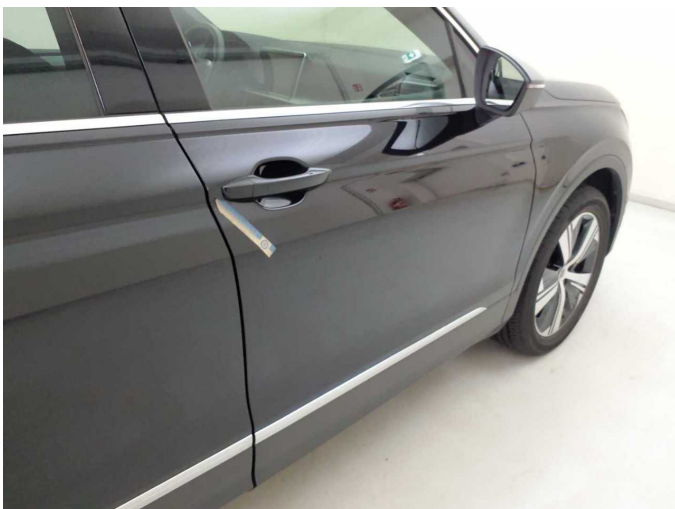
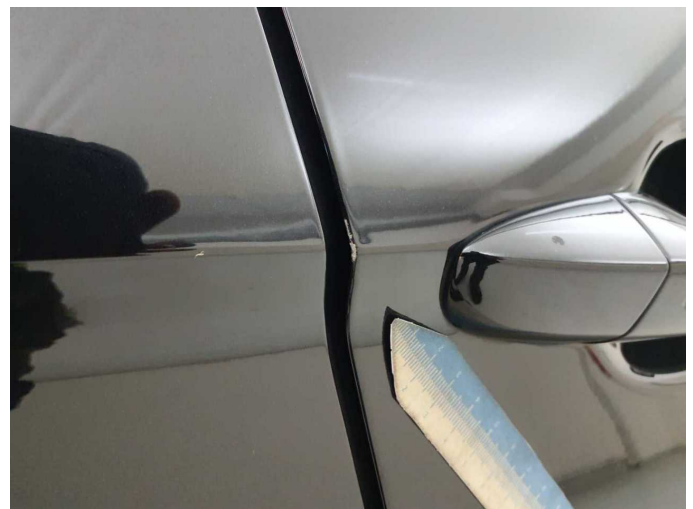
Damage 1: Door - front right side: Door edge - Scratch(es) - Smart repair

No.	Component group	Description
1	Door - front right side	Door edge - Scratch(es) - Smart repair
2	Interior	Cargo area floor - Broken / torn - Replace
3	Side panel - rear right side	Sill - Dent / paintcoat damage - Repair and paint

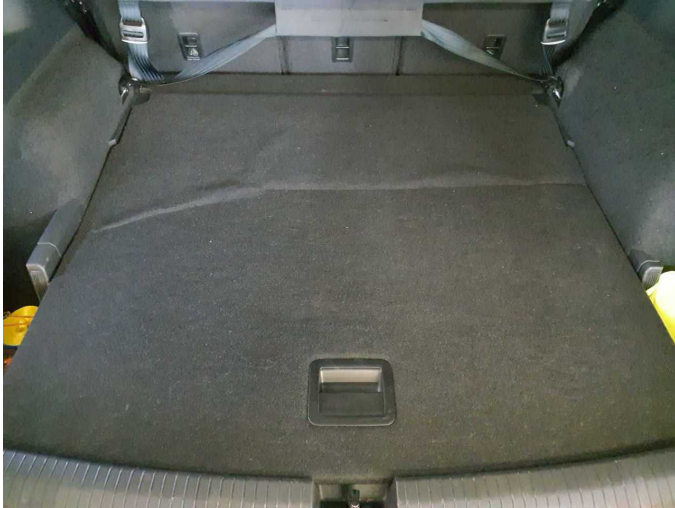
Damage 2: Interior: Cargo area floor - Broken / torn - Replace

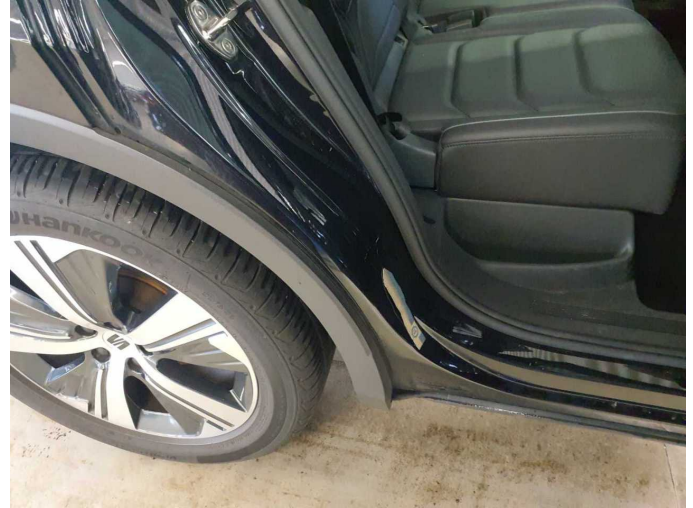
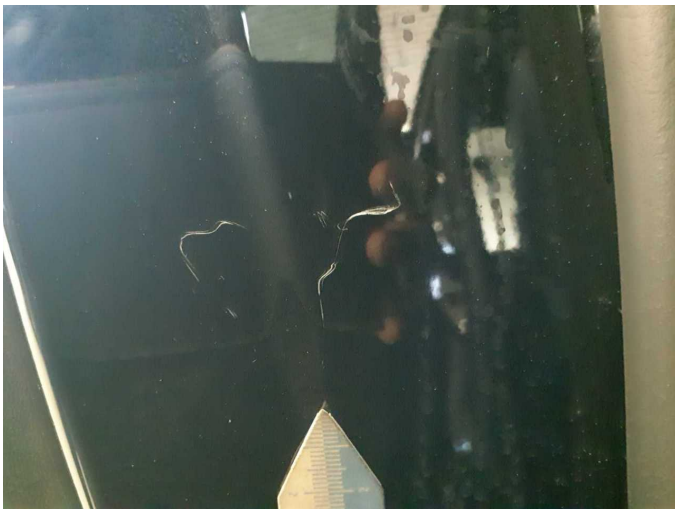
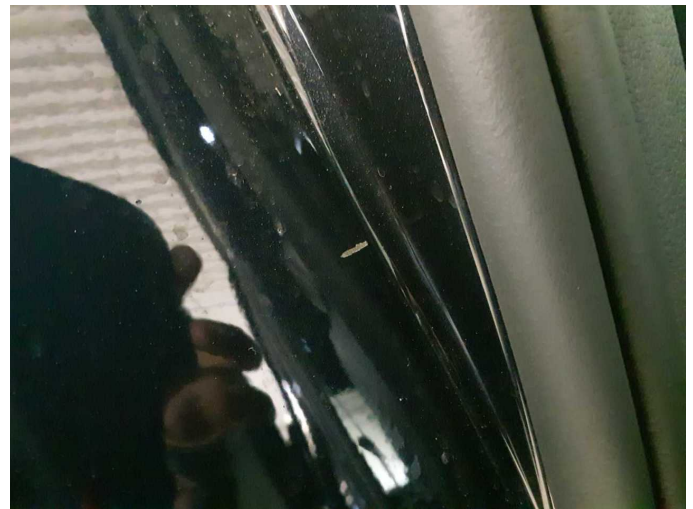
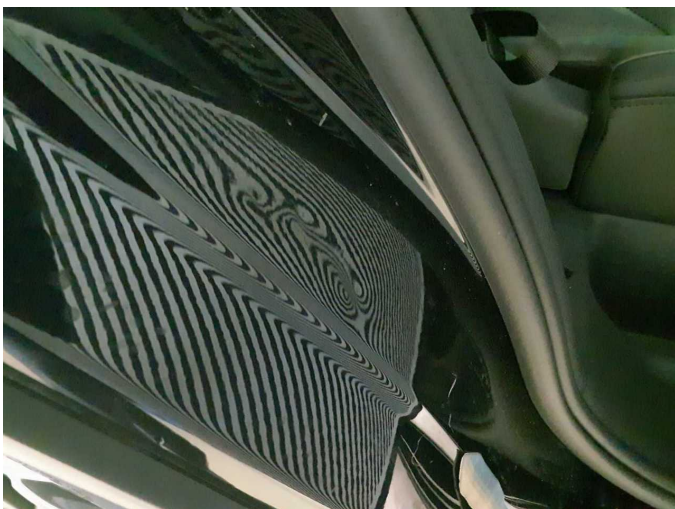
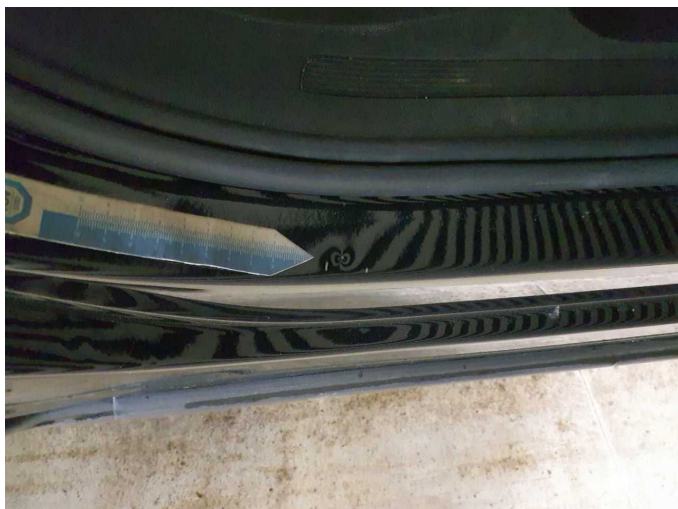
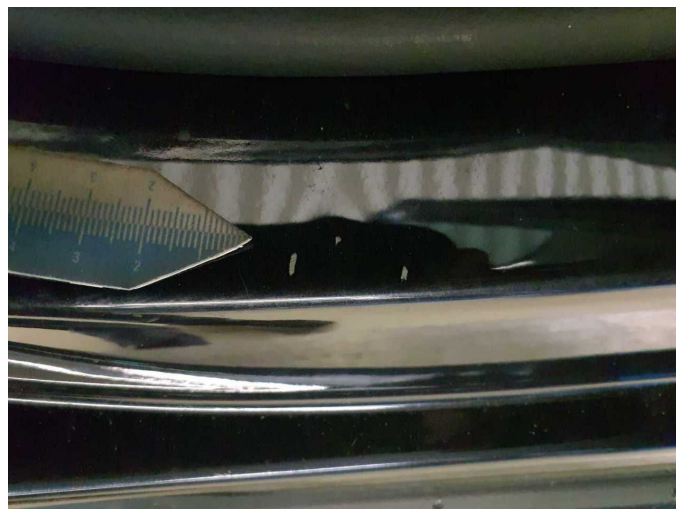
Damage 3: Side panel - rear right side: Sill - Dent / paintcoat damage - Repair and paint
