## Expertise

Protocol number: 46189526  
Order No. / Reference: 26546858  
Inspection date: 29 Jun 2026

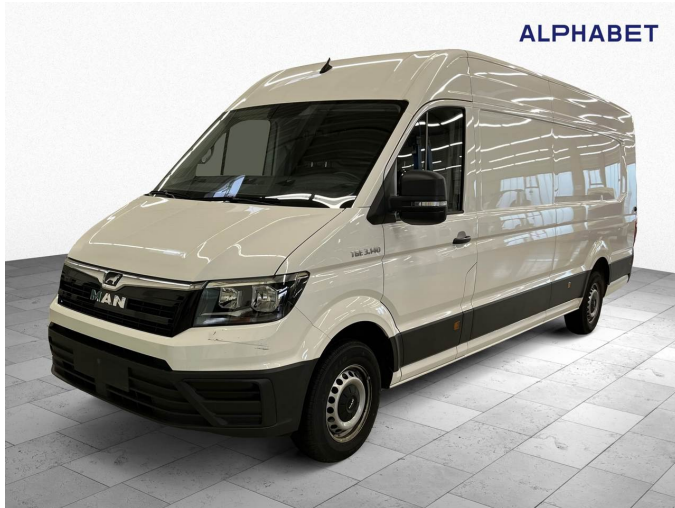
Figure 1: Diagonal front (left)

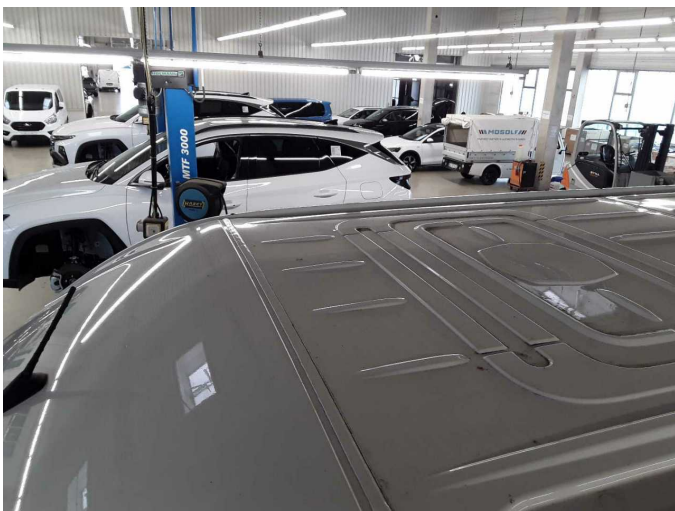
Damage 1: Roof: Roof - dent(s) - Smart repair

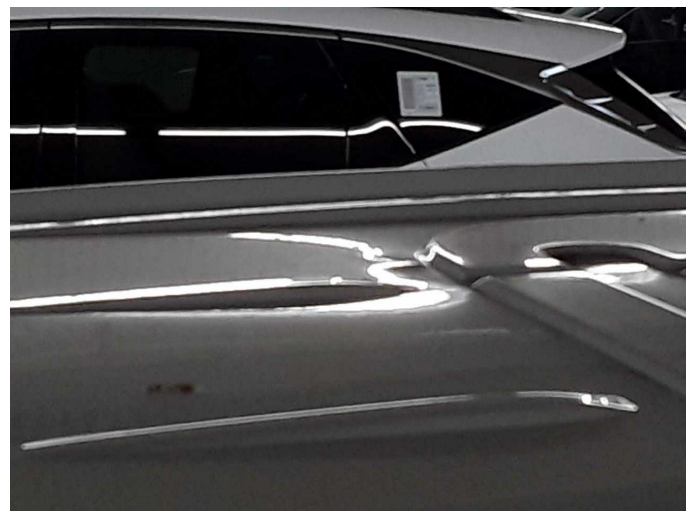
Damage 1: Roof: Roof - dent(s) - Smart repair

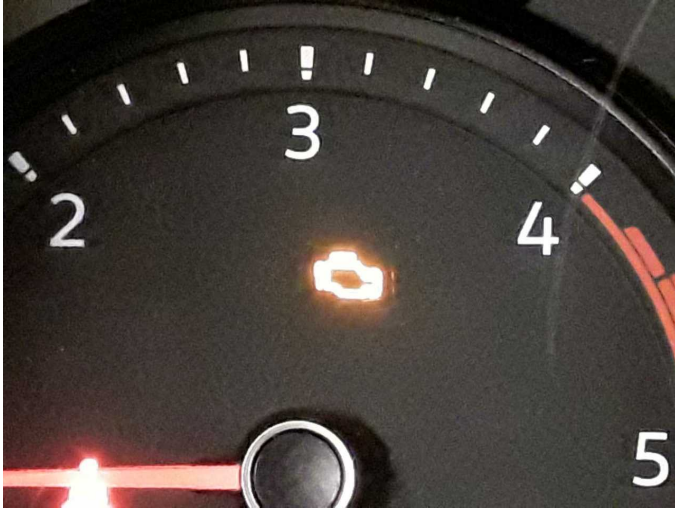
**Damage 2:** Instrument panel: Indicator light (Motorkontrolle) - on - Perform diagnosis

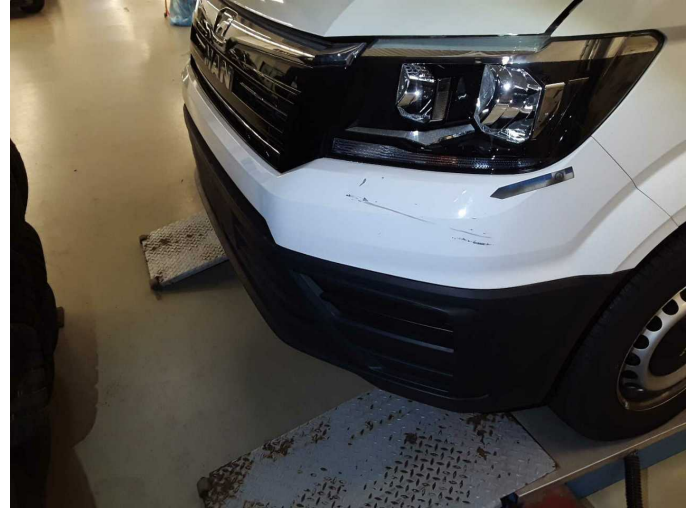
**Damage 3:** Front bumper: Front bumper (Oberteil) - Scratched - Paint

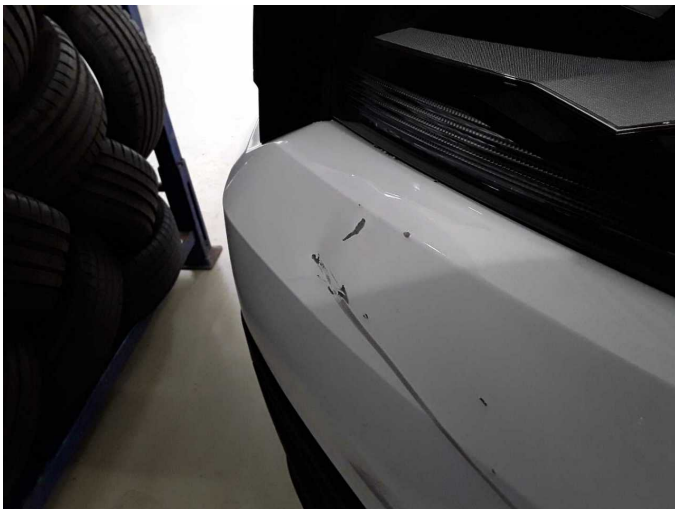
**Damage 3:** Front bumper: Front bumper (Oberteil) - Scratched - Paint

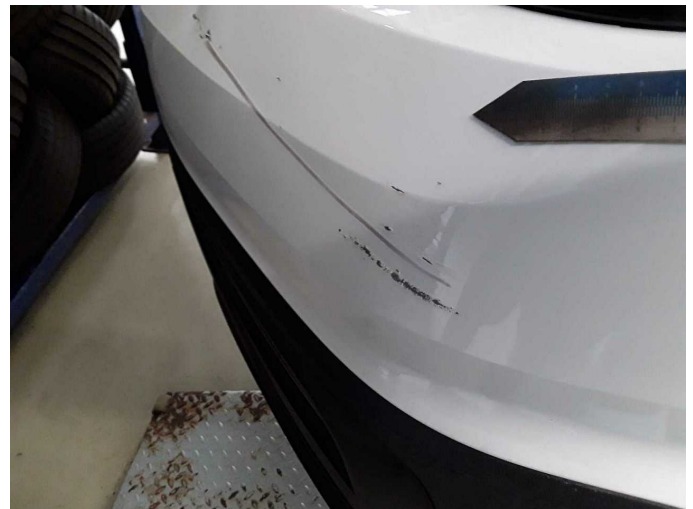
**Damage 3:** Front bumper: Front bumper (Oberteil) - Scratched - Paint

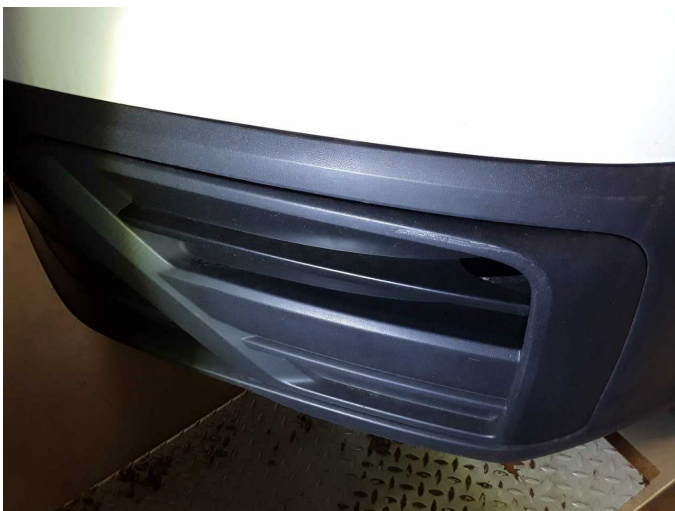
**Damage 3:** Front bumper: Front bumper (Oberteil) - Scratched - Paint

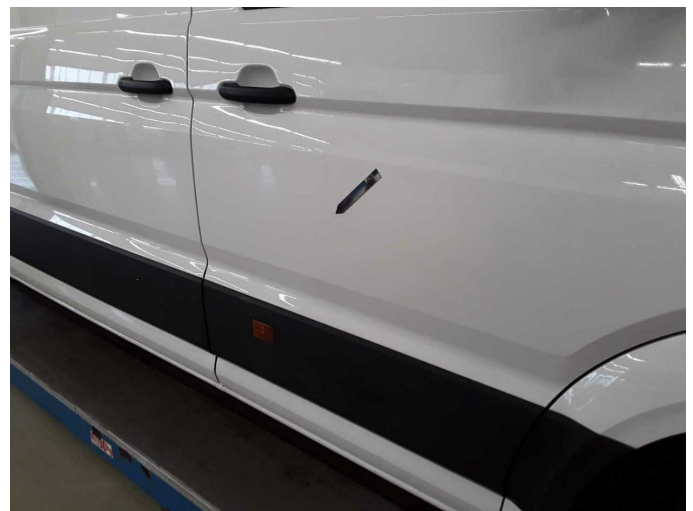
**Damage 4:** Door - front right side: Door (Lackeinschlüsse, Wellig, Orangenhaut) - Unprofessionally repaired - Paint

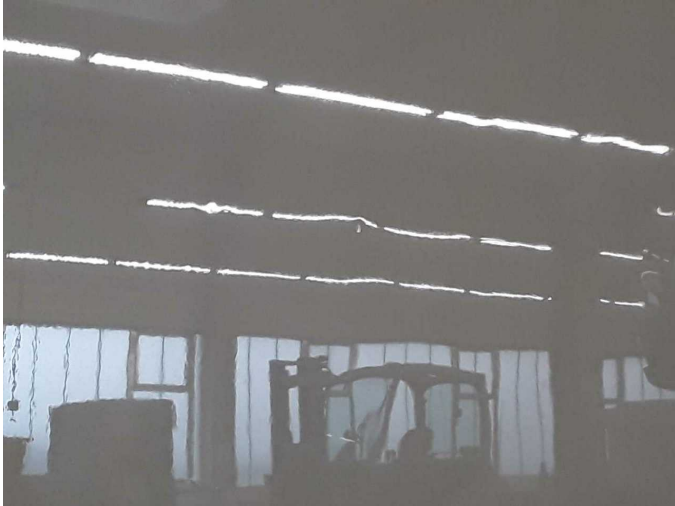
**Damage 4:** Door - front right side: Door (Lackeinschlüsse, Wellig, Orangenhaut) - Unprofessionally repaired - Paint

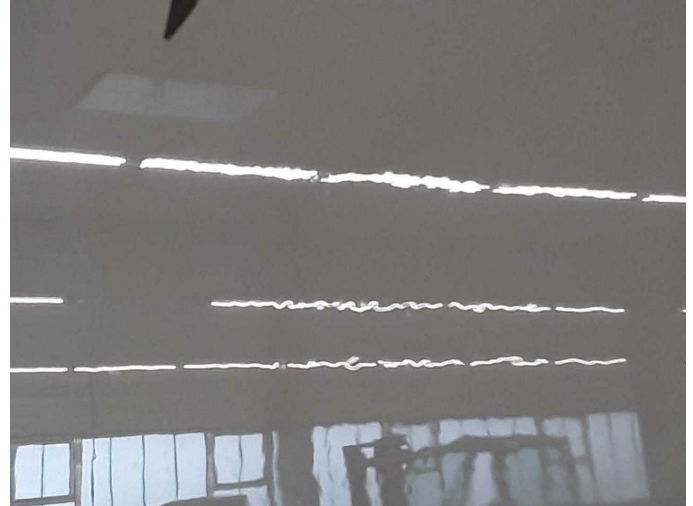
**Damage 4:** Door - front right side: Door (Lackeinschlüsse, Wellig, Orangenhaut) - Unprofessionally repaired - Paint

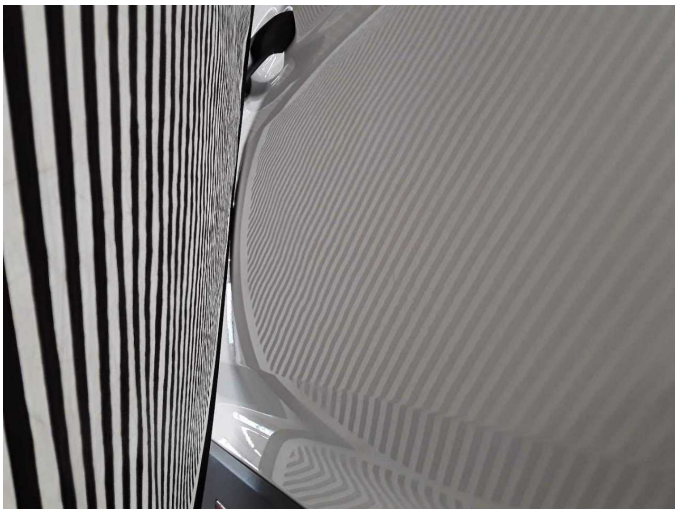
**Damage 4:** Door - front right side: Door (Lackeinschlüsse, Wellig, Orangenhaut) - Unprofessionally repaired - Paint

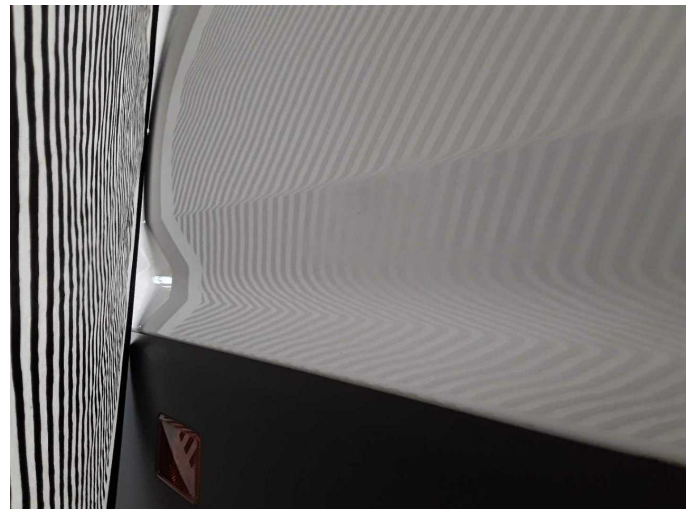
**Damage 4:** Door - front right side: Door (Lackeinschlüsse, Wellig, Orangenhaut) - Unprofessionally repaired - Paint

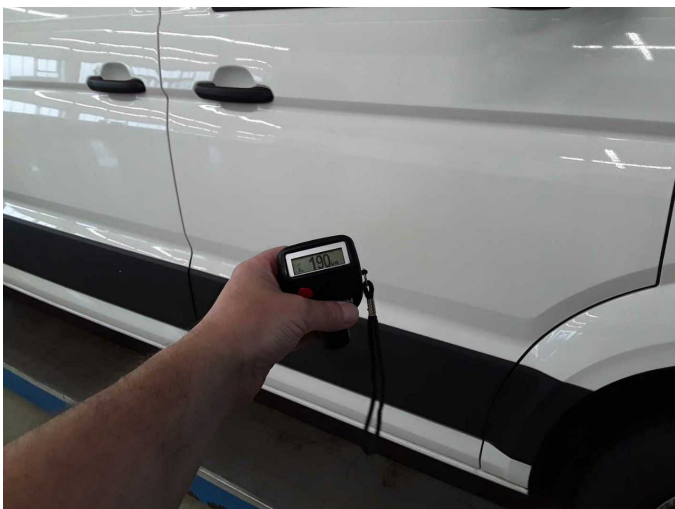
**Door - front right side: 190 µm**
