Expertise

Protocol number: 46401006  
Order No. / Reference: 26588251  
Inspection date: 8 Jul 2026

Manufacturer: Skoda  
VIN: TMBJJ7NS9P8038665

Model: Kodiahq 2.0 TDI DSG Ambition

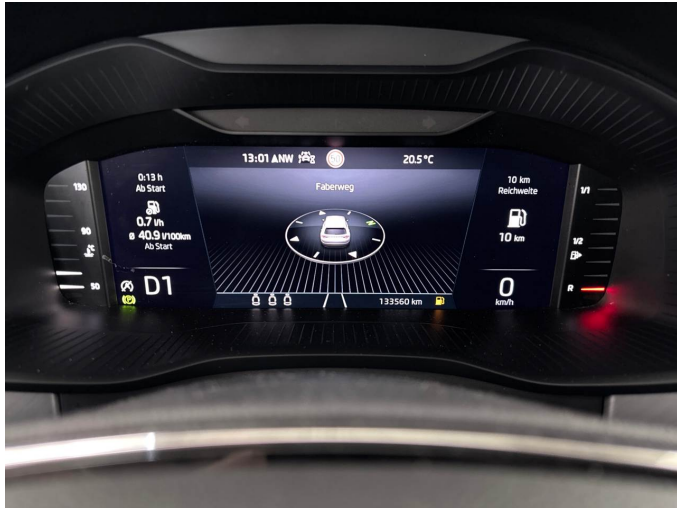
Figure 7: Instrument cluster

| Vehicle details | |
|---|---|
| Mileage (Read) | 133,560 km |

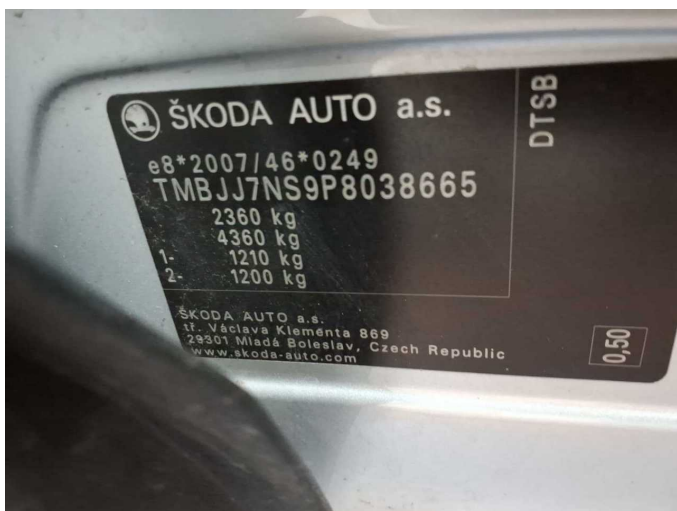
Figure 11: VIN

| VIN comparison | The vehicle identification number (VIN) was read from the vehicle and its conformity with the submitted documents was confirmed by the undersigned during the inspection. |

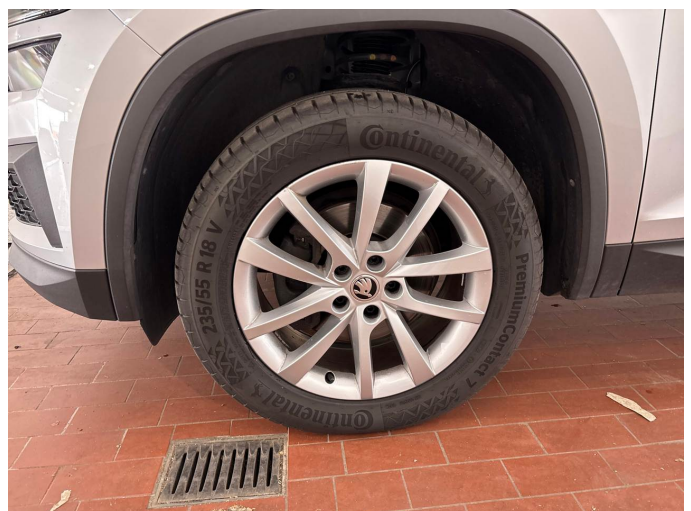
Figure 12: Mounted tyres

| # | Tyre size | Type of tyre | Manufacturer | Tread depth |
|---|---|---|---|---|
| 1) | 235/55 R18 100V | Summer tyres on Light alloy | Continental | 7mm / 7mm |
| 2) | 235/55 R18 100V | Summer tyres on Light alloy | Continental | 4mm / 4mm |

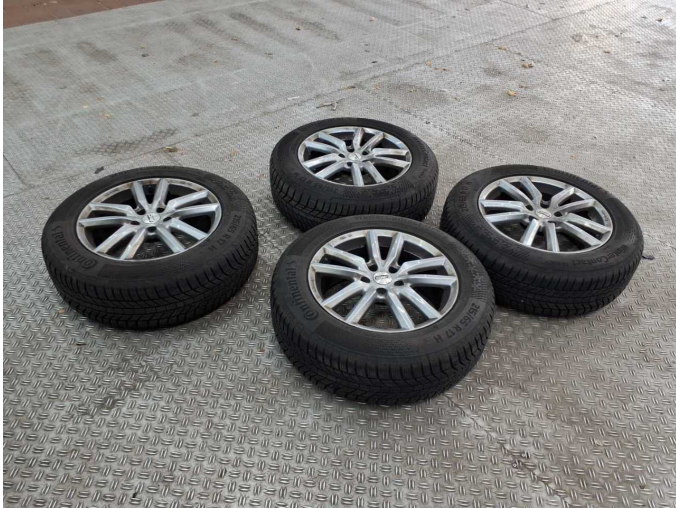
Figure 19: Additional tyres

| # | Tyre size | Type of tyre | Manufacturer | Tread depth |
|---|---|---|---|---|
| 1) | 215/65 R17 99H | Winter tyres on Light alloy | Continental | 8mm / 8mm |
| 2) | 215/65 R17 99H | Winter tyres on Light alloy | Continental | 8mm / 8mm |

Der beiliegende Winterradsatz ist nicht Bestandteil der Ausstattung.

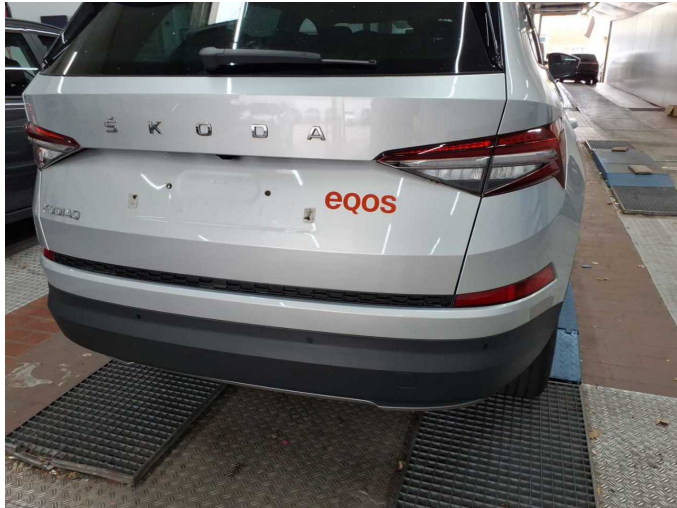
**Damage 1:** Body: Body - Glued / labelled - De-glue / neutralise

| No. | Component group | Description |
|---|---|---|
| 1 | Body | Body - Glued / labelled - De-glue / neutralise |
