Expertise

Protocol number: 46378721  
Order No. / Reference: 26443497  
Inspection date: 6 Jul 2026

Manufacturer: Volkswagen

Model: Passat Variant 1.4 TSI Plug-In-Hybrid DSG GTE

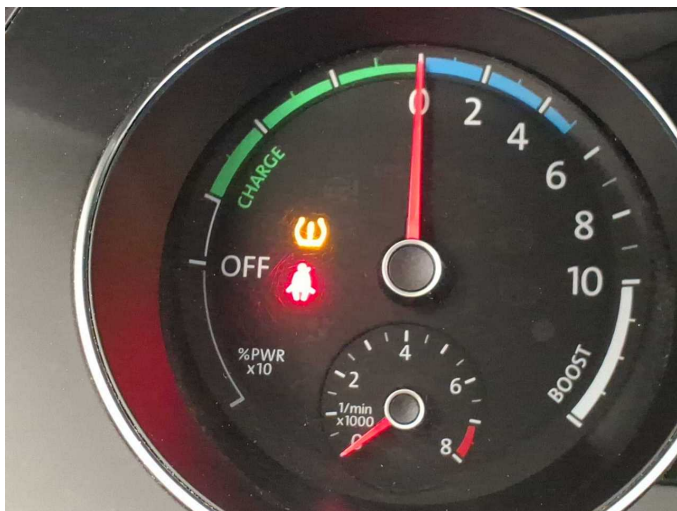
| No. | Component group | Description |
|---|---|---|
| 1 | Instrument panel | Indicator light (Reifendruck Kontrollleuchte) - on - Perform diagnosis |

**Damage 1:** Instrument panel: Indicator light (Reifendruck Kontrollleuchte)  
- on - Perform diagnosis

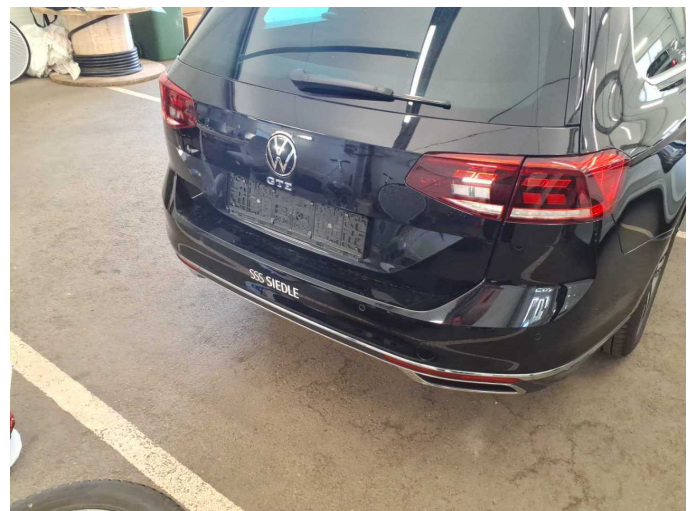
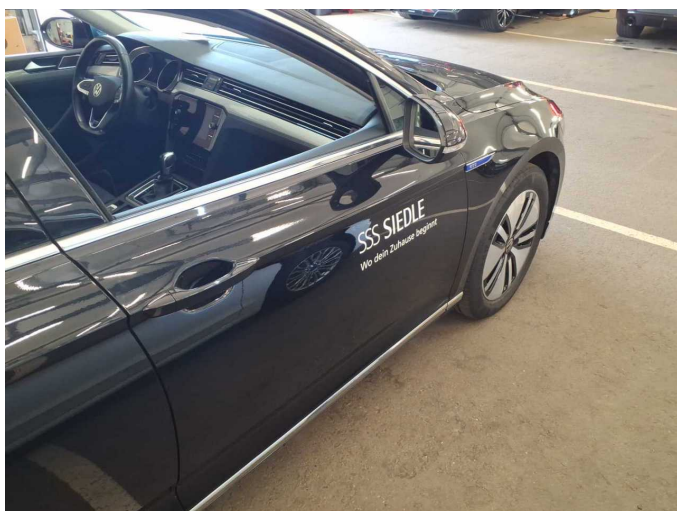
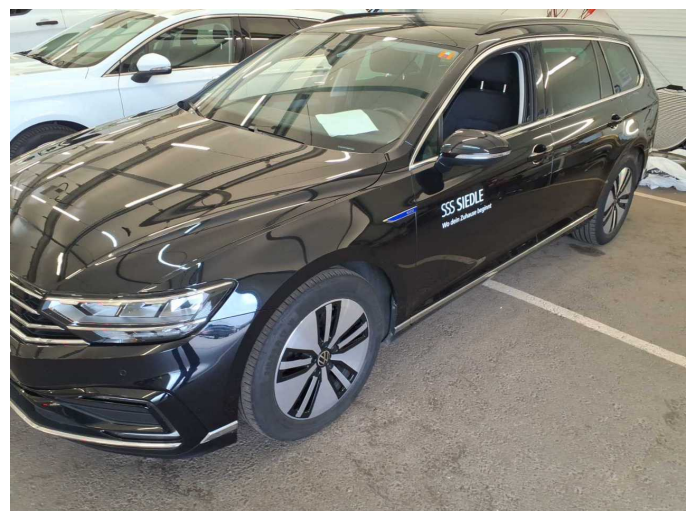
| No. | Component group | Description |
|---|---|---|
| 2 | Body | Body - Glued / labelled - De-glue / neutralise |

**Damage 2:** Body: Body - Glued / labelled - De-glue / neutralise

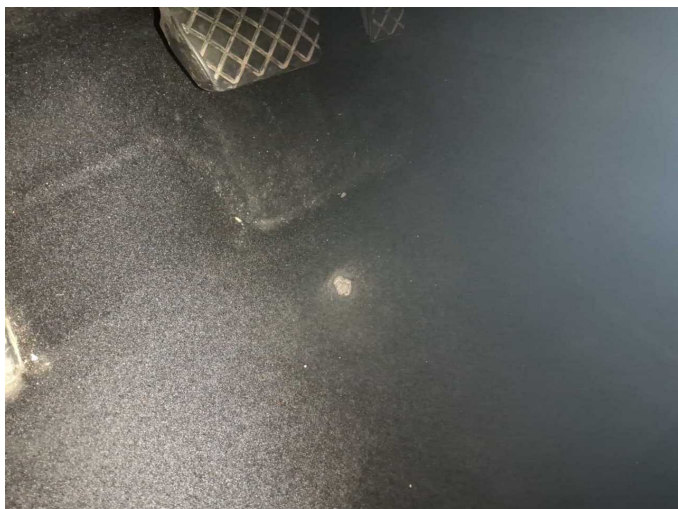
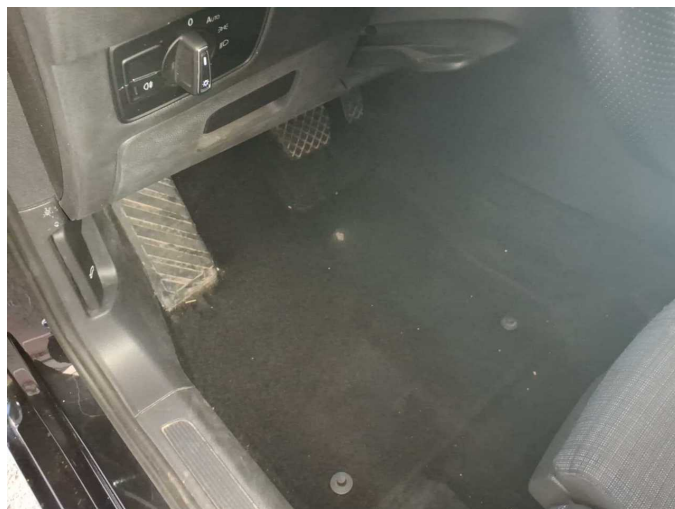
| No. | Component group | Description |
|---|---|---|
| 3 | Trim / covers | Carpet - front left side - Broken / torn - Smart repair |

**Damage 3:** Trim / covers: Carpet - front left side - Broken / torn - Smart repair

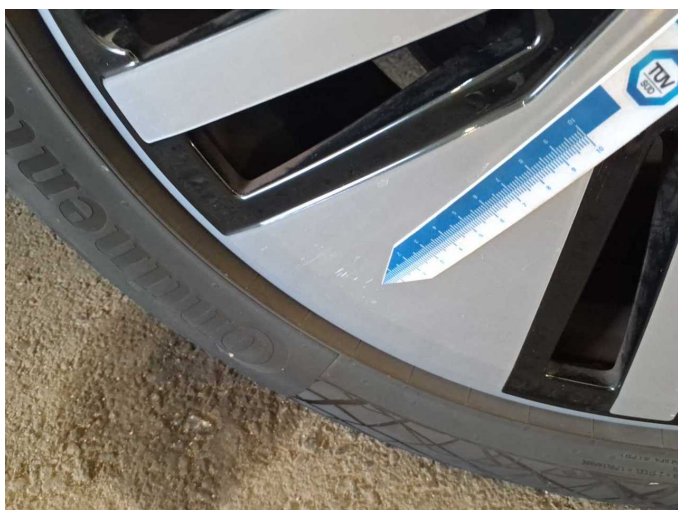
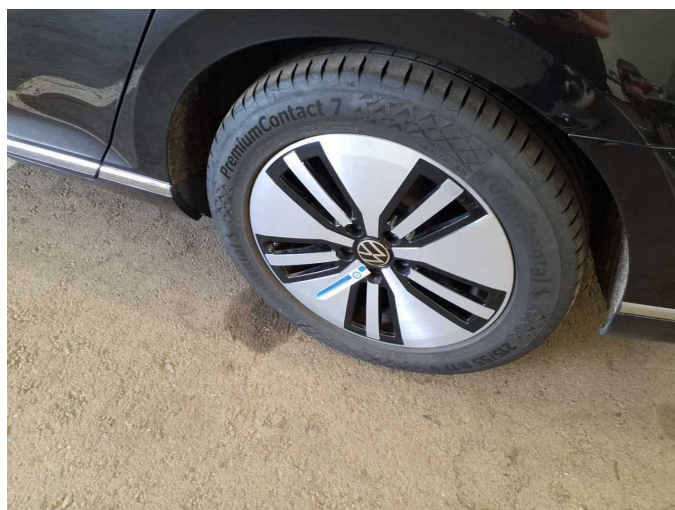
| No. | Component group | Description |
|---|---|---|
| 4 | Wheel / tyres | Alloy rim - rear left side - Scratch(es) - Loss in value |

**Damage 4:** Wheel / tyres: Alloy rim - rear left side - Scratch(es) - Loss in value

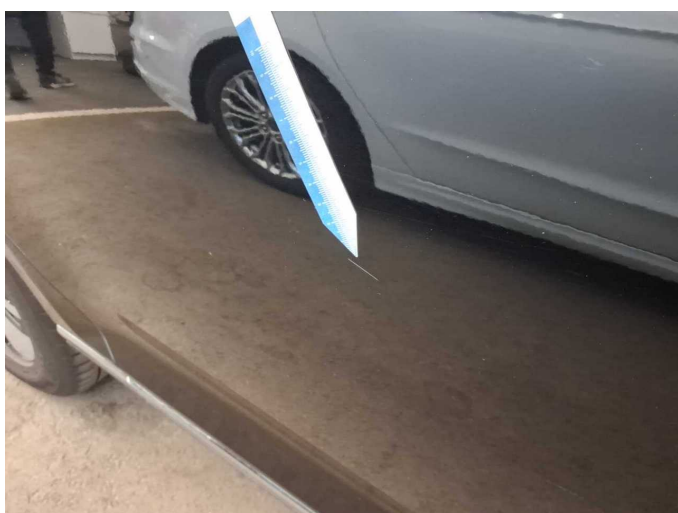
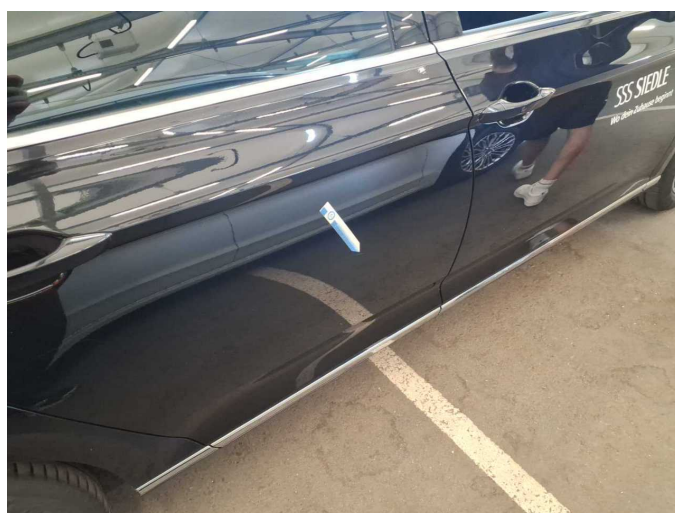
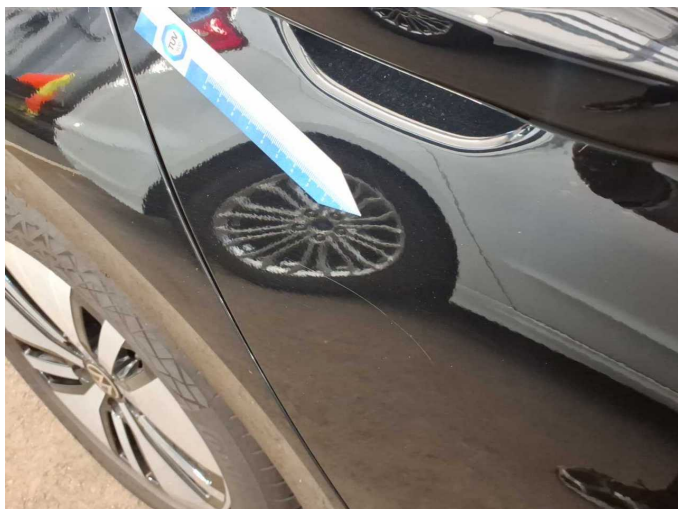
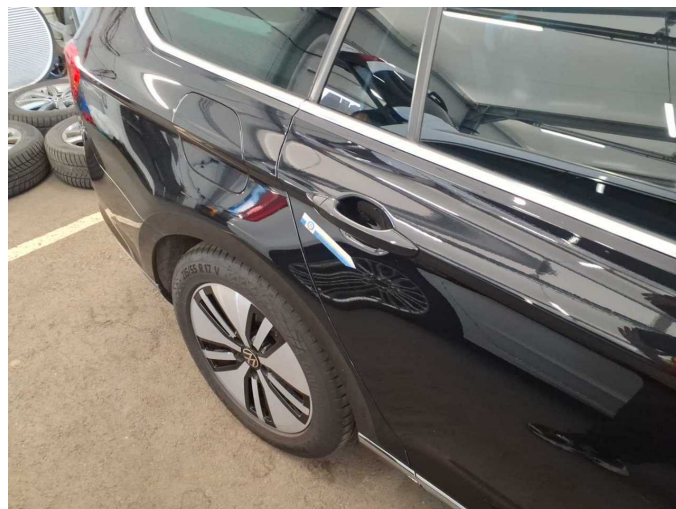
| No. | Component group | Description |
|---|---|---|
| 5 | Door - rear right side | Door - Scratch(es) - Paint |

**Damage 5:** Door - rear right side: Door - Scratch(es) - Paint

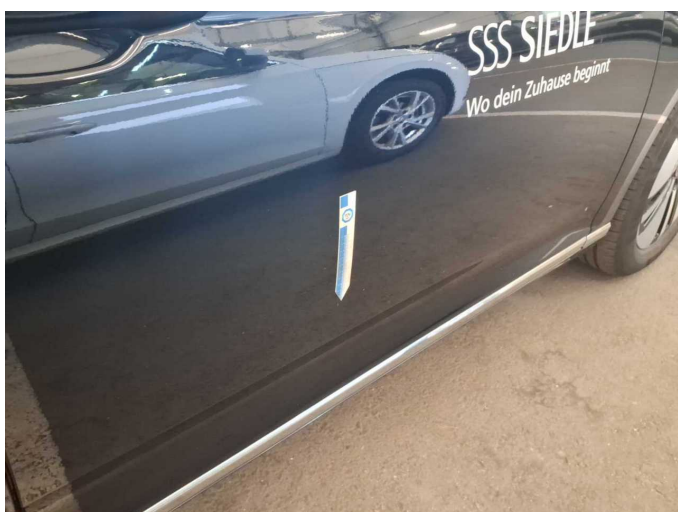
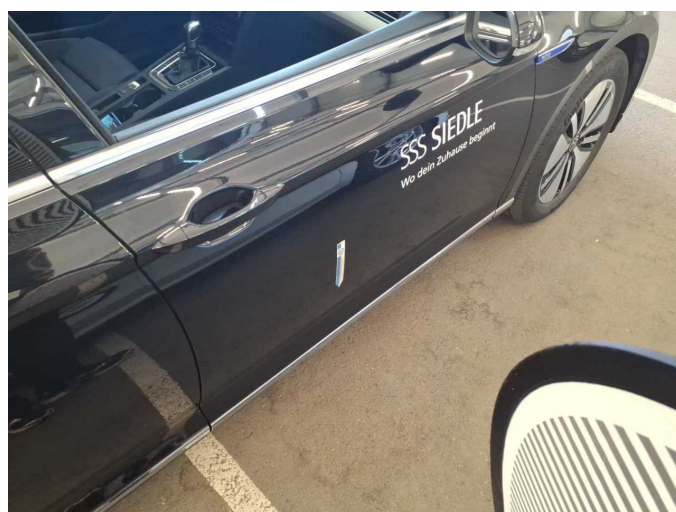
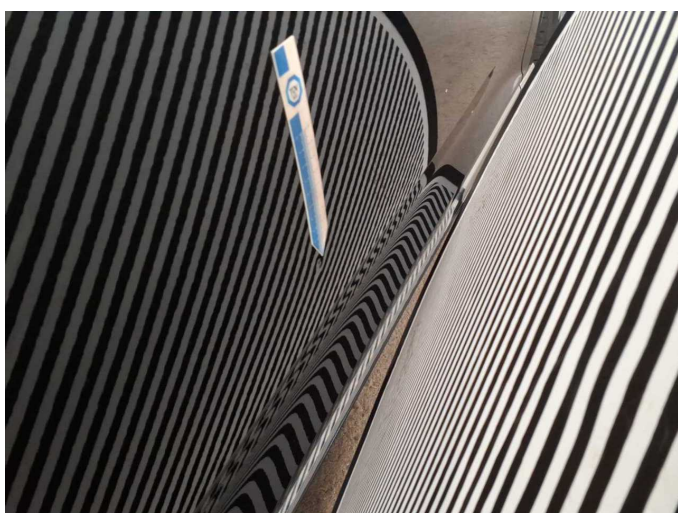
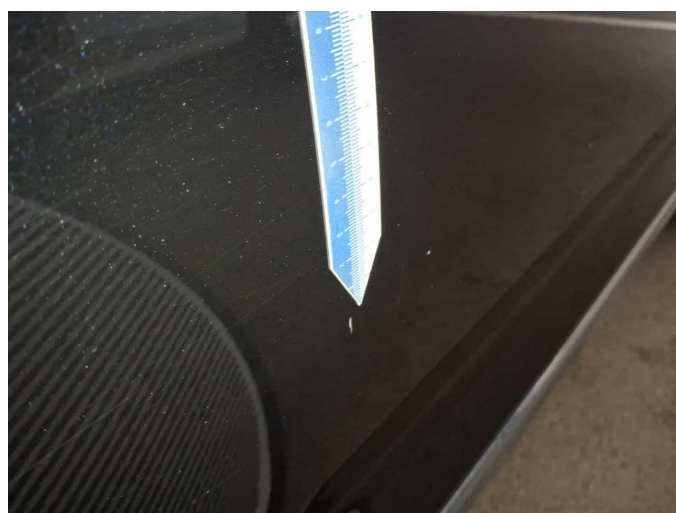
| No. | Component group | Description |
|---|---|---|
| 6 | Door - front right side | Door - Dent / paintcoat damage - Repair and paint |

**Damage 6:** Door - front right side: Door - Dent / paintcoat damage - Repair and paint

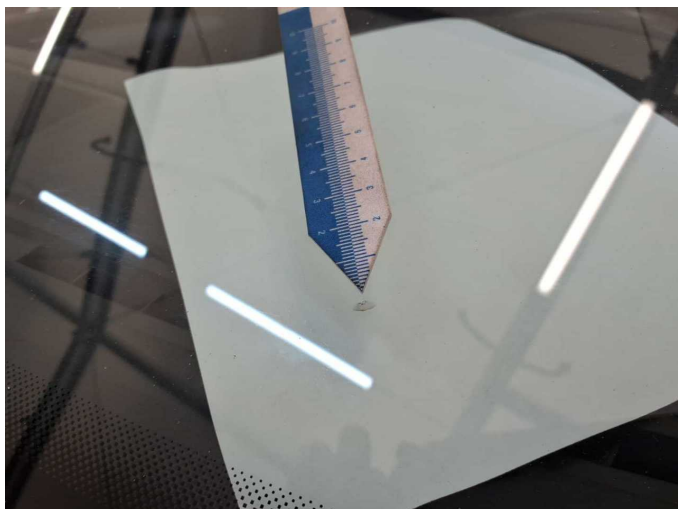
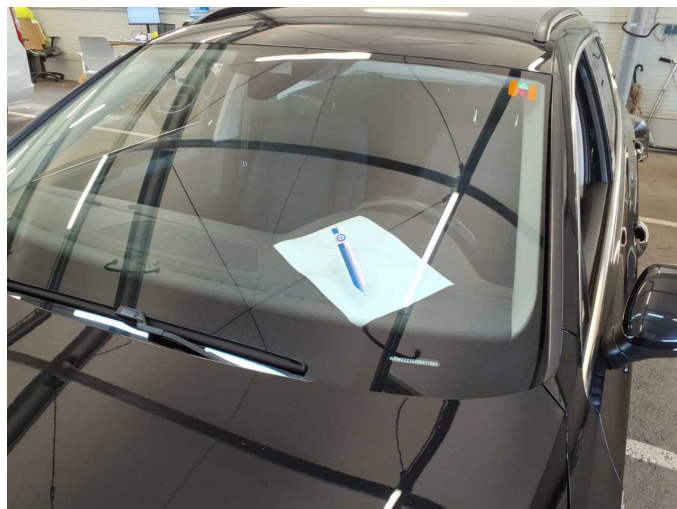
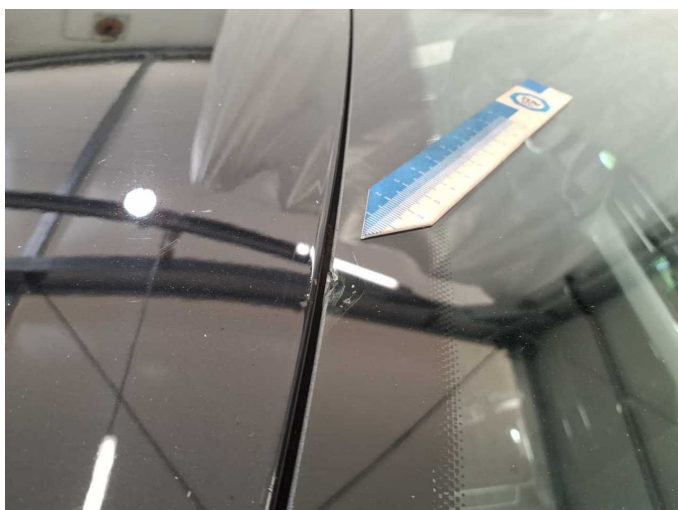
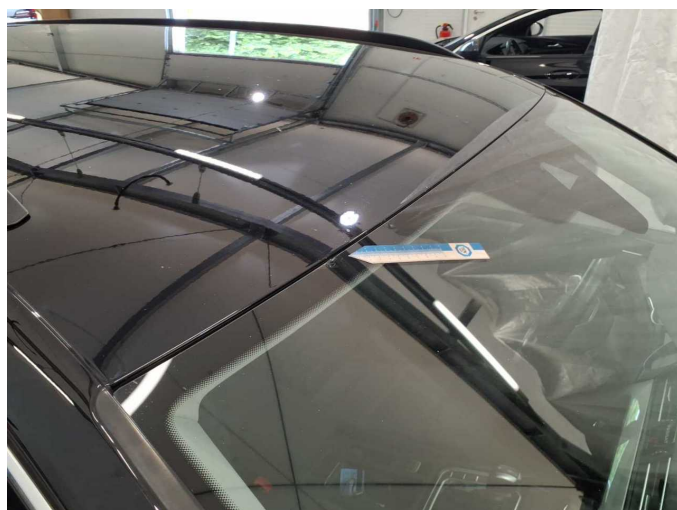
| No. | Component group | Description |
|---|---|---|
| 7 | Vehicle glazing | Windscreen (kein Staubschutz) - Broken / torn - repair according to calculation |

**Damage 7:** Vehicle glazing: Windscreen (kein Staubschutz) - Broken / torn - repair according to calculation

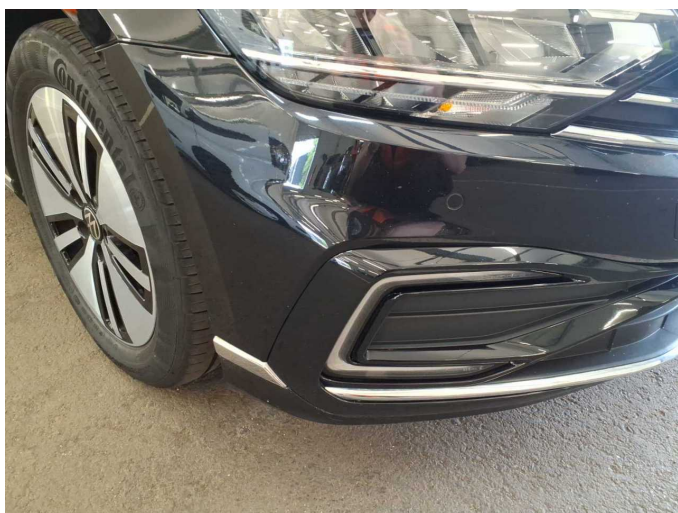
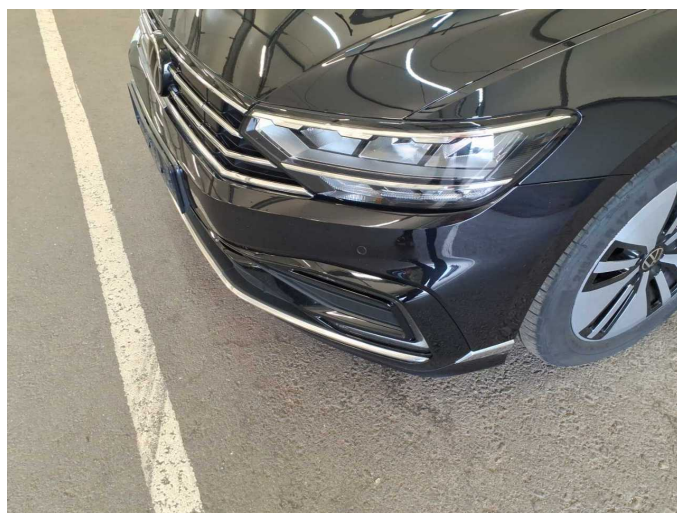
| No. | Component group | Description |
|---|---|---|
| 1 | Front bumper | Front bumper - Stone chips - No deduction |

**Wear and tear 1:** Front bumper: Front bumper - Stone chips - No deduction

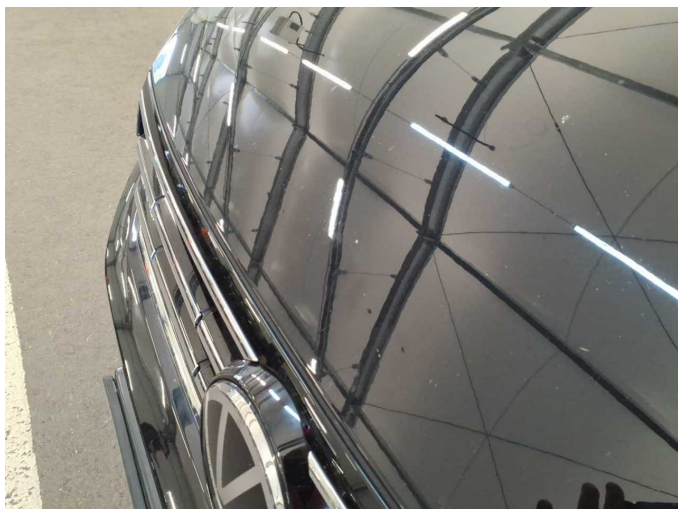
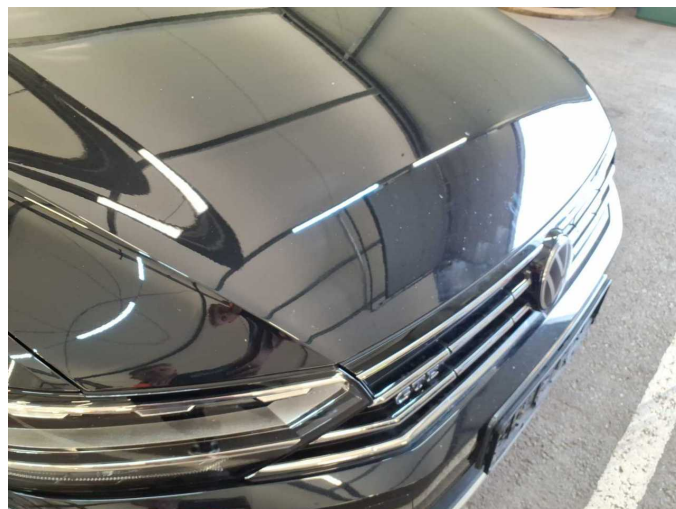
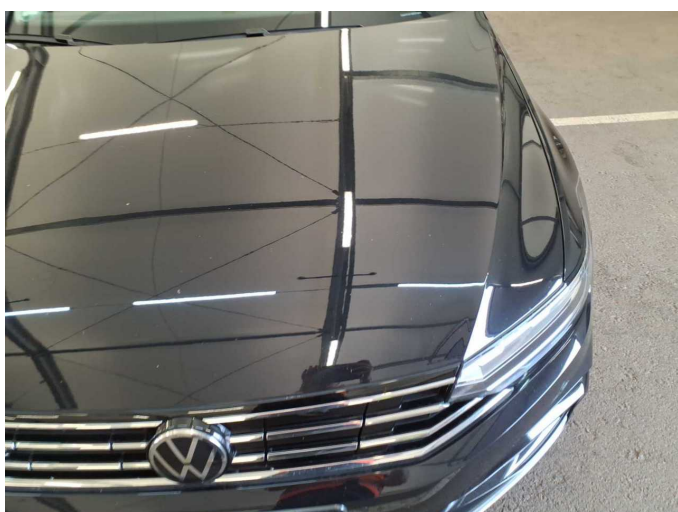
| No. | Component group | Description |
|---|---|---|
| 2 | Bonnet | Bonnet - Stone chips - No deduction |

**Wear and tear 2:** Bonnet: Bonnet - Stone chips - No deduction

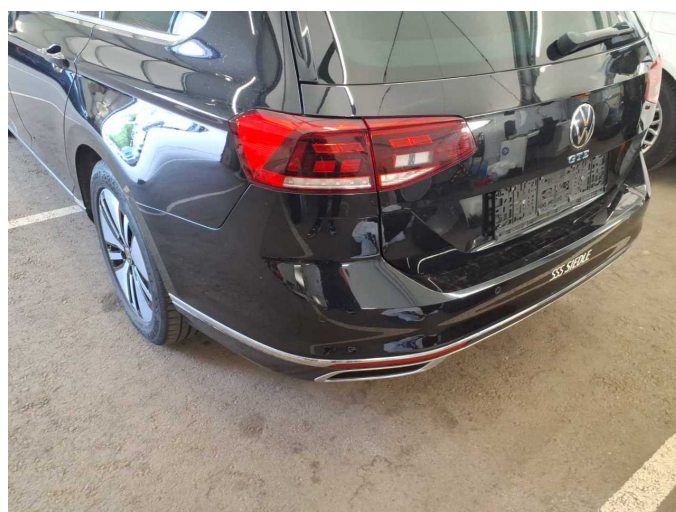
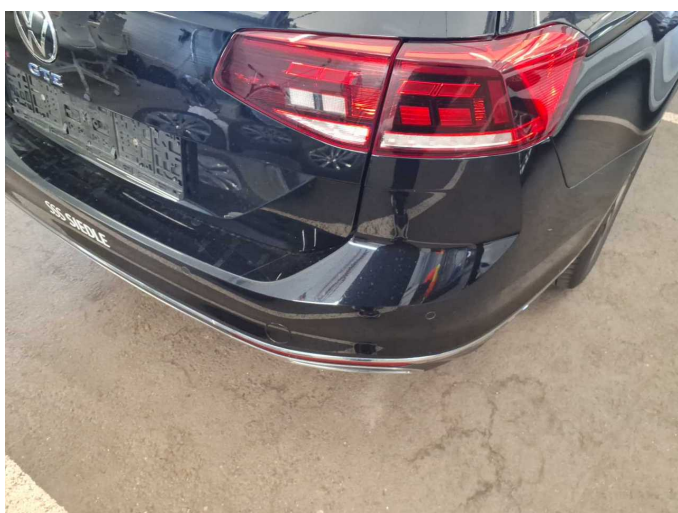
| No. | Component group | Description |
|---|---|---|
| 4 | Rear bumper | Rear bumper - Scratch(es) - No deduction |

**Wear and tear 4:** Rear bumper: Rear bumper - Scratch(es) - No deduction

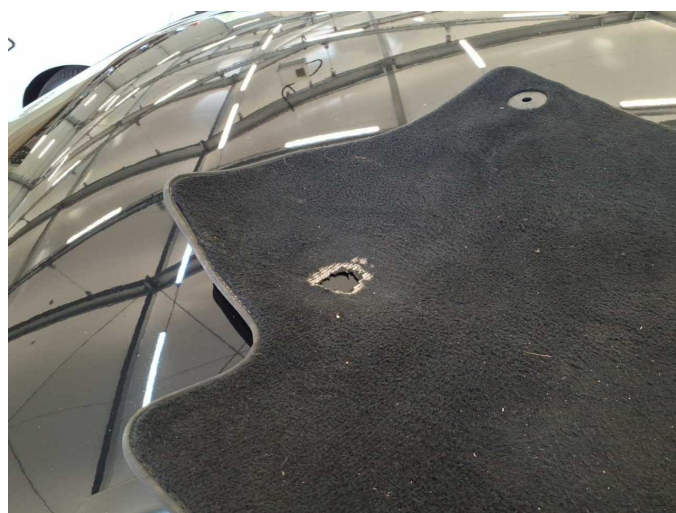
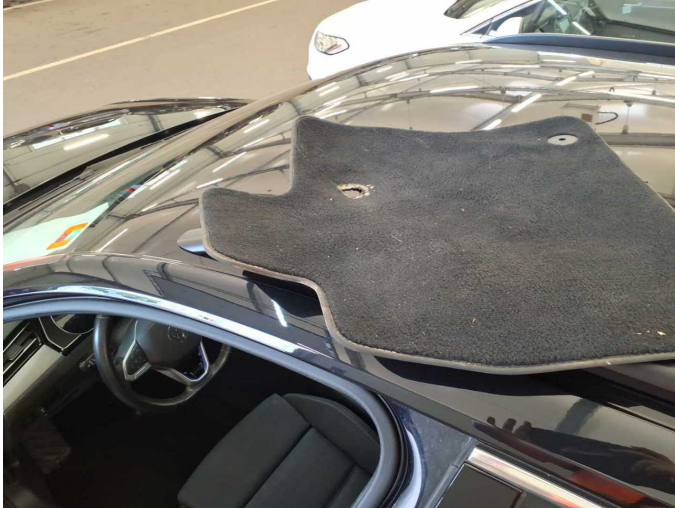
| No. | Component group | Description |
|---|---|---|
| 5 | Trim / covers | Floor mats (Fußmatte vorne Links) - Broken / torn - No deduction |

**Wear and tear 5:** Trim / covers: Floor mats (Fußmatte vorne Links) - Broken / torn - No deduction

**Wear and tear 5:** Trim / covers: Floor mats (Fußmatte vorne Links) -  
Broken / torn - No deduction
