Expertise

Protocol number: 46561379  
Order No. / Reference: 26740968  
Inspection date: 15 Jul 2026

Model: S-Max 2.0 EcoBlue Aut. TITANIUM

VIN: WF0JXXWPCJNS12028

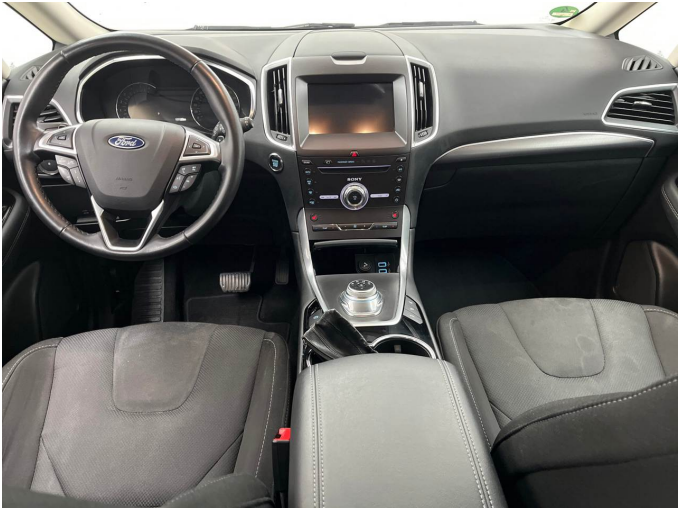
Figure 8: Instrument panel

| No. | Component group | Description |
|---|---|---|
| 9 | Instrument panel | Instrument cluster (Scheibe) - Broken / torn - repair according to calculation |

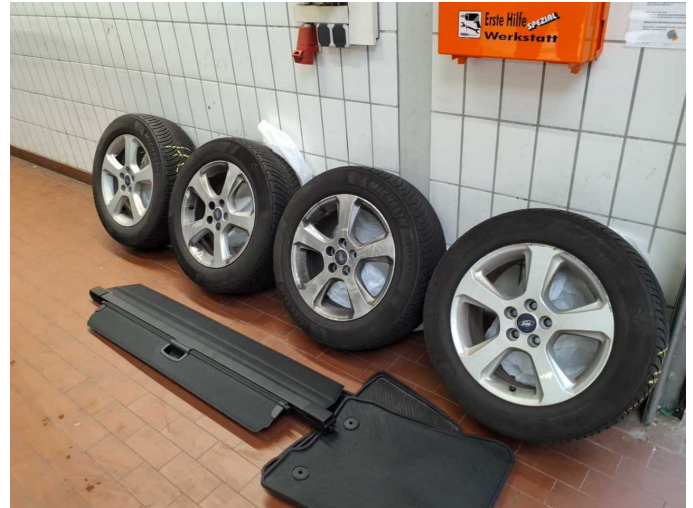
Figure 14: Additional tyres

Der beiliegende Winterradsatz ist kein Bestandteil der Auslieferungsumfangs.

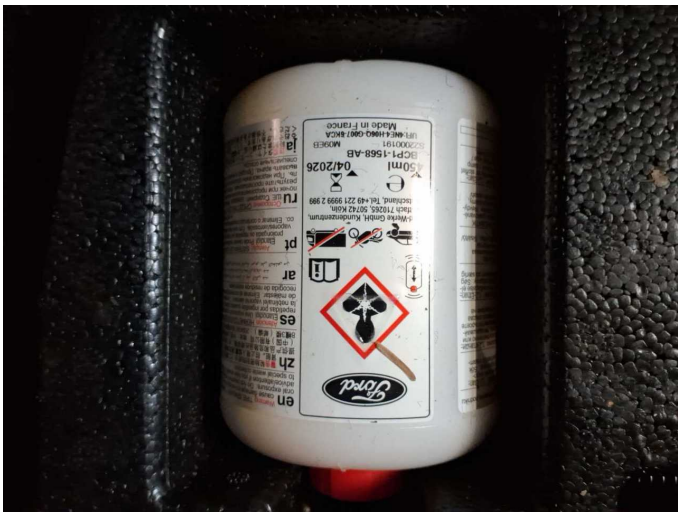
| No. | Component group | Description |
|---|---|---|
| 1 | Equipment | Tirefit filler - Due - Replace |

Damage 1: Equipment: Tirefit filler - Due - Replace

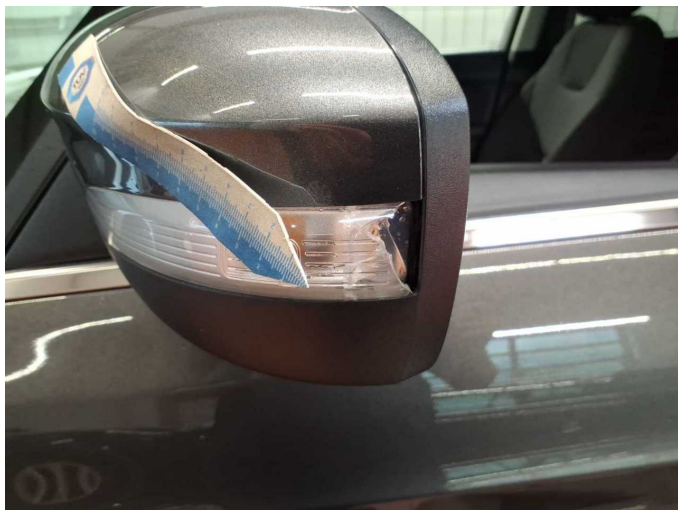
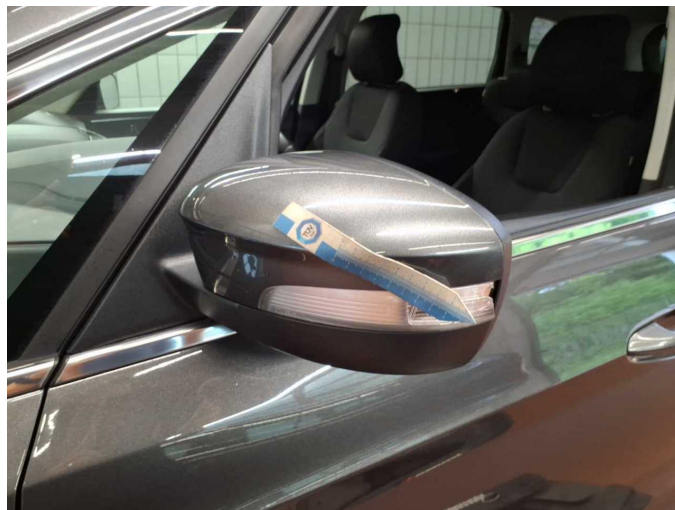
| No. | Component group | Description |
|---|---|---|
| 2 | Indicator - front | Mirror - left side - Broken / torn - Replace |

**Damage 2:** Indicator - front: Mirror - left side - Broken / torn - Replace

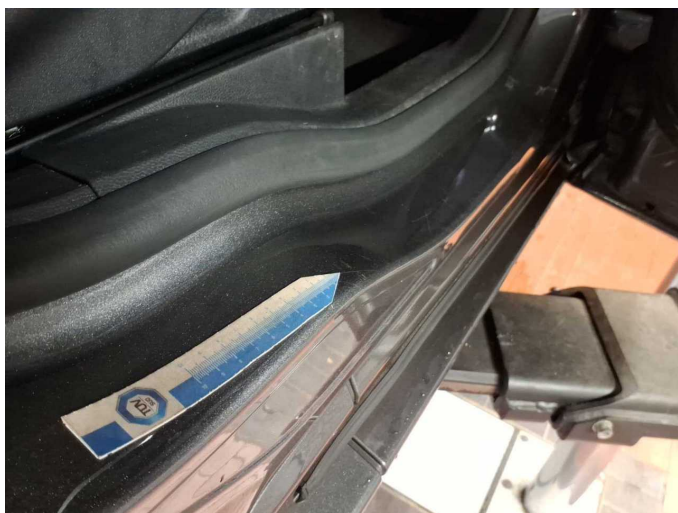
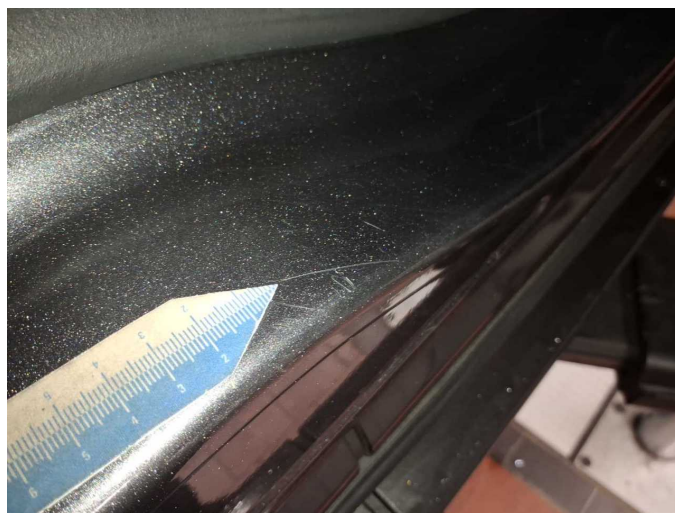
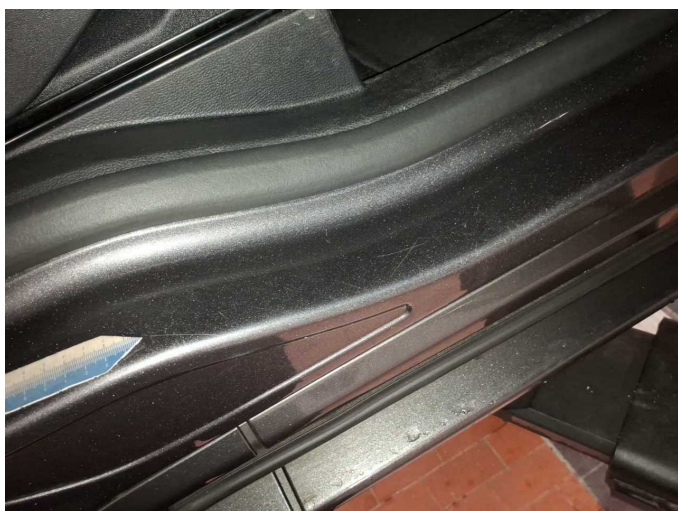
| No. | Component group | Description |
|---|---|---|
| 3 | Side panel - rear right side | Sill - Scratch(es) - Smart repair |

**Damage 3:** Side panel - rear right side: Sill - Scratch(es) - Smart repair

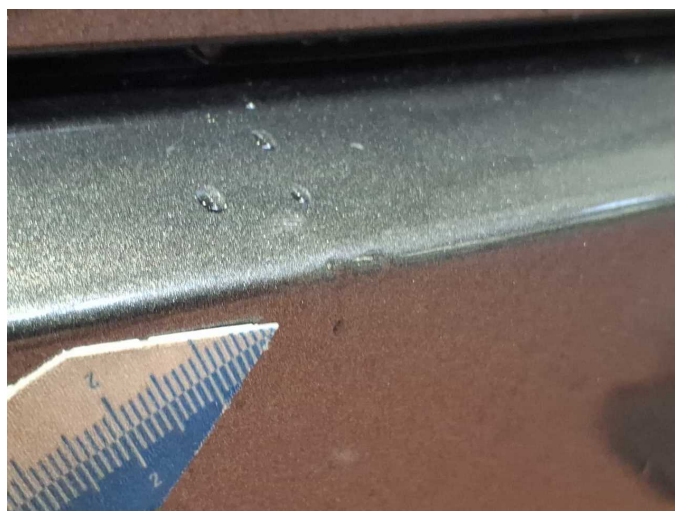
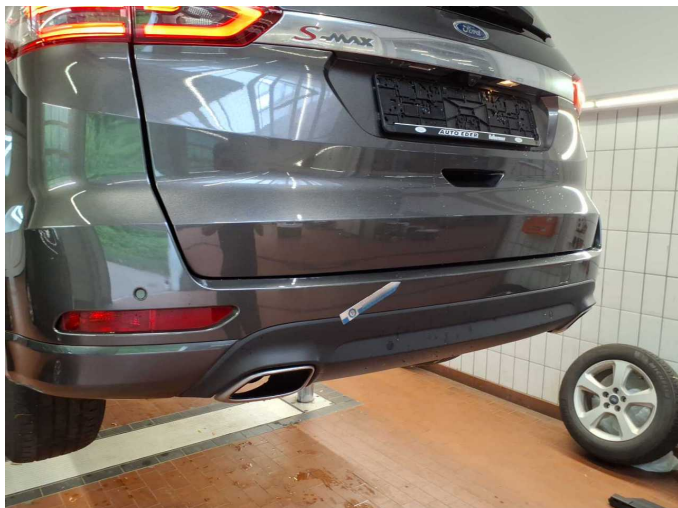
| No. | Component group | Description |
|---|---|---|
| 4 | Rear bumper | Rear bumper - Scratch(es) - Smart repair |

**Damage 4:** Rear bumper: Rear bumper - Scratch(es) - Smart repair

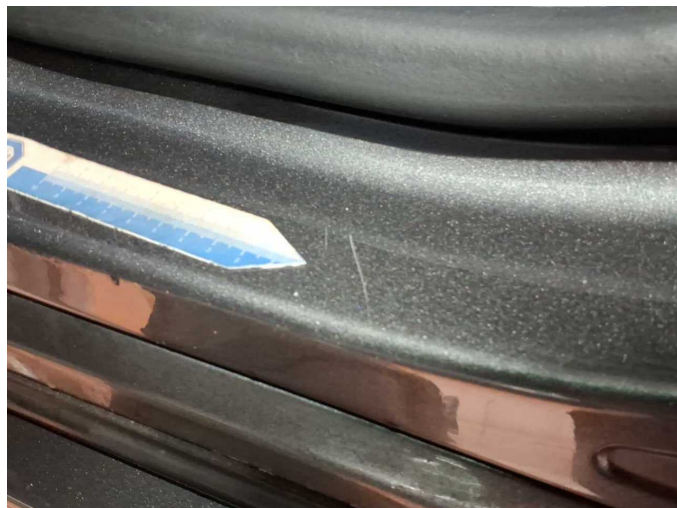
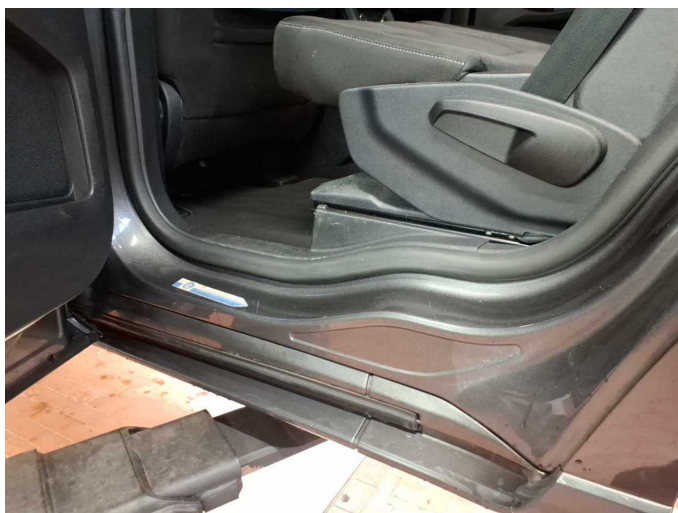
| No. | Component group | Description |
|---|---|---|
| 5 | Side panel - rear left side | Sill - Scratch(es) - Smart repair |

**Damage 5:** Side panel - rear left side: Sill - Scratch(es) - Smart repair

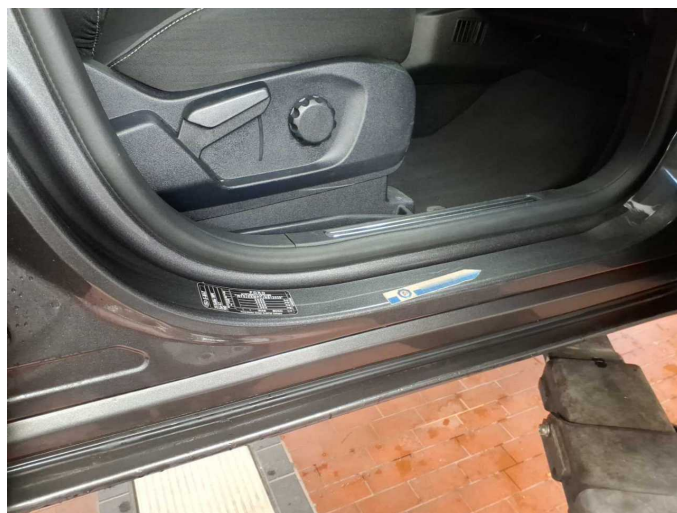
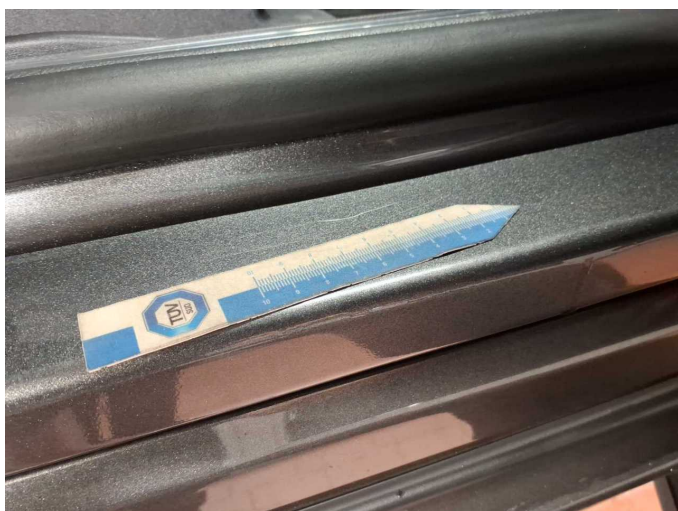
| No. | Component group | Description |
|---|---|---|
| 6 | Sill - right side | Sill - Scratch(es) - Smart repair |

**Damage 6:** Sill - right side: Sill - Scratch(es) - Smart repair

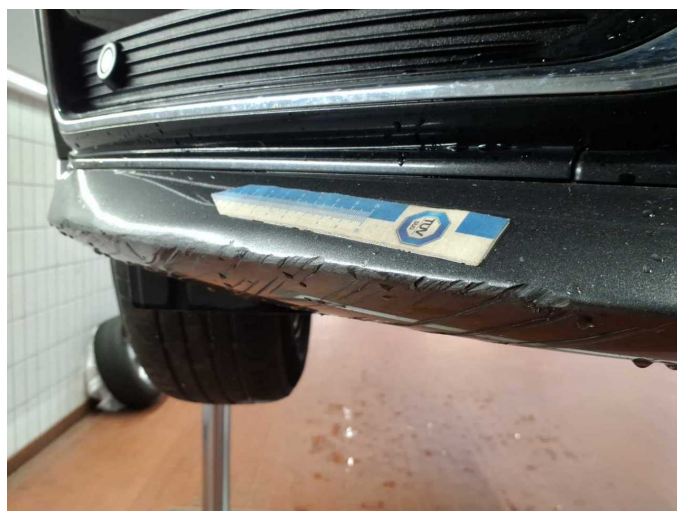
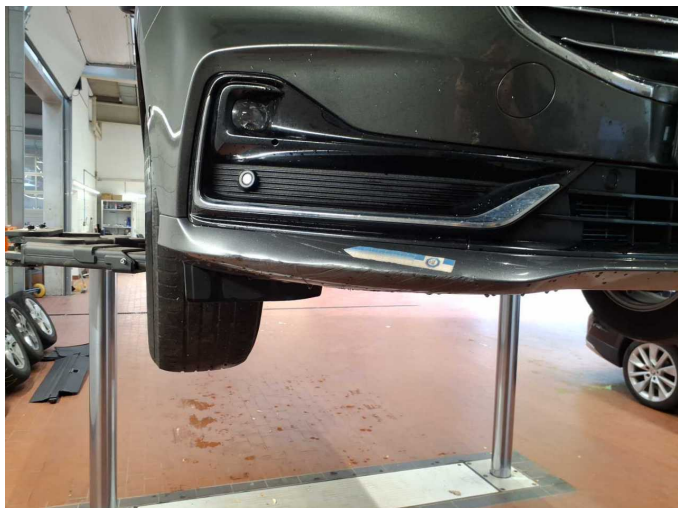
| No. | Component group | Description |
|---|---|---|
| 7 | Front bumper | Spoiler - Scratched - Paint |

**Damage 7:** Front bumper: Spoiler - Scratched - Paint

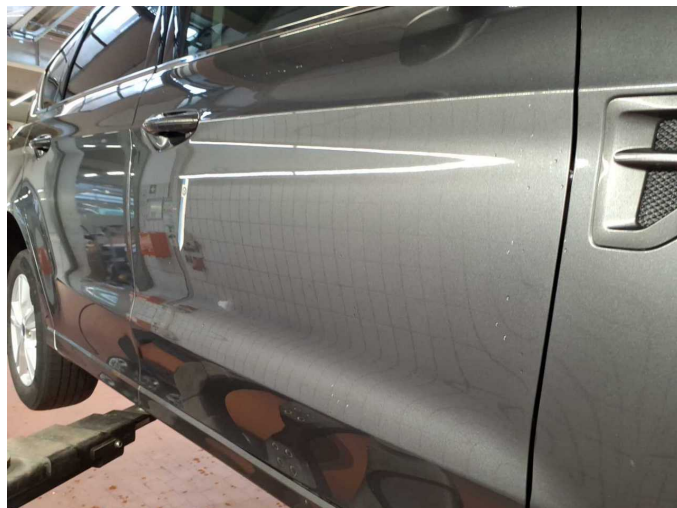
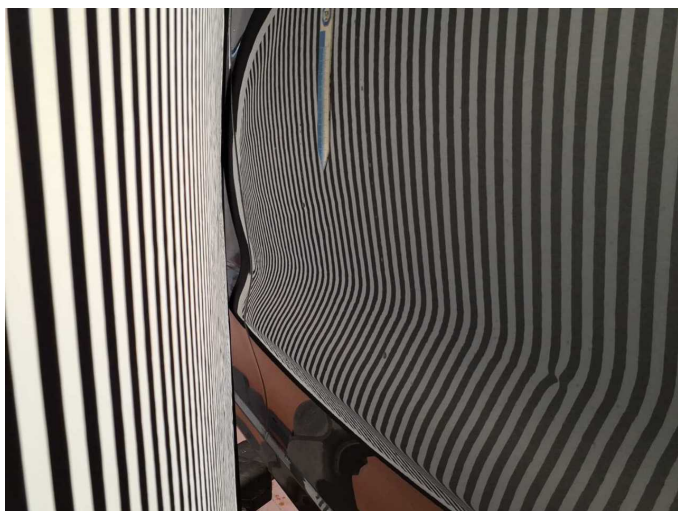
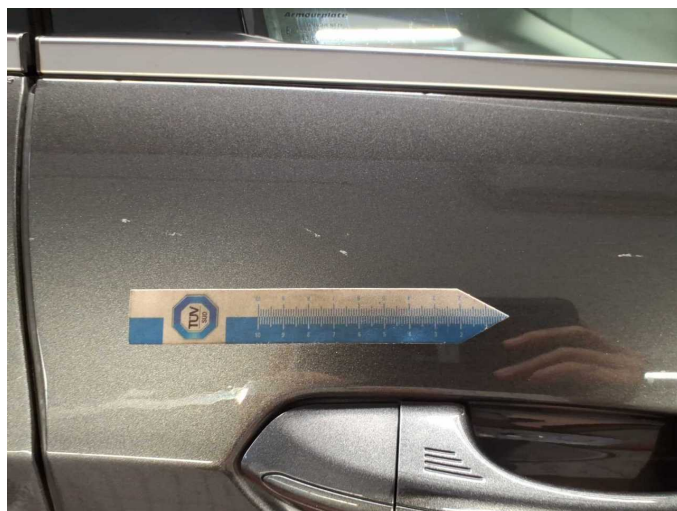
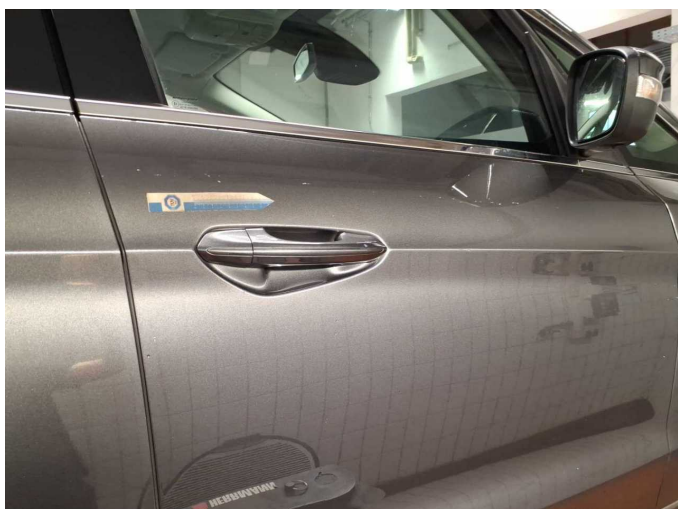
| No. | Component group | Description |
|---|---|---|
| 8 | Door - front right side | Door - Dent / paintcoat damage - Repair and paint |

**Damage 8:** Door - front right side: Door - Dent / paintcoat damage - Repair and paint

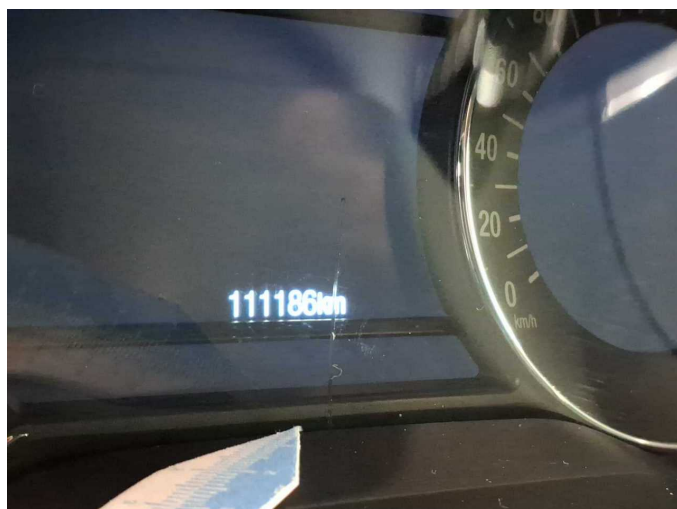
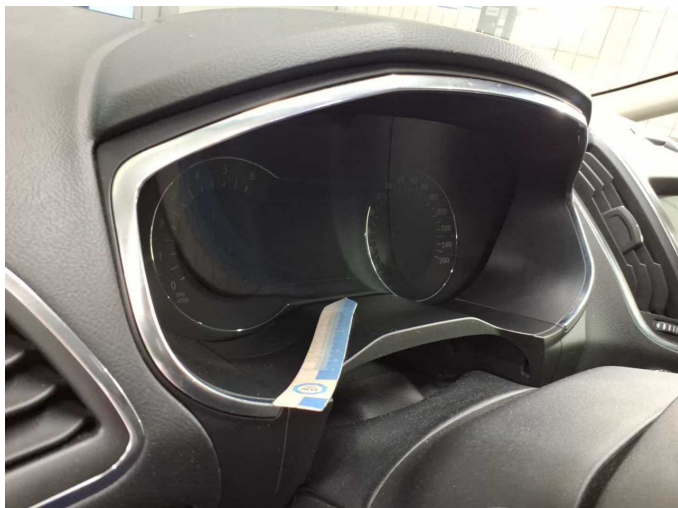
**Damage 9:** Instrument panel: Instrument cluster (Scheibe) - Broken / torn - repair according to calculation

**Damage 9:** Instrument panel: Instrument cluster (Scheibe) - Broken / torn  
- repair according to calculation

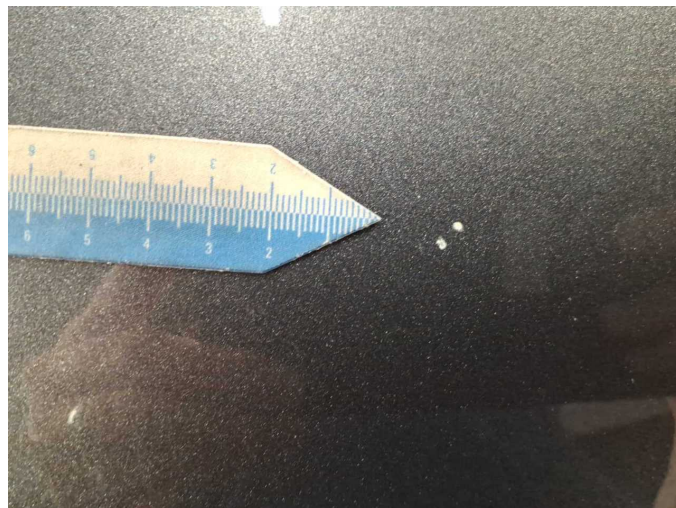
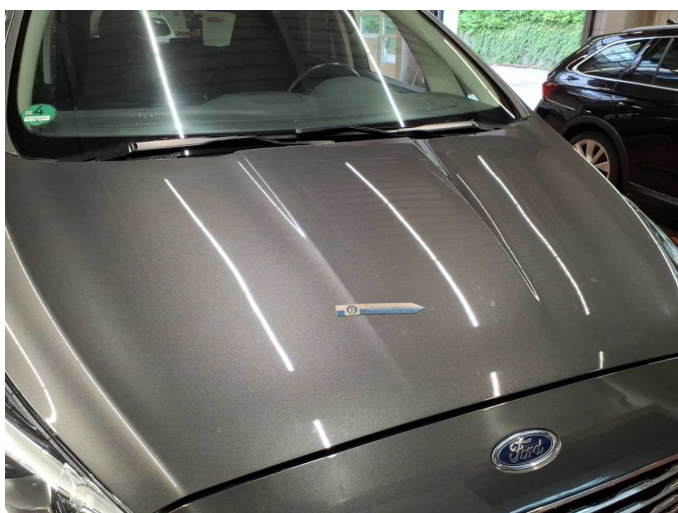
| No. | Component group | Description |
|---|---|---|
| 2 | Bonnet | Bonnet - Stone chips - No deduction |

**Wear and tear 2:** Bonnet: Bonnet - Stone chips - No deduction

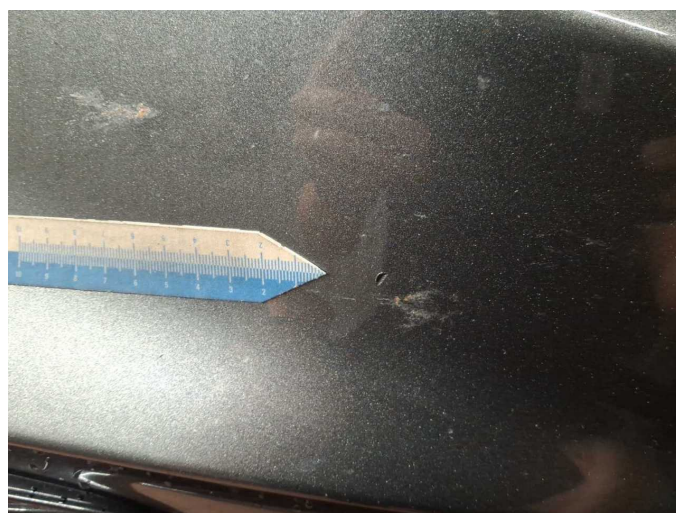
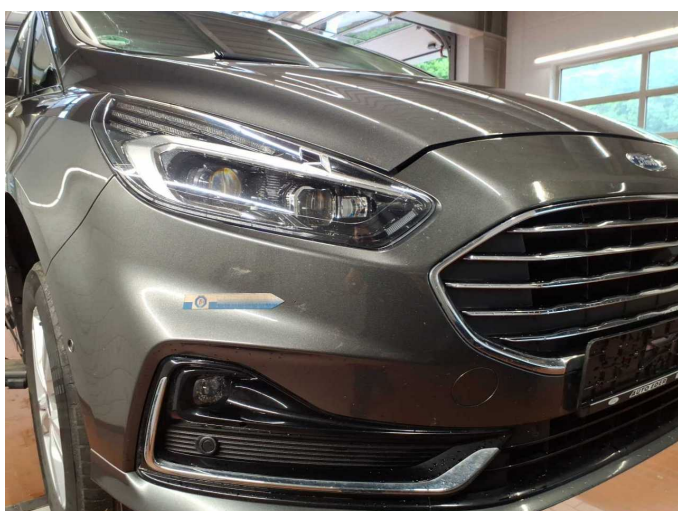
| No. | Component group | Description |
|---|---|---|
| 4 | Front bumper | Front bumper - Stone chips - No deduction |

**Wear and tear 4:** Front bumper: Front bumper - Stone chips - No deduction

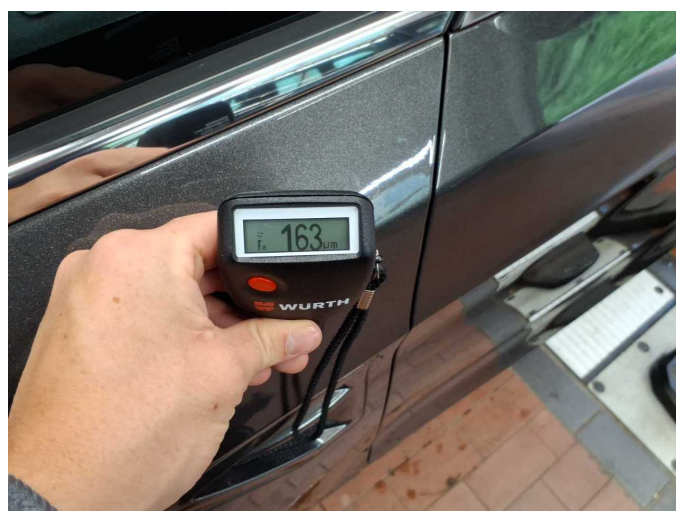
| No. | Repainting |
|---|---|
| 1 | Mudguard - left side, Professionally carried out, Invoice of repair done Non-existent |

| Mudguard - left side | 163 µm | Door - rear left side | 180 µm |

**Repainting 1:** Mudguard - left side

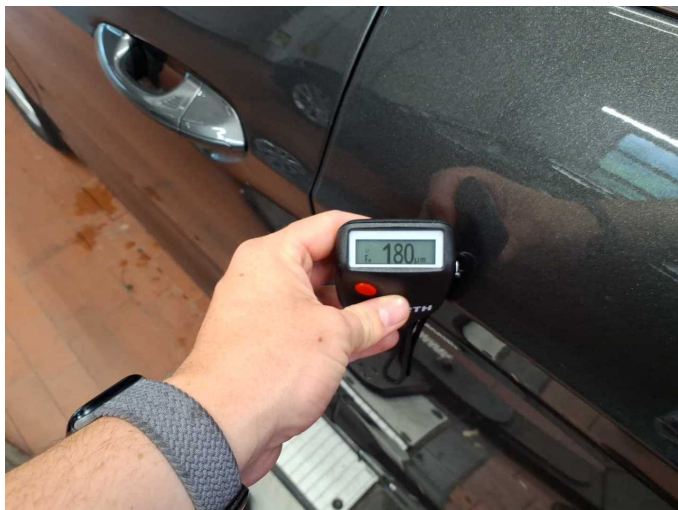
| No. | Repainting |
|---|---|
| 2 | Door - rear left side, Professionally carried out, Invoice of repair done Non-existent |

**Repainting 2:** Door - rear left side

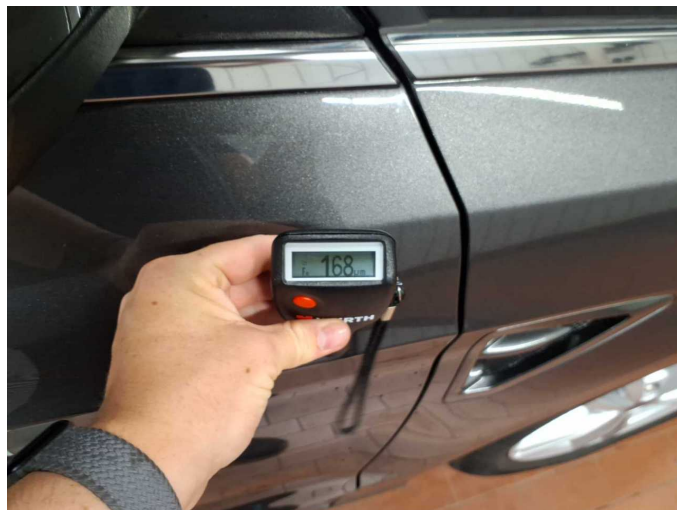
| No. | Repainting |
|---|---|
| 3 | Door - front right side, Professionally carried out, Invoice of repair done Non-existent |

| Door - front right side | 168 µm | | |

**Repainting 3:** Door - front right side
