Expertise

Protocol number: 46156461
Order No. / Reference: 26475726
Inspection date: 19 Jun 2026

Manufacturer: Ford

Model: Transit Connect 230 L1 LKW Trend

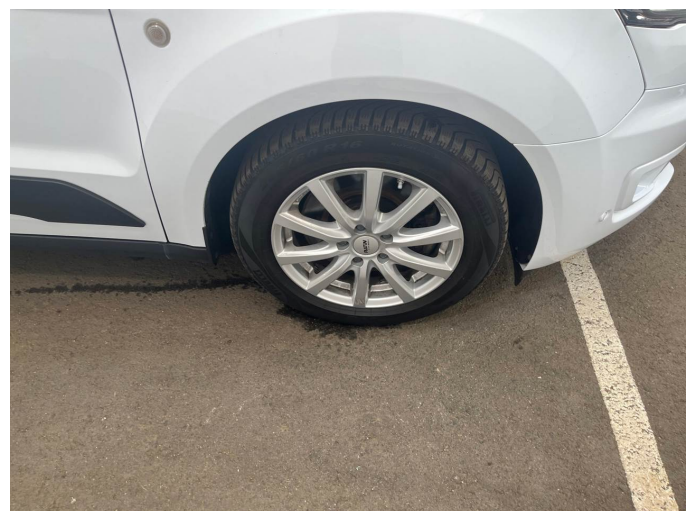
#	Tyre size	Type of tyre	Manufacturer	Tread depth
1)	205/60 R16 96H	Winter tyres on Light alloy	Pirelli	3mm / 3mm
2)	205/60 R16 96H	Winter tyres on Light alloy	Pirelli	5mm / 5mm

Figure 12: Mounted tyres

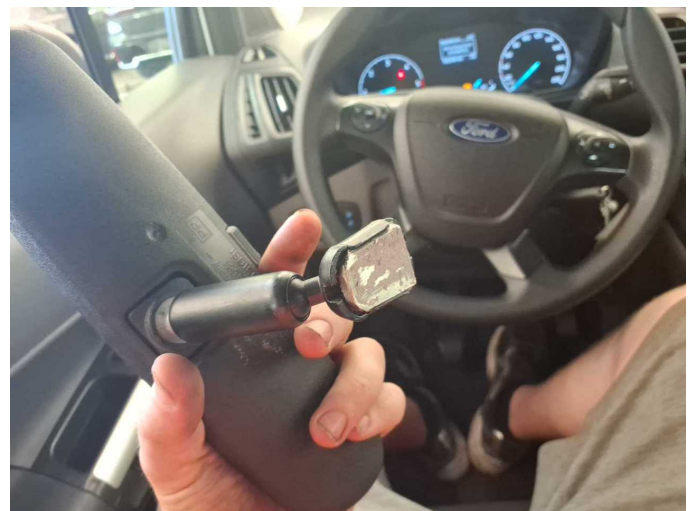
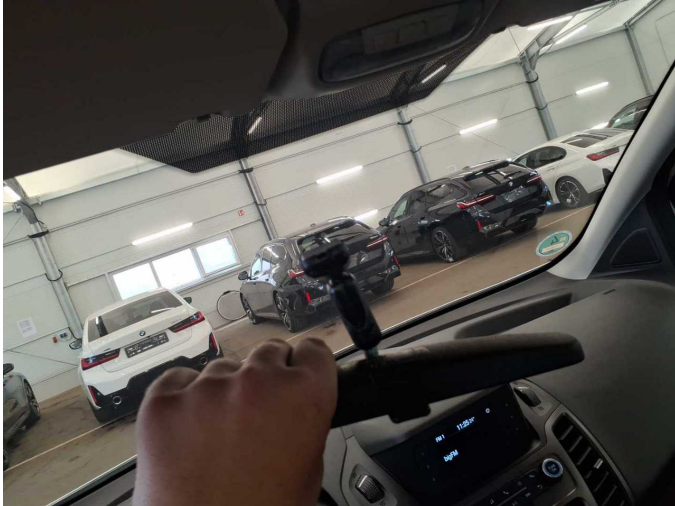
Damage 1: Instrument panel: Interior mirror - Loose - Un- / install

No.	Component group	Description
1	Instrument panel	Interior mirror - Loose - Un- / install
2	Misc.	Inspection / maintenance - Expired - Perform

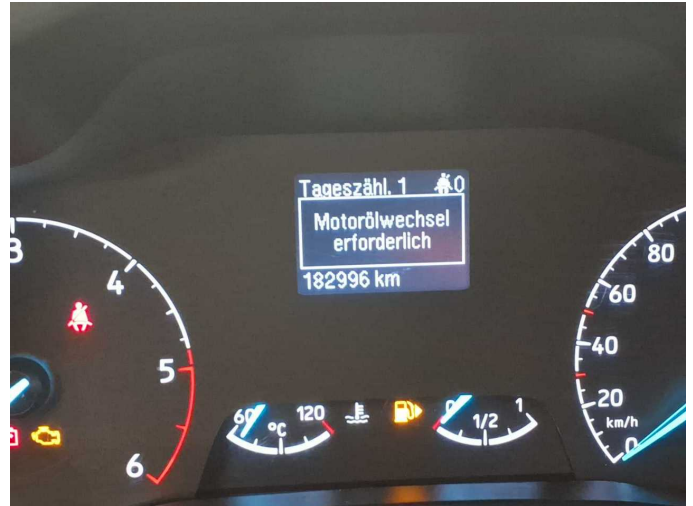
Damage 2: Misc.: Inspection / maintenance - Expired - Perform
