Expertise

Protocol number: 45811084
Order No. / Reference: 26549353
Inspection date: 8 Jun 2026

Model: A6 allroad quattro 40 TDI S tronic

VIN: WAUZZZF26PN009788

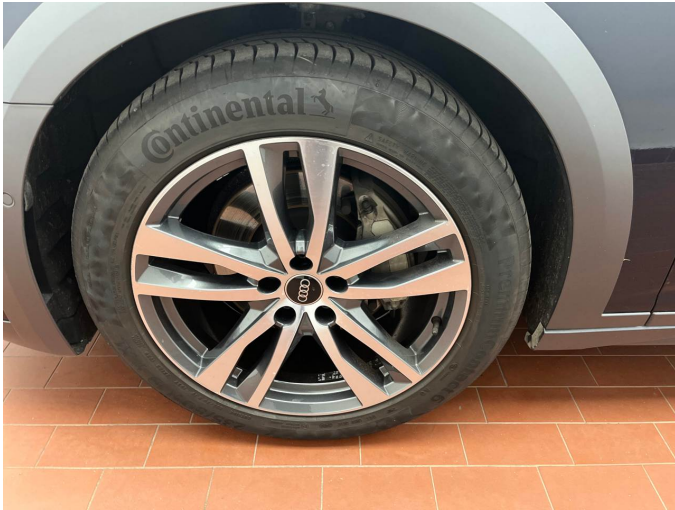
Figure 13: Mounted tyres

| Mounted tyres | | | | |
|---|---|---|---|---|
| 1) | 235/50 R19 103Y | Summer tyres on Light alloy | Continental | 6mm / 6mm |
| 2) | 235/50 R19 103Y | Summer tyres on Light alloy | Continental | 7mm / 7mm |

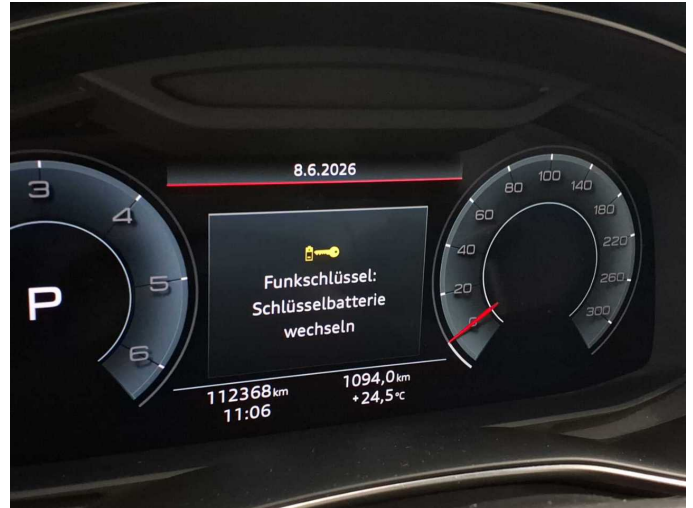
Damage 1: Equipment: Vehicle key with remote control (Batterie) - Due - Replace

| No. | Component group | Description |
|---|---|---|
| 1 | Equipment | Vehicle key with remote control (Batterie) - Due - Replace |

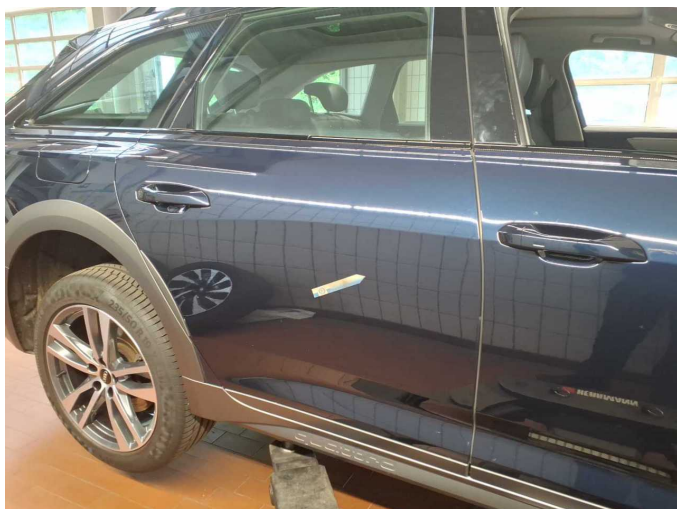
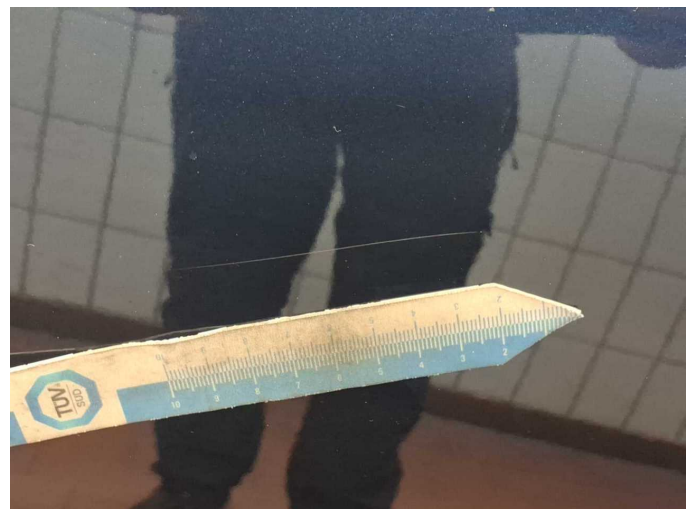
Damage 3: Door - rear right side: Door - Scratch(es) - Smart repair

| No. | Component group | Description |
|---|---|---|
| 3 | Door - rear right side | Door - Scratch(es) - Smart repair |

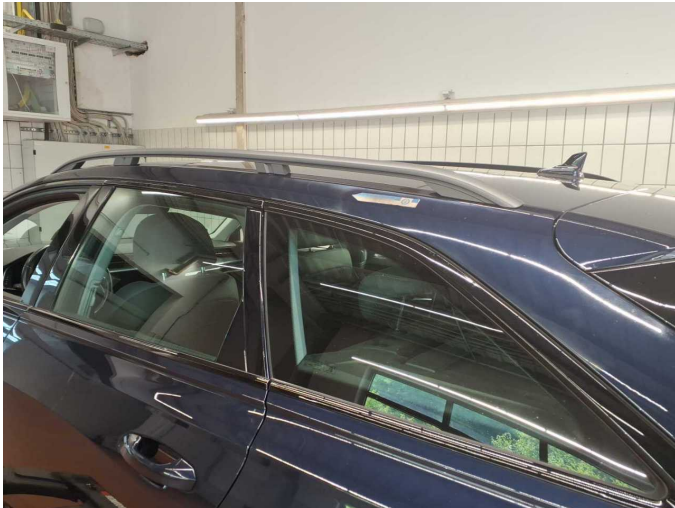
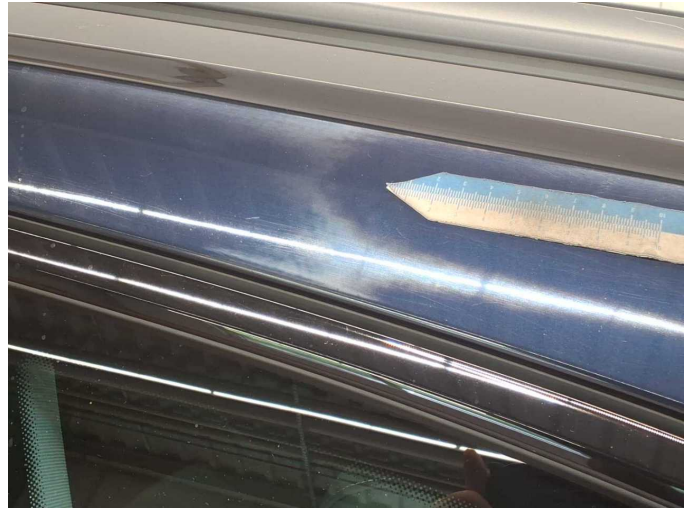
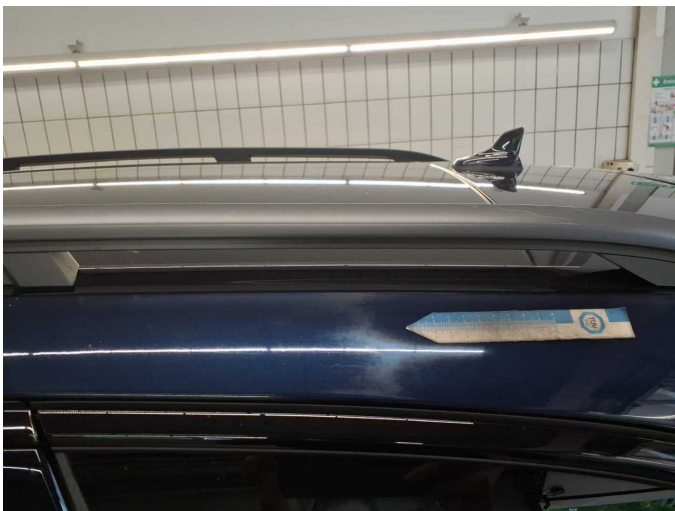
Damage 4: Roof: Roof rail - left side - Paint defect - Smart repair

| No. | Component group | Description |
|---|---|---|
| 4 | Roof | Roof rail - left side - Paint defect - Smart repair |

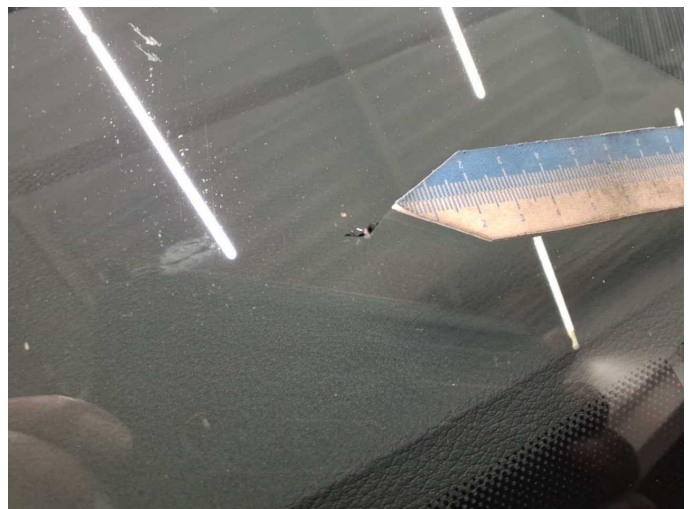
Damage 5: Vehicle glazing: Windscreen with lane departure assistant - Stone chips - Smart repair

| No. | Component group | Description |
|---|---|---|
| 5 | Vehicle glazing | Windscreen with lane departure assistant - Stone chips - Smart repair |

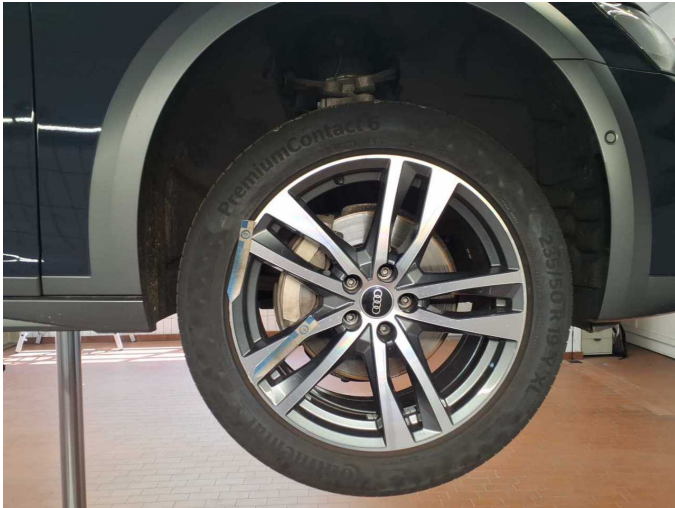
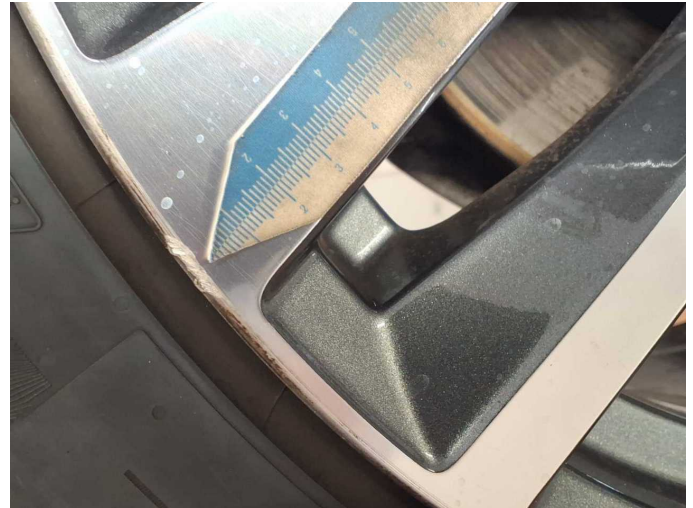
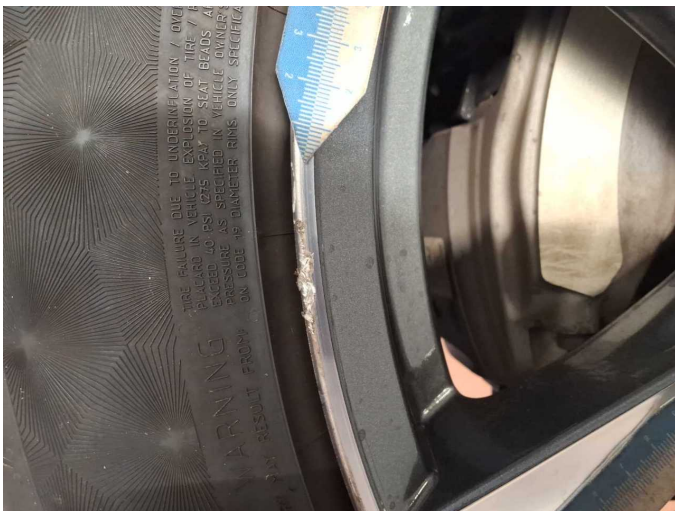
Damage 6: Wheel / tyres: Alloy rim - front right side - Scratched - Loss in value

| No. | Component group | Description |
|---|---|---|
| 6 | Wheel / tyres | Alloy rim - front right side - Scratched - Loss in value |

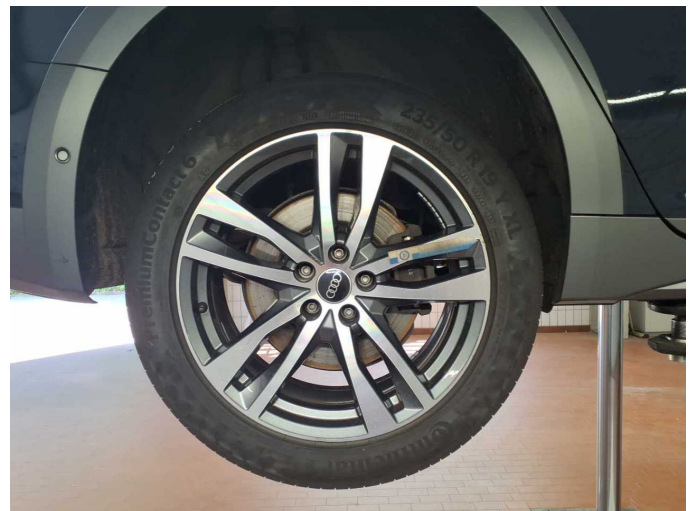
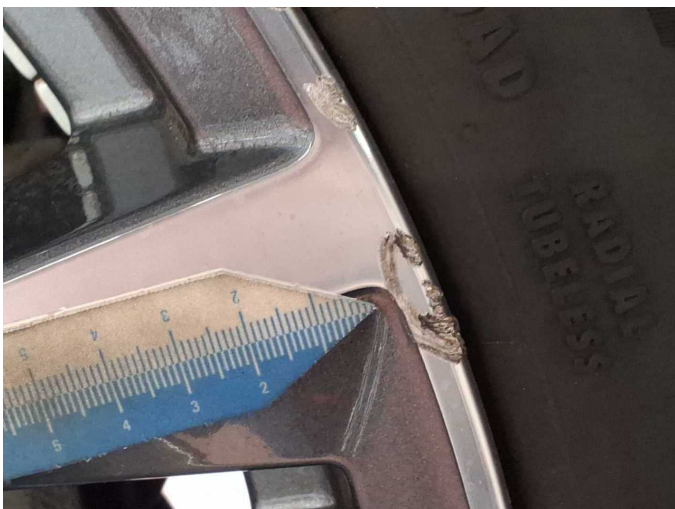
Damage 7: Wheel / tyres: Alloy rim - rear right side - Scratched - Loss in value

| No. | Component group | Description |
|---|---|---|
| 7 | Wheel / tyres | Alloy rim - rear right side - Scratched - Loss in value |

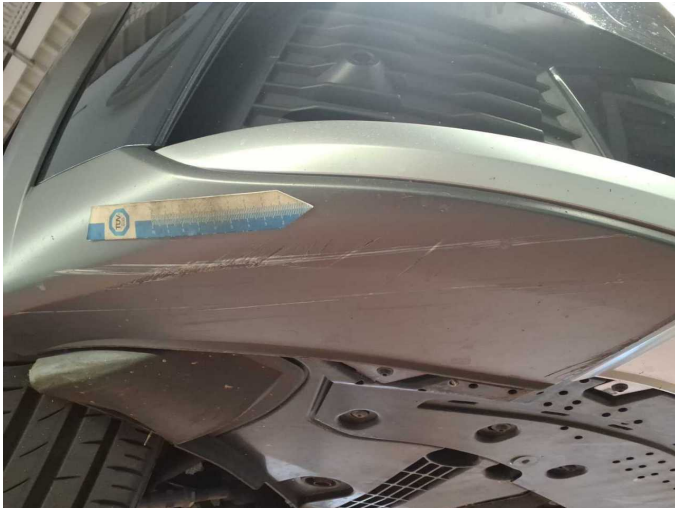
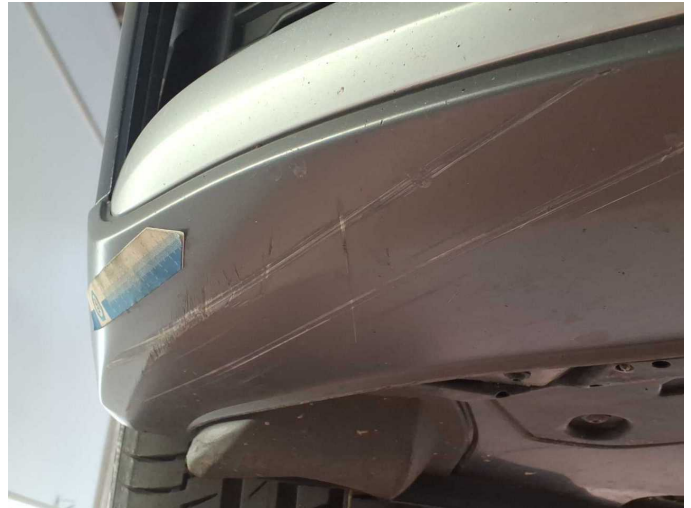
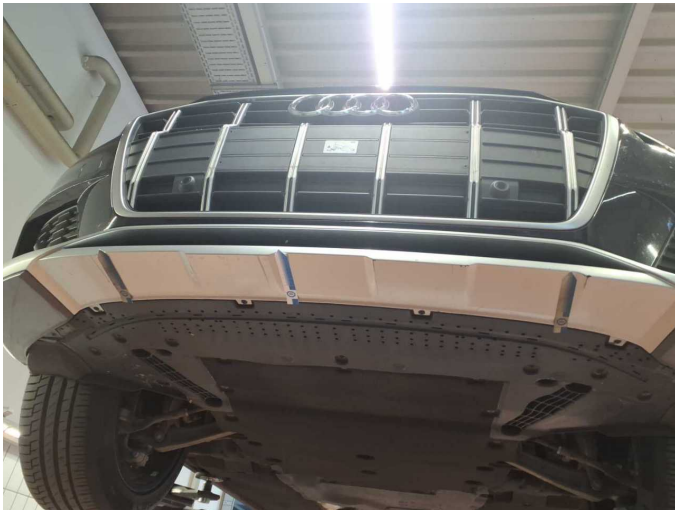
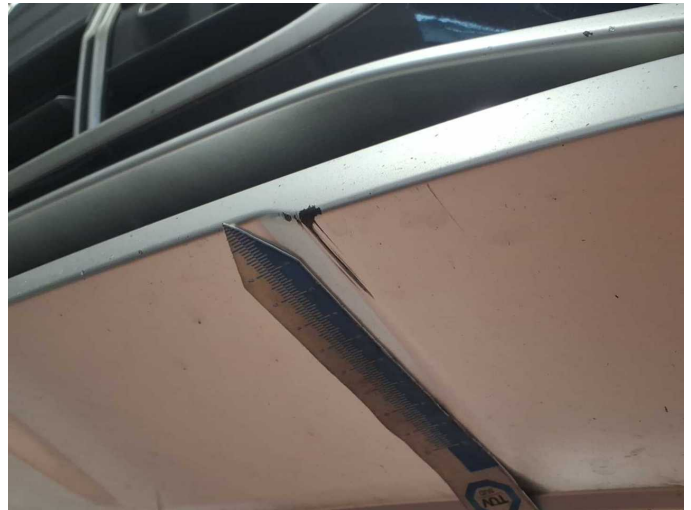
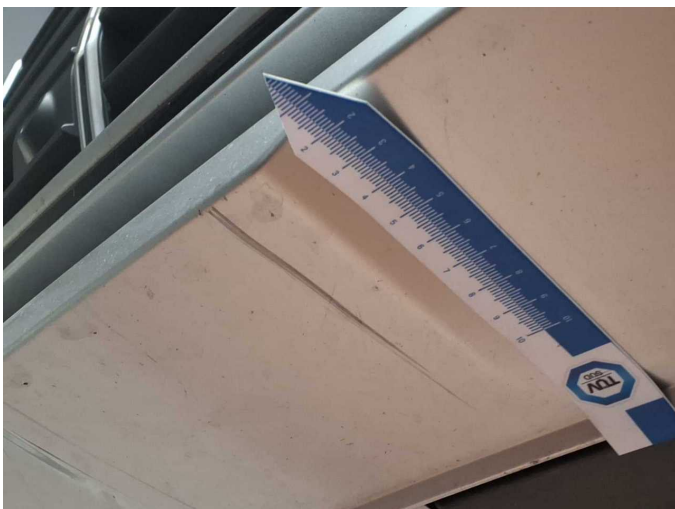
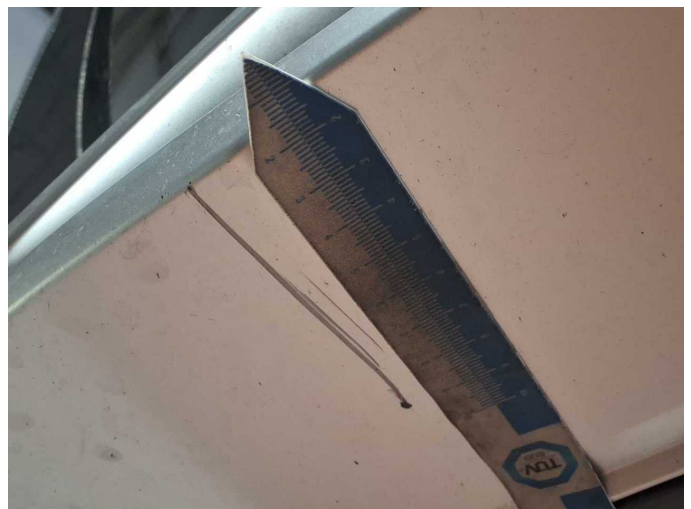
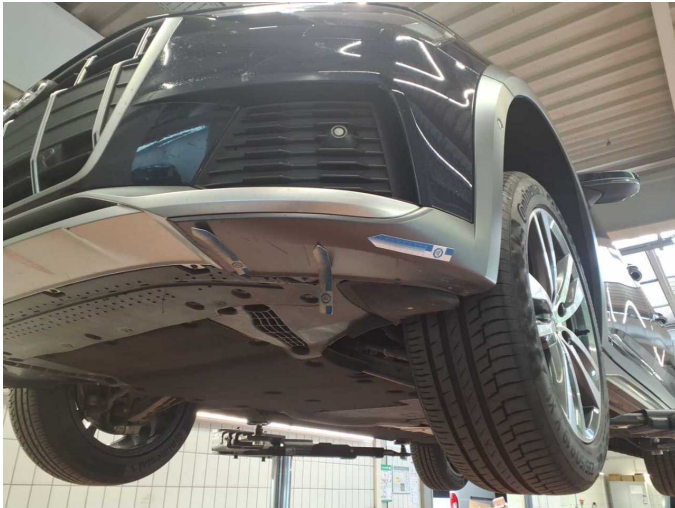
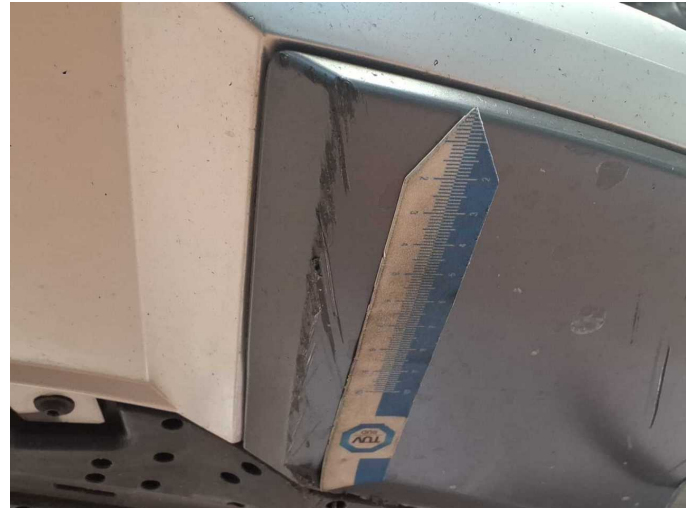
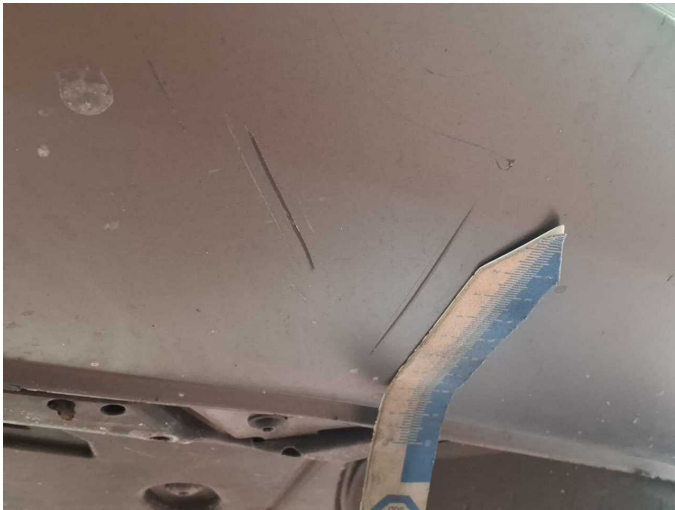
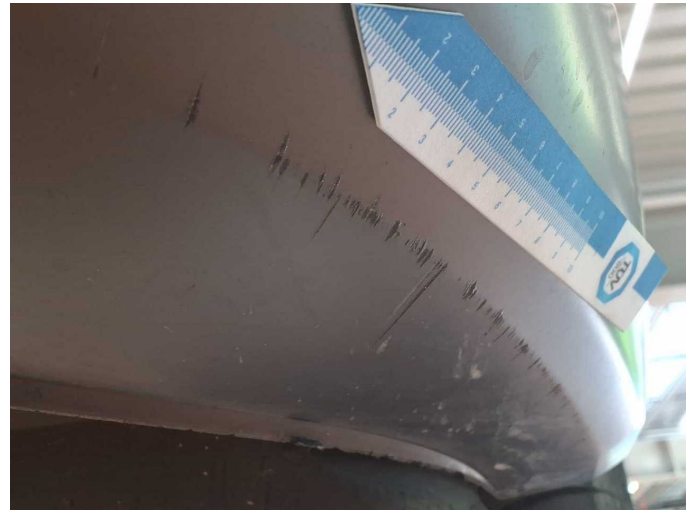
Damage 8: Front bumper: Spoiler (links + rechts + mitte) - Scratched - Loss in value

| No. | Component group | Description |
|---|---|---|
| 8 | Front bumper | Spoiler (links + rechts + mitte) - Scratched - Loss in value |

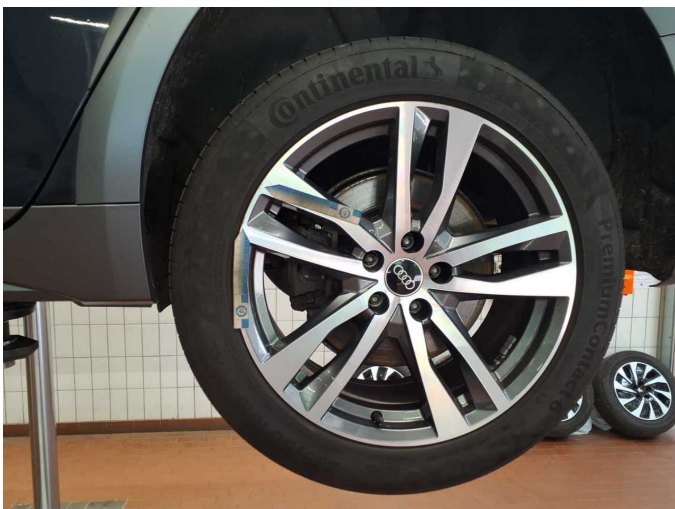
| No. | Component group | Description |
|---|---|---|
| 2 | Wheel / tyres | Alloy rim - rear left side - Scratch(es) - No deduction |

Wear and tear 2: Wheel / tyres: Alloy rim - rear left side - Scratch(es) - No deduction

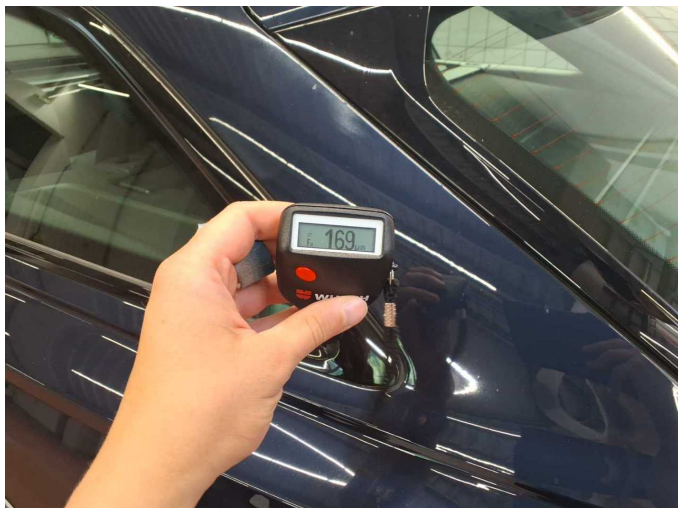
| No. | Repainting |
|---|---|
| 1 | Side panel - rear left side, Professionally carried out, Invoice of repair done Non-existent |

| Side panel - rear left side | 169 µm | Door - rear left side | 158 µm |

Repainting 1: Side panel - rear left side

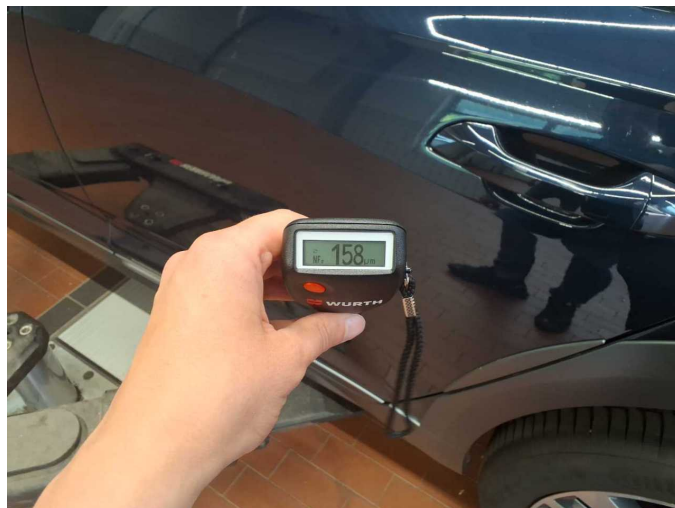
| No. | Repainting |
|---|---|
| 2 | Door - rear left side, Professionally carried out, Invoice of repair done Non-existent |

Repainting 2: Door - rear left side
