Expertise

Protocol number: 46486488  
Order No. / Reference: 26480462  
Inspection date: 14 Jul 2026

Manufacturer: Mercedes-Benz  
VIN: W1K5M1DB0PN400378

Model: CLA 200 d 4Matic Shooting Brake 8G-DCT Progressive

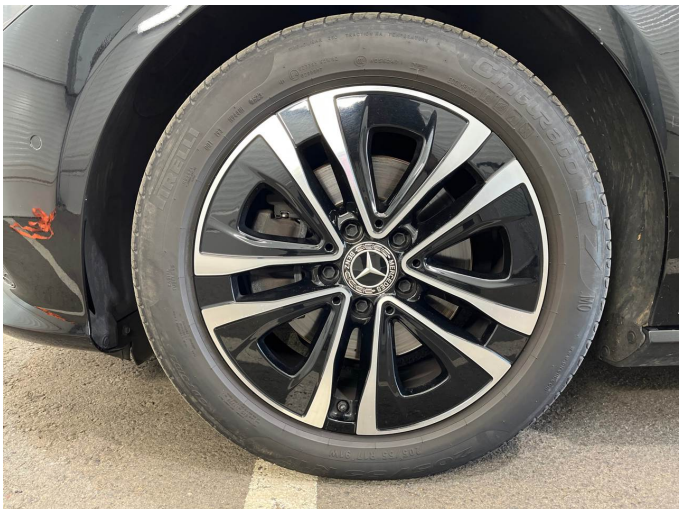
Figure 12: Mounted tyres

| # | Tyre size | Type of tyre | Manufacturer | Tread depth |
|---|---|---|---|---|
| 1) | 205/55 R17 91W | Summer tyres on Light alloy | Pirelli | 4mm / 4mm |
| 2) | 205/55 R17 91W | Summer tyres on Light alloy | Pirelli | 5mm / 5mm |

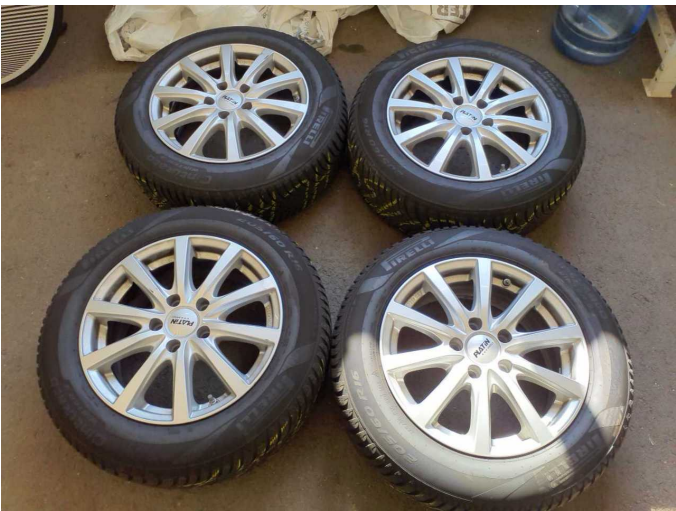
Figure 15: Additional tyres

| # | Tyre size | Type of tyre | Manufacturer | Tread depth |
|---|---|---|---|---|
| 1) | 205/60 R16 96U | Winter tyres on Light alloy | Pirelli | 6mm / 6mm |
| 2) | 205/60 R16 96U | Winter tyres on Light alloy | Pirelli | 7mm / 7mm |

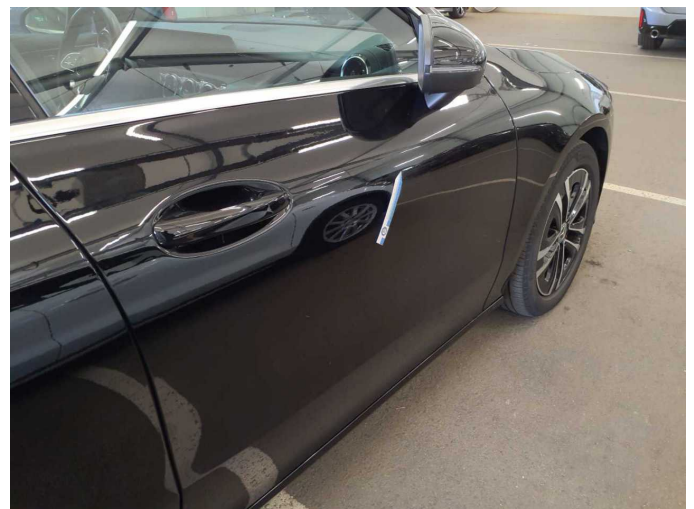
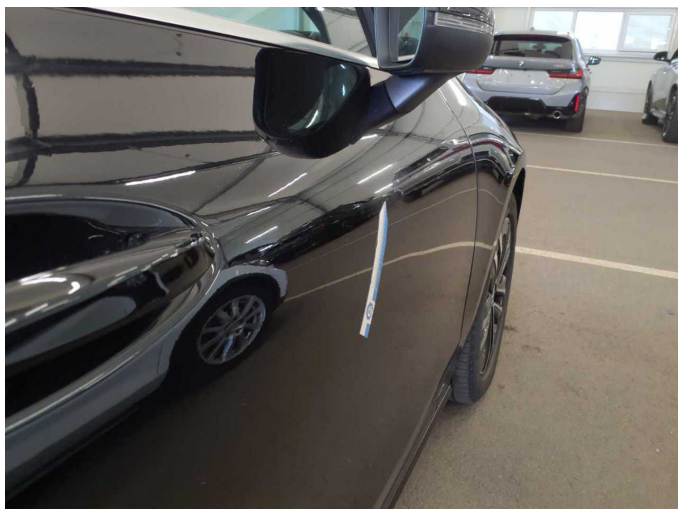
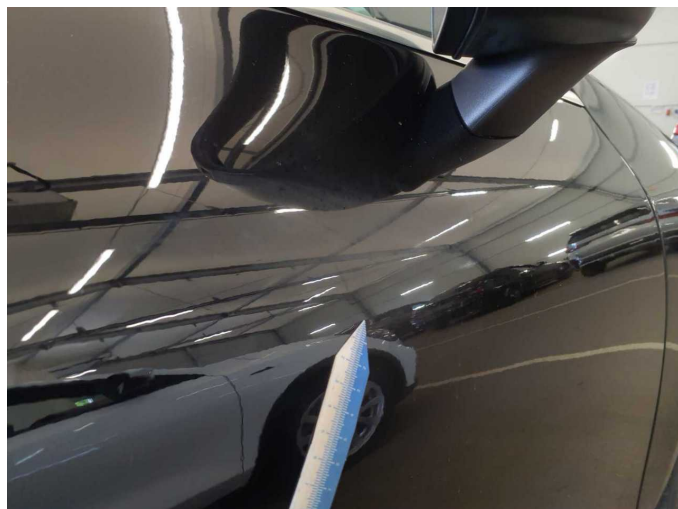
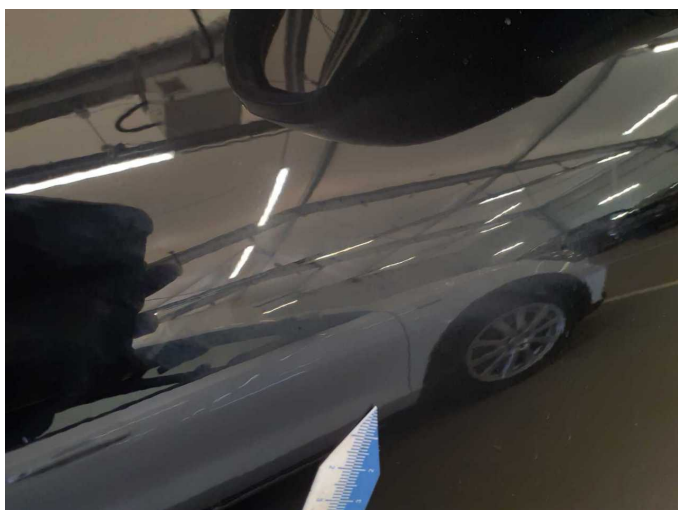
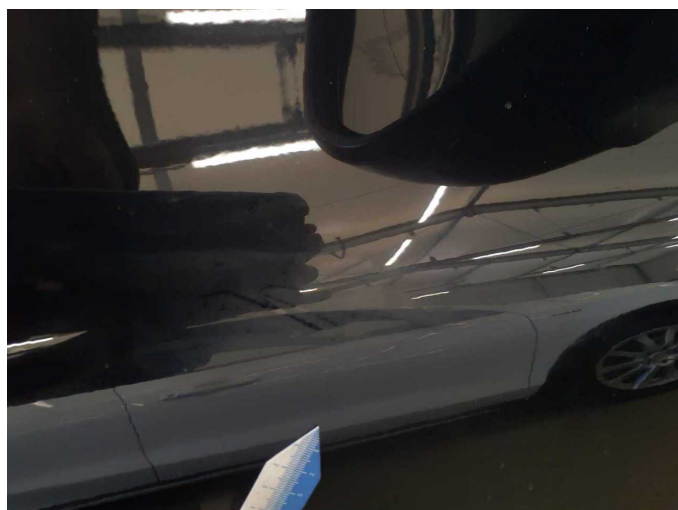
| No. | Component group | Description |
|---|---|---|
| 1 | Door - front right side | Door (Raue Oberfläche) - Paint defect - Paint |

Damage 1: Door - front right side: Door (Raue Oberfläche) - Paint defect - Paint

**Damage 1:** Door - front right side: Door (Raue Oberfläche) - Paint defect - Paint

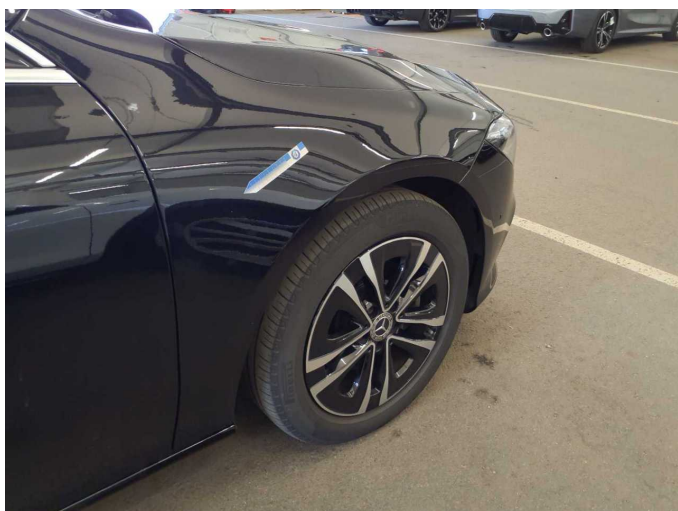
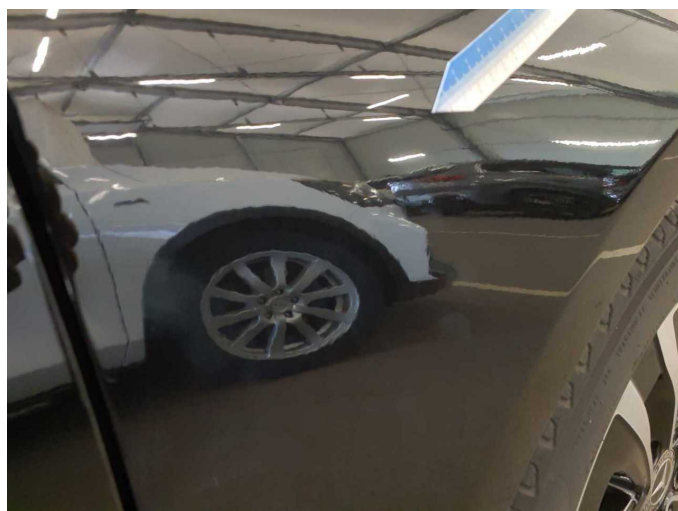
| No. | Component group | Description |
|---|---|---|
| 2 | Mudguard - right side | Mudguard - right side (Raue Oberfläche) - Paint defect - Paint |

**Damage 2:** Mudguard - right side: Mudguard - right side (Raue Oberfläche) - Paint defect - Paint

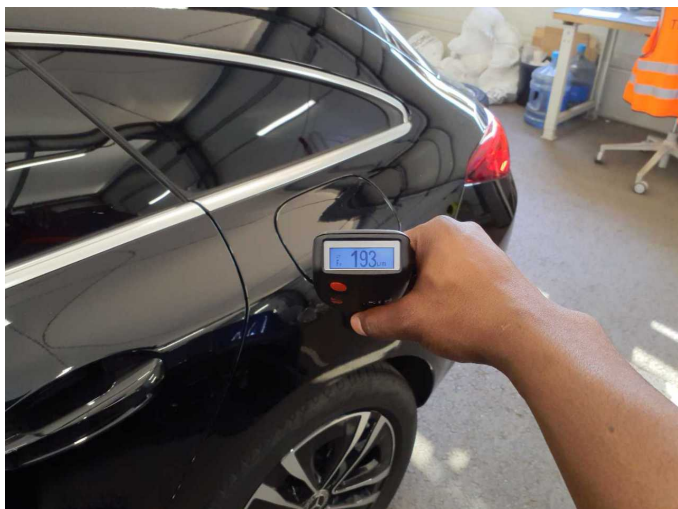
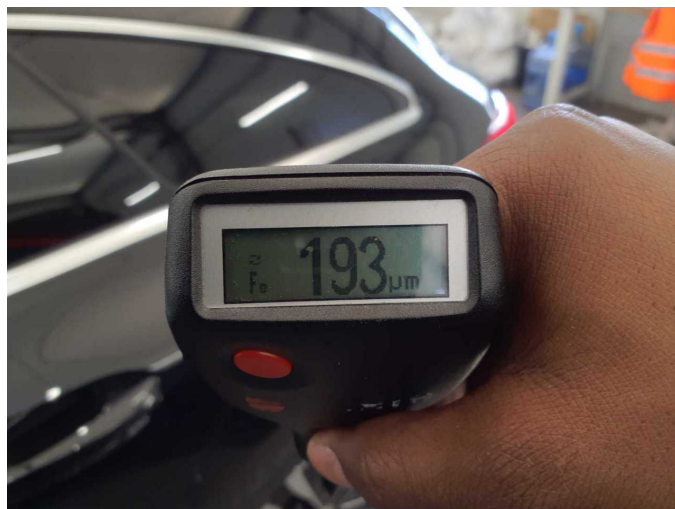
| No. | Repainting |
|---|---|
| 1 | Side panel - rear left side, Professionally carried out, Invoice of repair done Non-existent |

| Mudguard - right side | 293 µm | Side panel - rear left side | 193 µm |

**Repainting 1:** Side panel - rear left side

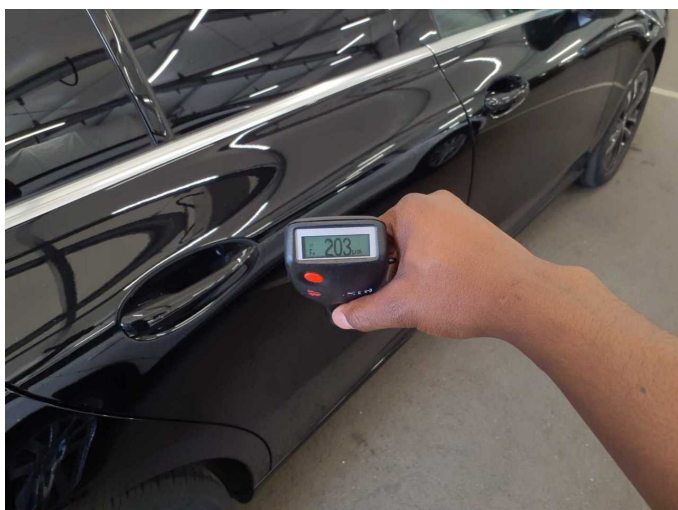
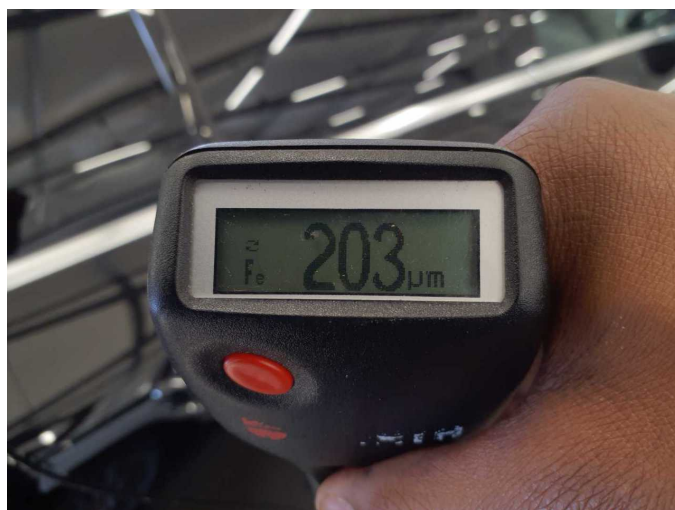
| No. | Repainting |
|---|---|
| 2 | Door - rear right side, Professionally carried out, Invoice of repair done Non-existent |

| Door - rear right side | 203 µm | Door - front left side | 195 µm |

**Repainting 2:** Door - rear right side

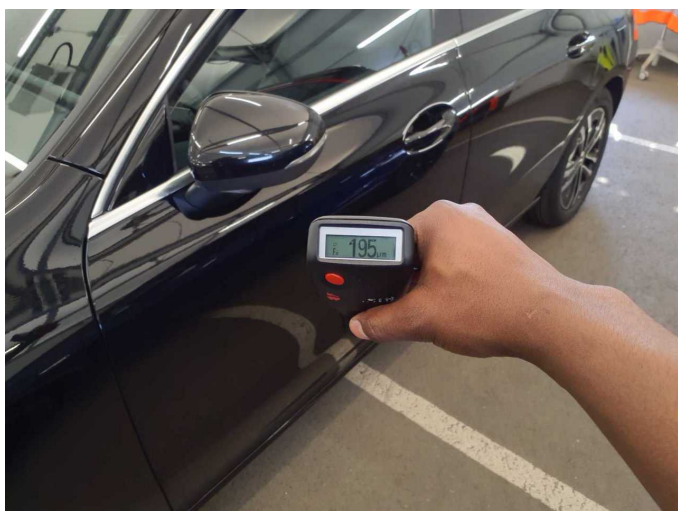
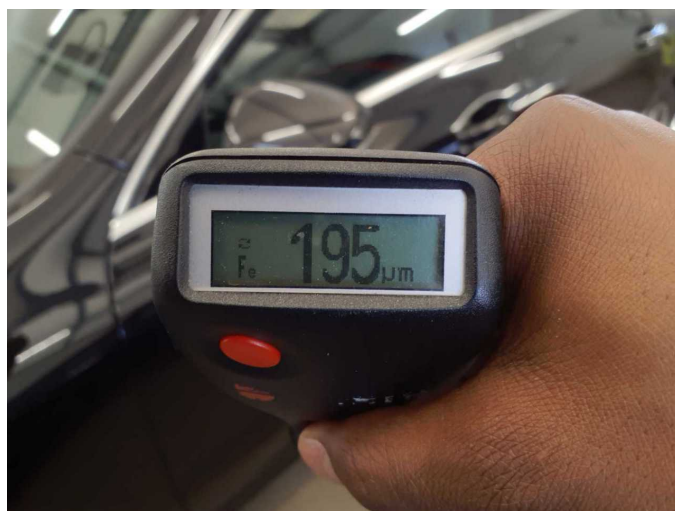
| No. | Repainting |
|---|---|
| 3 | Door - front left side, Professionally carried out, Invoice of repair done Non-existent |

**Repainting 3:** Door - front left side

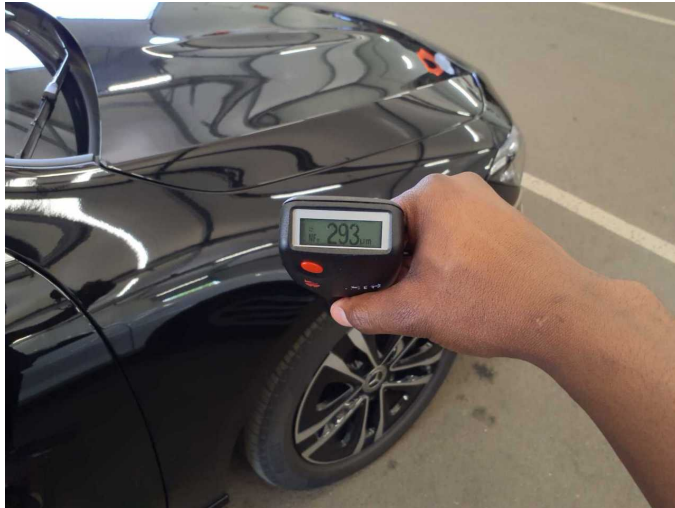
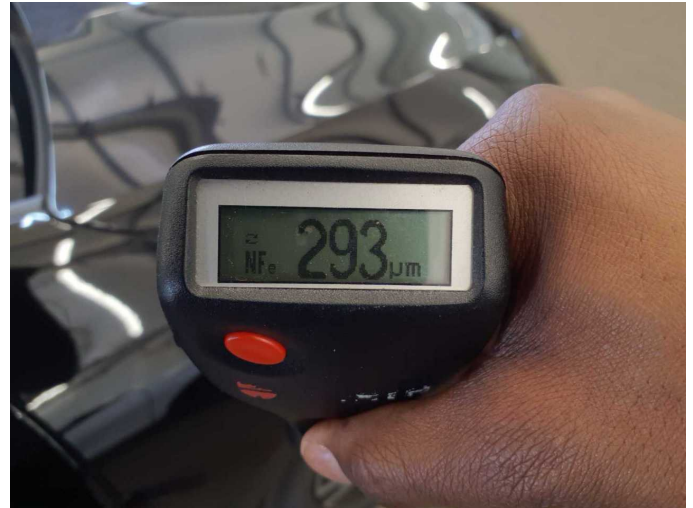
| No. | Repainting |
|---|---|
| 4 | Mudguard - right side, Unprofessionally carried out, Invoice of repair done Non-existent |

**Repainting 4:** Mudguard - right side

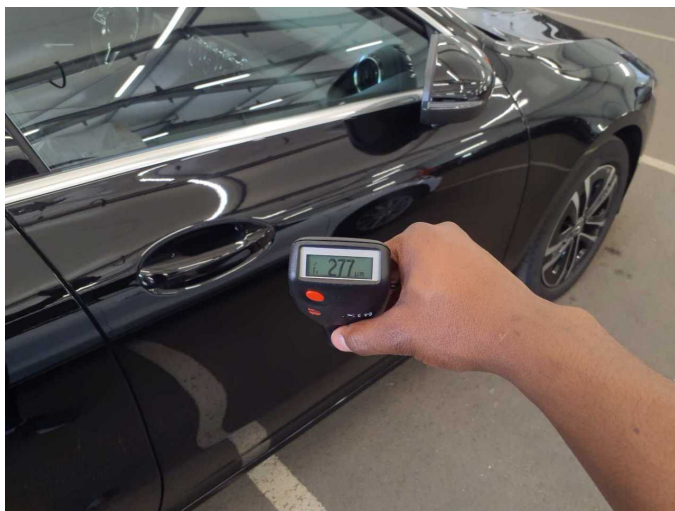
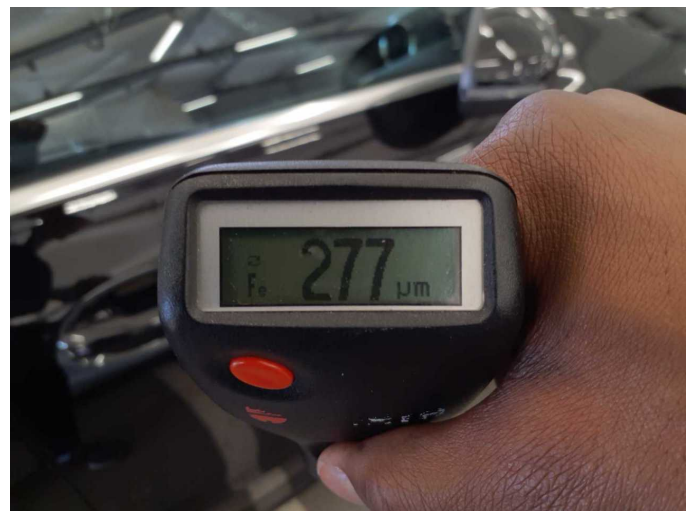
| No. | Repainting |
|---|---|
| 5 | Door - front right side, Unprofessionally carried out, Invoice of repair done Non-existent |

| Door - front right side | 277 µm | | |

**Repainting 5:** Door - front right side
