Expertise

Protocol number: 46472446  
Order No. / Reference: 26324629  
Inspection date: 9 Jul 2026

Manufacturer: Mercedes-Benz  
VIN: W1VVMFTZ5T4565504

Model: Vito 119 CDI 4MATIC Tourer Lang Aut. PRO

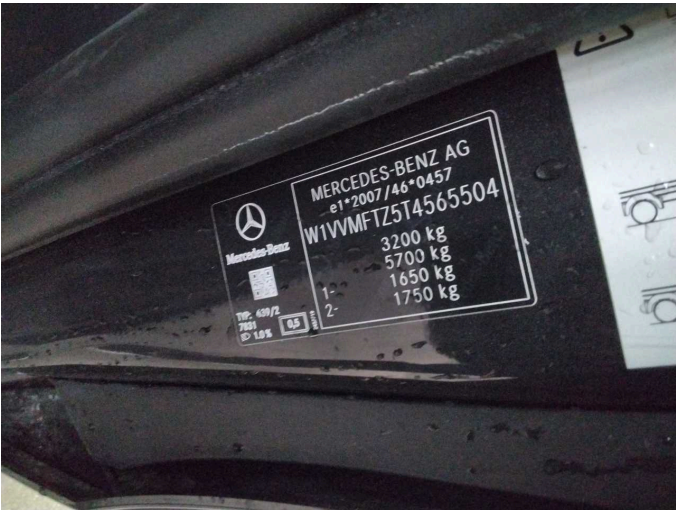
| VIN comparison | The vehicle identification number (VIN) was read from the vehicle and its conformity with the submitted documents was confirmed by the undersigned during the inspection. |

Figure 11: VIN

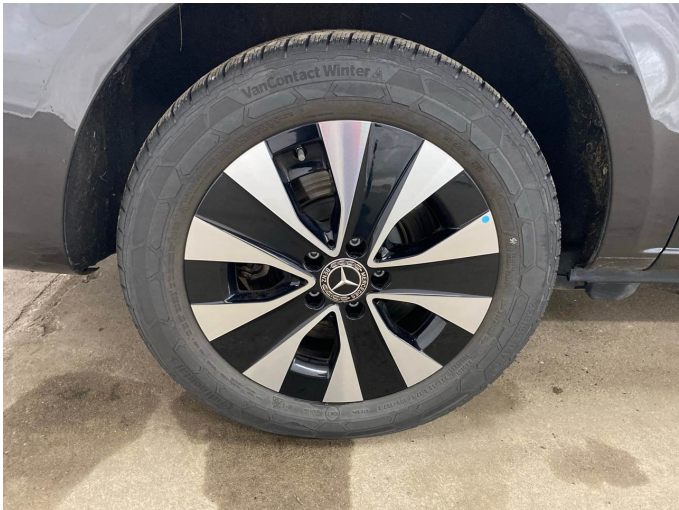
| # | Tyre size | Type of tyre | Manufacturer | Tread depth |
|---|---|---|---|---|
| 1) | 225/55 R17 109T | Winter tyres on Light alloy | Continental | 8mm / 8mm |
| 2) | 225/55 R17 109T | Winter tyres on Light alloy | Continental | 8mm / 8mm |

Figure 12: Mounted tyres

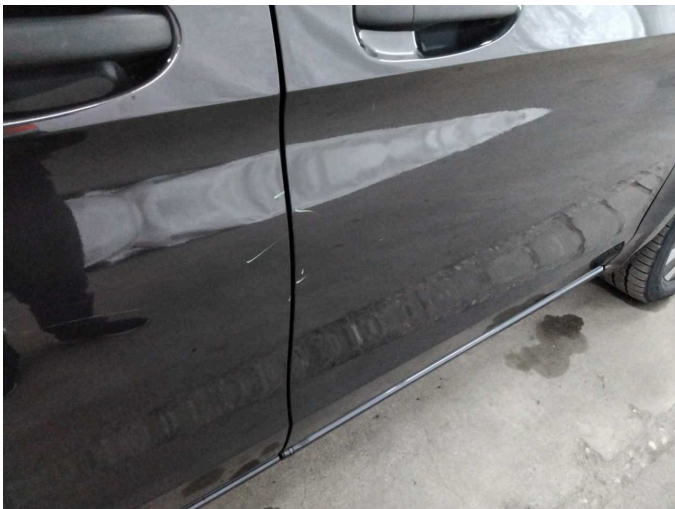
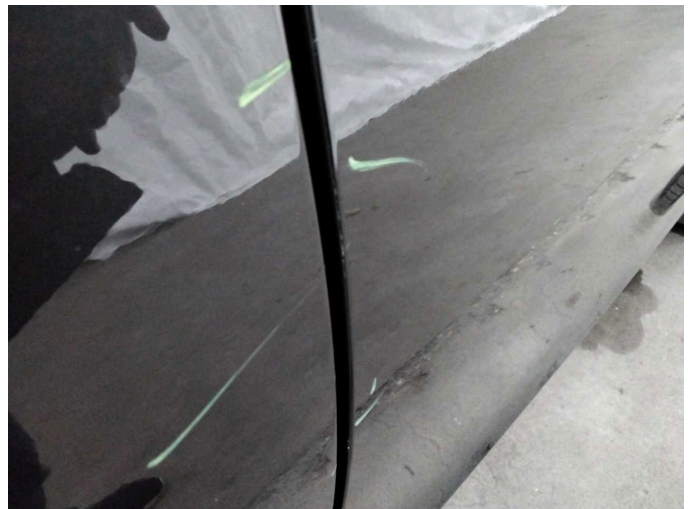
| No. | Component group | Description |
|---|---|---|
| 1 | Door - front right side | Door edge - Scratch(es) - Smart repair |

Damage 1: Door - front right side: Door edge - Scratch(es) - Smart repair

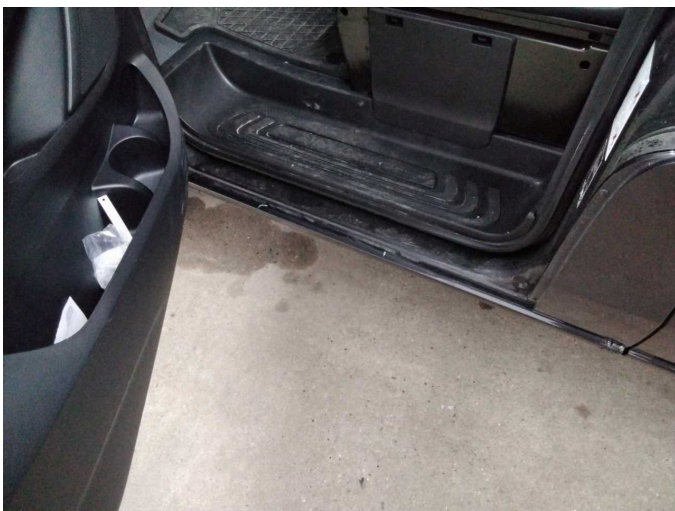
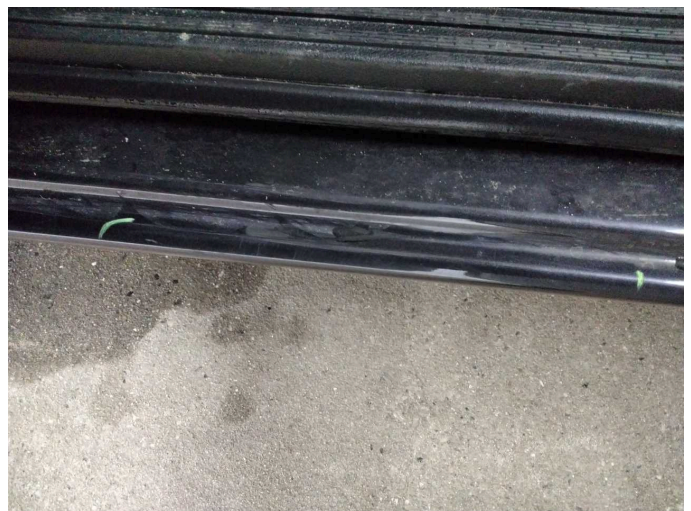
| No. | Component group | Description |
|---|---|---|
| 2 | Sill - left side | Sill - Scratch(es) - Smart repair |

Damage 2: Sill - left side: Sill - Scratch(es) - Smart repair

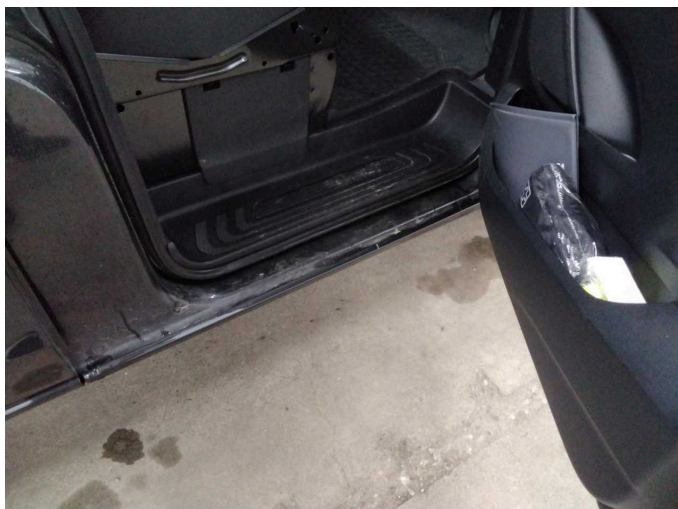
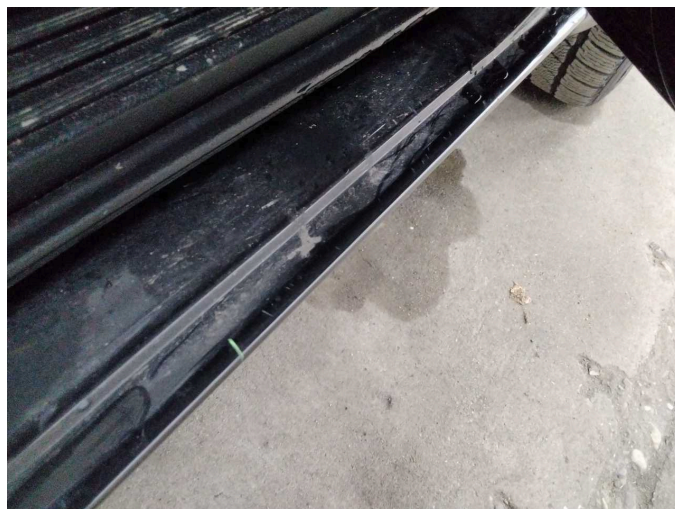
| No. | Component group | Description |
|---|---|---|
| 3 | Sill - right side | Sill - Scratch(es) - Smart repair |

**Damage 3:** Sill - right side: Sill - Scratch(es) - Smart repair

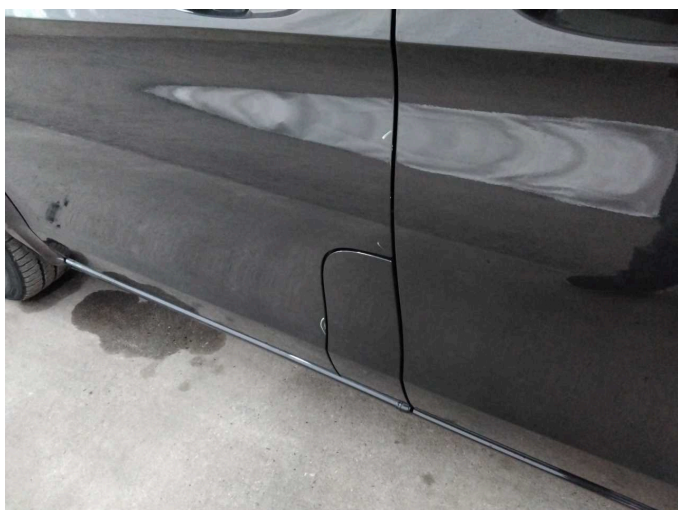
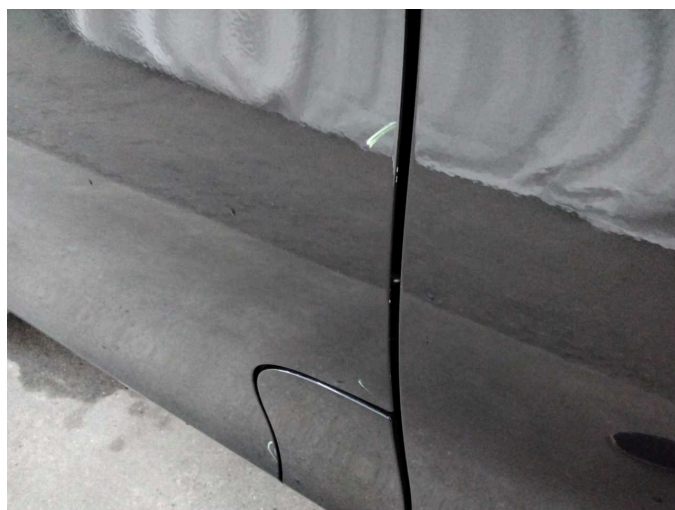
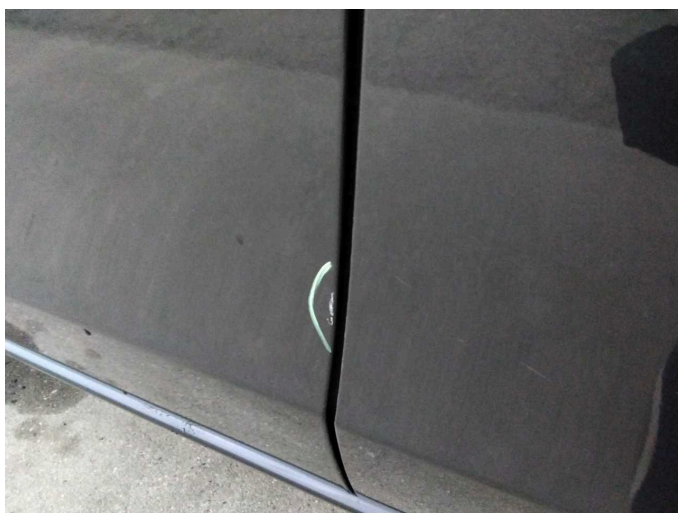
| No. | Component group | Description |
|---|---|---|
| 4 | Door - front left side | Door edge - Scratch(es) - Smart repair |

**Damage 4:** Door - front left side: Door edge - Scratch(es) - Smart repair

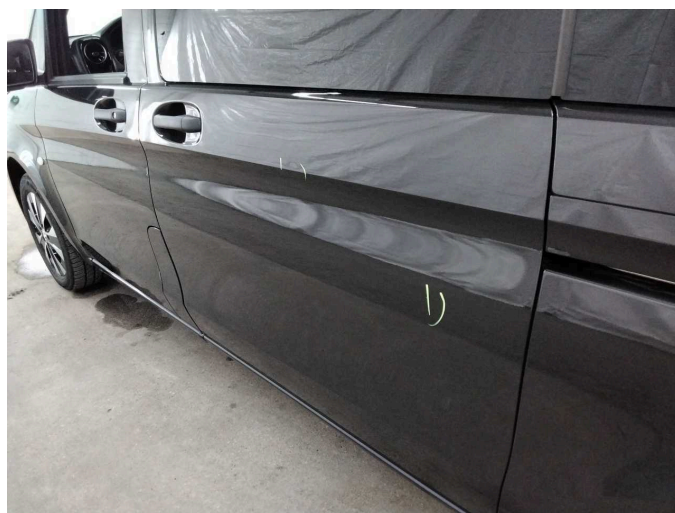
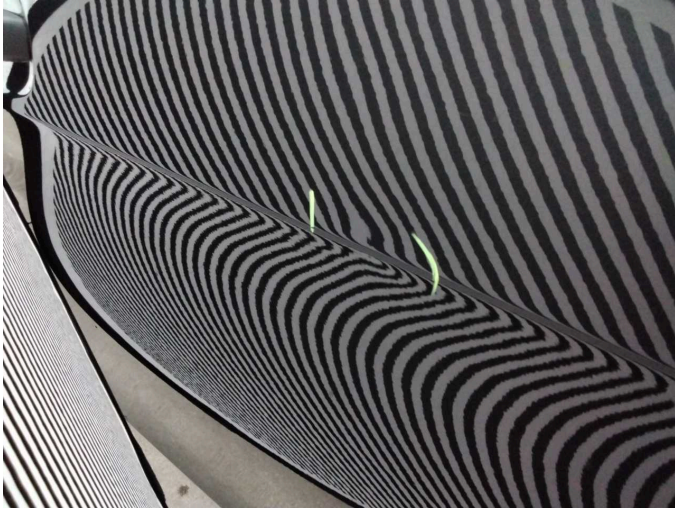
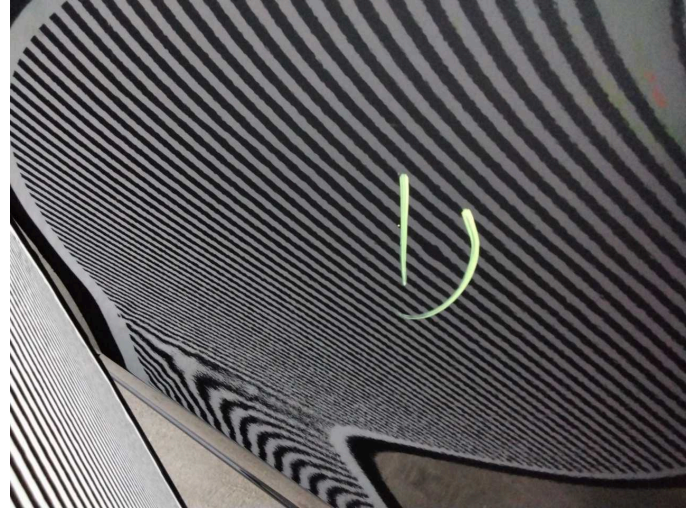
| No. | Component group | Description |
|---|---|---|
| 5 | Sliding door - left side | Sliding door with glass panel - dent(s) - Smooth repair work |

**Damage 5:** Sliding door - left side: Sliding door with glass panel - dent(s) - Smooth repair work

**Damage 5:** Sliding door - left side: Sliding door with glass panel - dent(s)  
- Smooth repair work

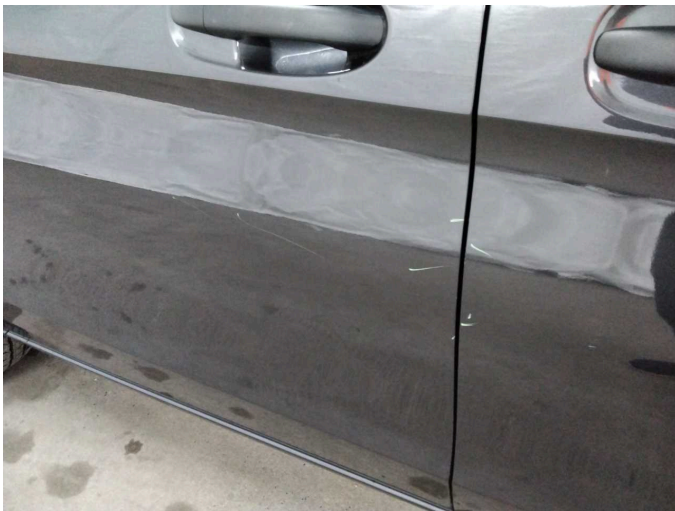
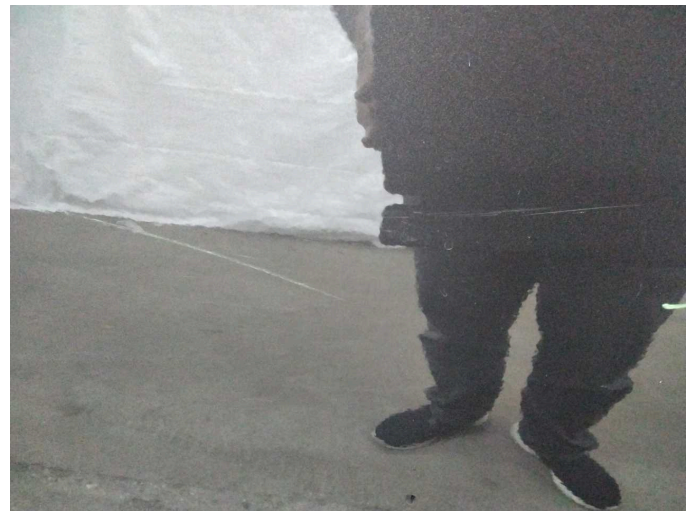
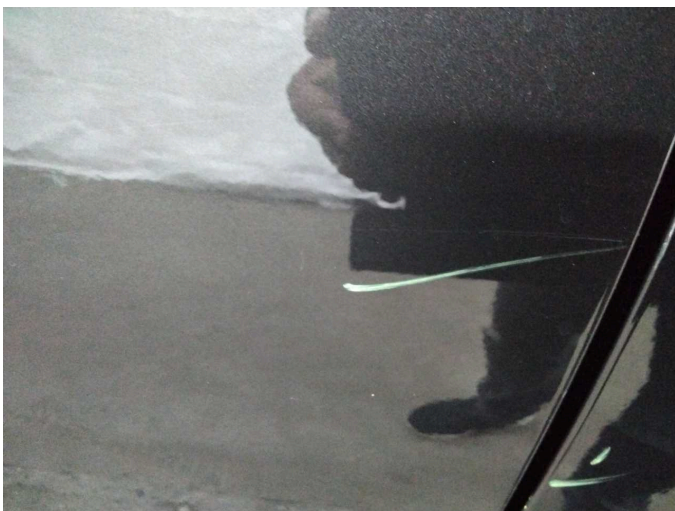
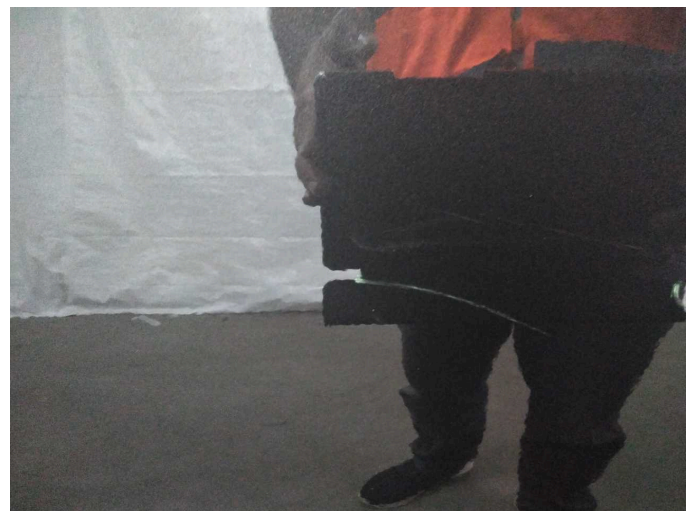
| No. | Component group | Description |
|---|---|---|
| 6 | Sliding door, right | Sliding door with glass panel - Scratch(es) - Smart repair |

**Damage 6:** Sliding door, right: Sliding door with glass panel - Scratch(es)  
- Smart repair

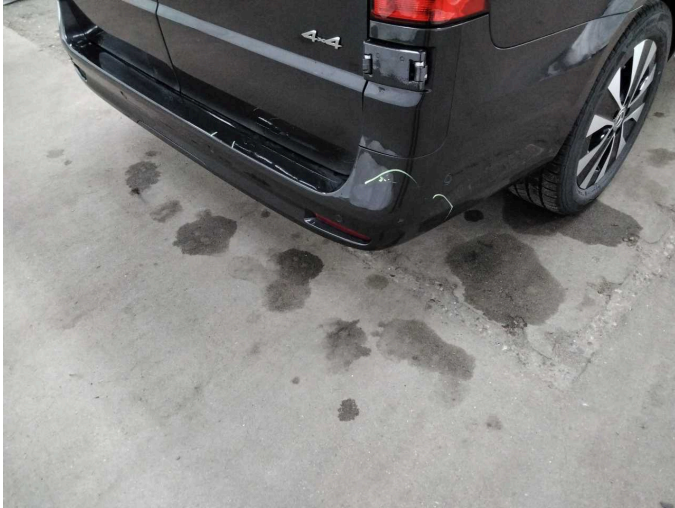
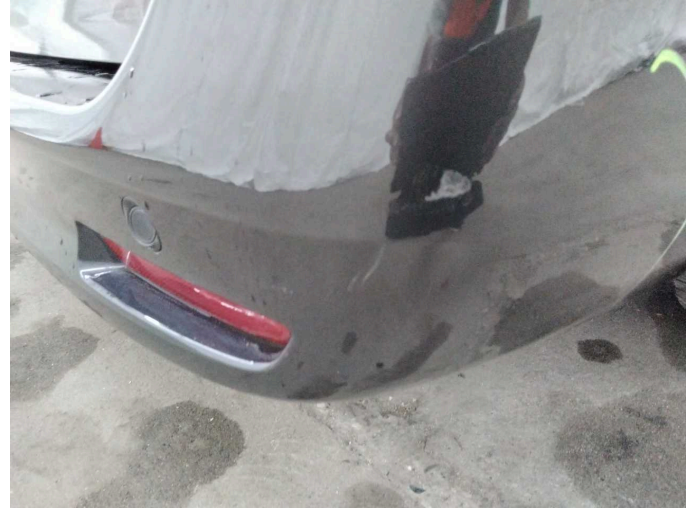
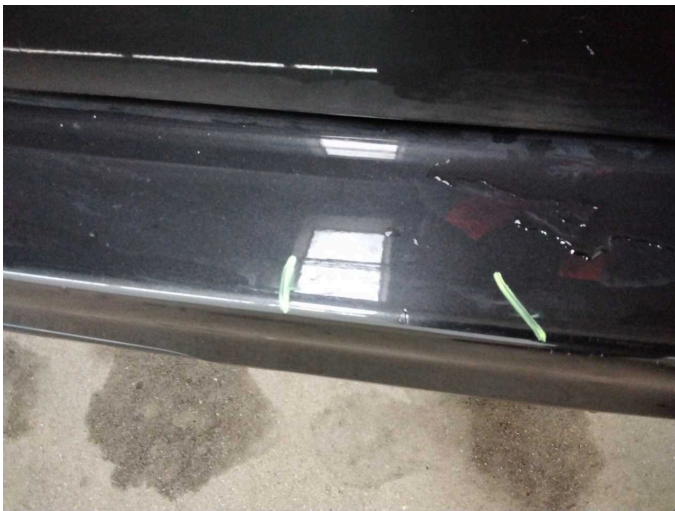
| No. | Component group | Description |
|---|---|---|
| 7 | Rear bumper | Rear bumper - Scratch(es) - Paint |

**Damage 7:** Rear bumper: Rear bumper - Scratch(es) - Paint
