Expertise

Protocol number: 46032547  
Order No. / Reference: 26453148  
Inspection date: 18 Jun 2026

Manufacturer: Mercedes-Benz  
VIN: W1N4M1ABXPW277184

Model: GLB 180 d 8G-DCT Style

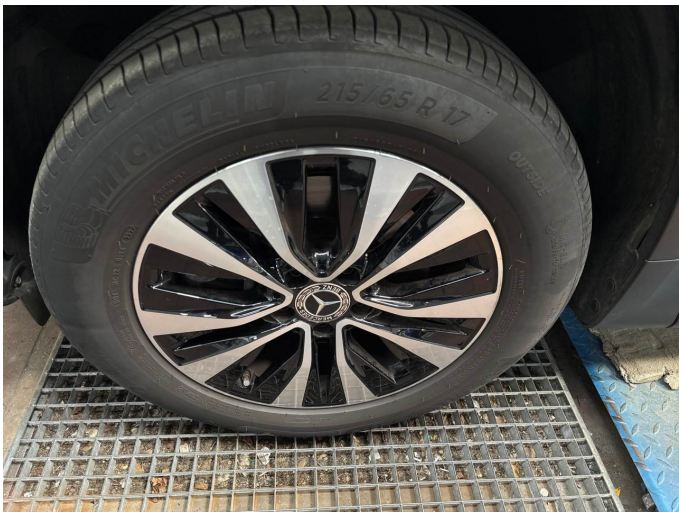
Figure 12: Mounted tyres

| # | Tyre size | Type of tyre | Manufacturer | Tread depth |
|---|---|---|---|---|
| 1) | 215/65 R17 99V | Summer tyres on Light alloy | Michelin | 4mm / 4mm |
| 2) | 215/65 R17 99V | Summer tyres on Light alloy | Michelin | 4mm / 4mm |

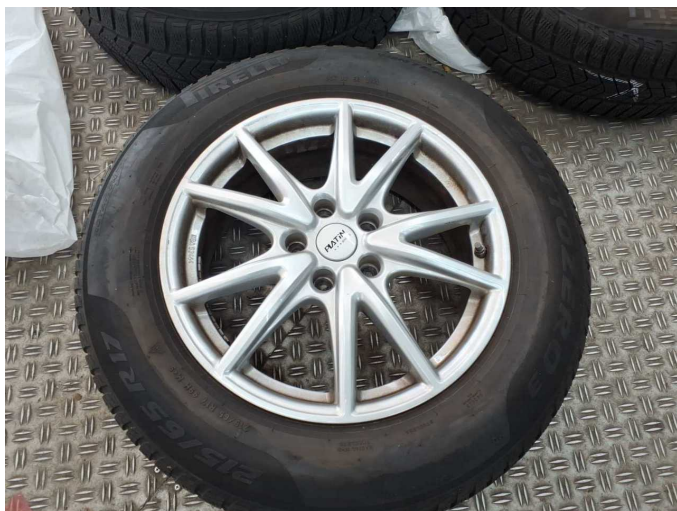
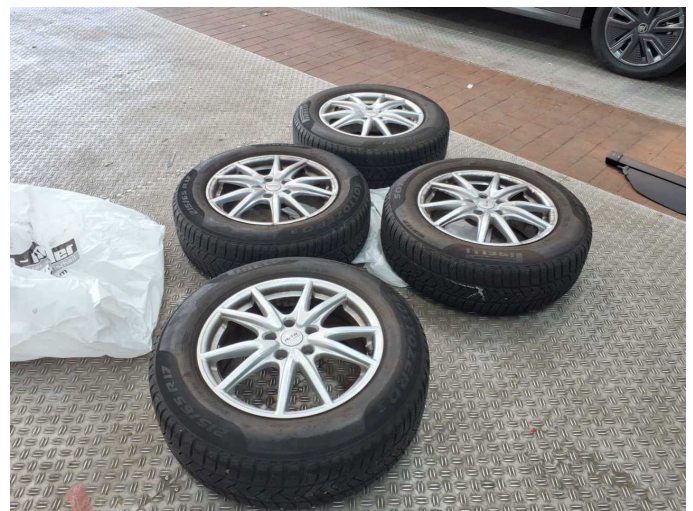
Figure 17: Additional tyres

| # | Tyre size | Type of tyre | Manufacturer | Tread depth |
|---|---|---|---|---|
| 1) | 215/65 R17 99H | Winter tyres on Light alloy | Pirelli | 5mm / 5mm |
| 2) | 215/65 R17 99H | Winter tyres on Light alloy | Pirelli | 5mm / 5mm |

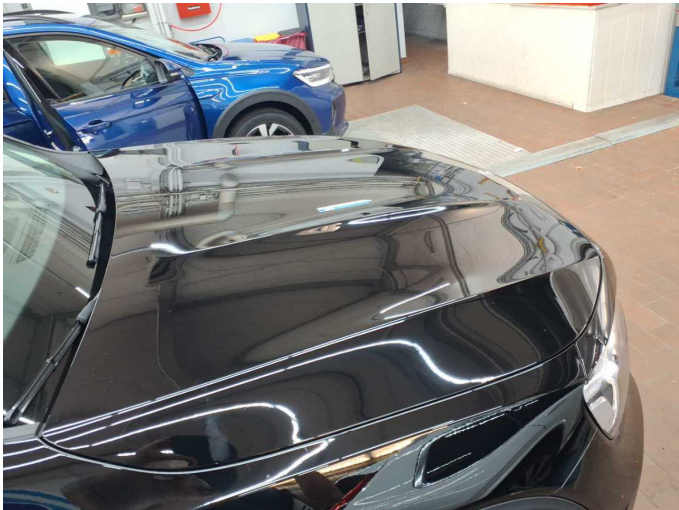
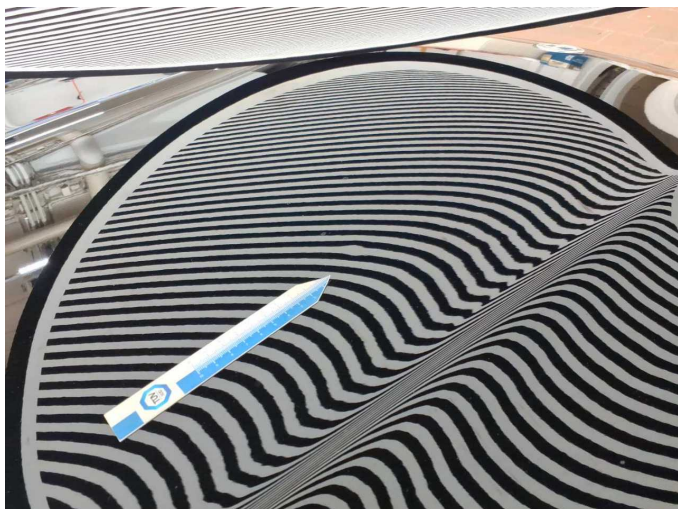
| No. | Component group | Description |
|---|---|---|
| 1 | Bonnet | Bonnet - dent(s) - Smooth repair work |

Damage 1: Bonnet: Bonnet - dent(s) - Smooth repair work

**Damage 1:** Bonnet: Bonnet - dent(s) - Smooth repair work

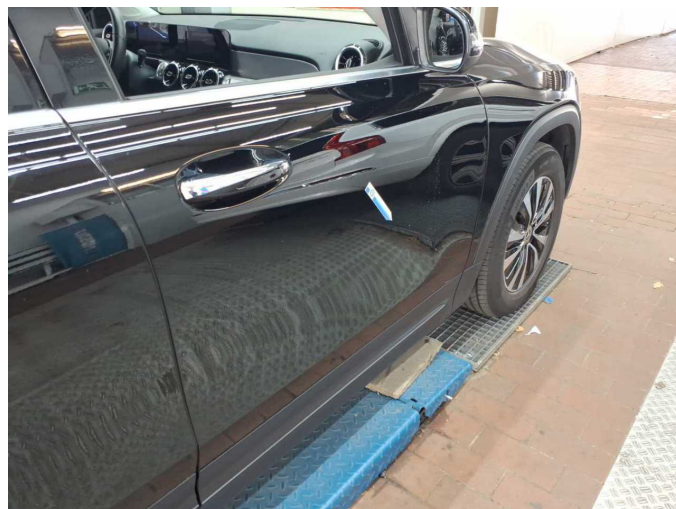
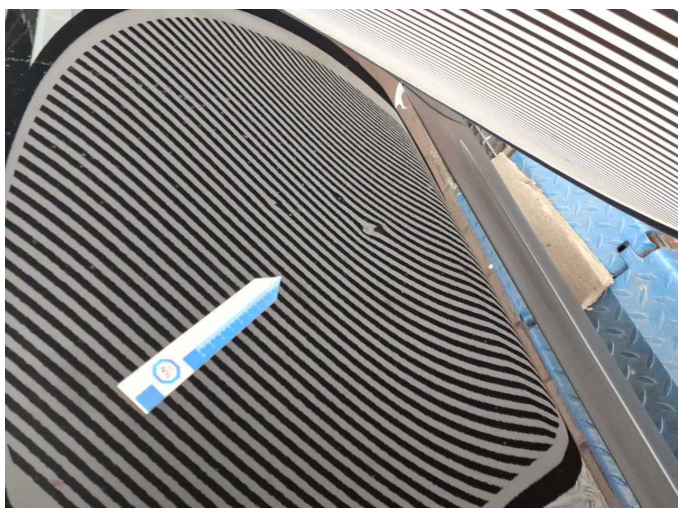
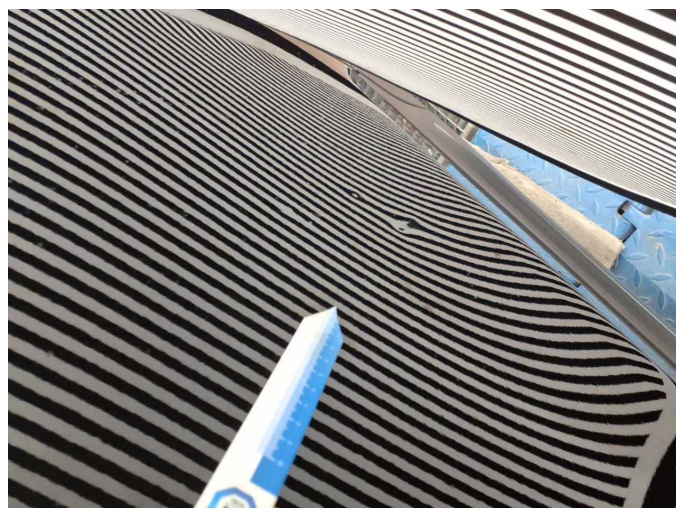
| No. | Component group | Description |
|---|---|---|
| 2 | Door - front right side | Door - dent(s) - Smooth repair work |

**Damage 2:** Door - front right side: Door - dent(s) - Smooth repair work

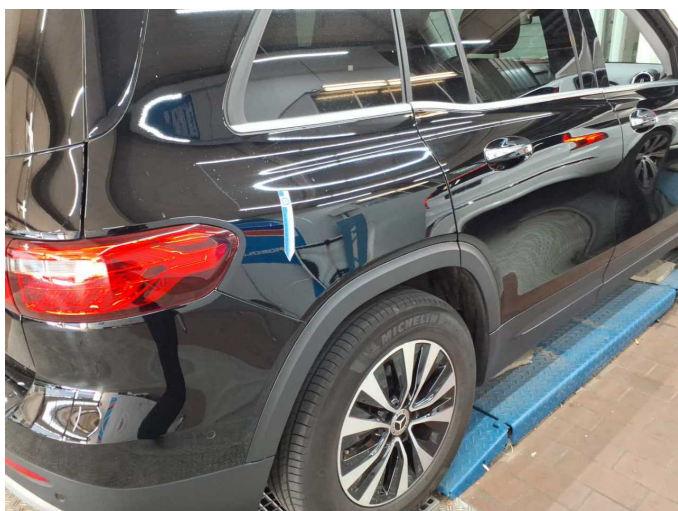
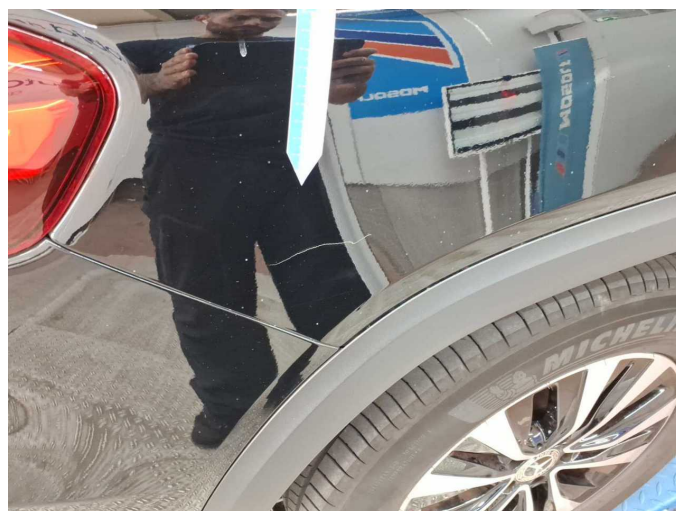
| No. | Component group | Description |
|---|---|---|
| 3 | Side panel - rear right side | Side panel - Scratch(es) - Paint |

**Damage 3:** Side panel - rear right side: Side panel - Scratch(es) - Paint
