Expertise

Protocol number: 45810314
Order No. / Reference: 26407620
Inspection date: 4 Jun 2026

Model: GLC 300 de 4Matic 9G-TRONIC AMG Line

VIN: W1N2539111V290740

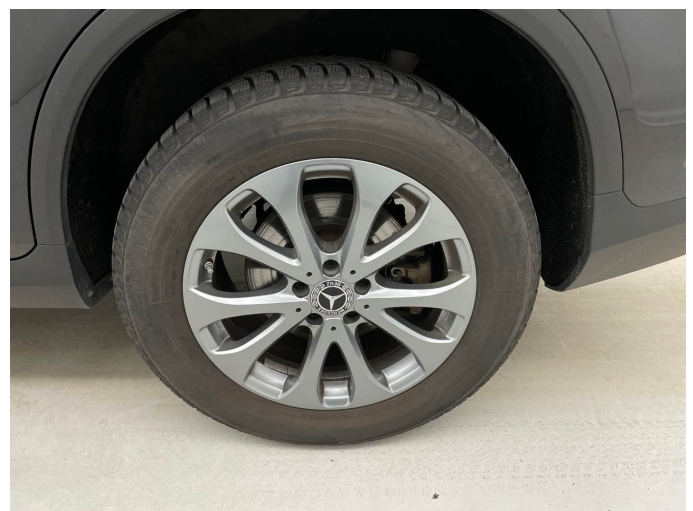
Figure 12: Mounted tyres

Mounted tyres				
#	Tyre size	Type of tyre	Manufacturer	Tread depth
1)	235/60 R18 103H	Winter tyres on Light alloy	Bridgestone	5mm / 3mm
2)	235/60 R18 103H	Winter tyres on Light alloy	Bridgestone	5mm / 5mm
Additional tyres				
#	Tyre size	Type of tyre	Manufacturer	Tread depth
1)	235/55 R19 101V	Summer tyres on Light alloy	Continental	6mm / 6mm
2)	235/55 R19 101V	Summer tyres on Light alloy	Bridgestone	4mm / 4mm

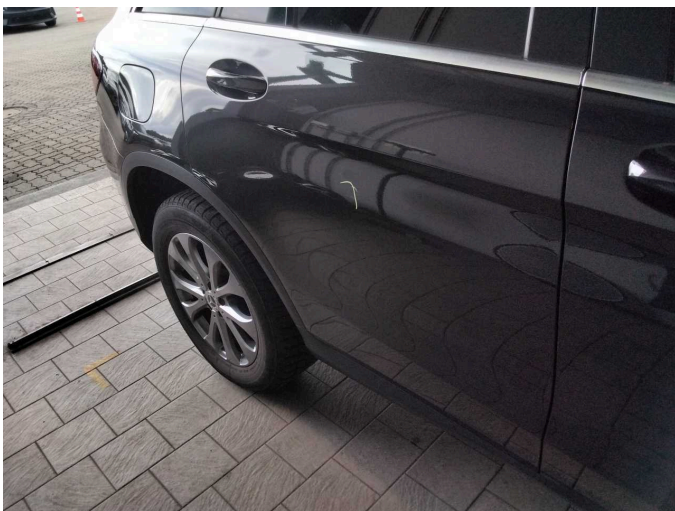
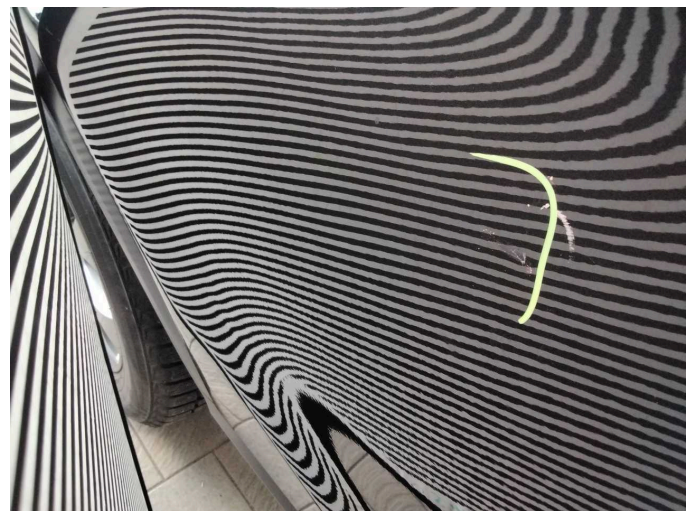
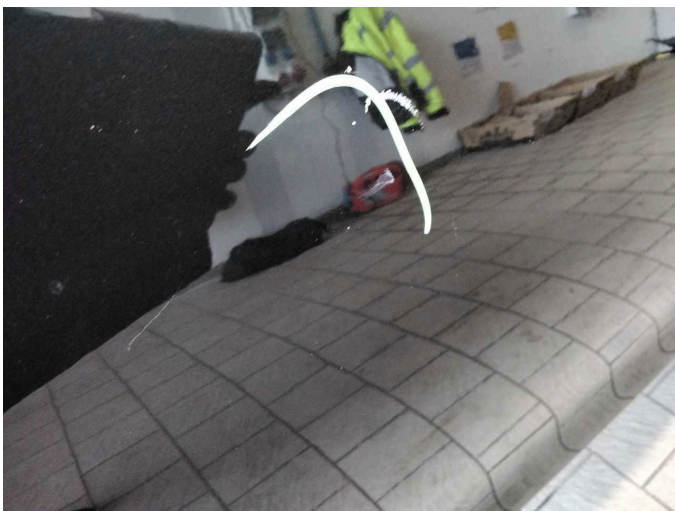
Damage 2: Door - rear right side: Door - Scratch(es) - Smart repair

No.	Component group	Description
1	Misc.	Main inspection - No evidence - No deduction
2	Door - rear right side	Door - Scratch(es) - Smart repair
3	Front bumper	Grille (Sternzeichen) - Broken / torn - Replace

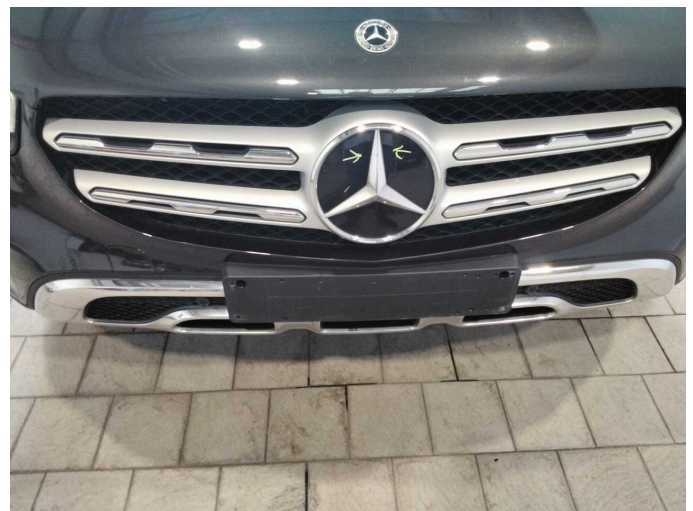
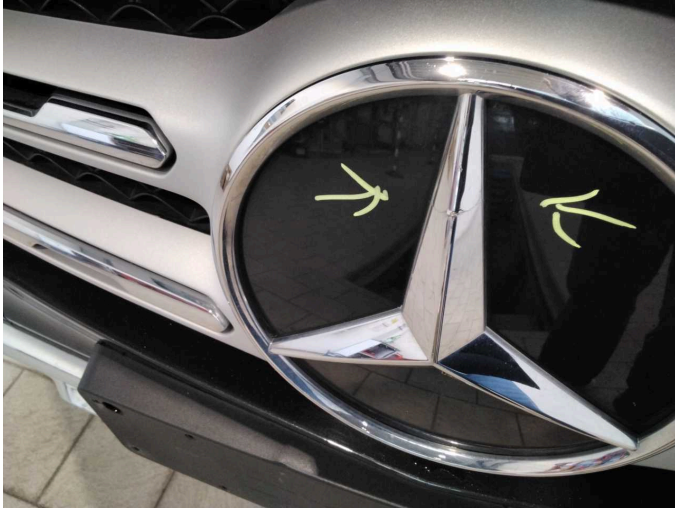
Damage 3: Front bumper: Grille (Sternzeichen) - Broken / torn - Replace

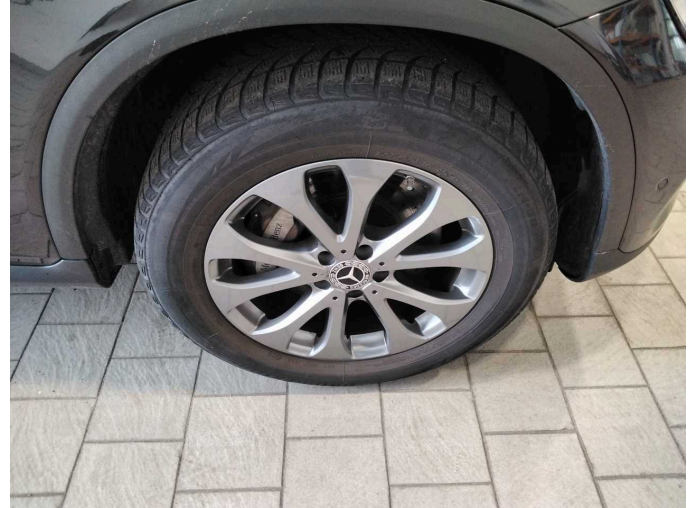
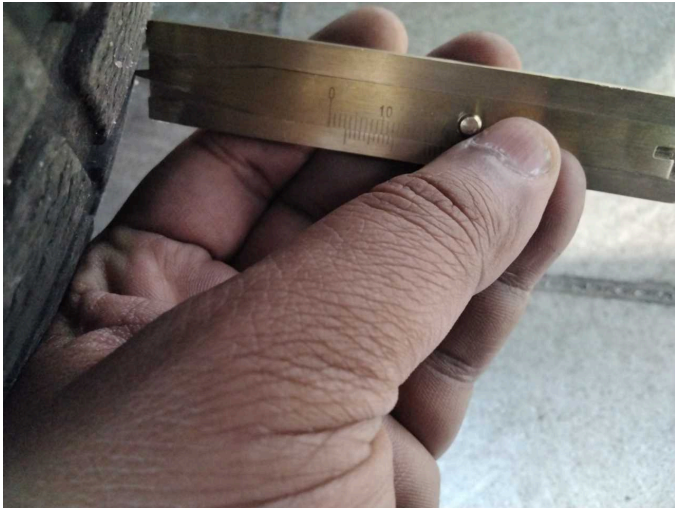
Wear and tear 6: Wheel / tyres: Tyre - front right side (Winterradsatz gehört nicht zur Ausstattung) - Does not meet the leasing specifications - No deduction
