Expertise

Protocol number: 46466973  
Order No. / Reference: 26578308  
Inspection date: 10 Jul 2026

Manufacturer: Volvo

Model: XC90 T8 AWD Recharge Geartronic Inscription Expression

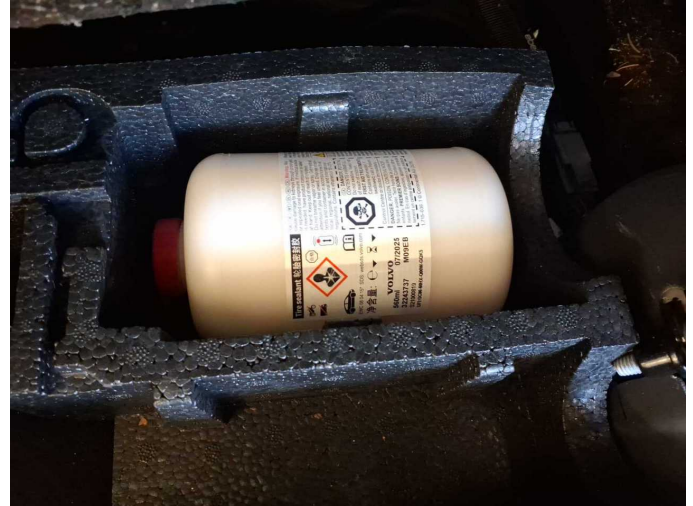
| No. | Component group | Description |
|---|---|---|
| 2 | Equipment | Tirefit filler - Expired - Replace |

**Damage 2:** Equipment: Tirefit filler - Expired - Replace

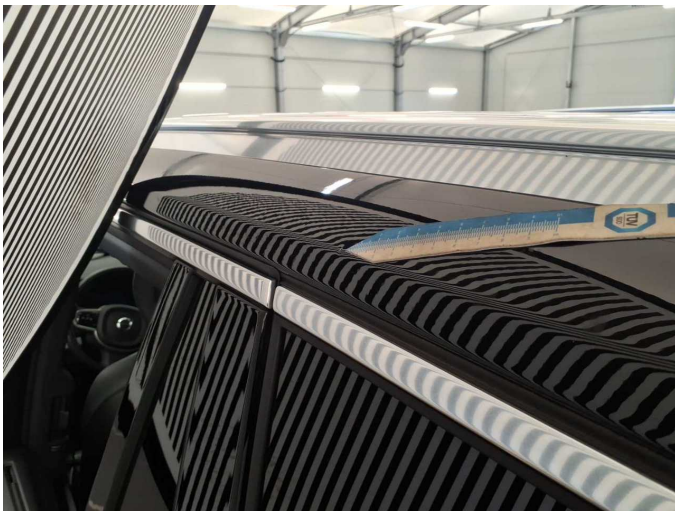
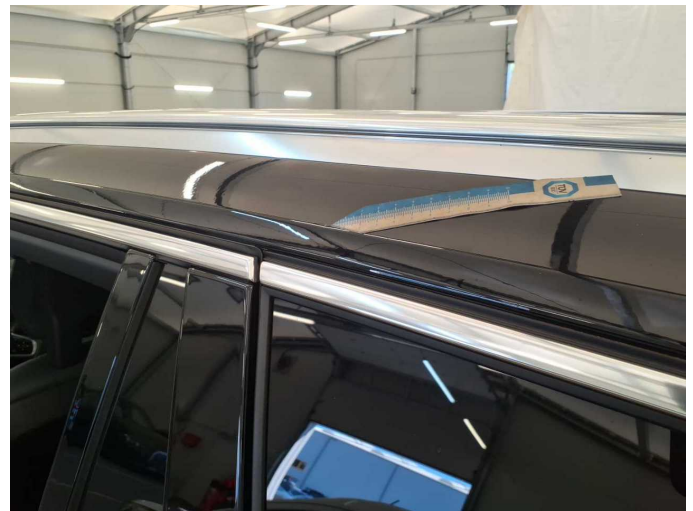
| No. | Component group | Description |
|---|---|---|
| 3 | Roof | Roof rail - left side - Dent / paintcoat damage - Smart repair |

**Damage 3:** Roof: Roof rail - left side - Dent / paintcoat damage - Smart repair

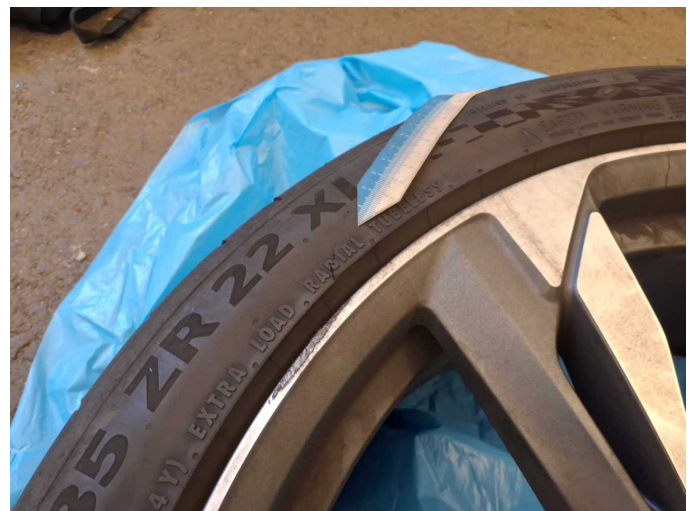
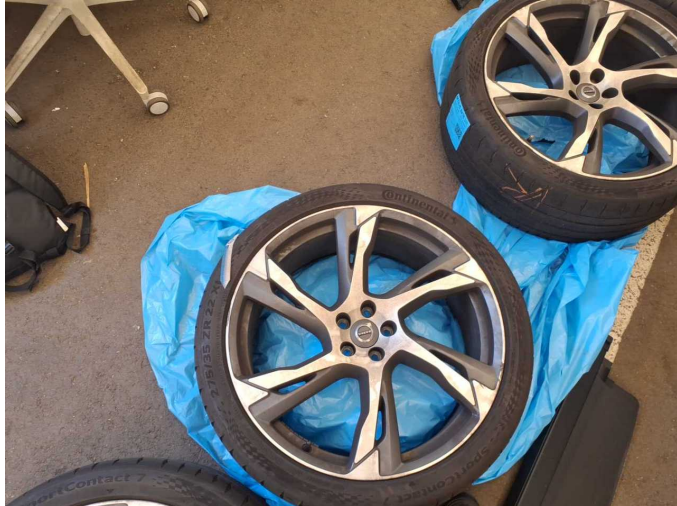
| No. | Component group | Description |
|---|---|---|
| 4 | 2nd wheel set | 1 tyre - Broken / torn - Replace |

**Damage 4:** 2nd wheel set: 1 tyre - Broken / torn - Replace

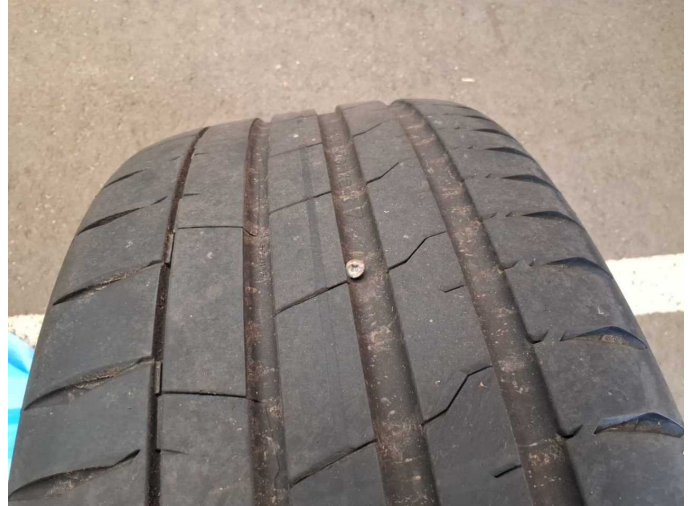
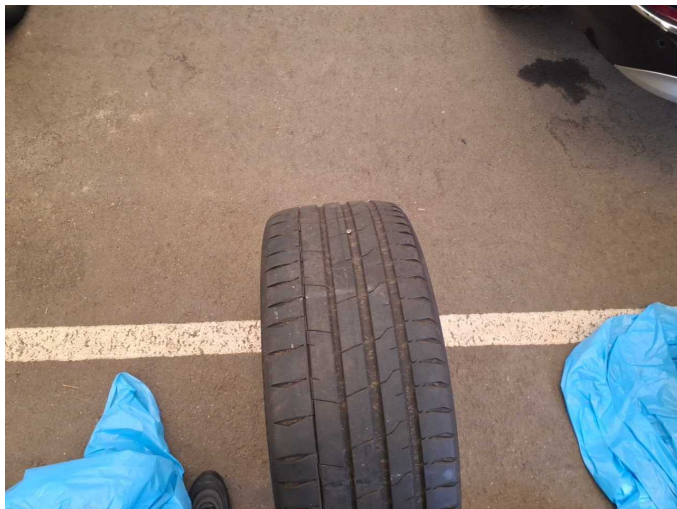
| No. | Component group | Description |
|---|---|---|
| 5 | 2nd wheel set | 1 tyre (Nagel im Reifen) - Damaged - Replace |

**Damage 5:** 2nd wheel set: 1 tyre (Nagel im Reifen) - Damaged - Replace

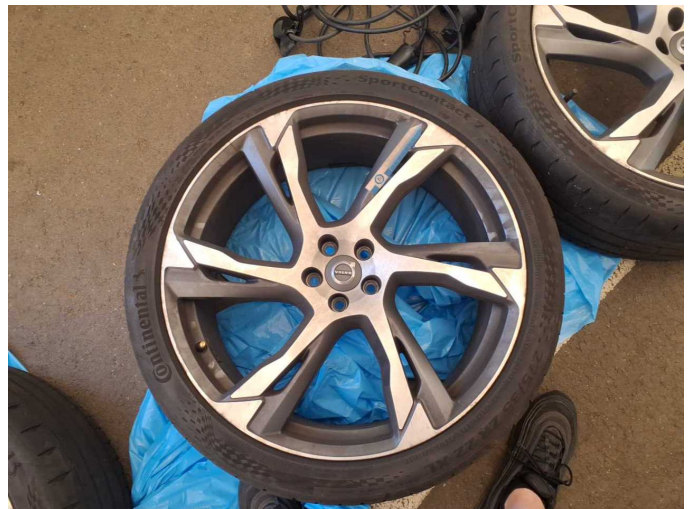
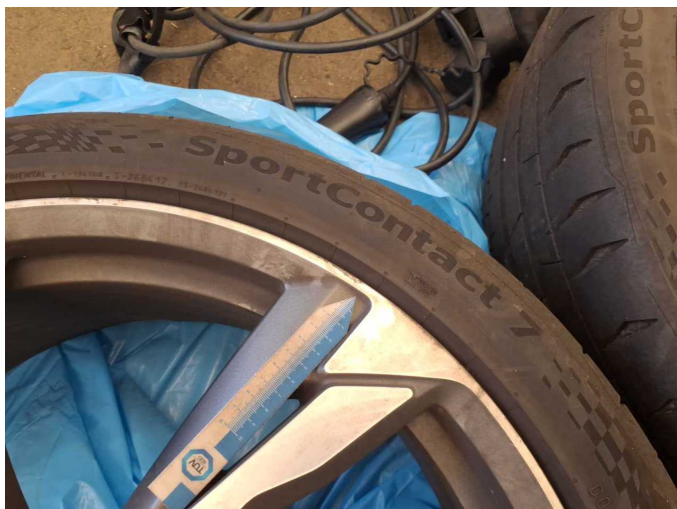
| No. | Component group | Description |
|---|---|---|
| 6 | 2nd wheel set | 1 alloy rim - Scratch(es) - Loss in value |

**Damage 6:** 2nd wheel set: 1 alloy rim - Scratch(es) - Loss in value

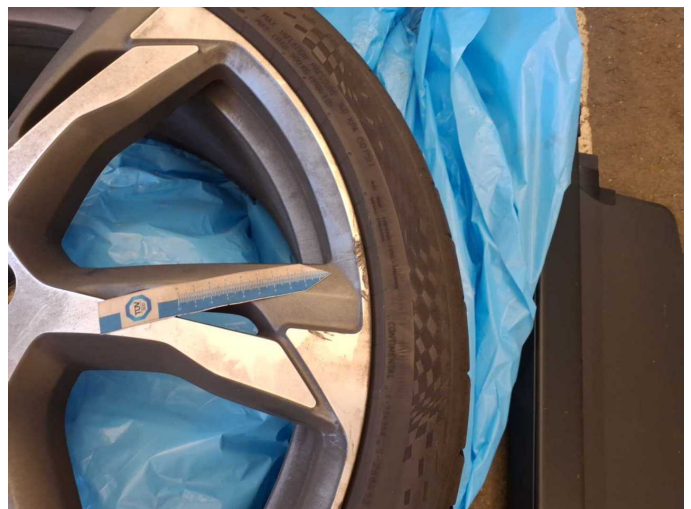
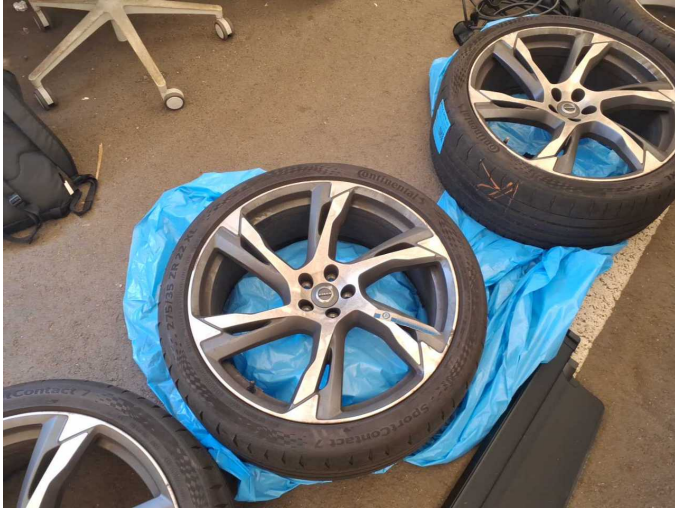
| No. | Component group | Description |
|---|---|---|
| 7 | 2nd wheel set | 1 alloy rim - Scratch(es) - Loss in value |

**Damage 7:** 2nd wheel set: 1 alloy rim - Scratch(es) - Loss in value

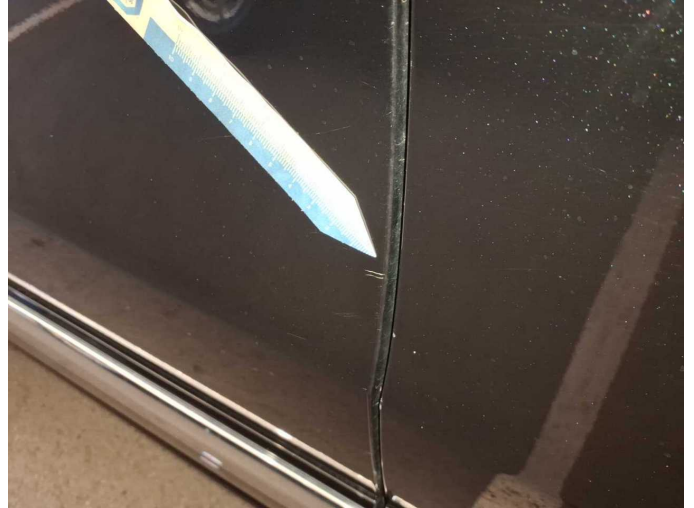
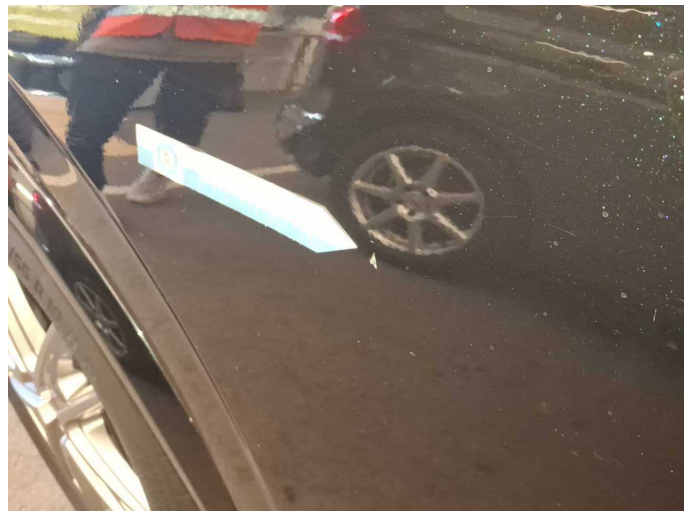
| No. | Component group | Description |
|---|---|---|
| 8 | Door - rear right side | Door - Scratch(es) - Paint |

**Damage 8:** Door - rear right side: Door - Scratch(es) - Paint

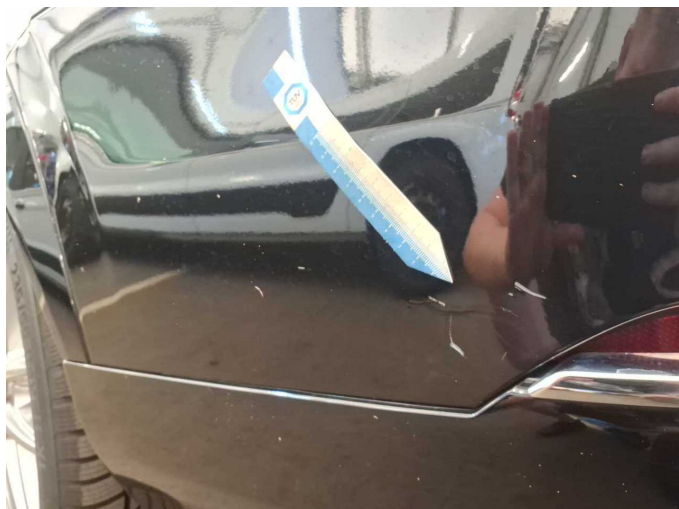
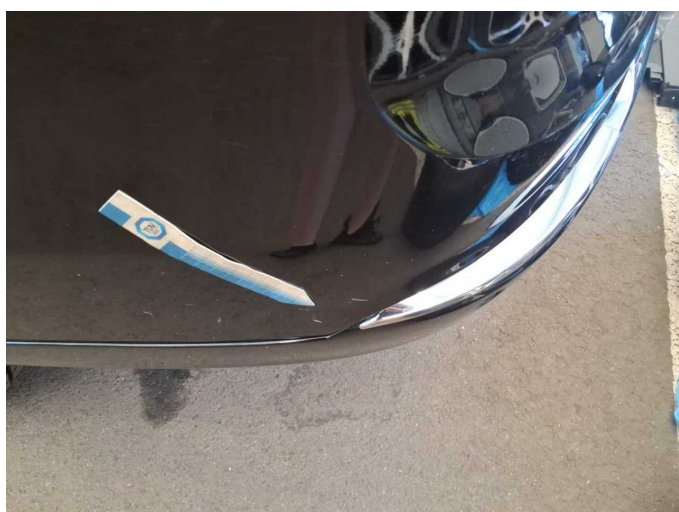
| No. | Component group | Description |
|---|---|---|
| 9 | Rear bumper | Rear bumper - Scratch(es) - Paint |

**Damage 9:** Rear bumper: Rear bumper - Scratch(es) - Paint

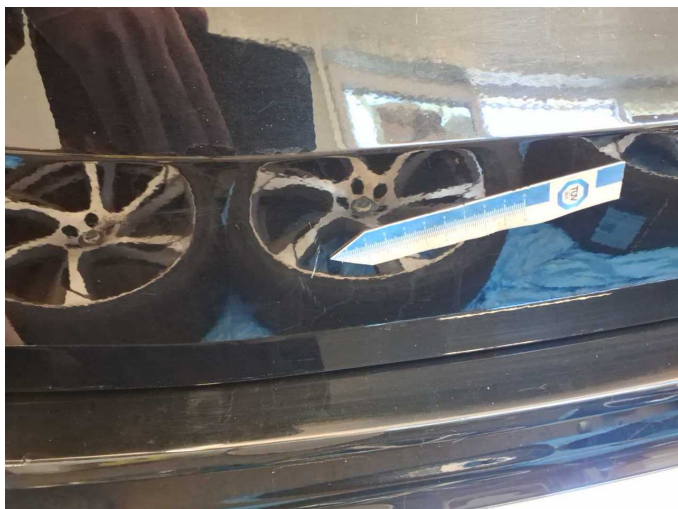
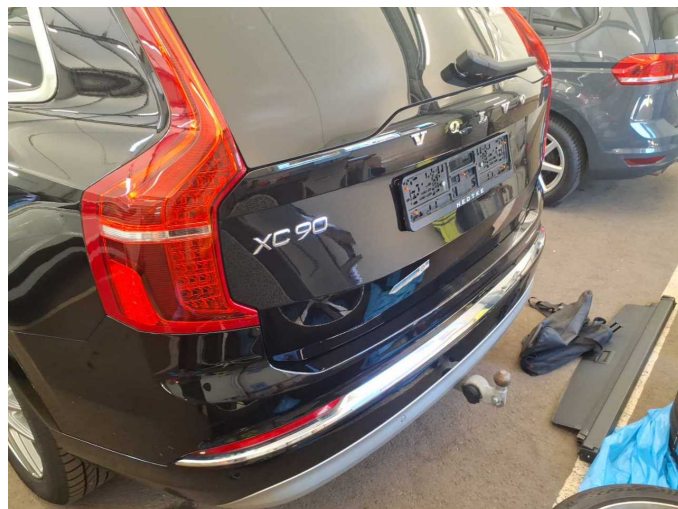
| No. | Component group | Description |
|---|---|---|
| 10 | Boot lid / rear door | Boot lid - Scratch(es) - Paint |

**Damage 10:** Boot lid / rear door: Boot lid - Scratch(es) - Paint

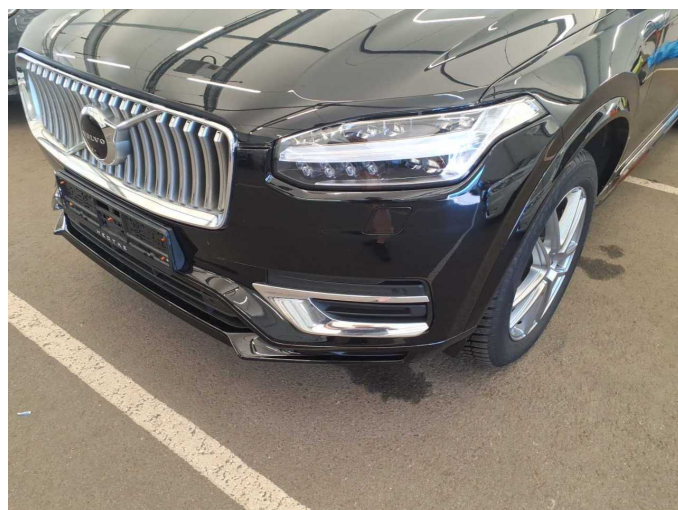
| No. | Component group | Description |
|---|---|---|
| 1 | Front bumper | Front bumper - Stone chips - No deduction |

**Wear and tear 1:** Front bumper: Front bumper - Stone chips - No deduction

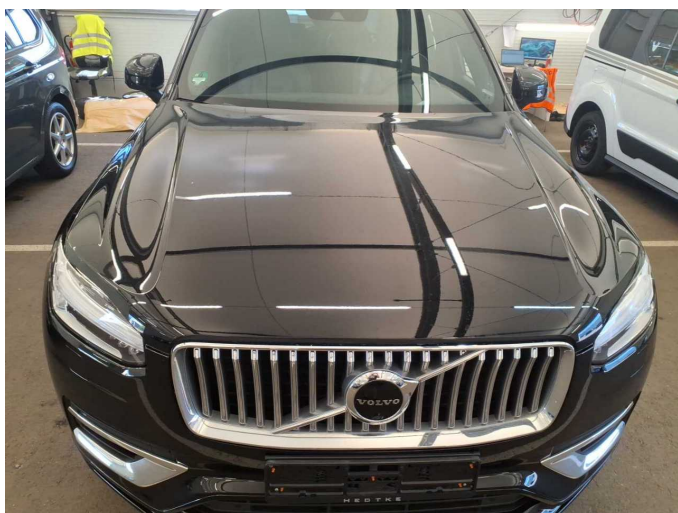
| No. | Component group | Description |
|---|---|---|
| 2 | Bonnet | Bonnet - Stone chips - No deduction |

**Wear and tear 2:** Bonnet: Bonnet - Stone chips - No deduction
