Expertise

Protocol number: 46231665  
Order No. / Reference: 26618651  
Inspection date: 30 Jun 2026

Manufacturer: Volkswagen

Model: Passat Variant 2.0 TDI SCR DSG Business

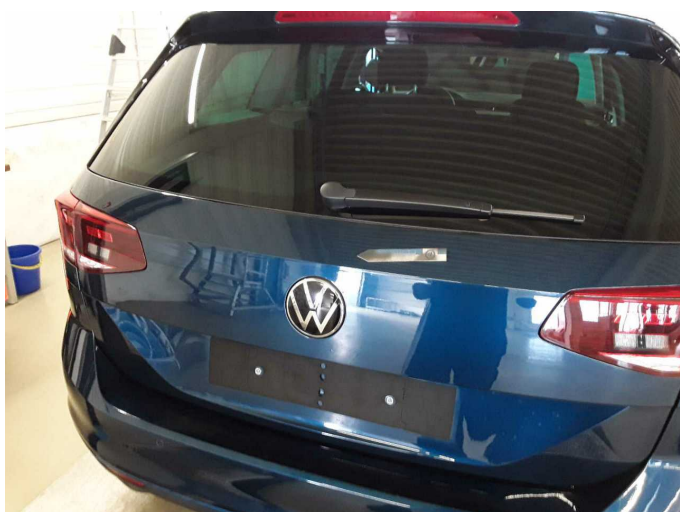
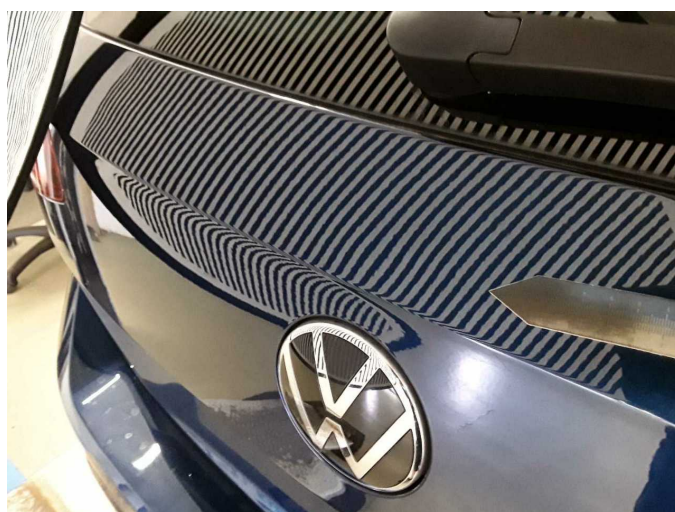
| No. | Component group | Description |
|---|---|---|
| 1 | Boot lid / rear door | Boot lid glazed - dent(s) - Smart repair |

**Damage 1:** Boot lid / rear door: Boot lid glazed - dent(s) - Smart repair

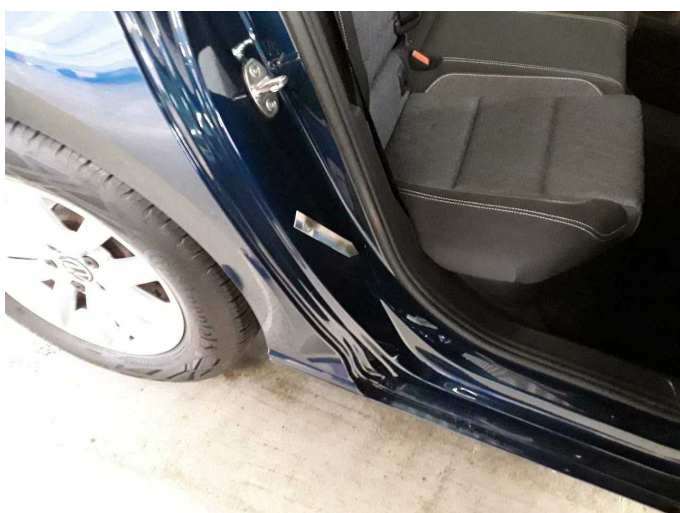
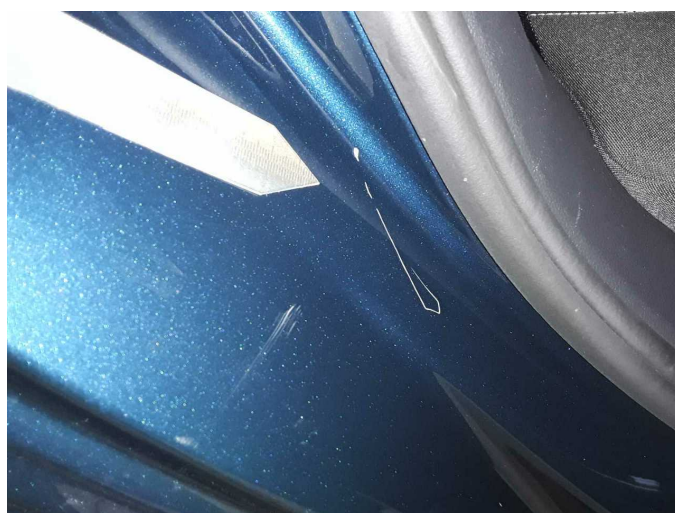
| No. | Component group | Description |
|---|---|---|
| 2 | Body | C-pillar - right side - Scratch(es) - Smart repair |

**Damage 2:** Body: C-pillar - right side - Scratch(es) - Smart repair

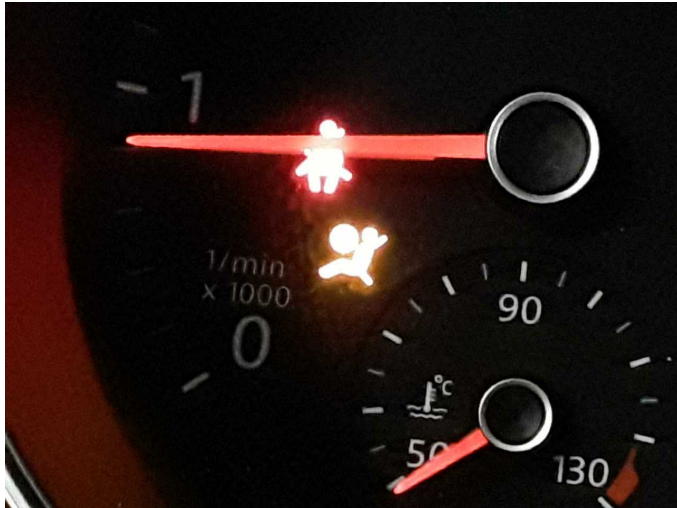
| No. | Component group | Description |
|---|---|---|
| 3 | Instrument panel | Indicator light (Airbag, Zusatzkosten können entstehen) - on - Perform diagnosis |

**Damage 3:** Instrument panel: Indicator light (Airbag, Zusatzkosten können entstehen) - on - Perform diagnosis

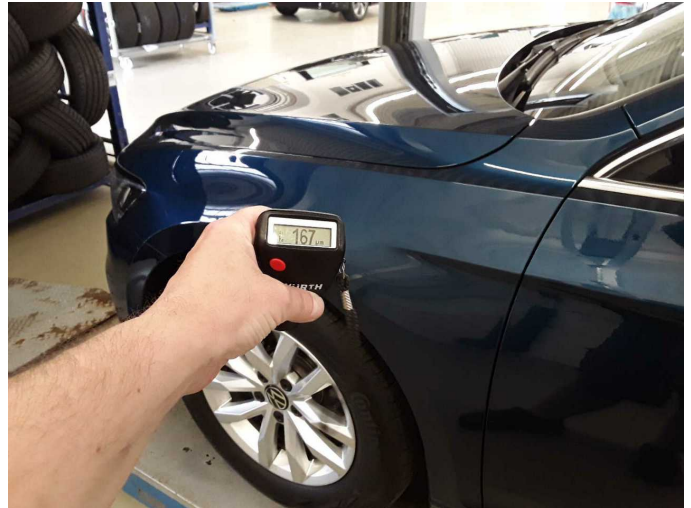
1 Mudguard - left side, Mudguard - right side, Professionally carried out

| Mudguard - left side | 167 µm | Mudguard - right side | 303 µm |

**Mudguard - left side:** 167  $\mu\text{m}$

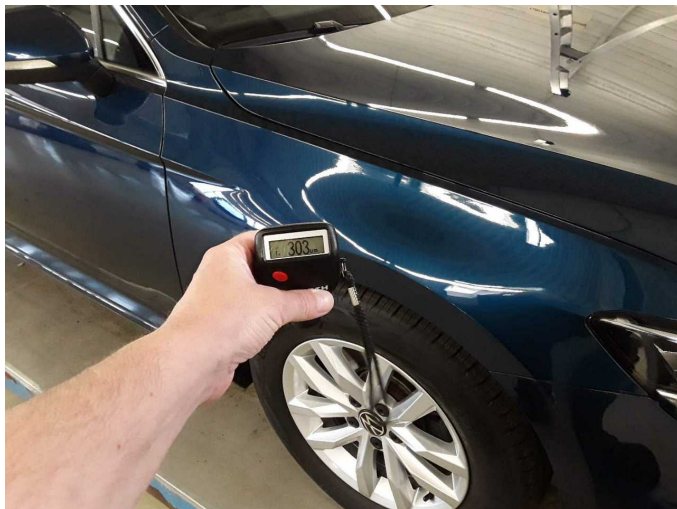
**Mudguard - right side:** 303  $\mu\text{m}$
