Expertise

Protocol number: 46745357  
Order No. / Reference: 26661053  
Inspection date: 28 Jul 2026

Manufacturer: Mercedes-Benz  
VIN: W1KAH0DB5PF116476

Model: C 200 d T 9G-TRONIC Avantgarde

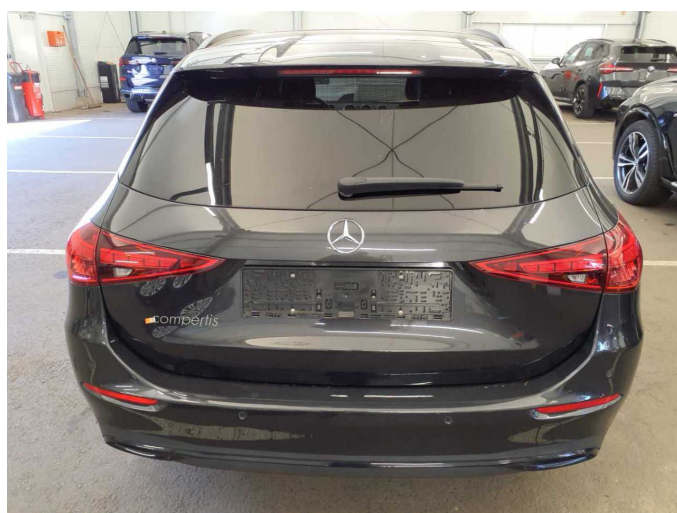
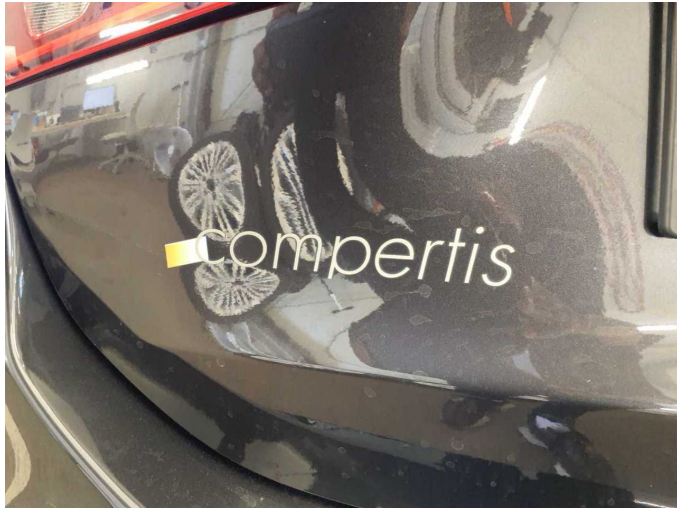
**Damage 1:** Boot lid / rear door: Boot lid - Glued / labelled - De-glue / neutralise

| No. | Component group | Description |
|---|---|---|
| 1 | Boot lid / rear door | Boot lid - Glued / labelled - De-glue / neutralise |

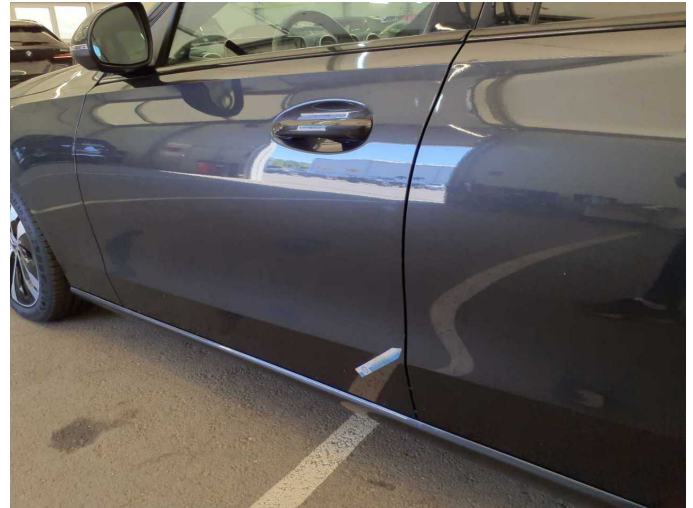
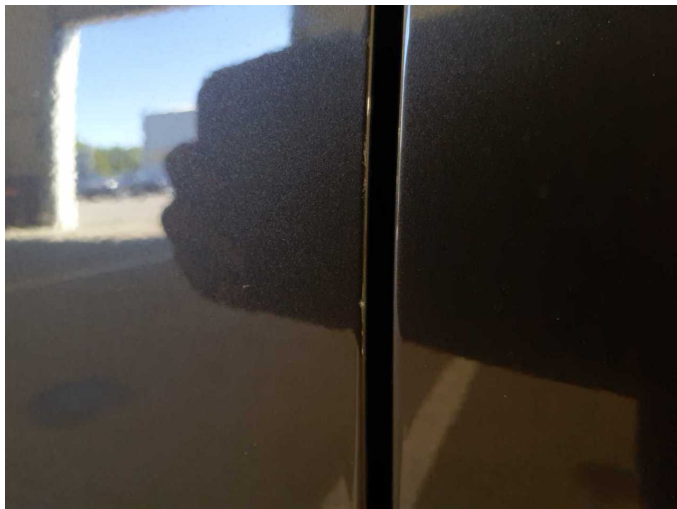
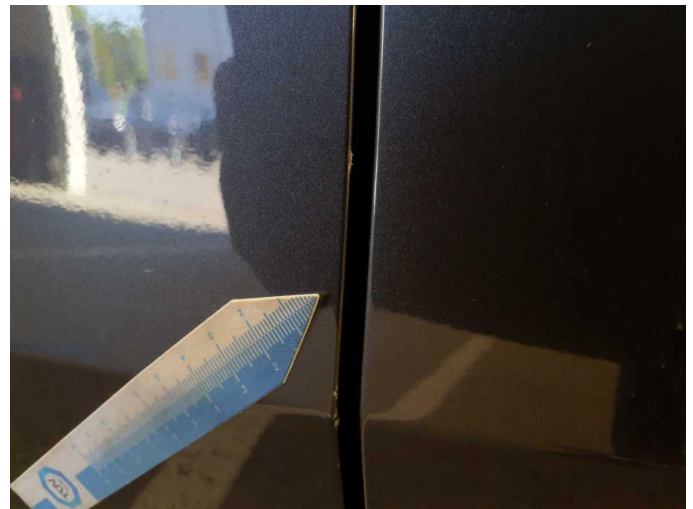
**Damage 2:** Door - front left side: Door edge - Scratch(es) - Smart repair

| No. | Component group | Description |
|---|---|---|
| 2 | Door - front left side | Door edge - Scratch(es) - Smart repair |

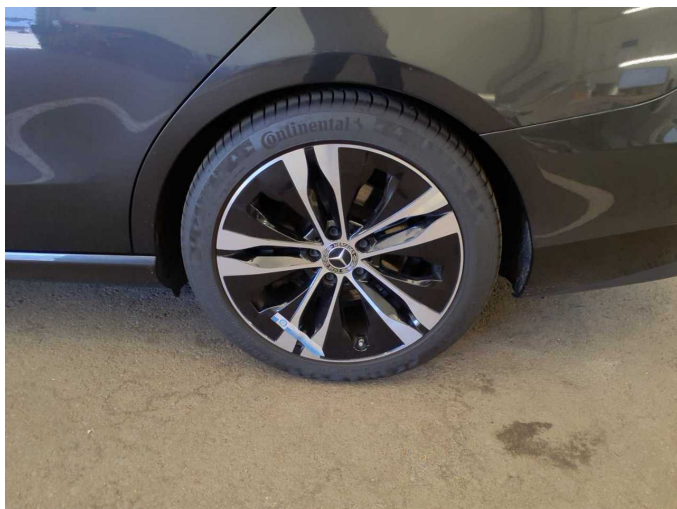
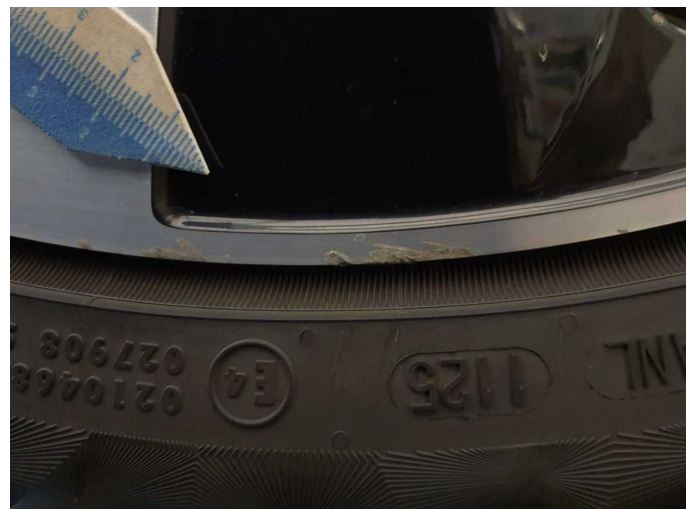
**Damage 3:** Wheel / tyres: Alloy rim - rear left side - Scratch(es) - Loss in value

| No. | Component group | Description |
|---|---|---|
| 3 | Wheel / tyres | Alloy rim - rear left side - Scratch(es) - Loss in value |

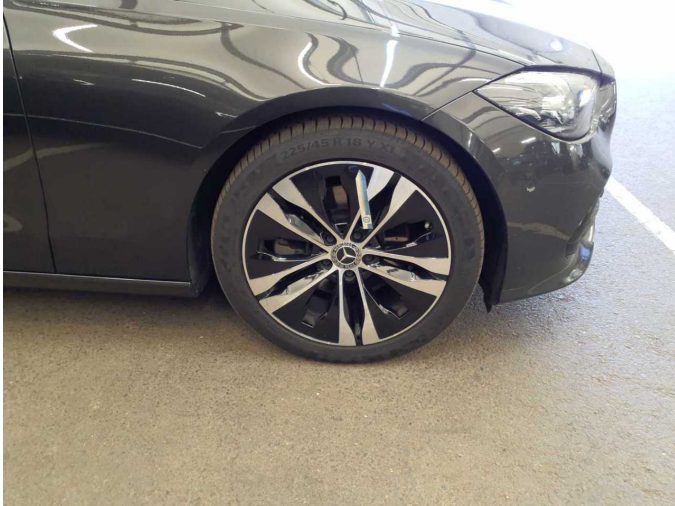
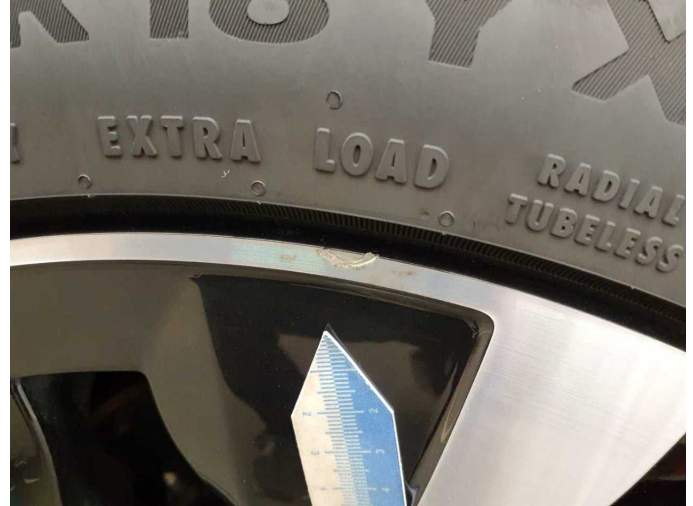
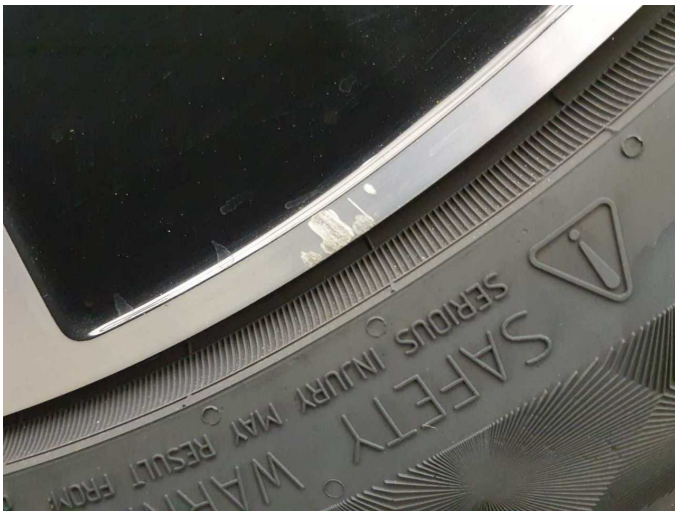
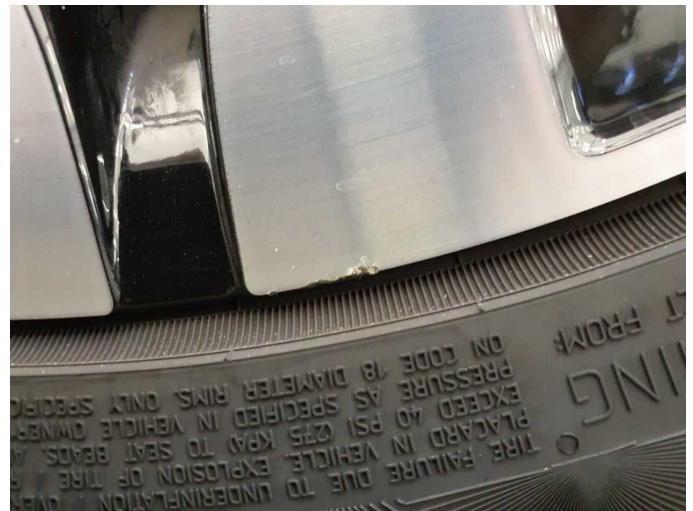
**Damage 4:** Wheel / tyres: Alloy rim - front right side - Scratch(es) - Loss in value

| No. | Component group | Description |
|---|---|---|
| 4 | Wheel / tyres | Alloy rim - front right side - Scratch(es) - Loss in value |

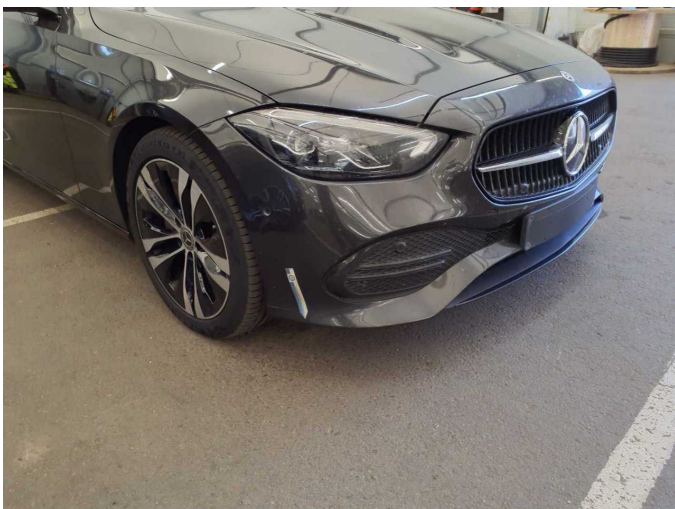
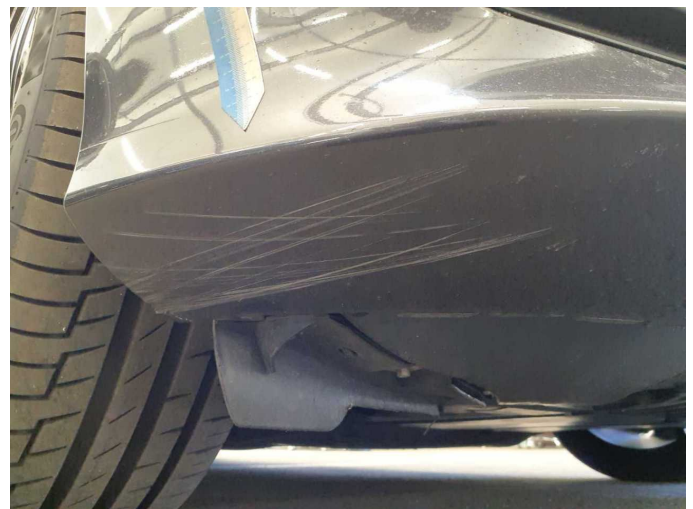
**Damage 5:** Front bumper: Front bumper - Scratch(es) - Paint

| No. | Component group | Description |
|---|---|---|
| 5 | Front bumper | Front bumper - Scratch(es) - Paint |

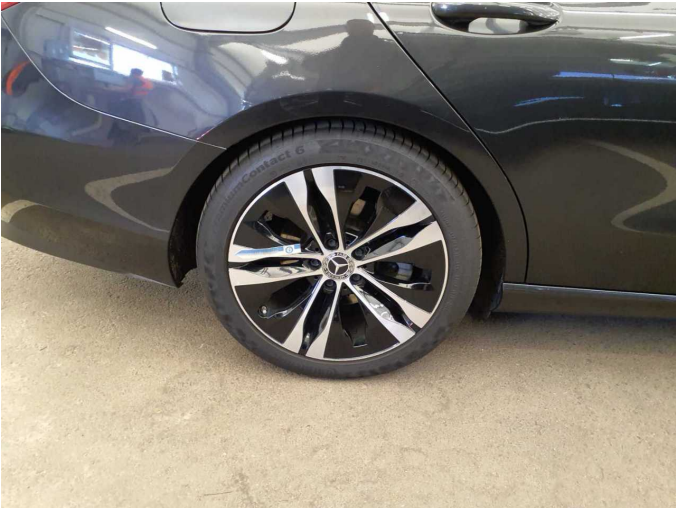
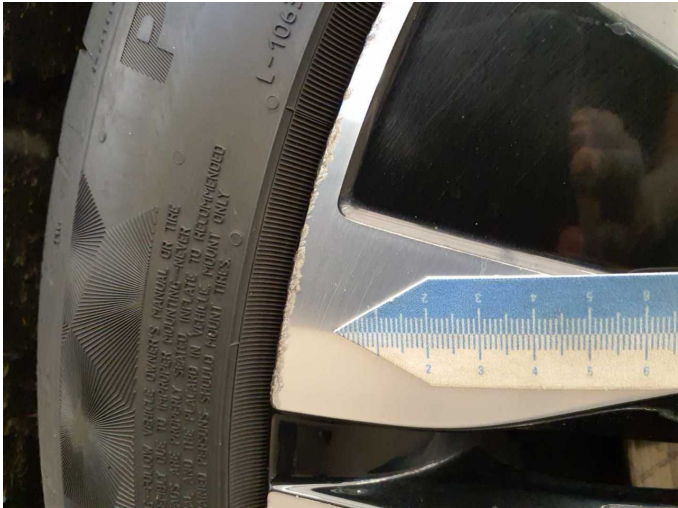
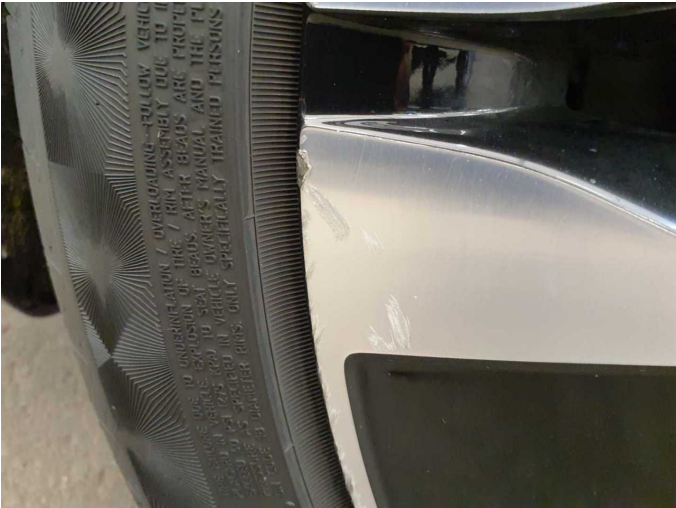
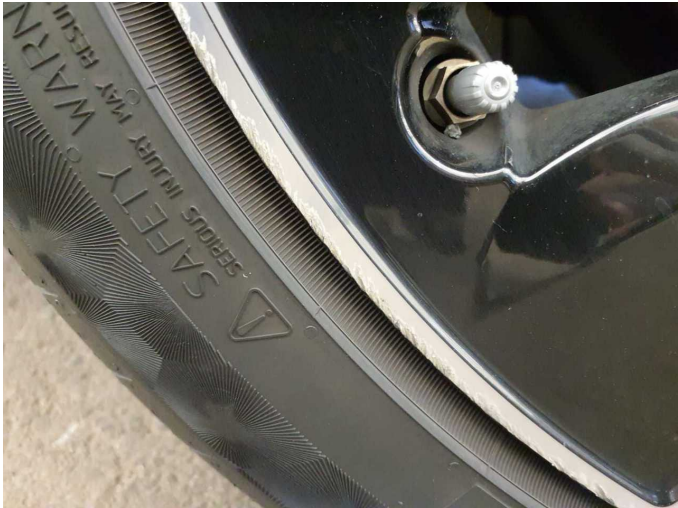
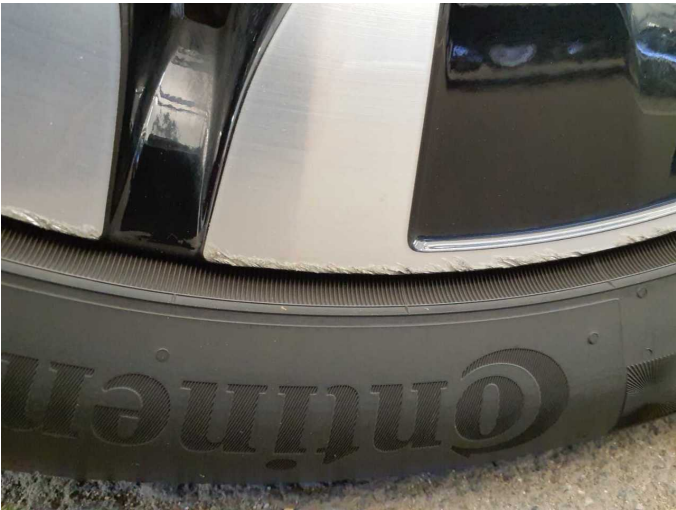
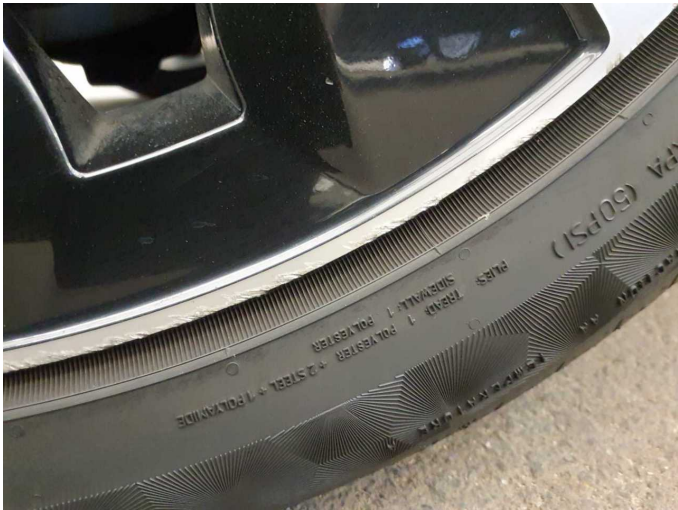
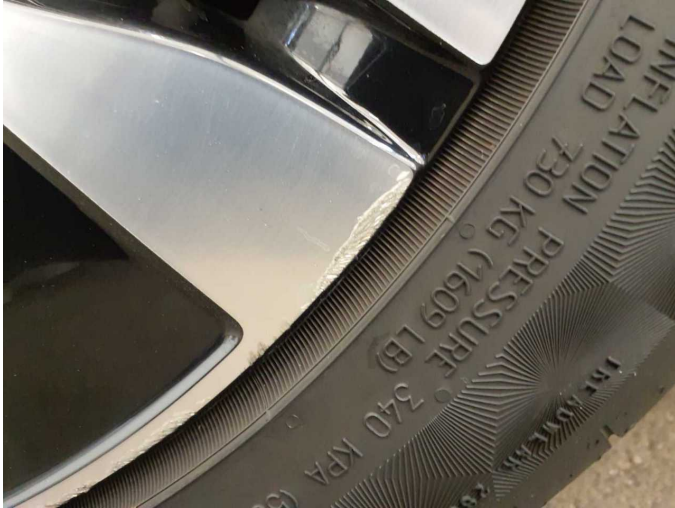
Damage 6: Wheel / tyres: Alloy rim - rear right side - Scratched - Replace

**Damage 6:** Wheel / tyres: Alloy rim - rear right side - Scratched - Replace

| No. | Component group | Description |
|---|---|---|
| 6 | Wheel / tyres | Alloy rim - rear right side - Scratched - Replace |
