Expertise

Protocol number: 46050426  
Order No. / Reference: 26365616  
Inspection date: 19 Jun 2026

Manufacturer: Mercedes-Benz  
VIN: W1NKM0FB6PF025278

Model: GLC 220 d 4Matic 9G-TRONIC AMG Line Advanced

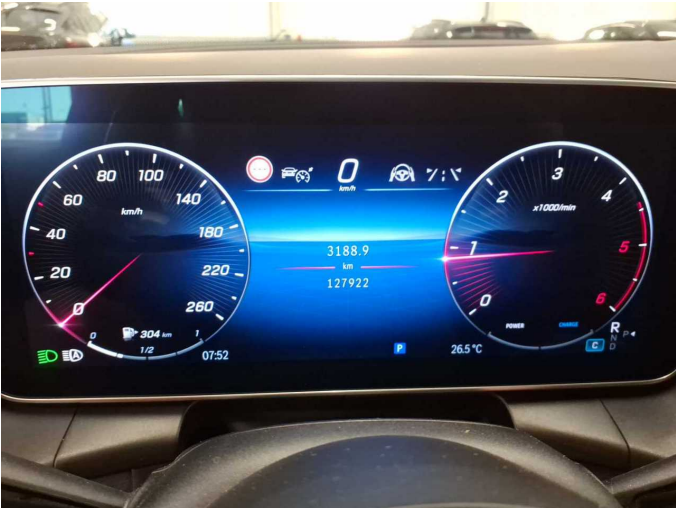
| Vehicle details | |
|---|---|
| Mileage (Read) | 127,922 km |

Figure 7: Instrument cluster

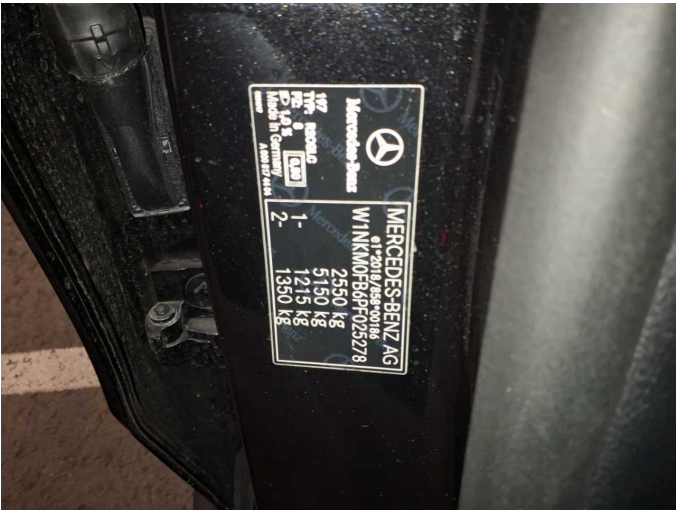
| VIN comparison | The vehicle identification number (VIN) was read from the vehicle and its conformity with the submitted documents was confirmed by the undersigned during the inspection. |

Figure 11: VIN

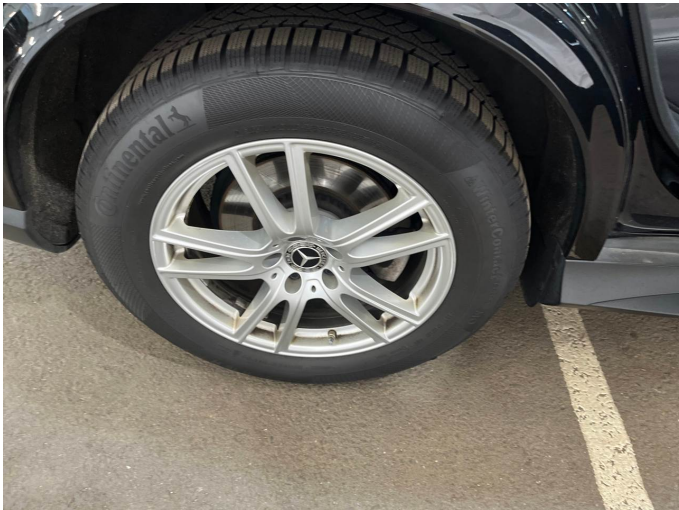
| # | Tyre size | Type of tyre | Manufacturer | Tread depth |
|---|---|---|---|---|
| 1) | 235/60 R18 103H | Winter tyres on Light alloy | Continental | 3mm / 3mm |
| 2) | 235/60 R18 103H | Winter tyres on Light alloy | Continental | 6mm / 6mm |

Figure 12: Mounted tyres

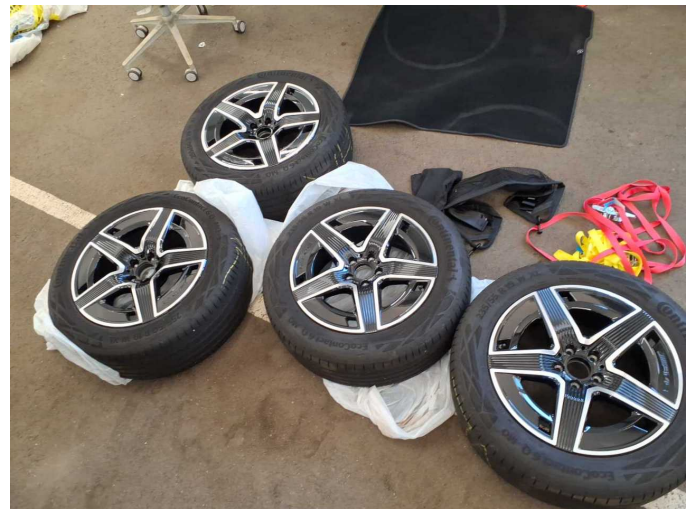
| # | Tyre size | Type of tyre | Manufacturer | Tread depth |
|---|---|---|---|---|
| 1) | 235/55 R19 105W | Summer tyres on Light alloy | Continental | 5mm / 5mm |
| 2) | 255/50 R19 107W | Summer tyres on Light alloy | Continental | 6mm / 6mm |

Figure 16: Additional tyres

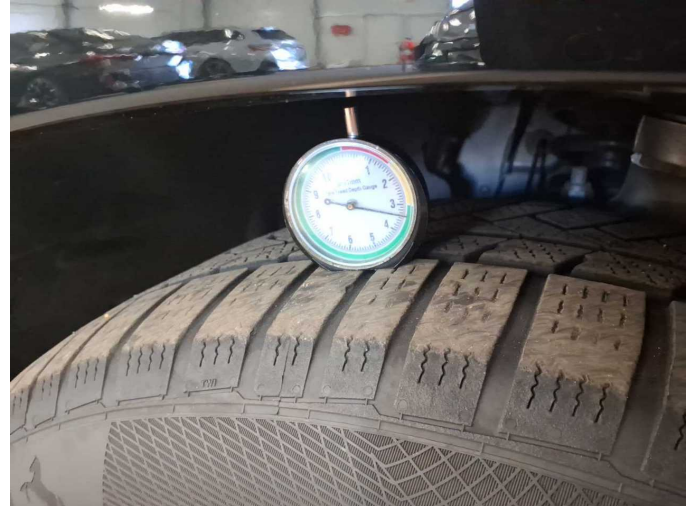
| No. | Component group | Description |
|---|---|---|
| 2 | Wheel / tyres | Tyre - front left side - Does not meet the leasing specifications - Replace |

**Damage 2:** Wheel / tyres: Tyre - front left side - Does not meet the leasing specifications - Replace

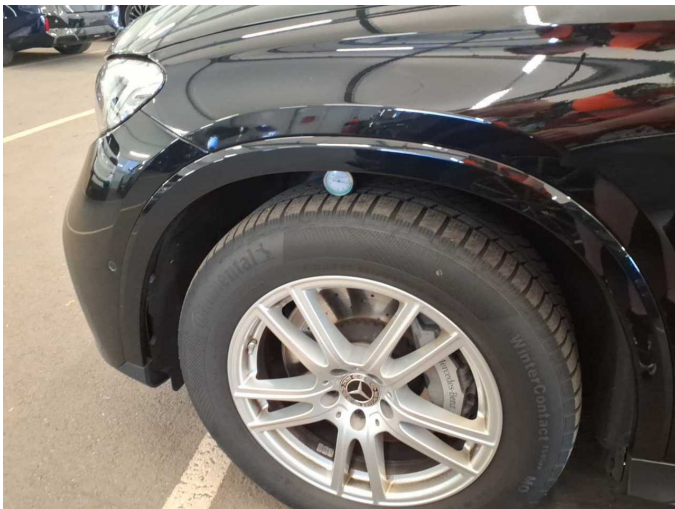
**Damage 2:** Wheel / tyres: Tyre - front left side - Does not meet the leasing specifications - Replace

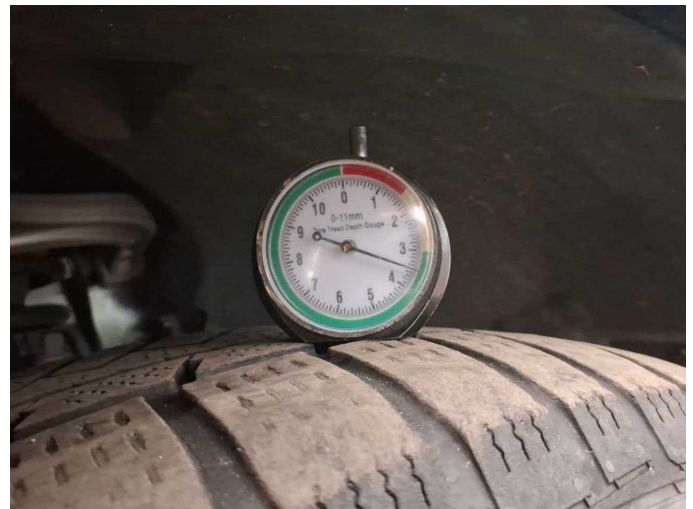
| No. | Component group | Description |
|---|---|---|
| 3 | Wheel / tyres | Tyre - front right side - Does not meet the leasing specifications - Replace |

**Damage 3:** Wheel / tyres: Tyre - front right side - Does not meet the leasing specifications - Replace

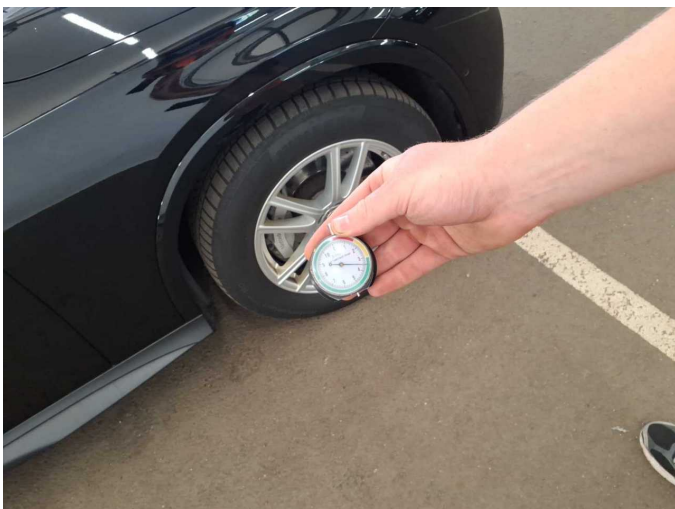
**Damage 3:** Wheel / tyres: Tyre - front right side - Does not meet the leasing specifications - Replace

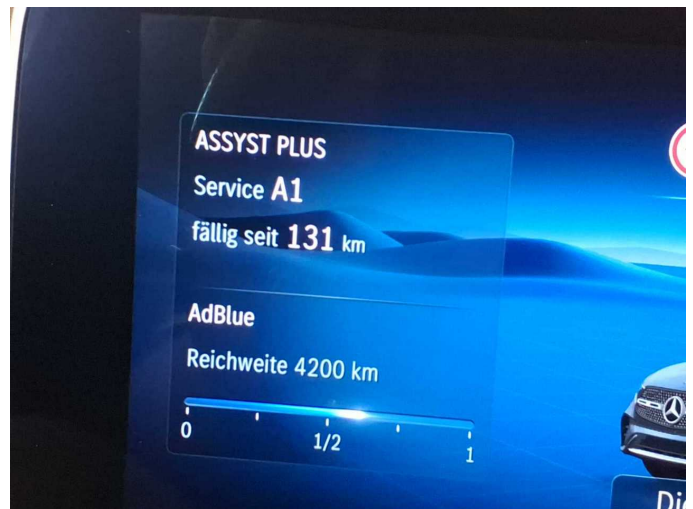
| No. | Component group | Description |
|---|---|---|
| 4 | Misc. | Inspection / maintenance - Expired - Perform |

**Damage 4:** Misc.: Inspection / maintenance - Expired - Perform
