Expertise

Protocol number: 47209652  
Order No. / Reference: 26832842  
Inspection date: 20 Aug 2026

Manufacturer: Ford

Model: S-Max 2.0 EcoBlue Aut. TITANIUM

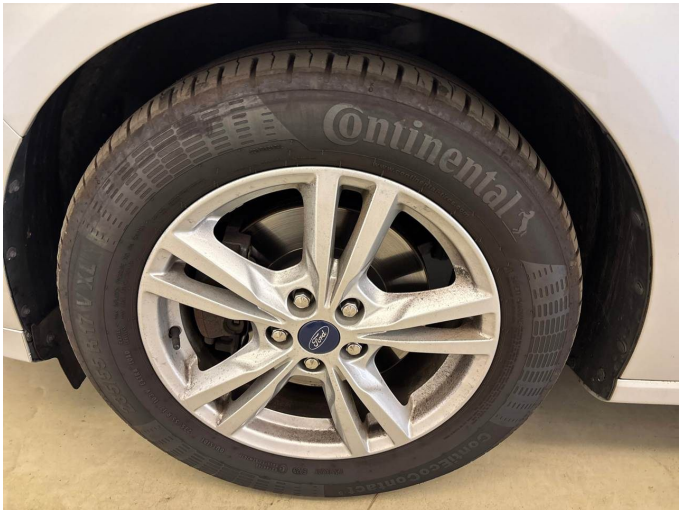
Figure 12: Mounted tyres

| # | Tyre size | Type of tyre | Manufacturer | Tread depth |
|---|---|---|---|---|
| 1) | 235/55 R17 103V | Summer tyres on Light alloy | Continental | 5mm / 5mm |
| 2) | 235/55 R17 103V | Summer tyres on Light alloy | Continental | 6mm / 6mm |

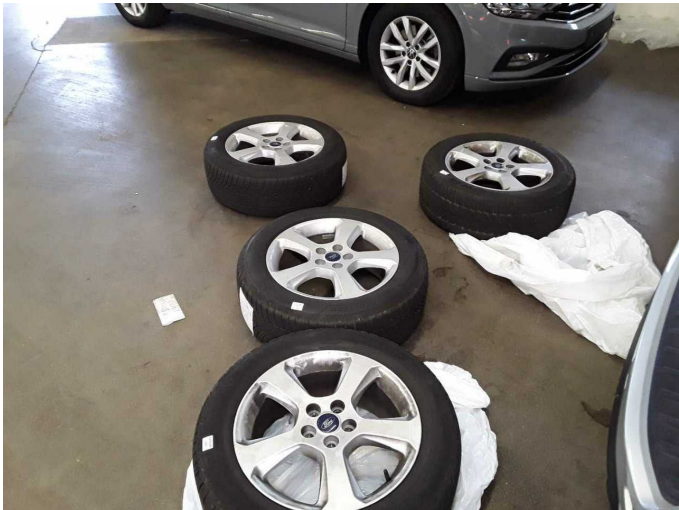
Figure 18: Additional tyres

| # | Tyre size | Type of tyre | Manufacturer | Tread depth |
|---|---|---|---|---|
| 1) | 235/55 R17 103V | Winter tyres on Light alloy | Goodyear | 5mm / 5mm |
| 2) | 235/55 R17 103V | Winter tyres on Light alloy | Goodyear | 6mm / 6mm |

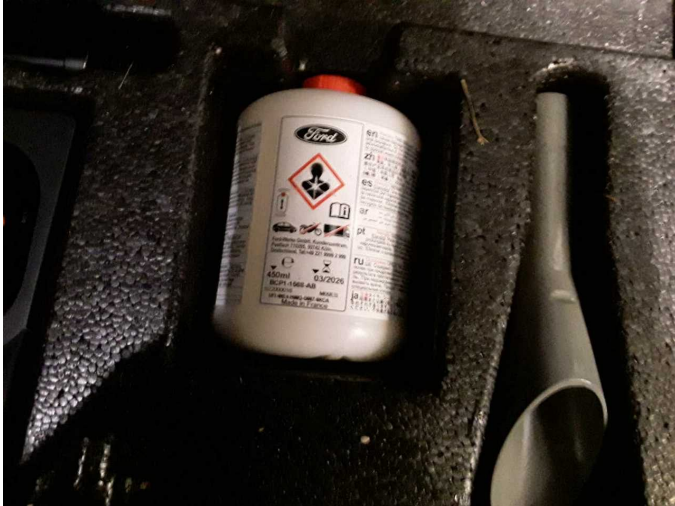
| No. | Component group | Description |
|---|---|---|
| 1 | Equipment | Tirefit filler - Expired - Replace |

**Damage 1:** Equipment: Tirefit filler - Expired - Replace

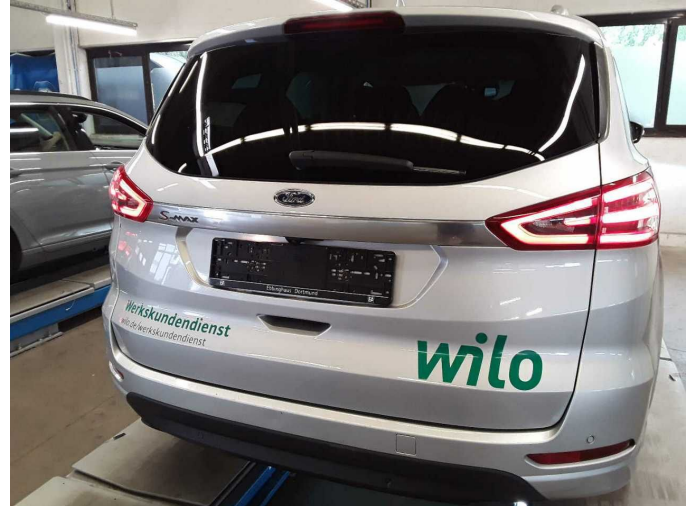
| No. | Component group | Description |
|---|---|---|
| 2 | Boot lid / rear door | Boot lid - Glued / labelled - De-glue / neutralise |

**Damage 2:** Boot lid / rear door: Boot lid - Glued / labelled - De-glue / neutralise

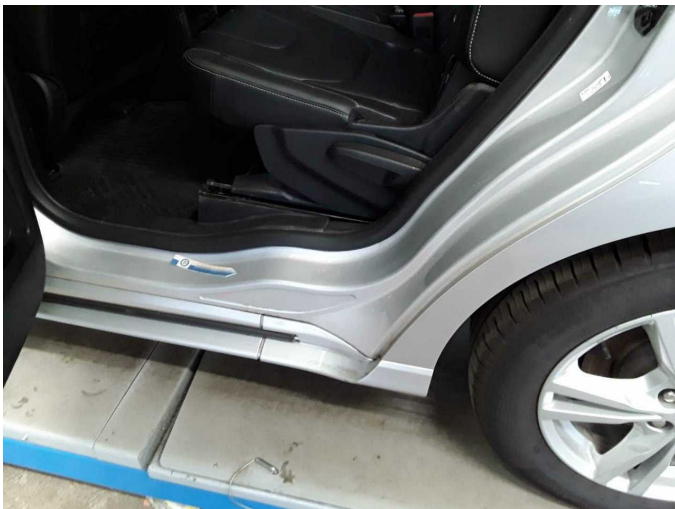
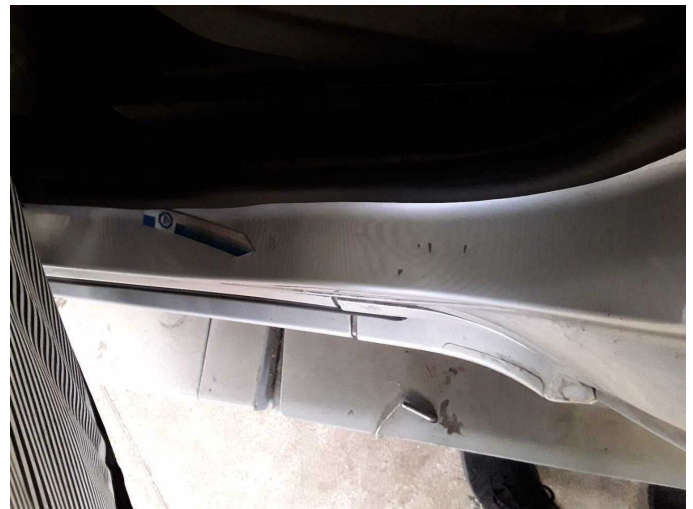
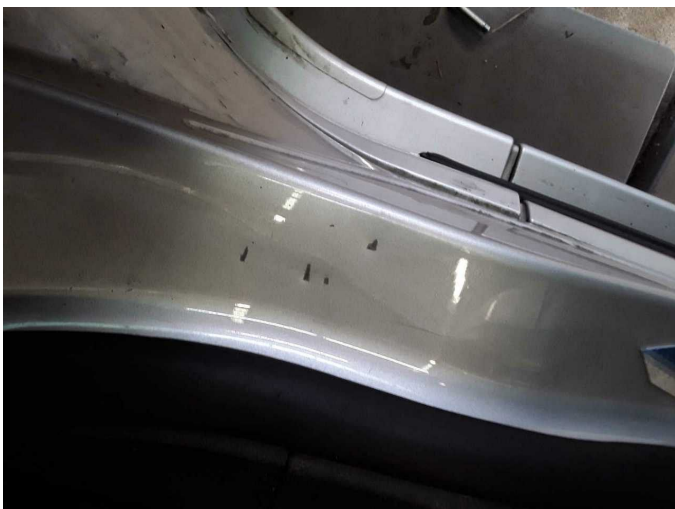
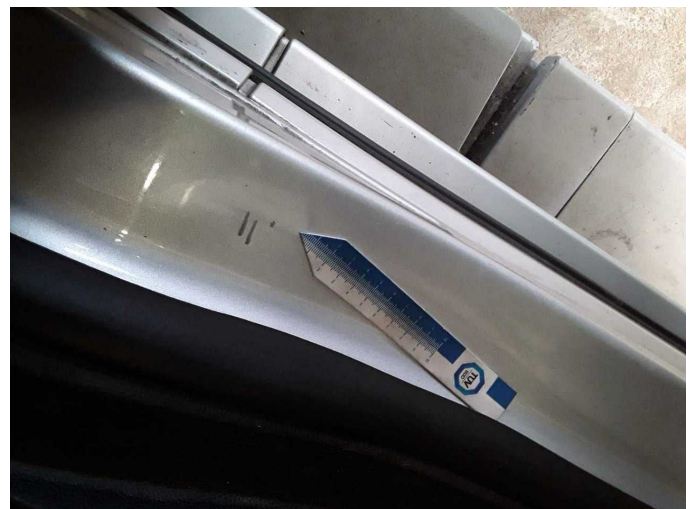
| No. | Component group | Description |
|---|---|---|
| 3 | Side panel - rear left side | Sill - Dent / paintcoat damage - Smart repair |

**Damage 3:** Side panel - rear left side: Sill - Dent / paintcoat damage - Smart repair

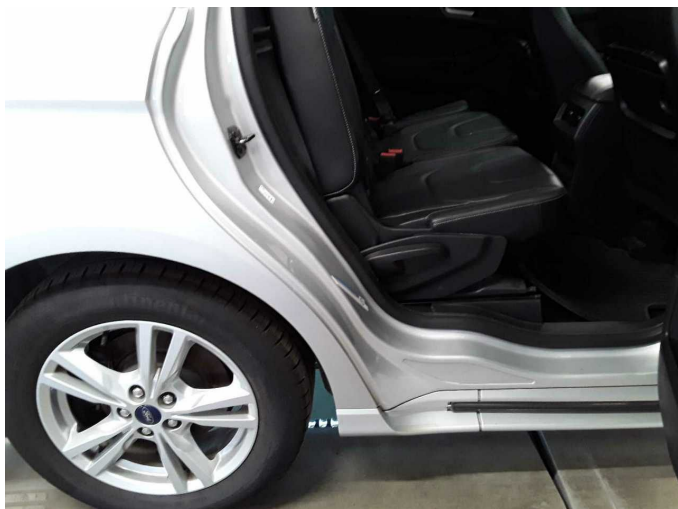
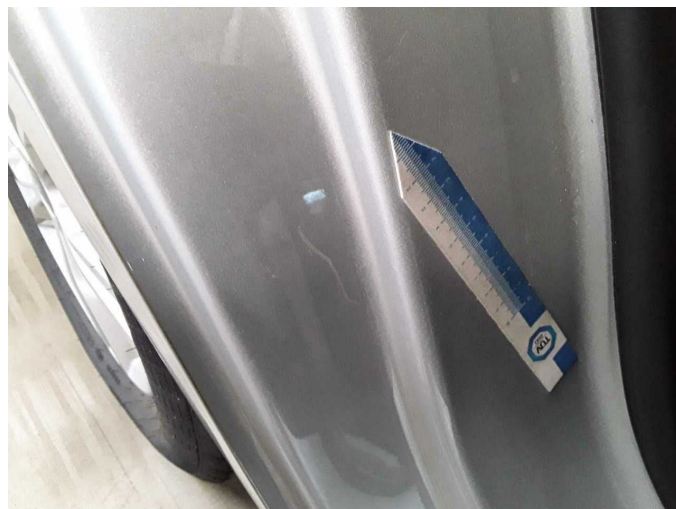
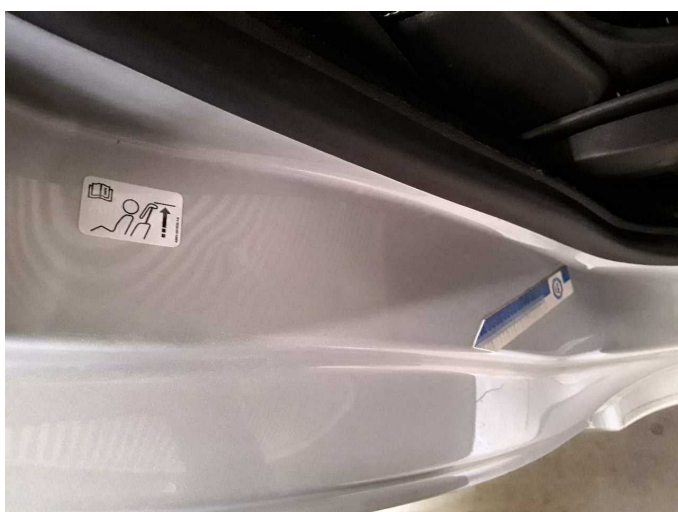
| No. | Component group | Description |
|---|---|---|
| 4 | Side panel - rear right side | Sill - Dent / paintcoat damage - Smart repair |

**Damage 4:** Side panel - rear right side: Sill - Dent / paintcoat damage - Smart repair

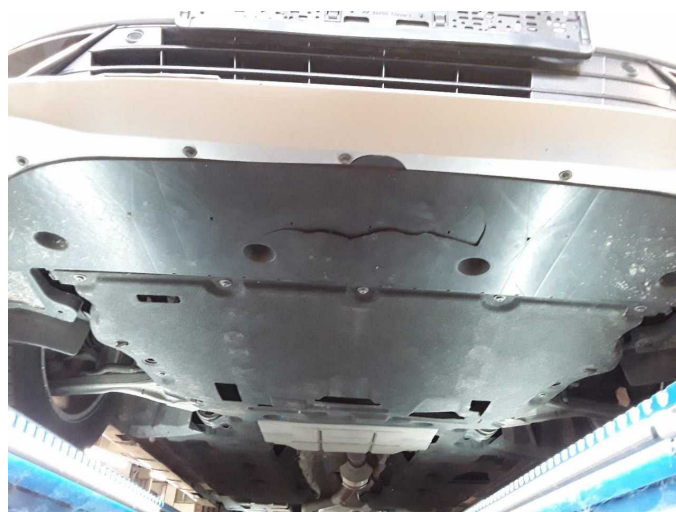
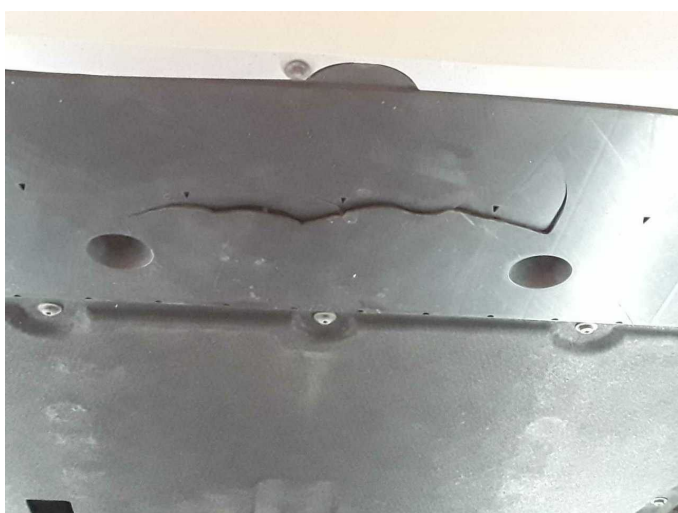
| No. | Component group | Description |
|---|---|---|
| 5 | Body | Underbody panelling - Broken / torn - Replace |

**Damage 5:** Body: Underbody panelling - Broken / torn - Replace

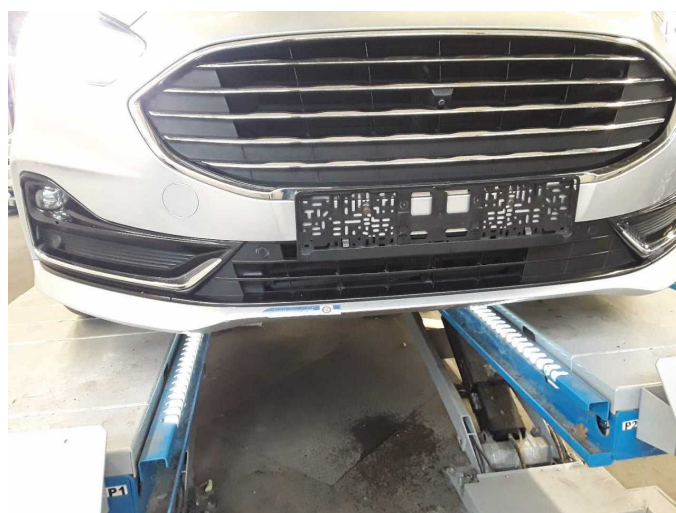
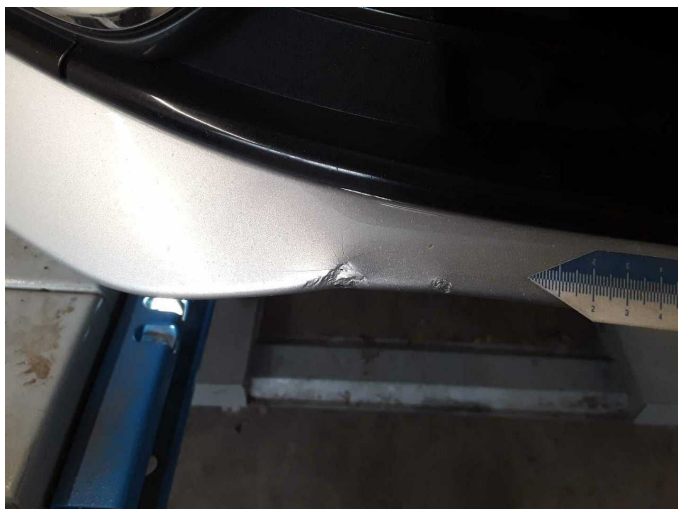
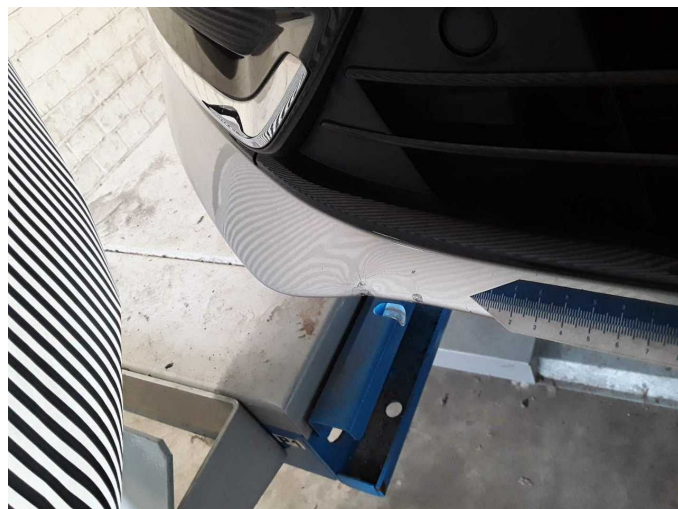
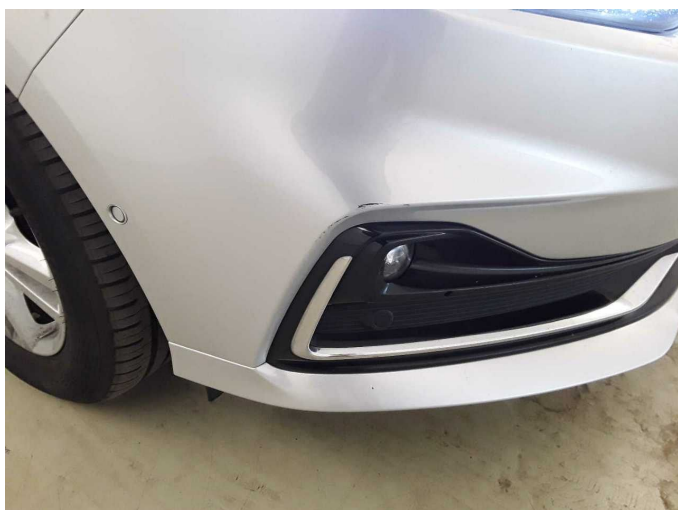
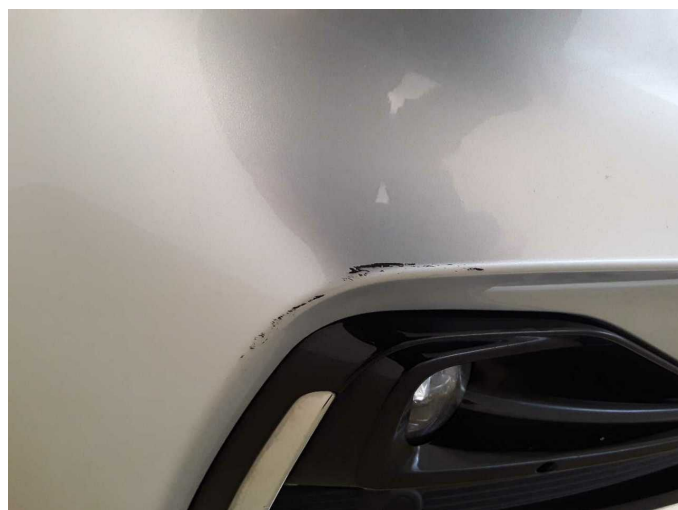
| No. | Component group | Description |
|---|---|---|
| 6 | Front bumper | Front bumper - Dent / paintcoat damage - Repair and paint |

**Damage 6:** Front bumper: Front bumper - Dent / paintcoat damage - Repair and paint

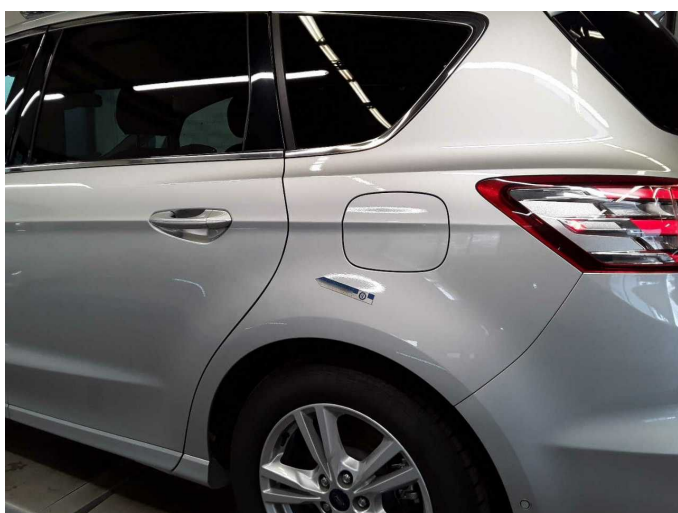
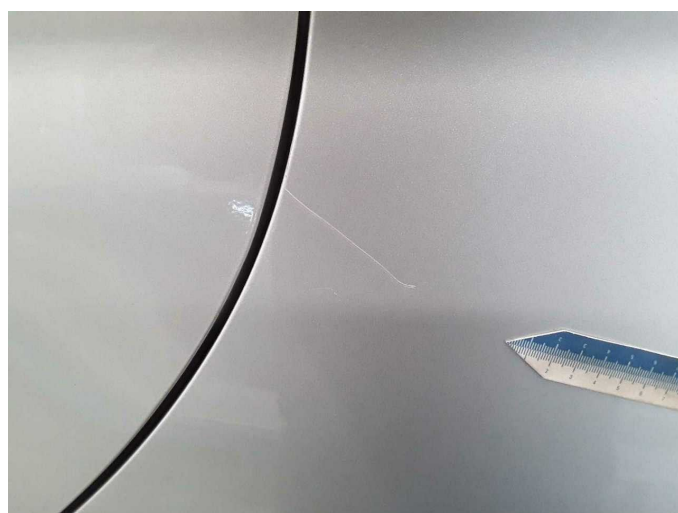
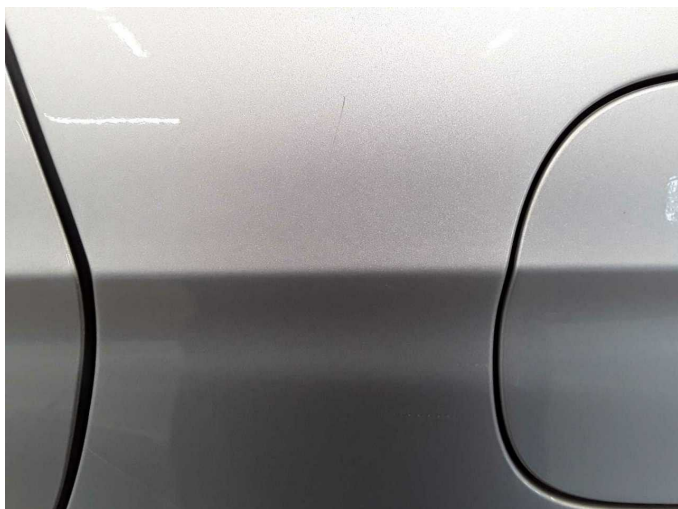
| No. | Component group | Description |
|---|---|---|
| 7 | Side panel - rear left side | Side panel - Scratch(es) - Paint |

**Damage 7:** Side panel - rear left side: Side panel - Scratch(es) - Paint

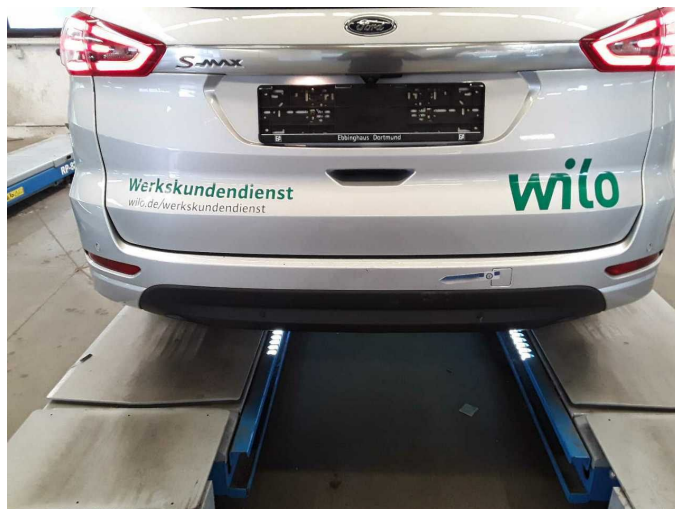
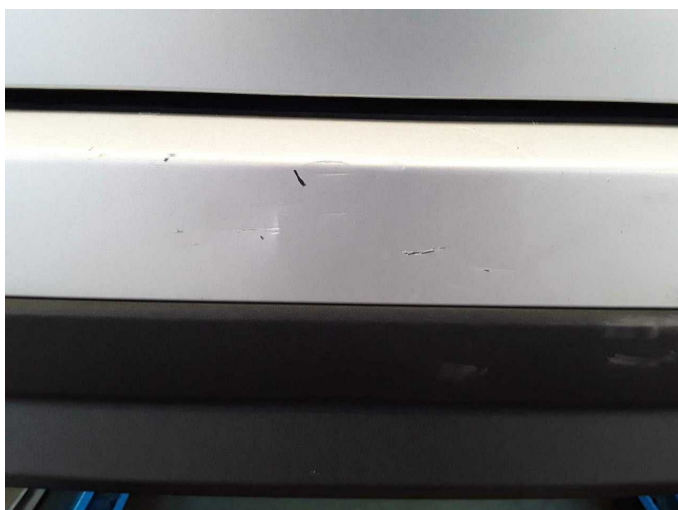
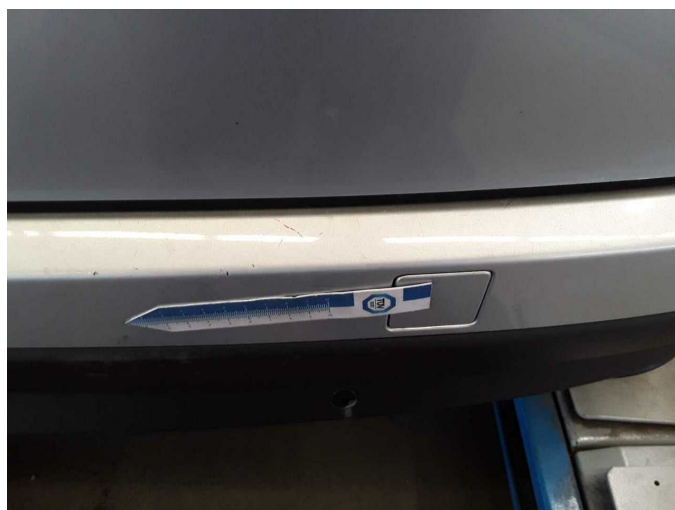
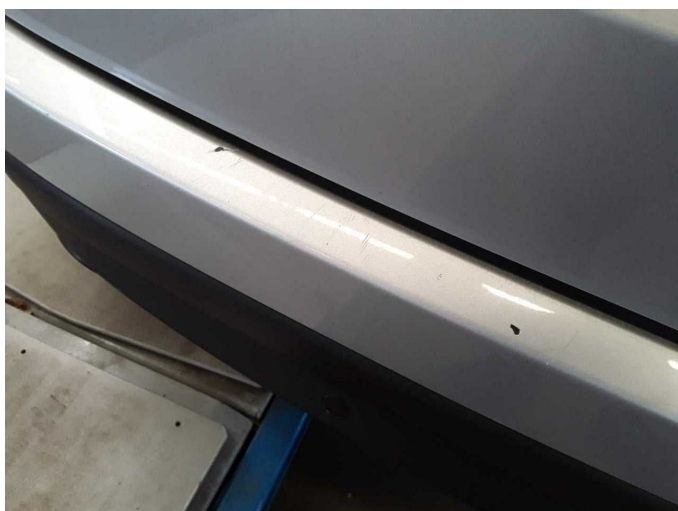
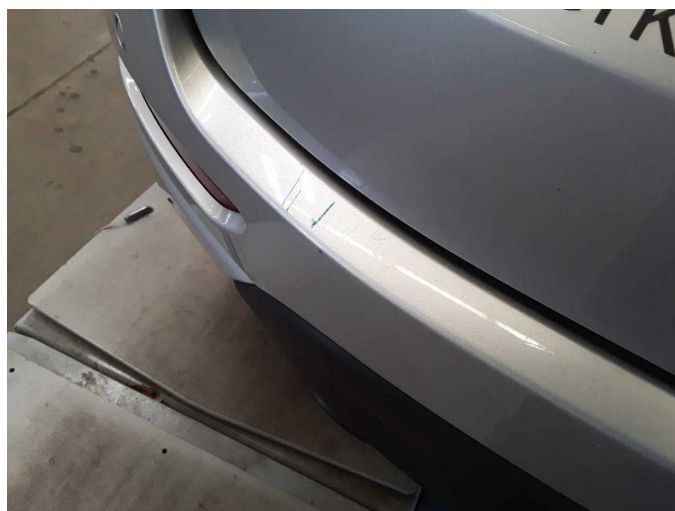
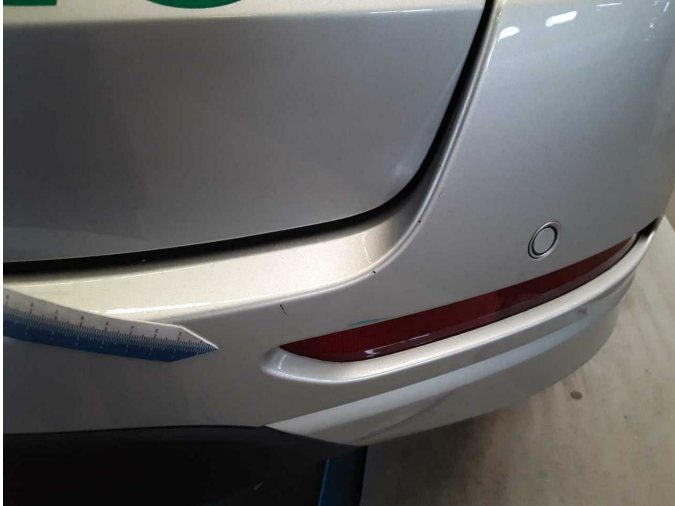
| No. | Component group | Description |
|---|---|---|
| 8 | Rear bumper | Rear bumper - Scratch(es) - Paint |

**Damage 8:** Rear bumper: Rear bumper - Scratch(es) - Paint

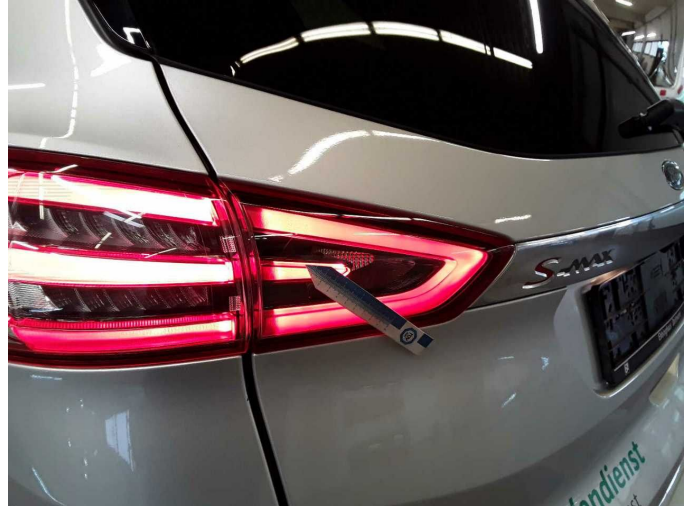
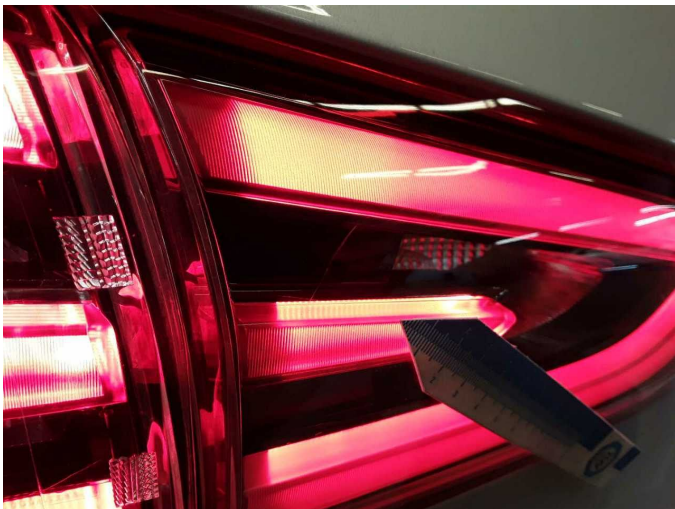
| No. | Component group | Description |
|---|---|---|
| 1 | Tail light | Auxiliary brake light - Scratch(es) - No deduction |

**Wear and tear 1:** Tail light: Auxiliary brake light - Scratch(es) - No deduction

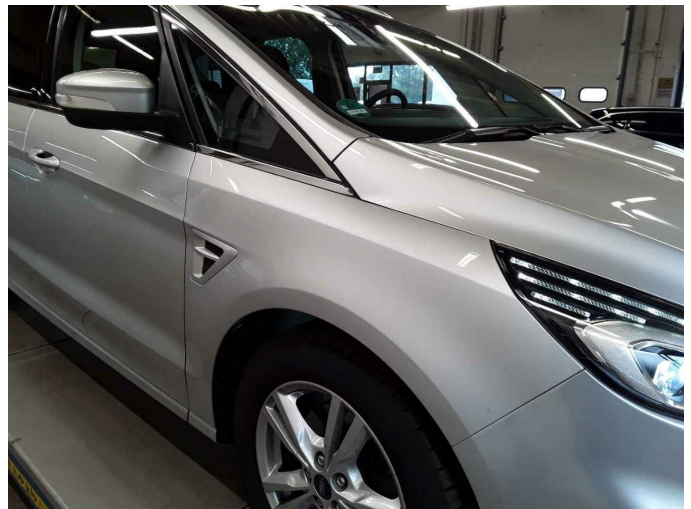
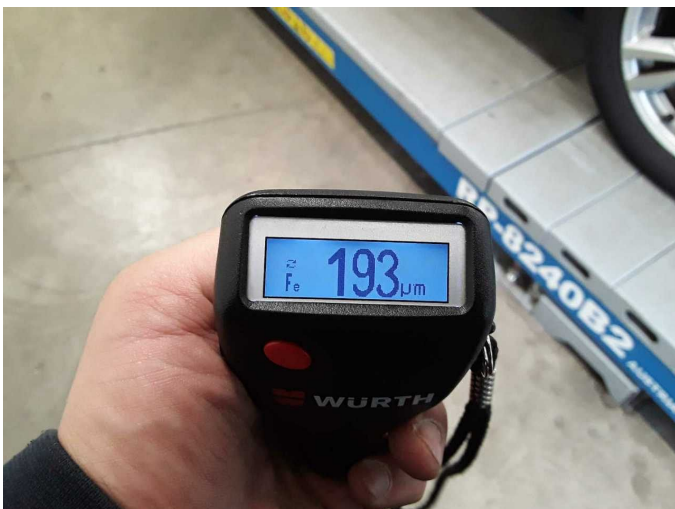
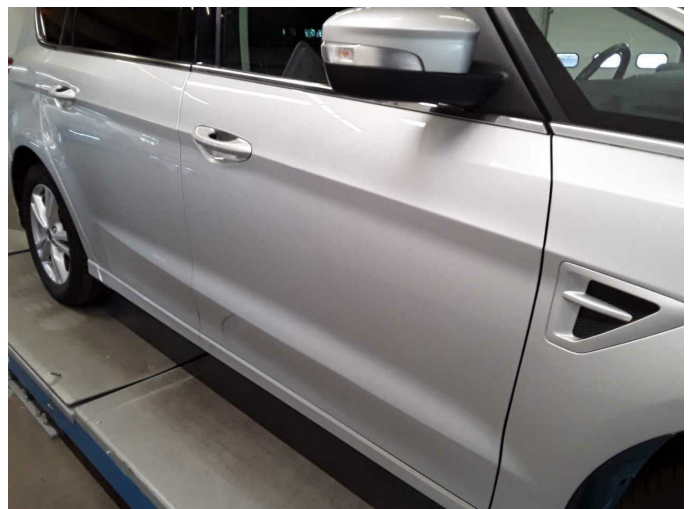
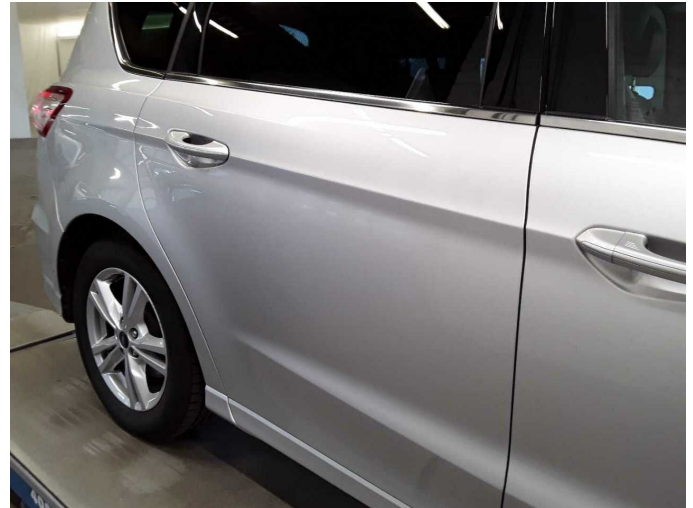
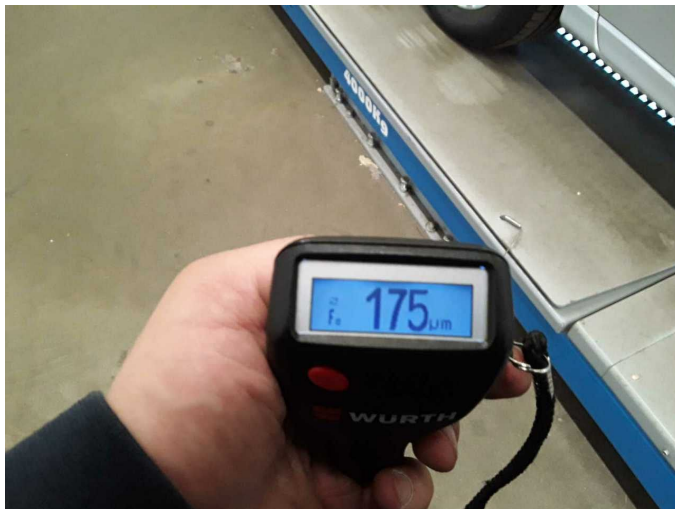
1 Mudguard - right side, Door - rear right side, Door - front right side

| Mudguard - right side | 172 µm | Door - rear right side | 162 µm |
| Door - front right side | 199 µm | | |

**Repainting 1:** Mudguard - right side, Door - rear right side, Door - front right side
