Expertise

Protocol number: 46738331  
Order No. / Reference: 26744858  
Inspection date: 27 Jul 2026

Manufacturer: Ford

Model: Focus Turnier 1.5 EcoBlue Start-Stopp-System  
COOL&CONNECT

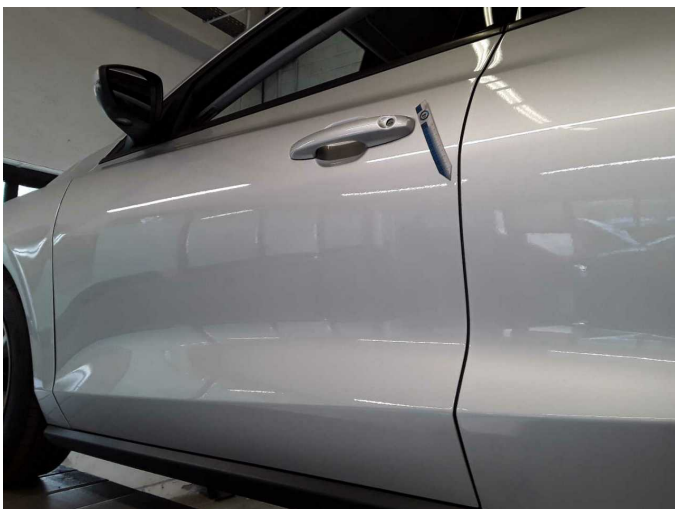
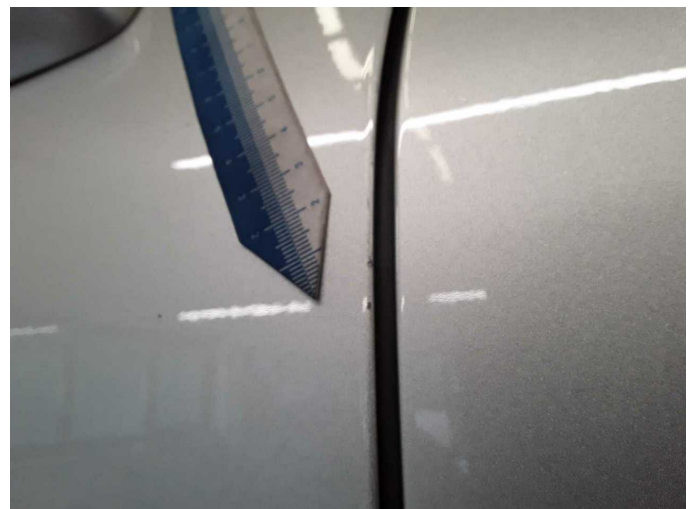
| No. | Component group | Description |
|---|---|---|
| 1 | Door - front left side | Door edge - Scratched - Smart repair |

Damage 1: Door - front left side: Door edge - Scratched - Smart repair

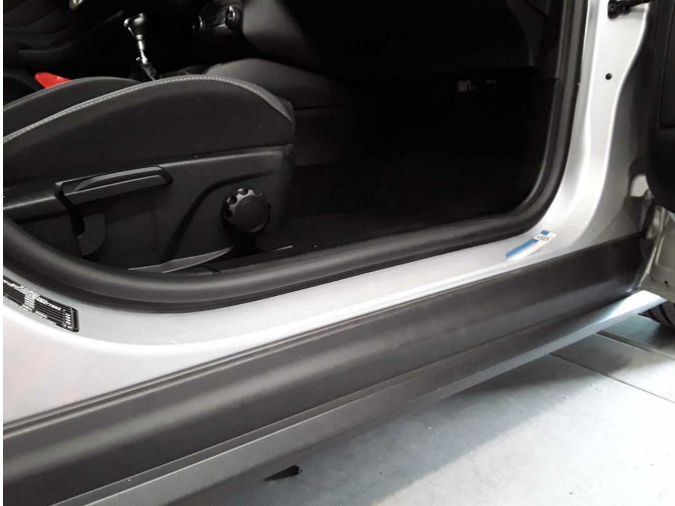
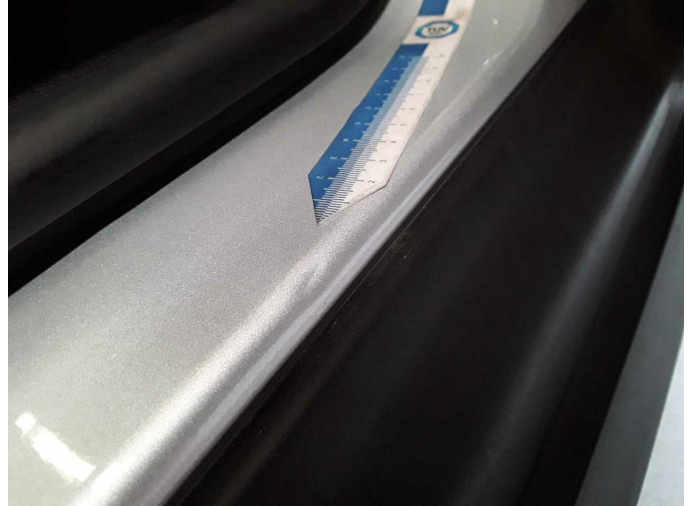
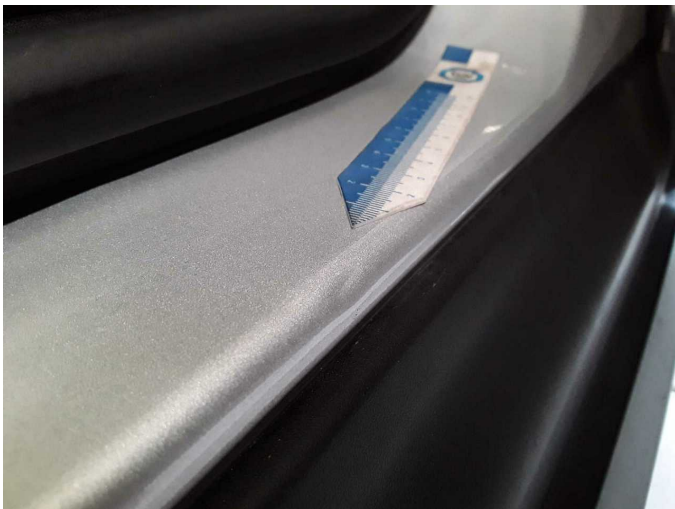
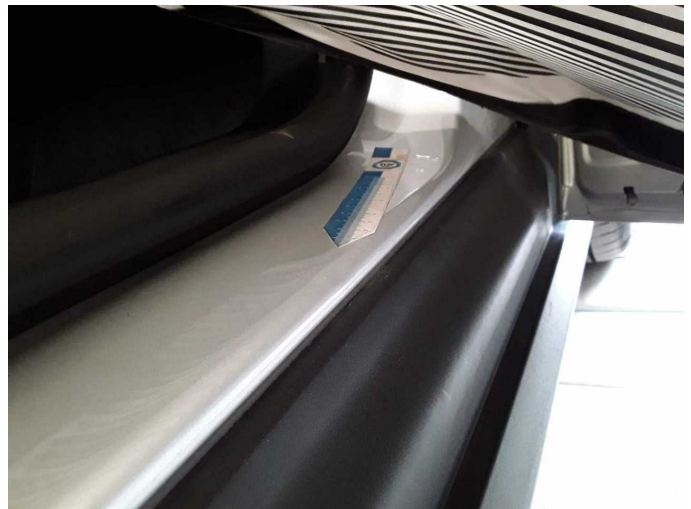
| No. | Component group | Description |
|---|---|---|
| 2 | Sill - right side | Sill - Dent / paintcoat damage - Smart repair |

**Damage 2:** Sill - right side: Sill - Dent / paintcoat damage - Smart repair

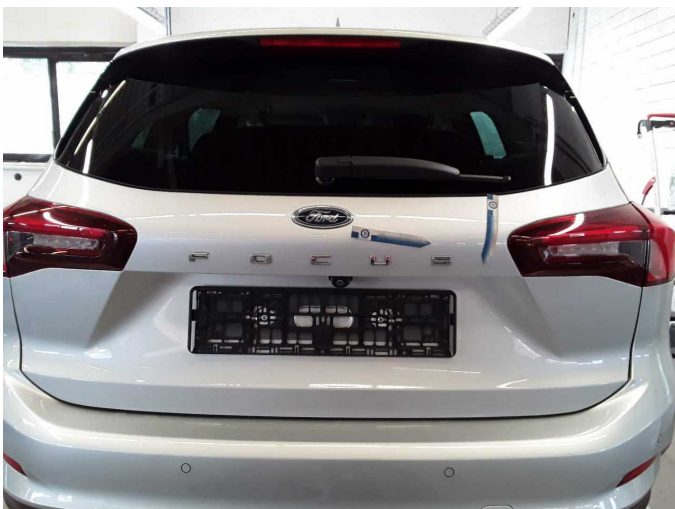
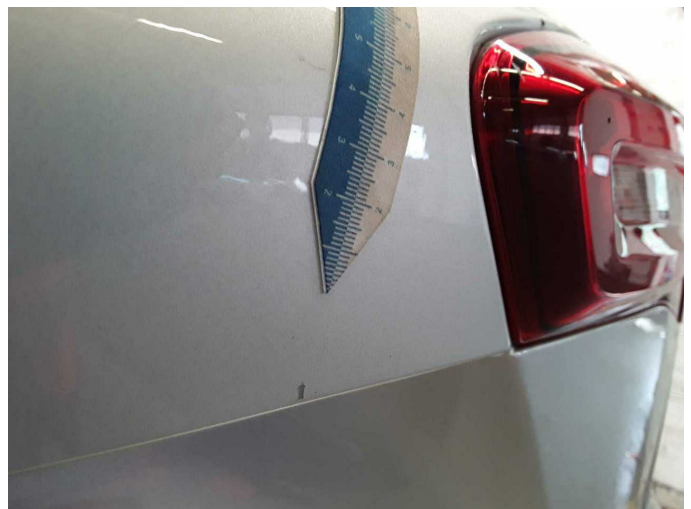
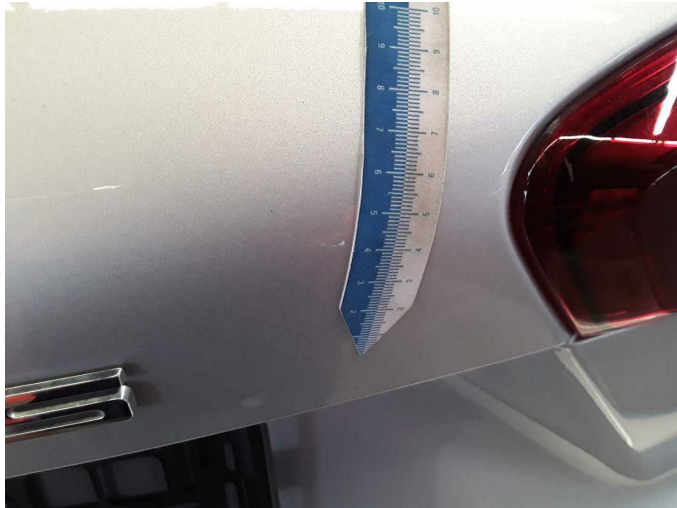
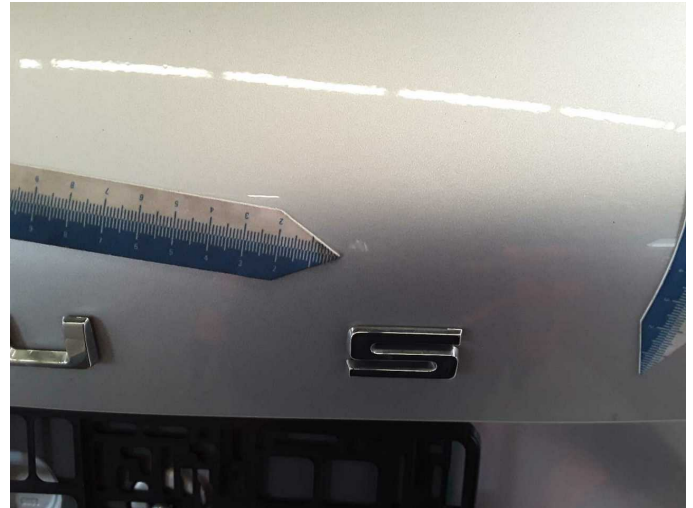
| No. | Component group | Description |
|---|---|---|
| 3 | Boot lid / rear door | Boot lid - Scratched - Smart repair |

**Damage 3:** Boot lid / rear door: Boot lid - Scratched - Smart repair

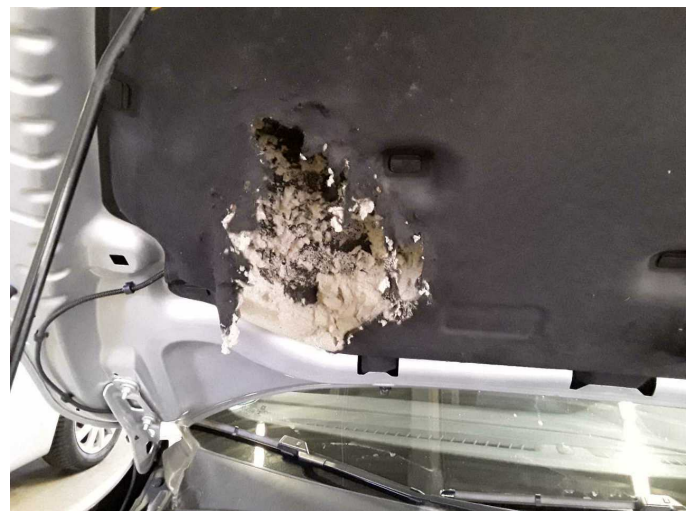
| No. | Component group | Description |
|---|---|---|
| 4 | Bonnet | Insulation lining - Damage caused by marten / rodent - Replace |

**Damage 4:** Bonnet: Insulation lining - Damage caused by marten / rodent  
- Replace

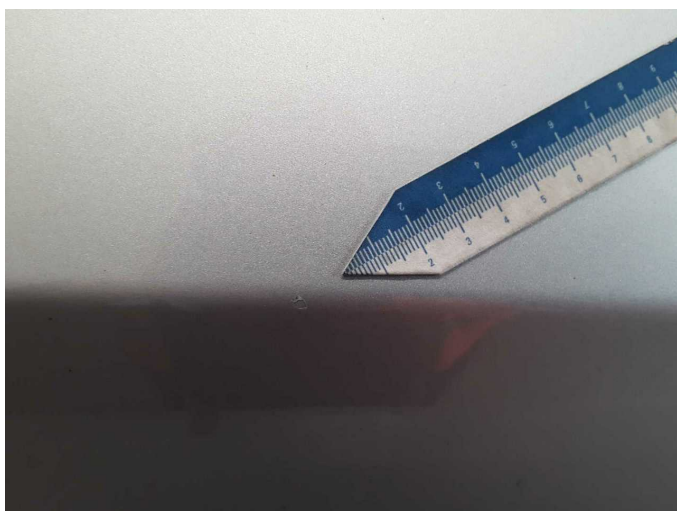
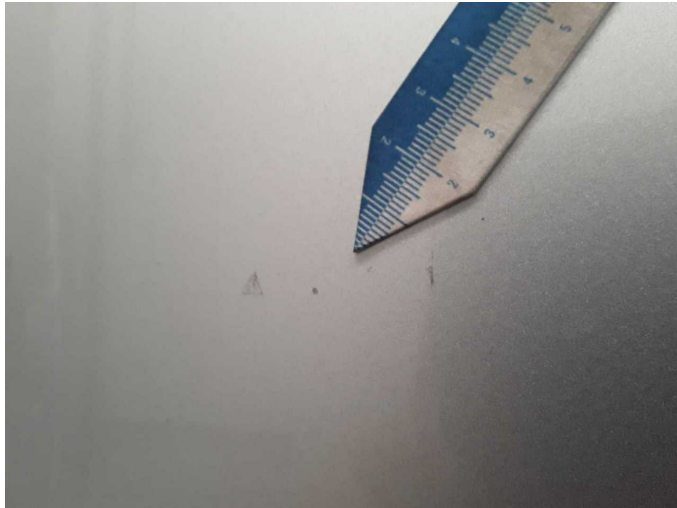
| No. | Component group | Description |
|---|---|---|
| 5 | Door - front right side | Door - Scratched - Paint |

**Damage 5:** Door - front right side: Door - Scratched - Paint

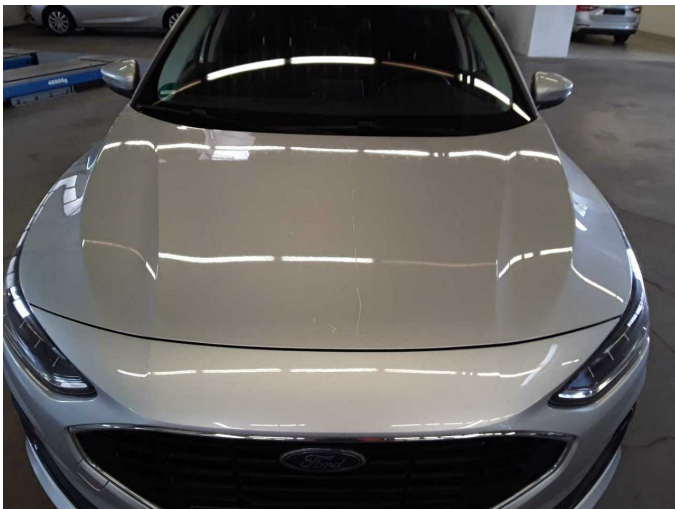
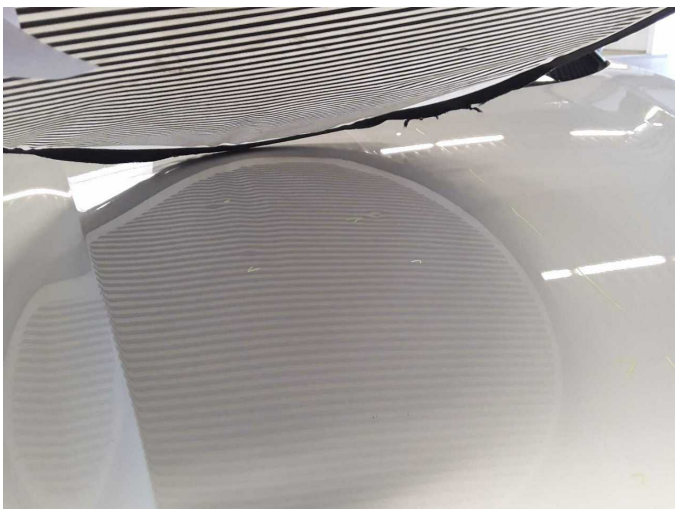
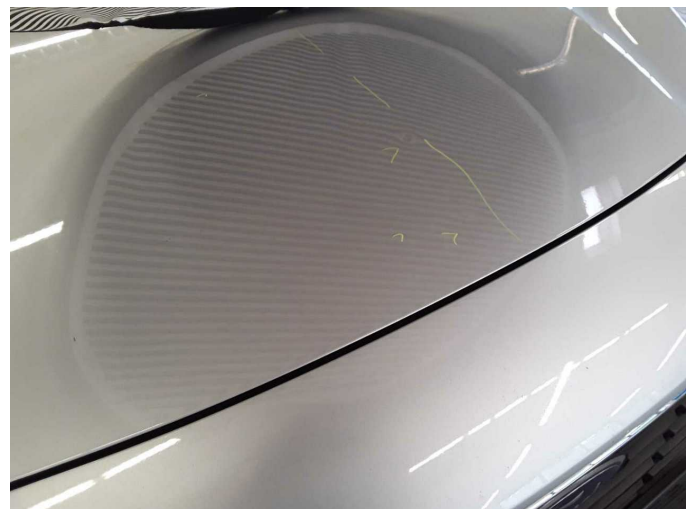
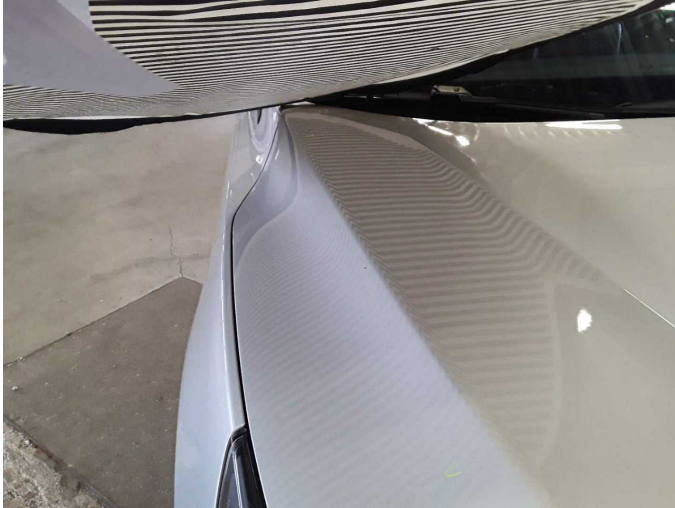
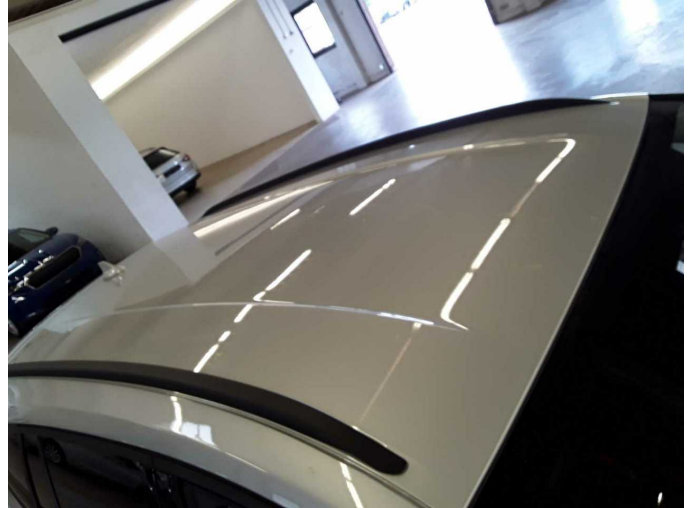
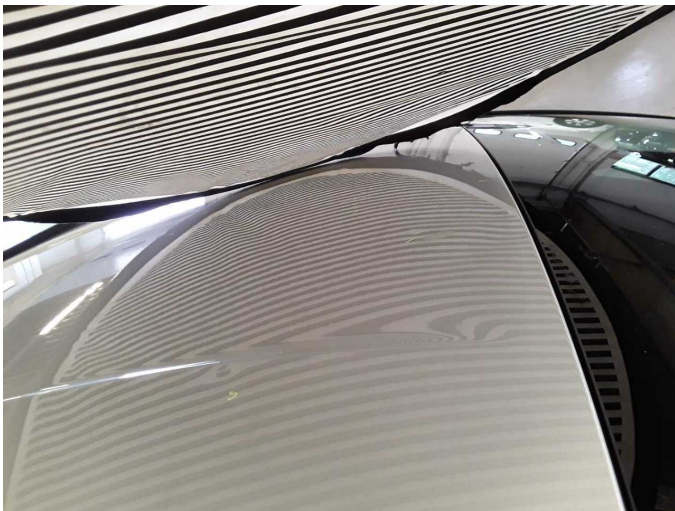
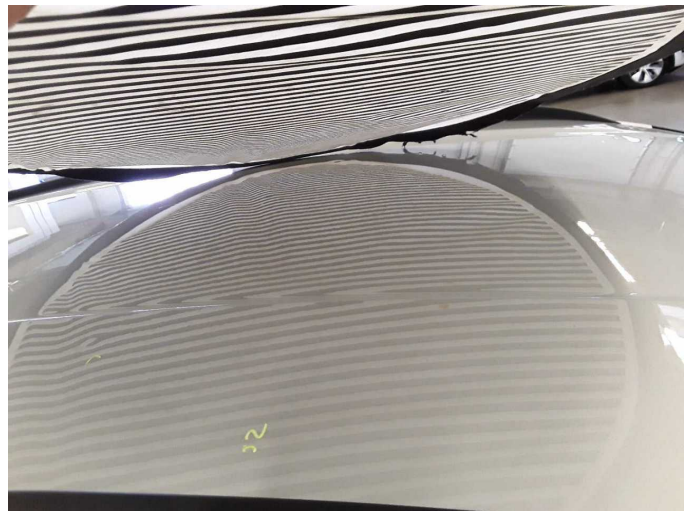
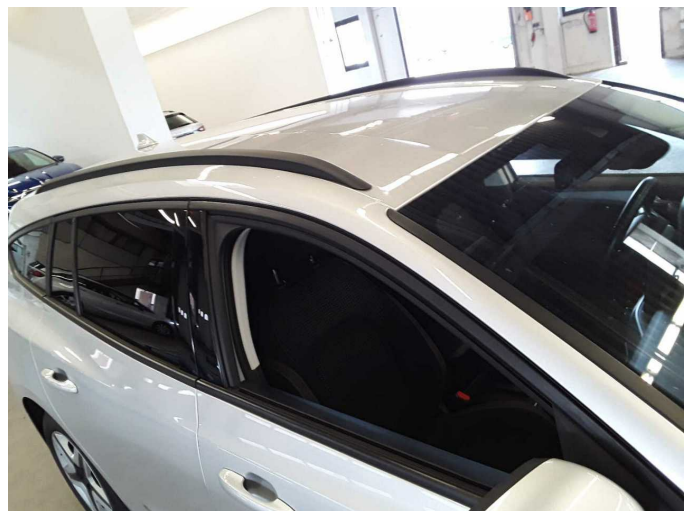
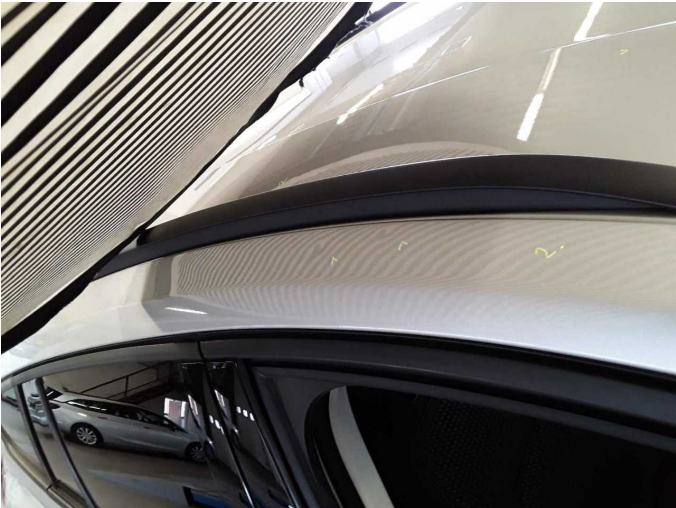
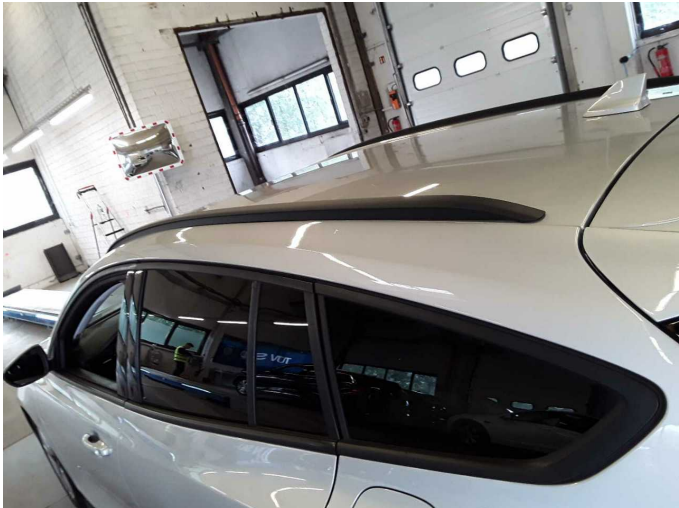
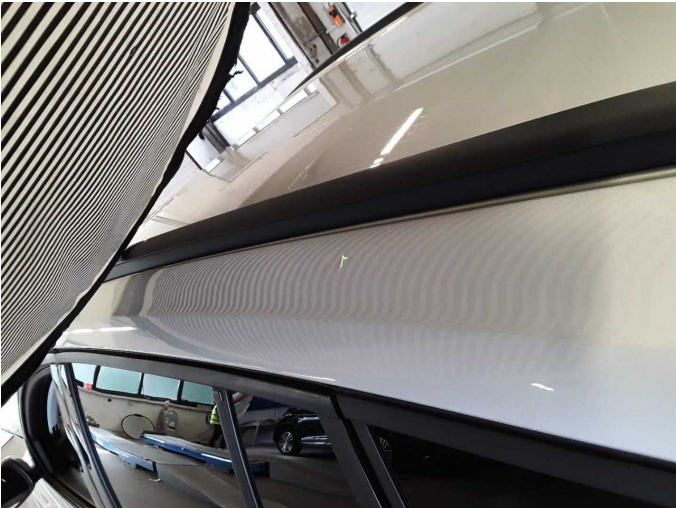
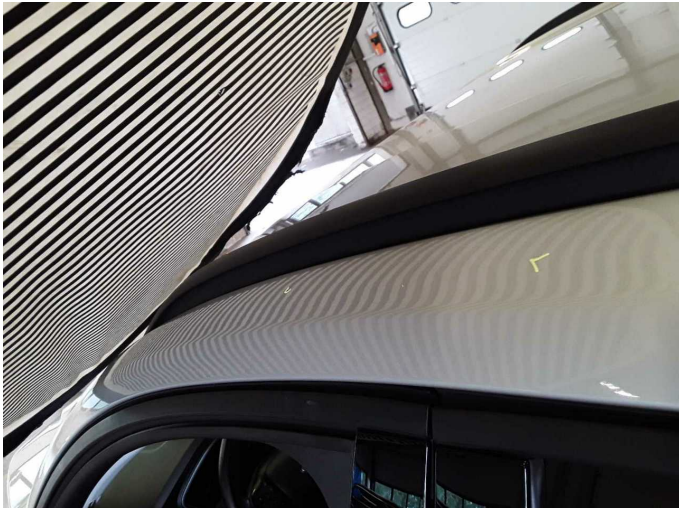
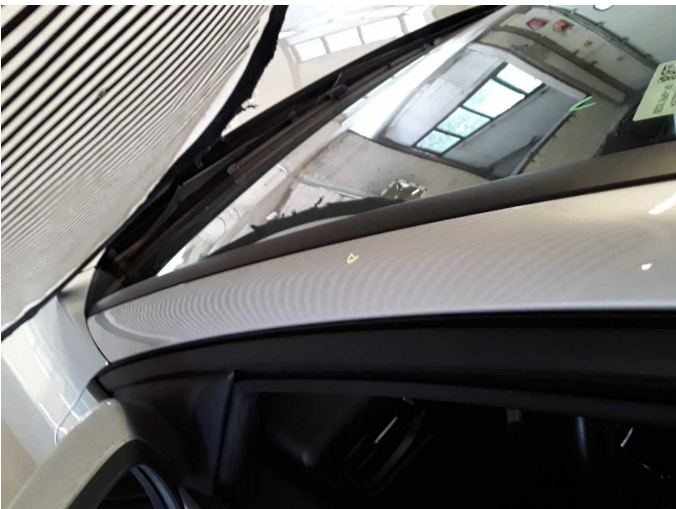
| No. | Component group | Description |
|---|---|---|
| 7 | Body | Body - Damage by hail - Smooth repair work |

**Damage 7:** Body: Body - Damage by hail - Smooth repair work

Damage 7: Body: Body - Damage by hail - Smooth repair work

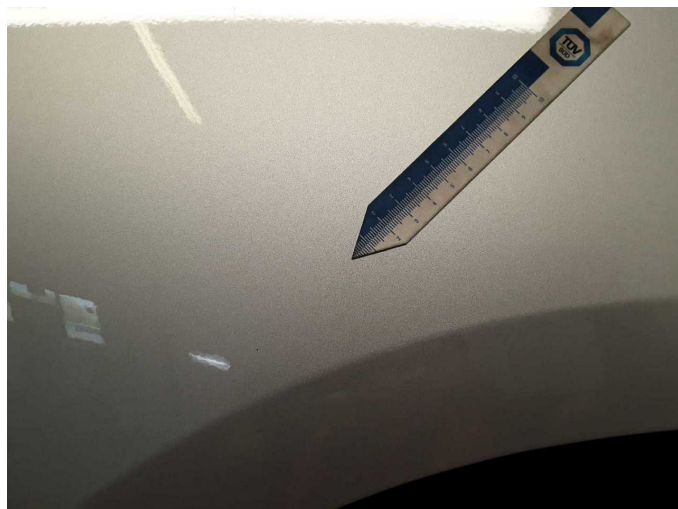
| No. | Component group | Description |
|---|---|---|
| 1 | Side panel - rear right side | Side panel - Scratch(es) - No deduction |

**Wear and tear 1:** Side panel - rear right side: Side panel - Scratch(es) - No deduction

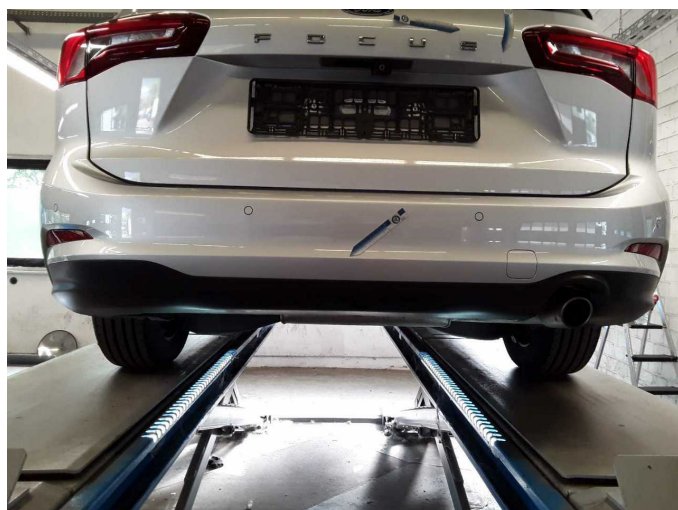
| No. | Component group | Description |
|---|---|---|
| 2 | Rear bumper | Rear bumper - Scratch(es) - No deduction |

**Wear and tear 2:** Rear bumper: Rear bumper - Scratch(es) - No deduction
