Expertise

Protocol number: 46376239  
Order No. / Reference: 26558776  
Inspection date: 7 Jul 2026

Manufacturer: Mercedes-Benz  
VIN: W1KAH0DBXPF101374

Model: C 200 d T 9G-TRONIC Avantgarde

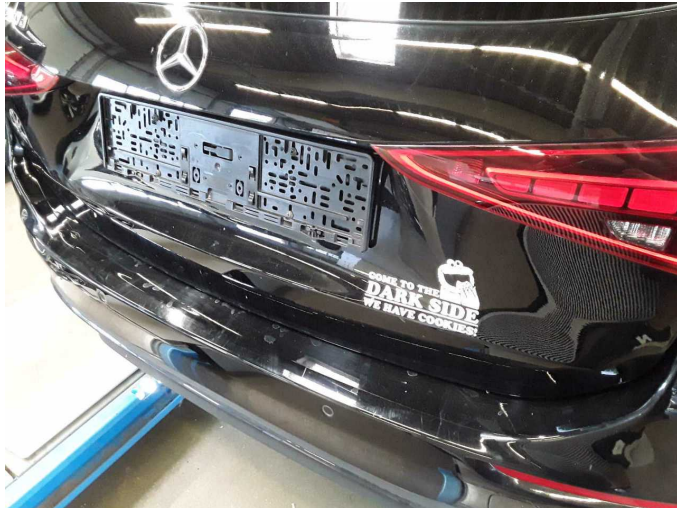
| No. | Component group | Description |
|---|---|---|
| 1 | Boot lid / rear door | Boot lid - Glued / labelled - De-glue / neutralise |

**Damage 1:** Boot lid / rear door: Boot lid - Glued / labelled - De-glue / neutralise

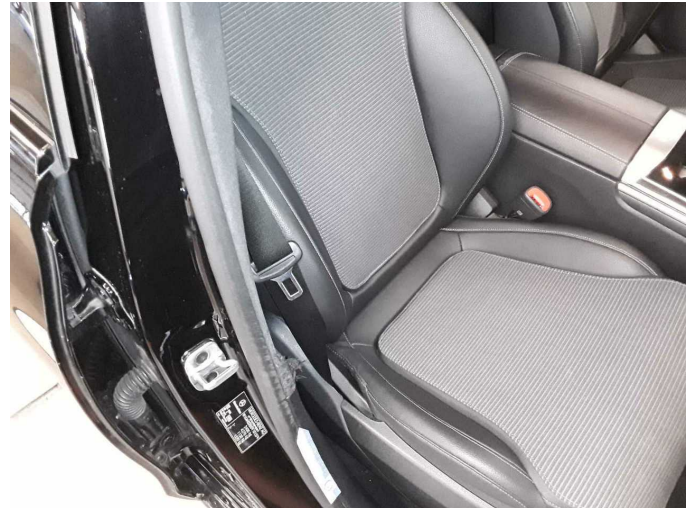
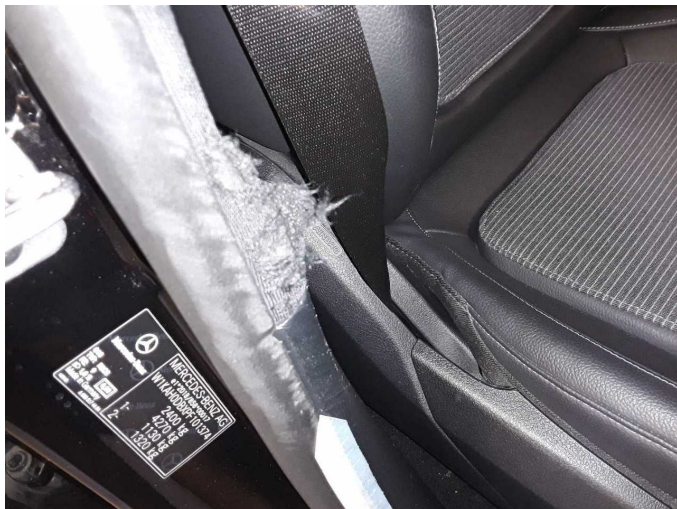
| No. | Component group | Description |
|---|---|---|
| 2 | Cab | Door rubber seal - right side - Scratched - Replace |

**Damage 2:** Cab: Door rubber seal - right side - Scratched - Replace

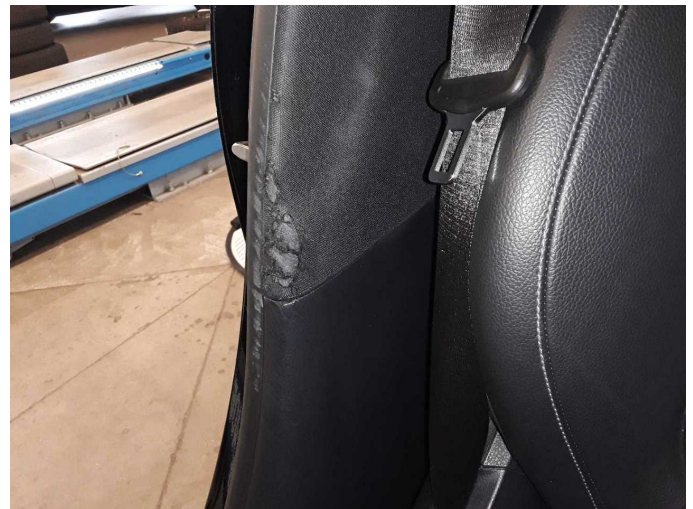
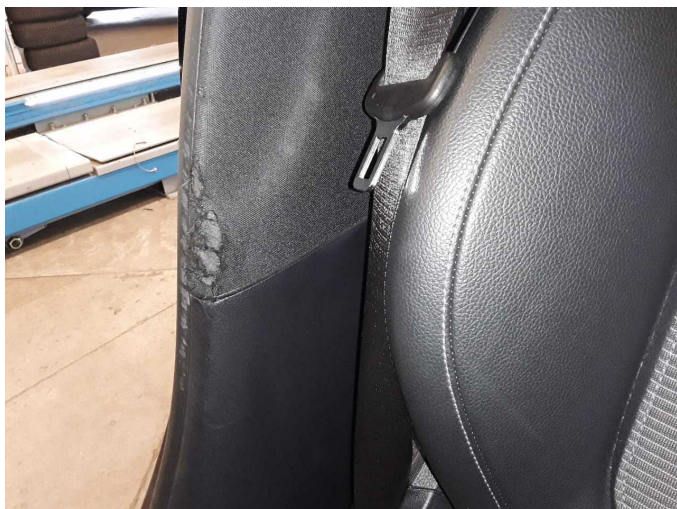
| No. | Component group | Description |
|---|---|---|
| 3 | Trim / covers | B-pillar - trim - interior, right side - Damaged - Replace |

**Damage 3:** Trim / covers: B-pillar - trim - interior, right side - Damaged - Replace

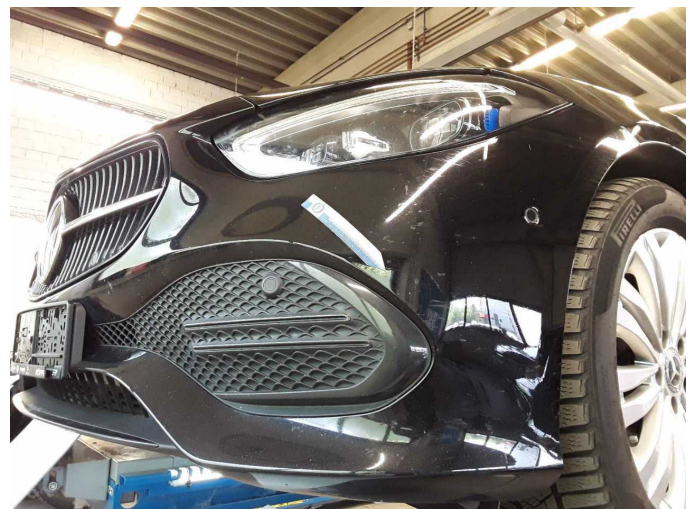
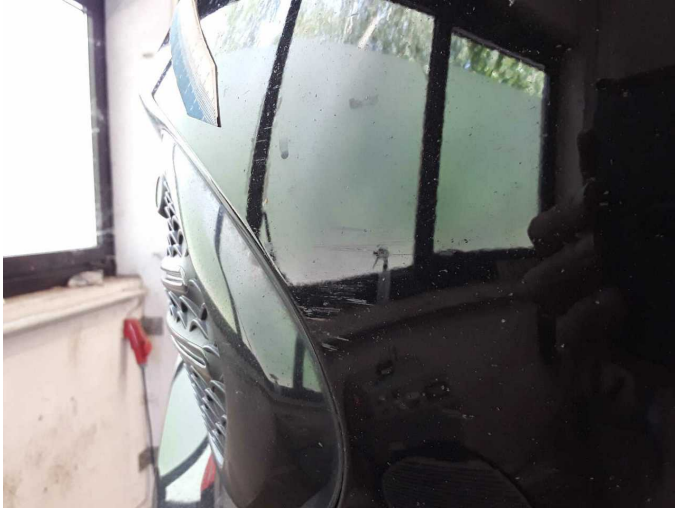
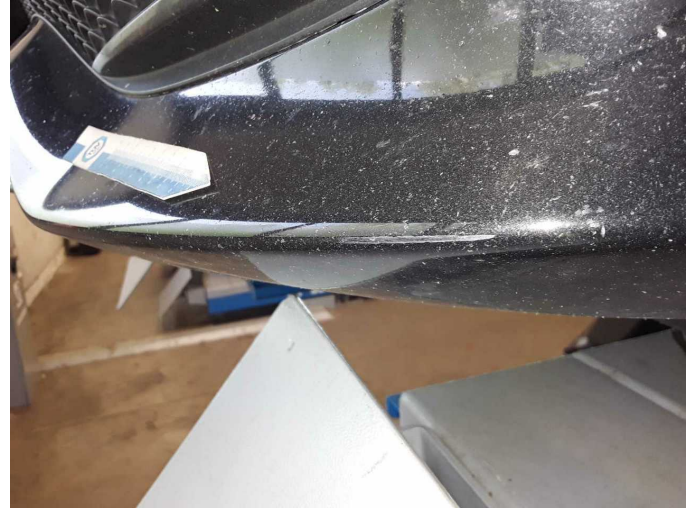
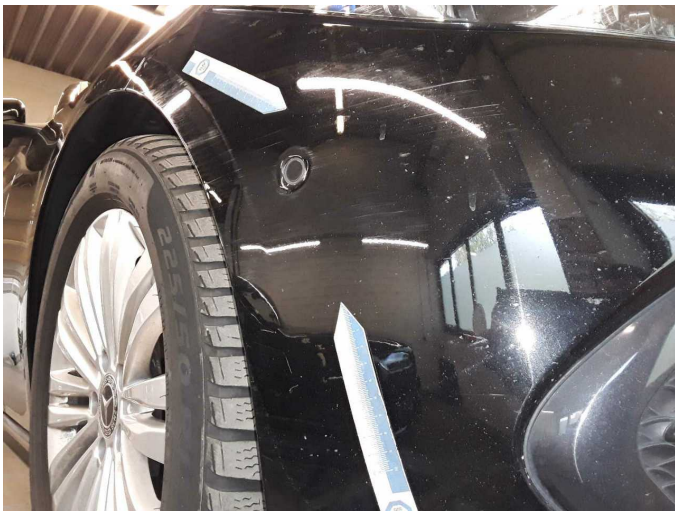
| No. | Component group | Description |
|---|---|---|
| 4 | Front bumper | Front bumper - Scratched - Paint |

**Damage 4:** Front bumper: Front bumper - Scratched - Paint

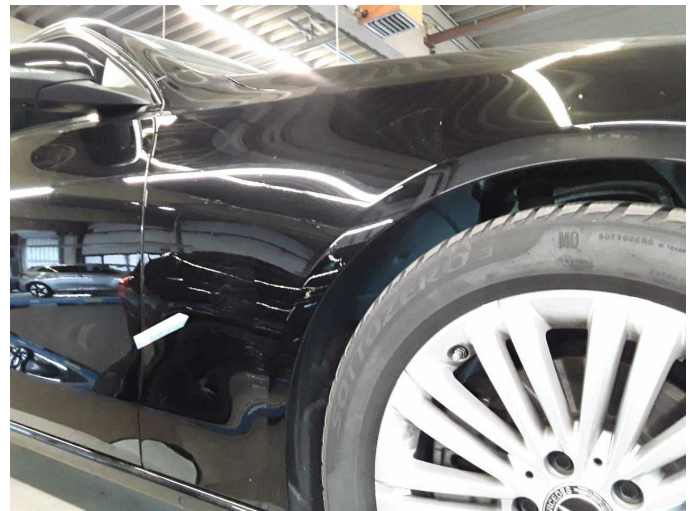
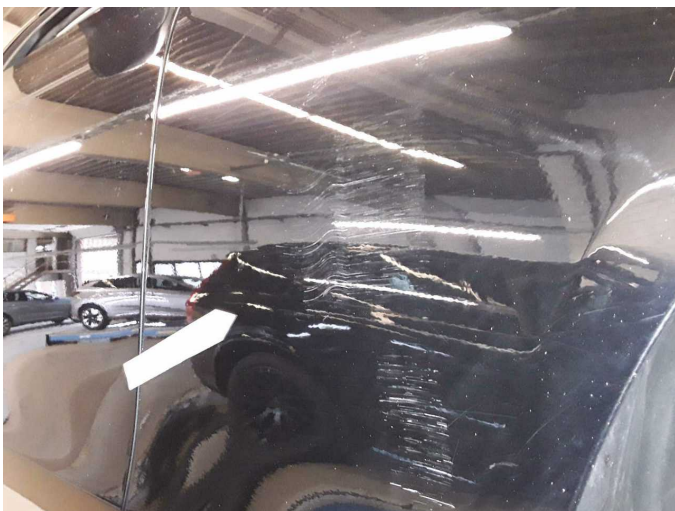
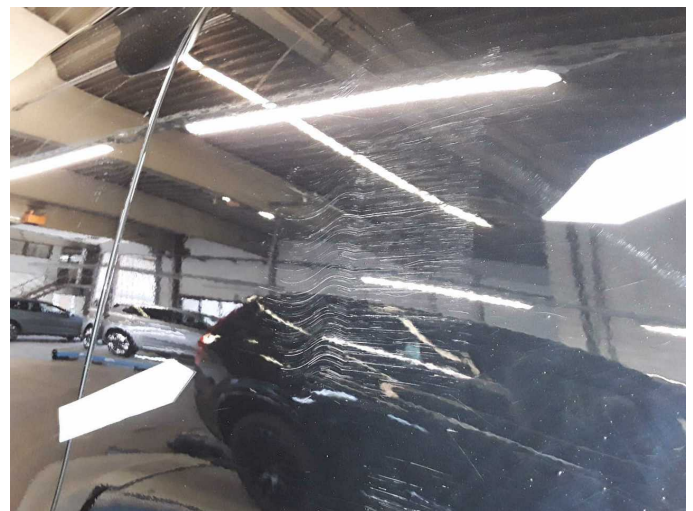
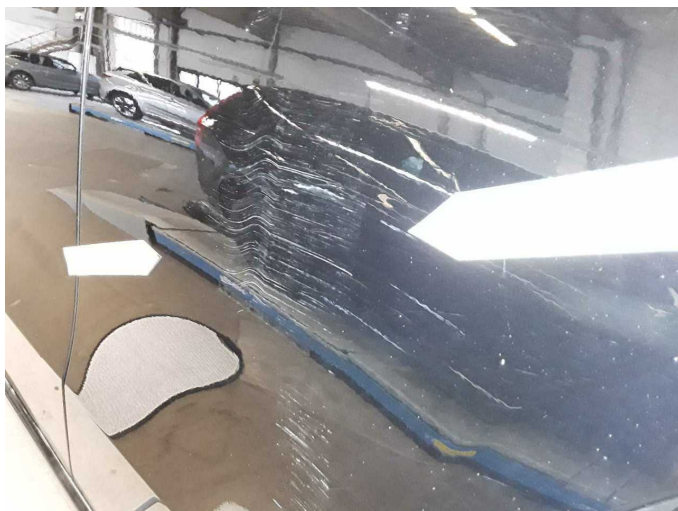
| No. | Component group | Description |
|---|---|---|
| 5 | Mudguard - right side | Mudguard - right side - Scratched - Paint |

**Damage 5:** Mudguard - right side: Mudguard - right side - Scratched - Paint

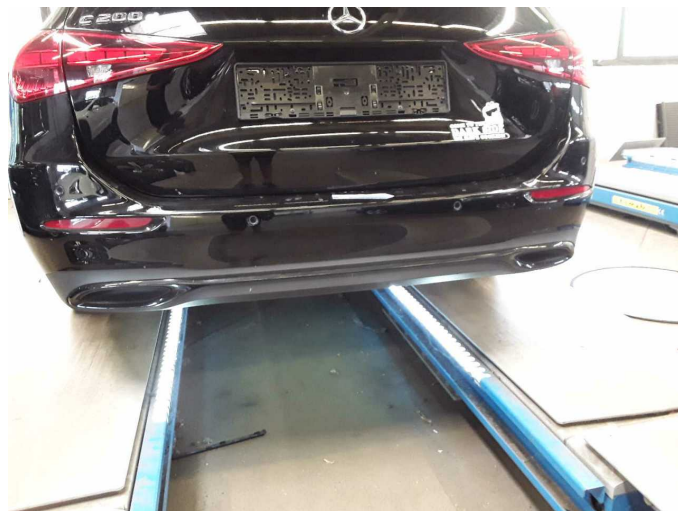
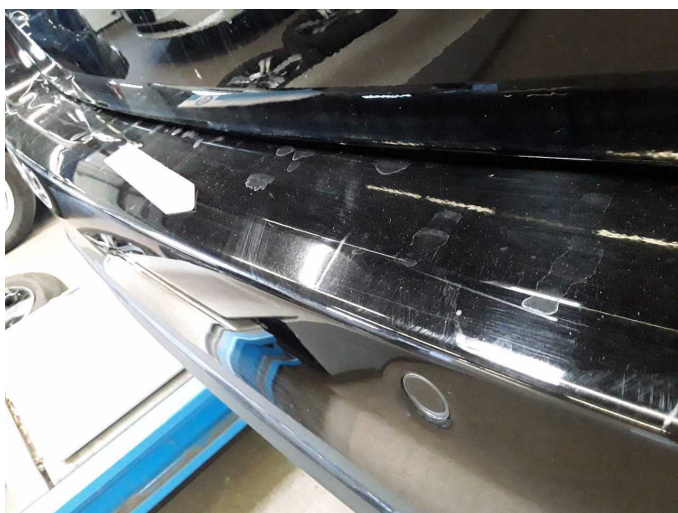
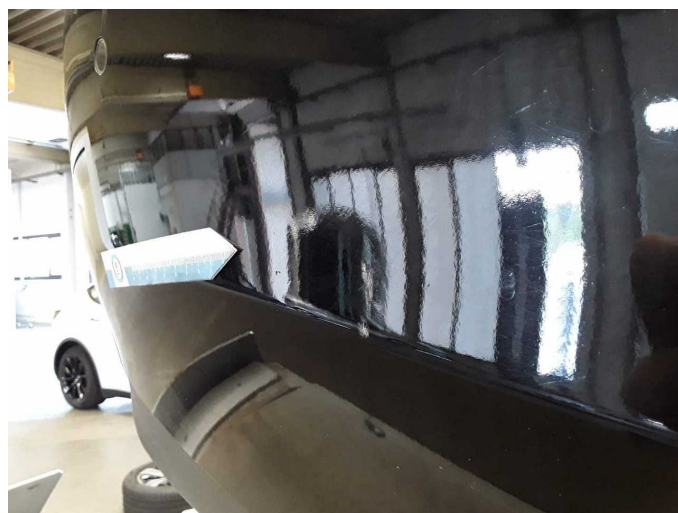
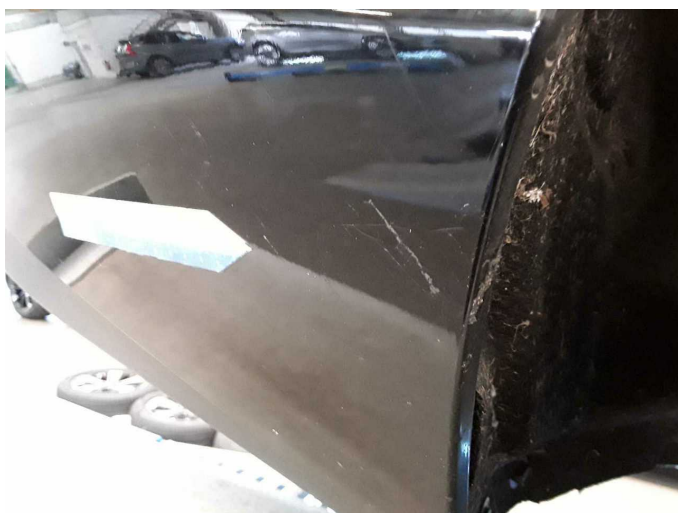
| No. | Component group | Description |
|---|---|---|
| 6 | Rear bumper | Rear bumper - Scratch(es) - Paint |

**Damage 6:** Rear bumper: Rear bumper - Scratch(es) - Paint

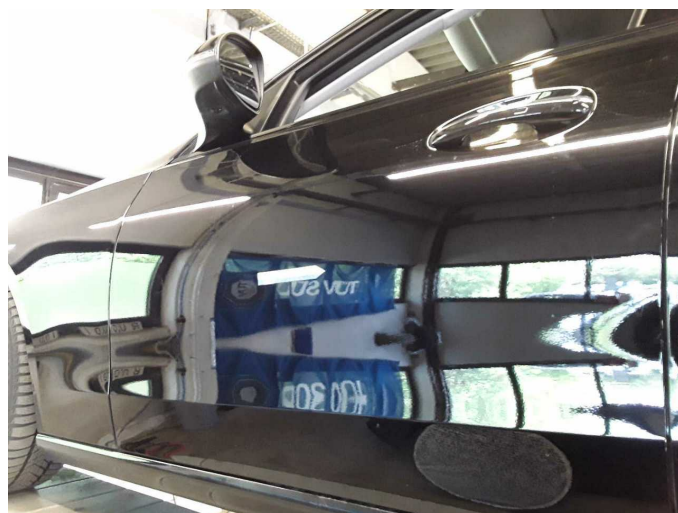
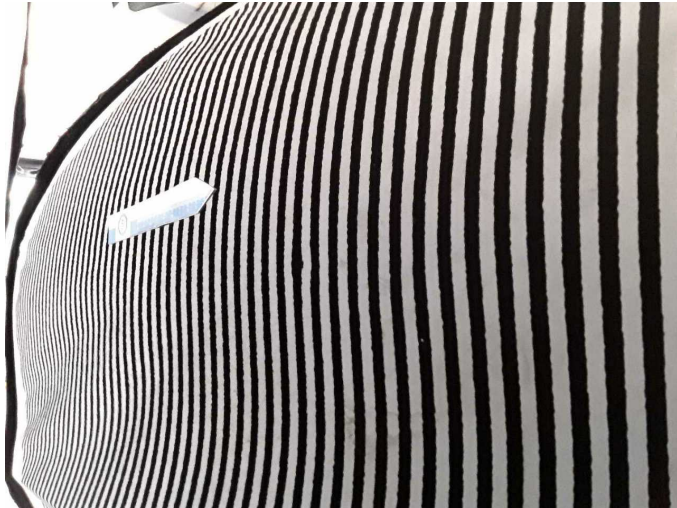
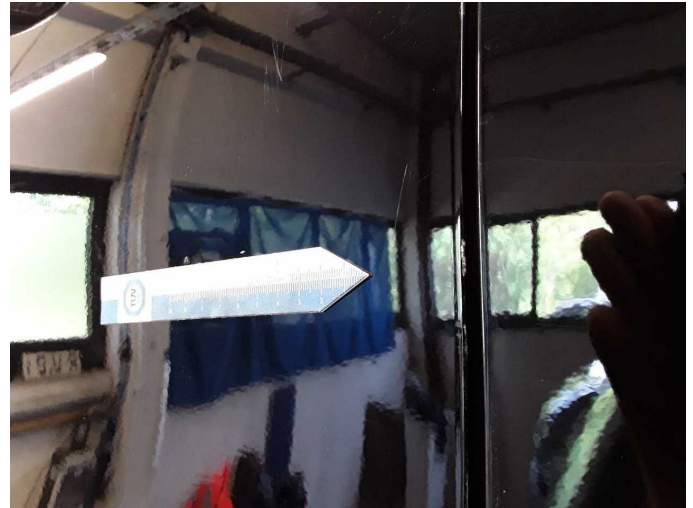
| No. | Component group | Description |
|---|---|---|
| 7 | Door - front left side | Door - Dent / paintcoat damage - Repair and paint |

**Damage 7:** Door - front left side: Door - Dent / paintcoat damage - Repair and paint

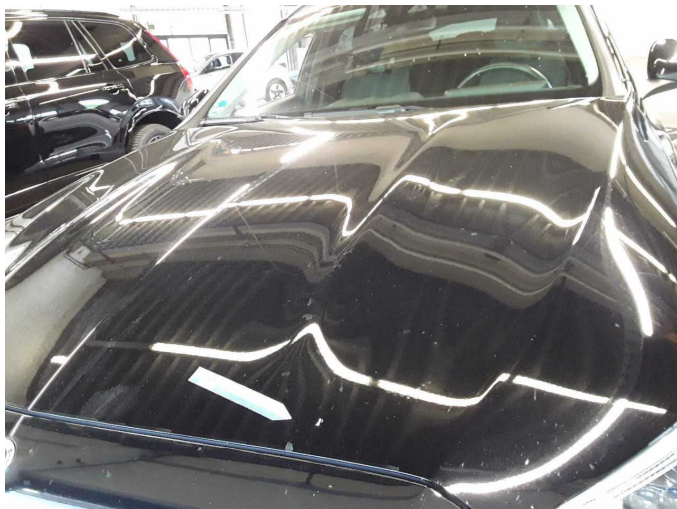
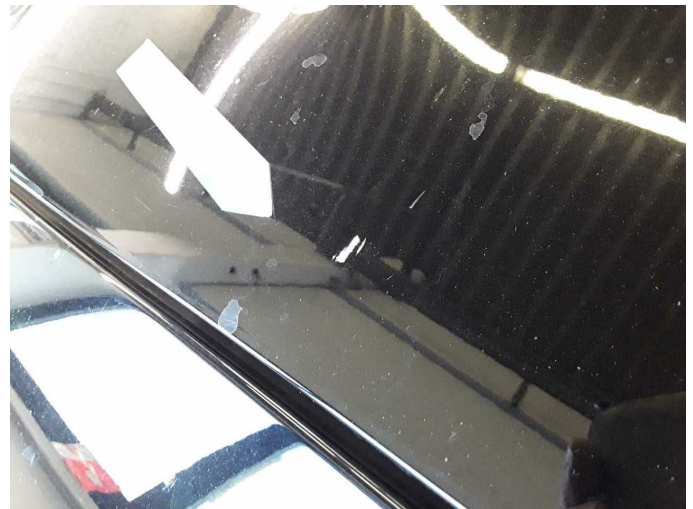
| No. | Component group | Description |
|---|---|---|
| 8 | Bonnet | Bonnet - Scratch(es) - Paint |

**Damage 8:** Bonnet: Bonnet - Scratch(es) - Paint

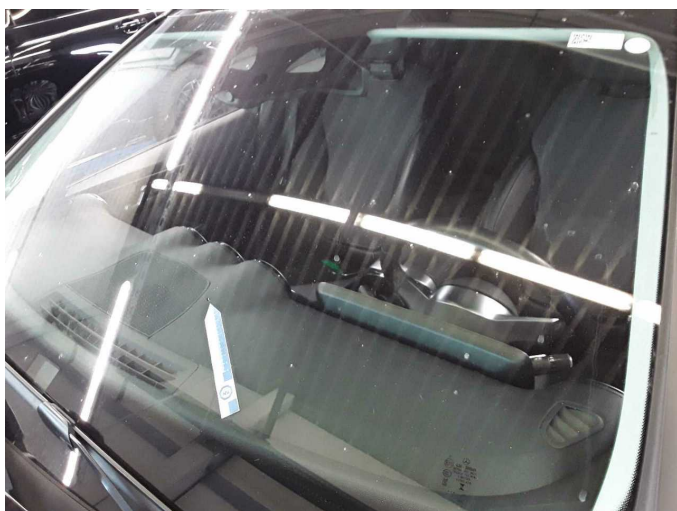
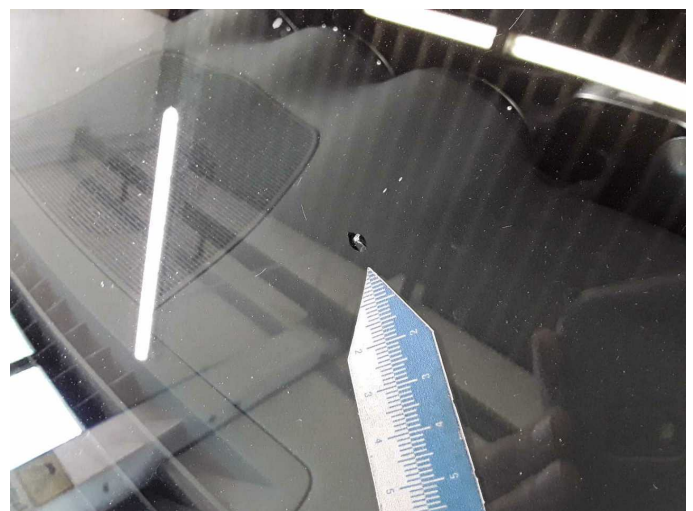
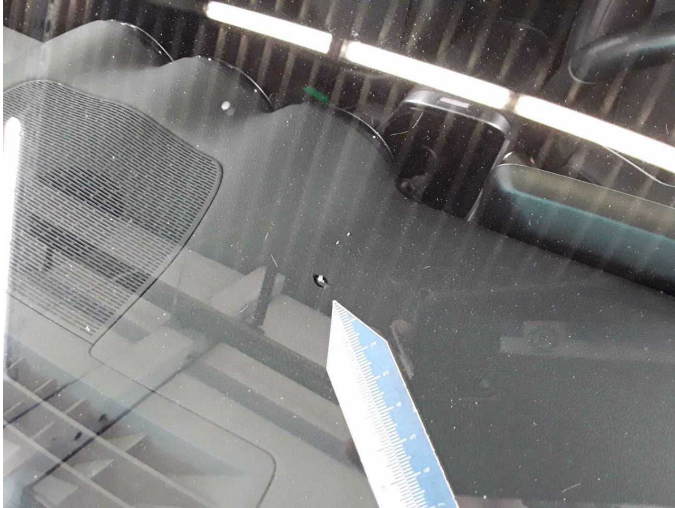
| No. | Component group | Description |
|---|---|---|
| 9 | Vehicle glazing | Windscreen (Rissbildung) - Stone chips - Replace |

**Damage 9:** Vehicle glazing: Windscreen (Rissbildung) - Stone chips - Replace

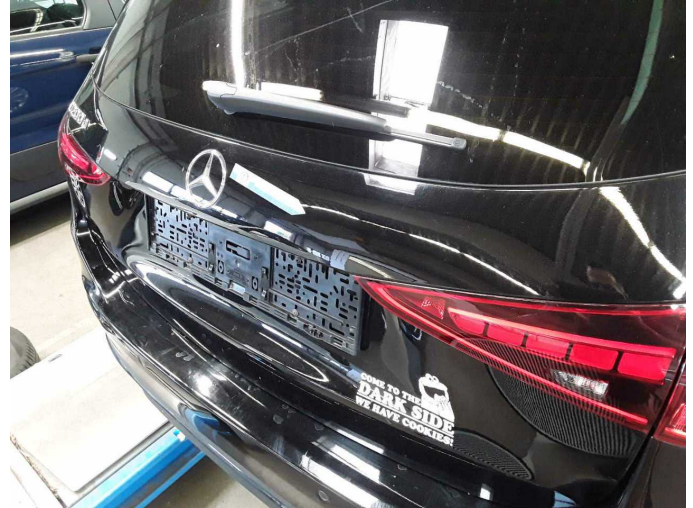
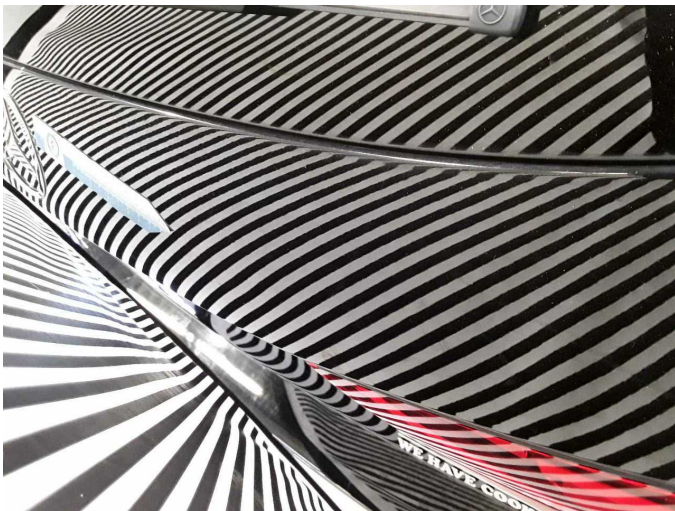
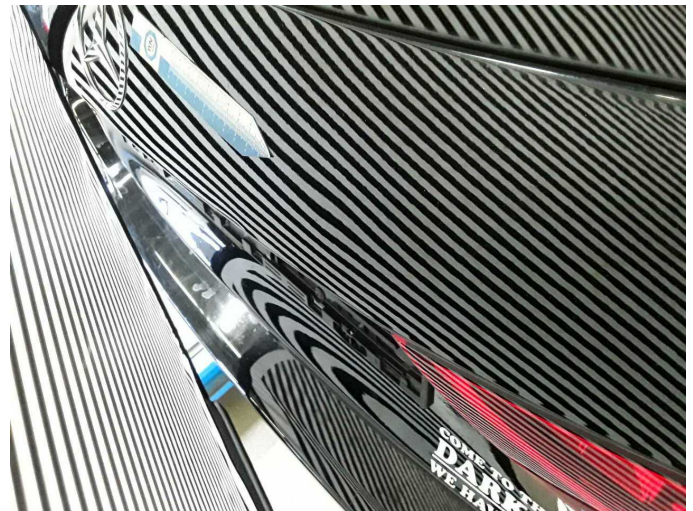
| No. | Component group | Description |
|---|---|---|
| 2 | Boot lid / rear door | Boot lid - dent(s) - No deduction |

**Wear and tear 2:** Boot lid / rear door: Boot lid - dent(s) - No deduction

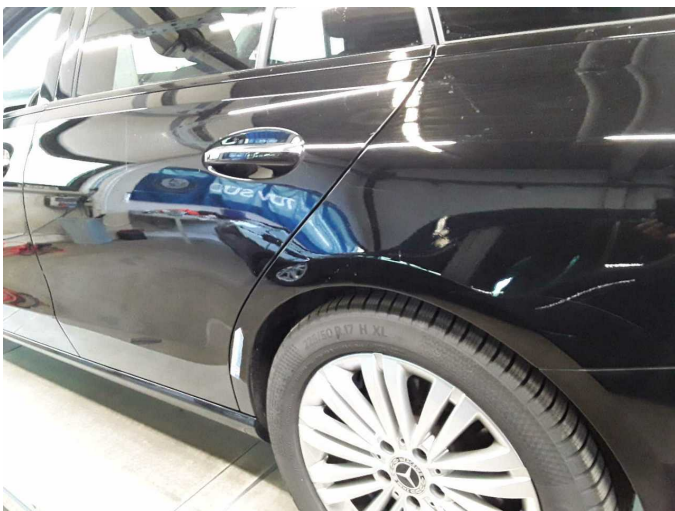
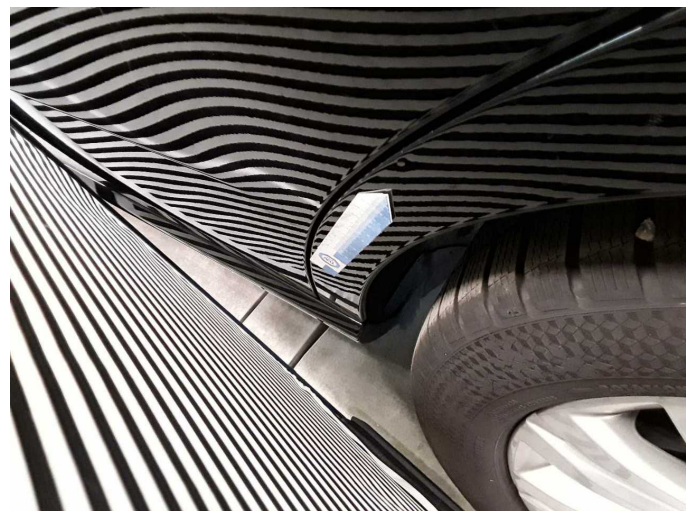
| No. | Component group | Description |
|---|---|---|
| 3 | Side panel - rear left side | Side panel - dent(s) - No deduction |

**Wear and tear 3:** Side panel - rear left side: Side panel - dent(s) - No deduction

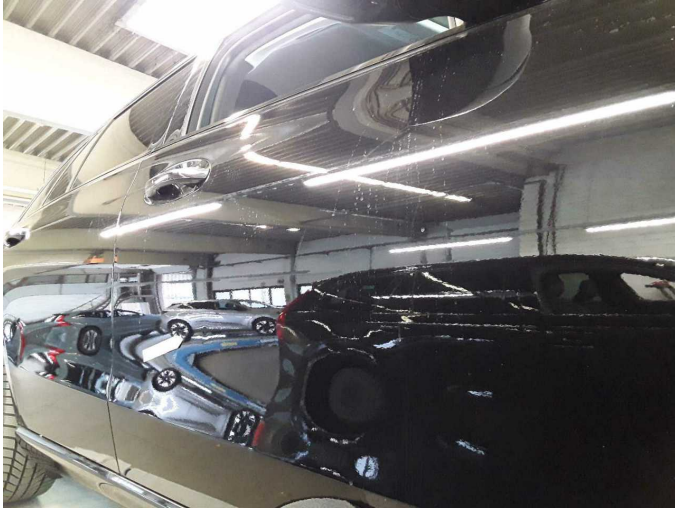
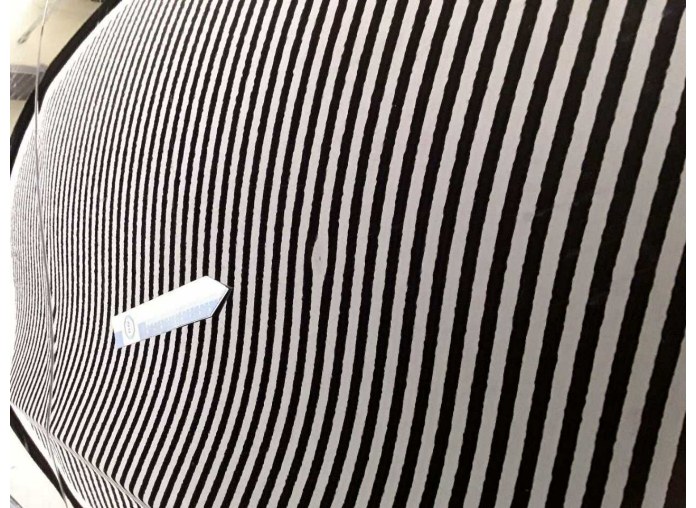
| No. | Component group | Description |
|---|---|---|
| 4 | Door - front right side | Door - Dent / paintcoat damage - No deduction |

**Wear and tear 4:** Door - front right side: Door - Dent / paintcoat damage -  
No deduction
