Expertise

Protocol number: 46413241  
Order No. / Reference: 26584114  
Inspection date: 9 Jul 2026

Model: S-Max 2.0 EcoBlue Aut. TREND

VIN: WF0JXXWPCJLS19463

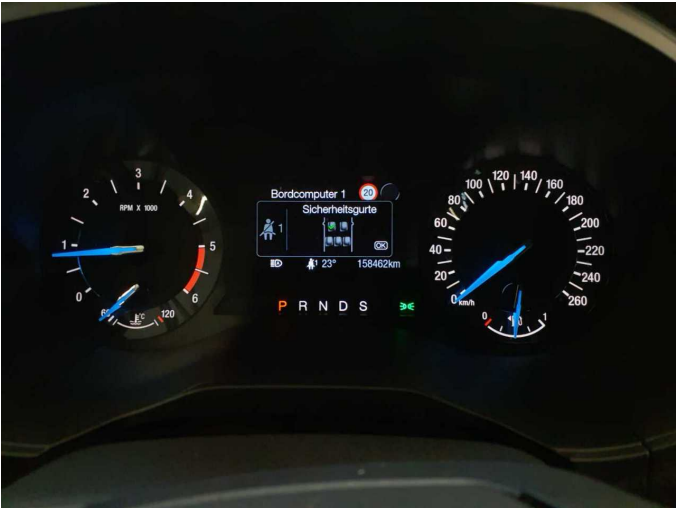
| Vehicle details | |
|---|---|
| Mileage (Read) | 158,462 km |

Figure 7: Instrument cluster

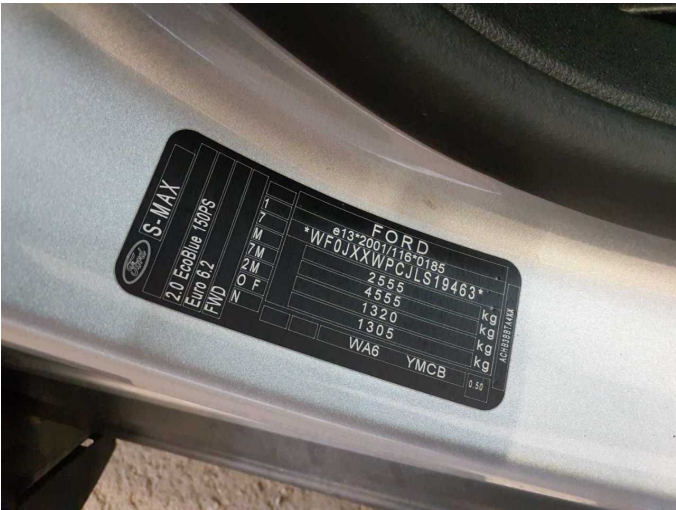
| VIN comparison | The vehicle identification number (VIN) was read from the vehicle and its conformity with the submitted documents was confirmed by the undersigned during the inspection. |

Figure 11: VIN

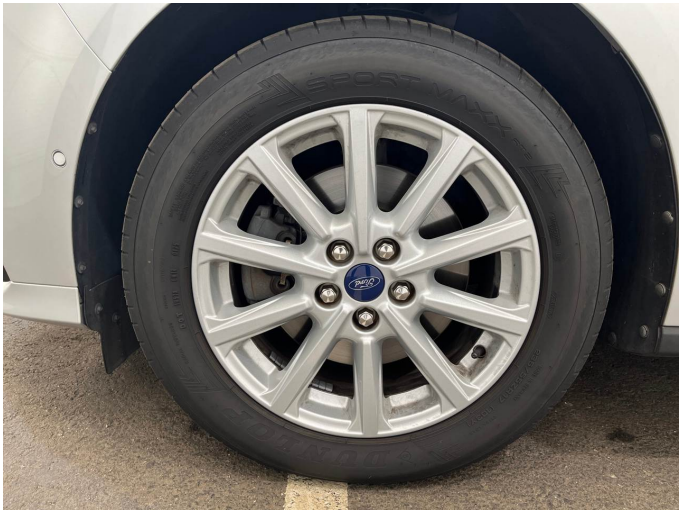
| Tyres | | | | |
|---|---|---|---|---|
| 1) | 235/55 R17 103Y | Summer tyres on Light alloy | Dunlop | 6mm / 6mm |
| 2) | 235/55 R17 103Y | Summer tyres on Light alloy | Dunlop | 6mm / 6mm |

Figure 12: Mounted tyres

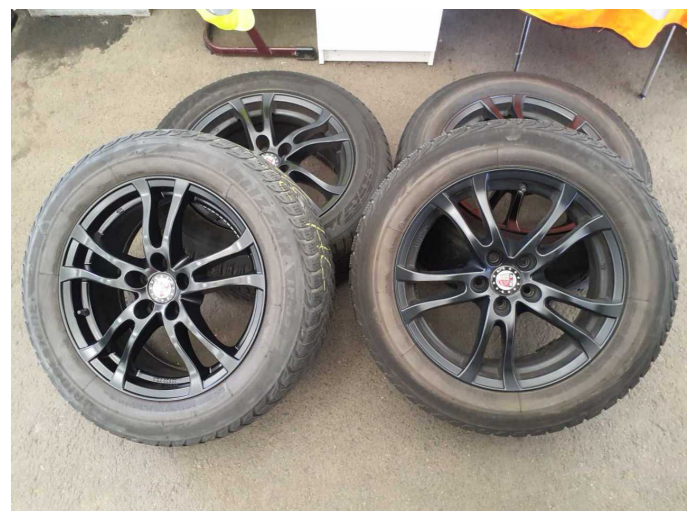
| Tyres | | | | |
|---|---|---|---|---|
| 1) | 235/55 R17 103V | Winter tyres on Light alloy | Bridgestone | 4mm / 4mm |
| 2) | 235/55 R17 103V | Winter tyres on Light alloy | unterschiedliche Hersteller | 7mm / 6mm |

Figure 18: Additional tyres

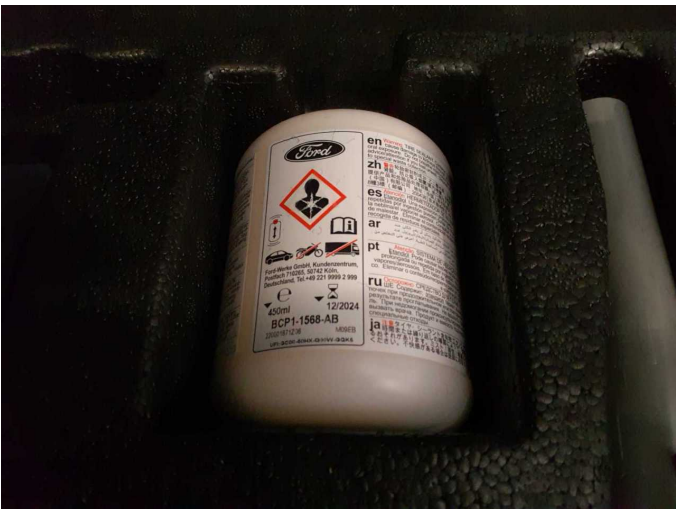
Damage 1: Equipment: Tirefit filler - Expired - Replace

| No. | Component group | Description |
|---|---|---|
| 1 | Equipment | Tirefit filler - Expired - Replace |

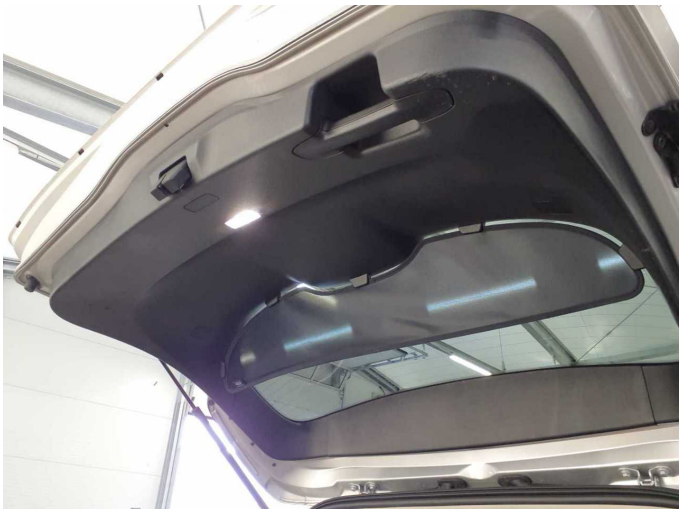
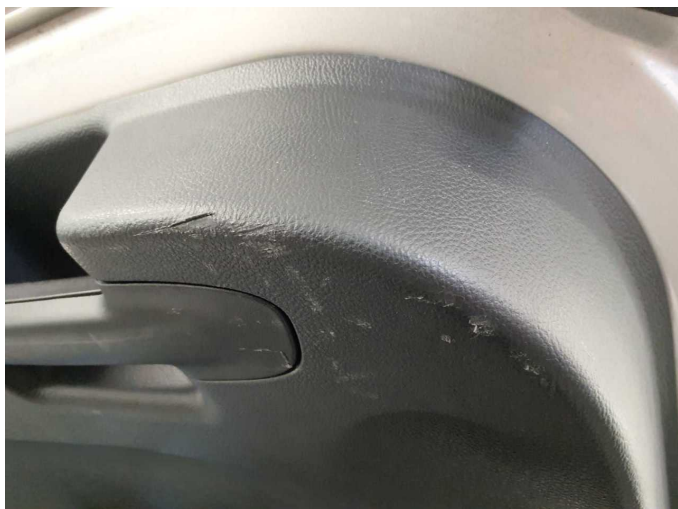
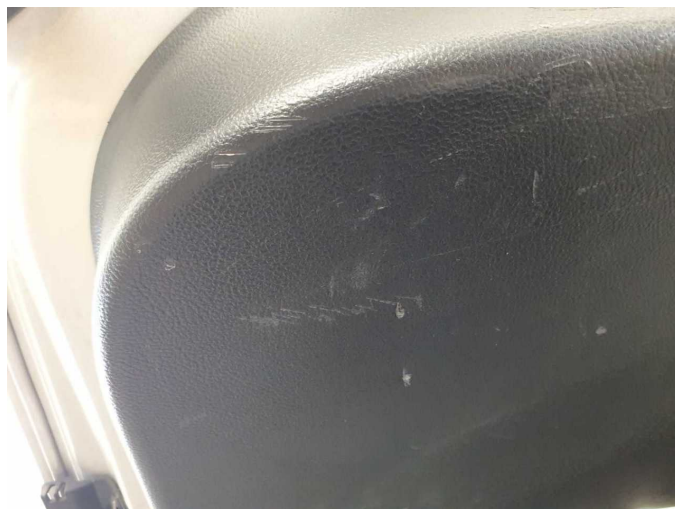
Damage 2: Trim / covers: Boot lid - interior trim - Scratch(es) - Loss in value

**Damage 2:** Trim / covers: Boot lid - interior trim - Scratch(es) - Loss in value

| No. | Component group | Description |
|---|---|---|
| 2 | Trim / covers | Boot lid - interior trim - Scratch(es) - Loss in value |

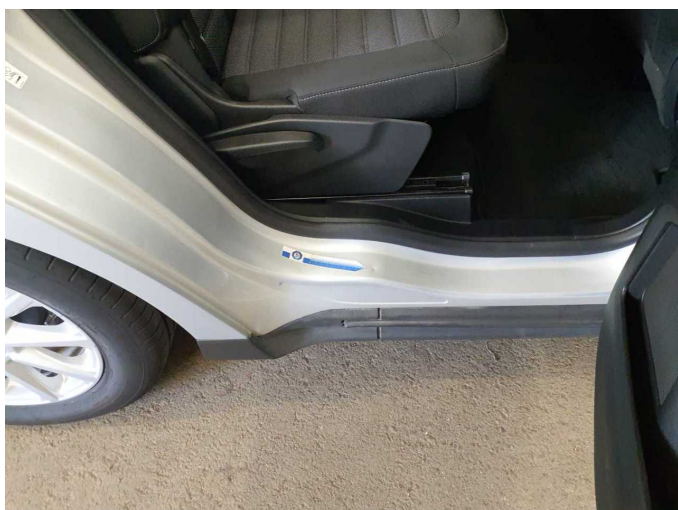
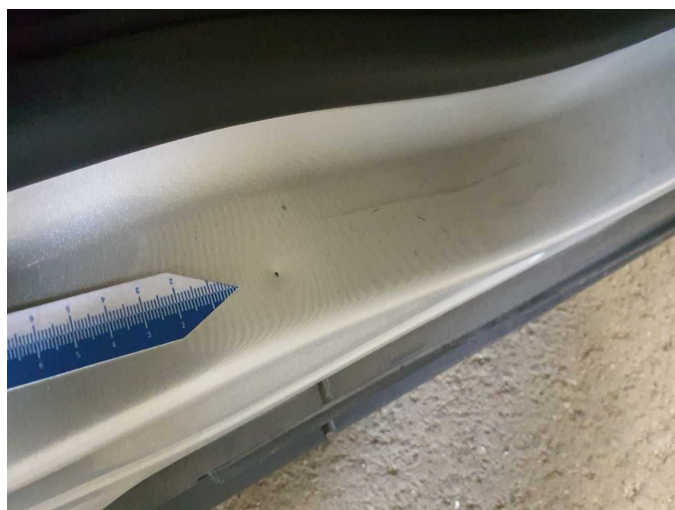
**Damage 3:** Side panel - rear right side: Sill - Dent / paintcoat damage - Smart repair

| No. | Component group | Description |
|---|---|---|
| 3 | Side panel - rear right side | Sill - Dent / paintcoat damage - Smart repair |

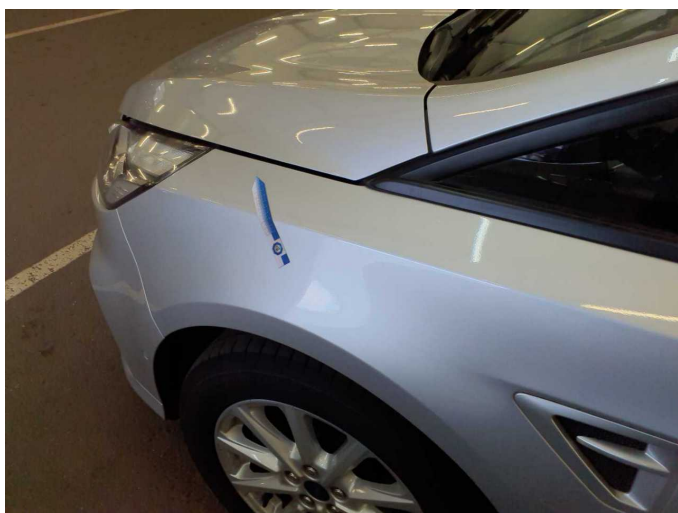
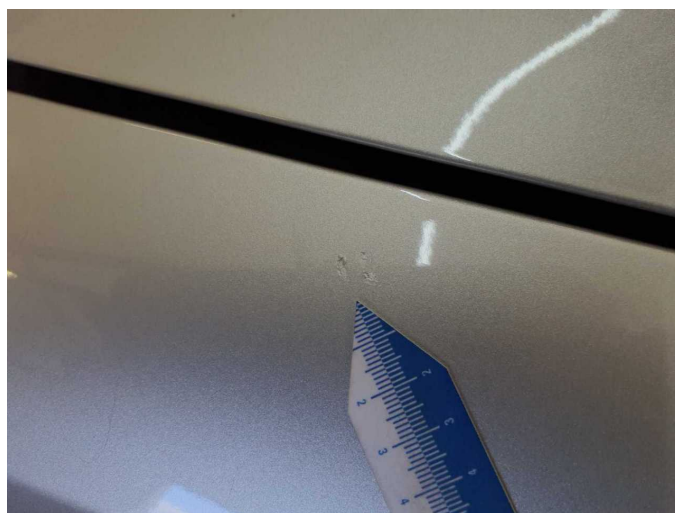
**Damage 4:** Mudguard - left side: Mudguard - left side - Stone chips - Smart repair

| No. | Component group | Description |
|---|---|---|
| 4 | Mudguard - left side | Mudguard - left side - Stone chips - Smart repair |

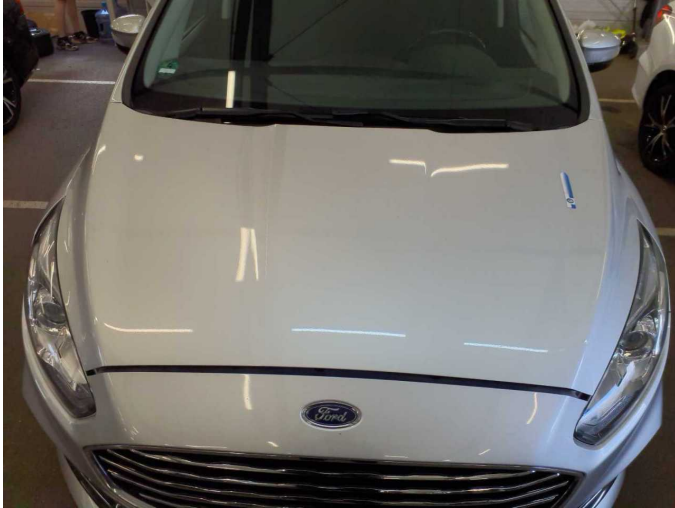
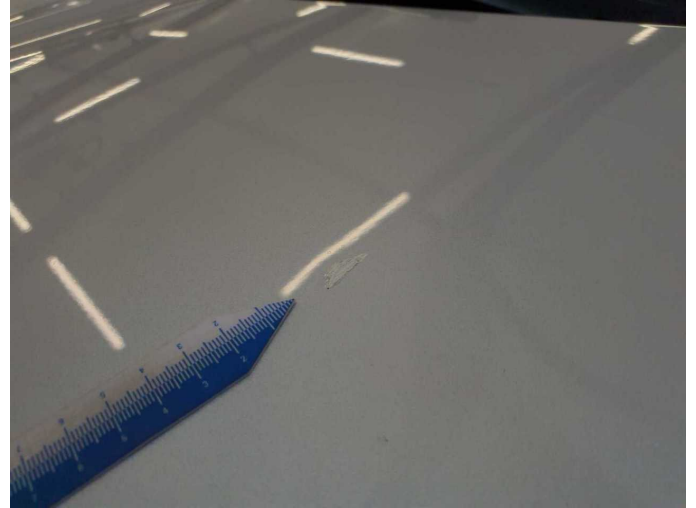
**Damage 5:** Bonnet: Bonnet - Stone chips - Smart repair

| No. | Component group | Description |
|---|---|---|
| 5 | Bonnet | Bonnet - Stone chips - Smart repair |
