Expertise

Manufacturer: Volkswagen

Model: Passat Variant 2.0 TDI SCR DSG Business

VIN: WVGZZZ3CZPE069504

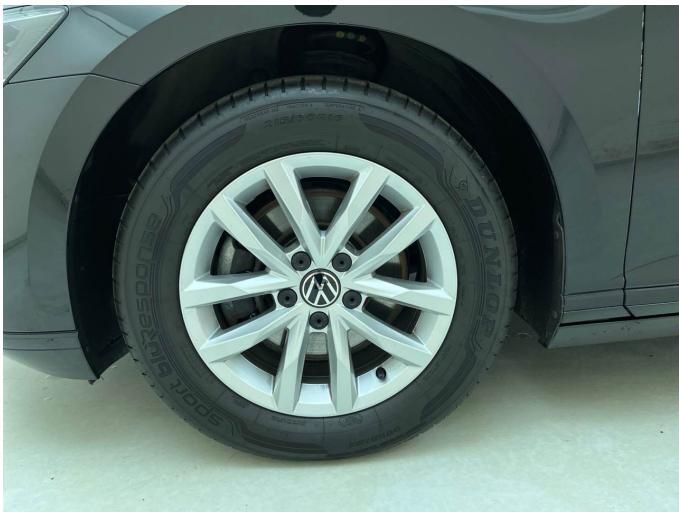
Figure 12: Mounted tyres

| # | Tyre size | Type of tyre | Manufacturer | Tread depth |
|---|---|---|---|---|
| 1) | 215/60 R16 95V | Summer tyres on Light alloy | Dunlop | 6mm / 6mm |
| 2) | 215/60 R16 95V | Summer tyres on Light alloy | Dunlop | 4mm / 4mm |

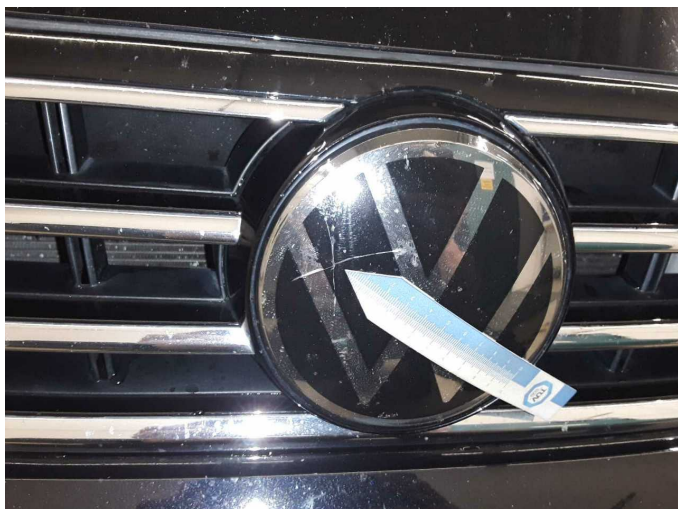
| No. | Component group | Description |
|---|---|---|
| 1 | Front structure | Emblem (Auf dem Kühlergrill) - Broken / torn - Replace |

**Damage 1:** Front structure: Emblem (Auf dem Kühlergrill) - Broken / torn  
- Replace

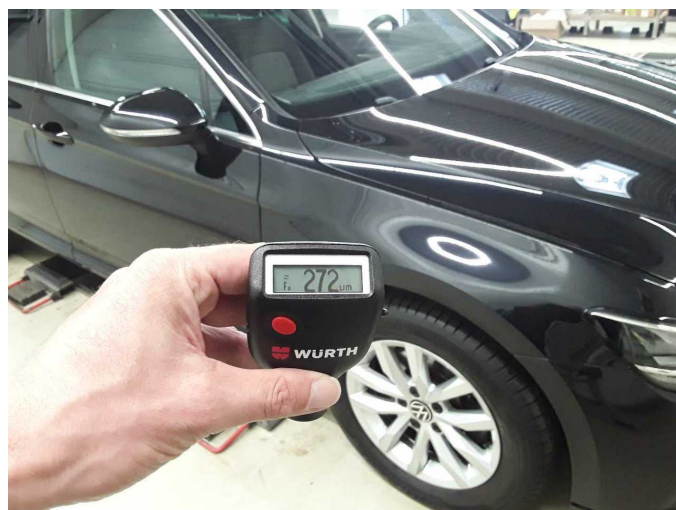
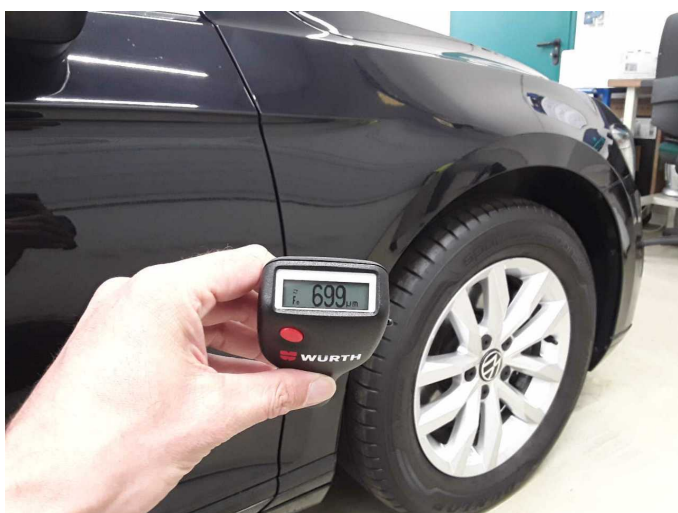
1 Mudguard - right side, Door - front right side, Professionally carried out

| Mudguard - right side | 699 µm | Door - front right side | 274 µm |

**Mudguard - right side:** 699 µm

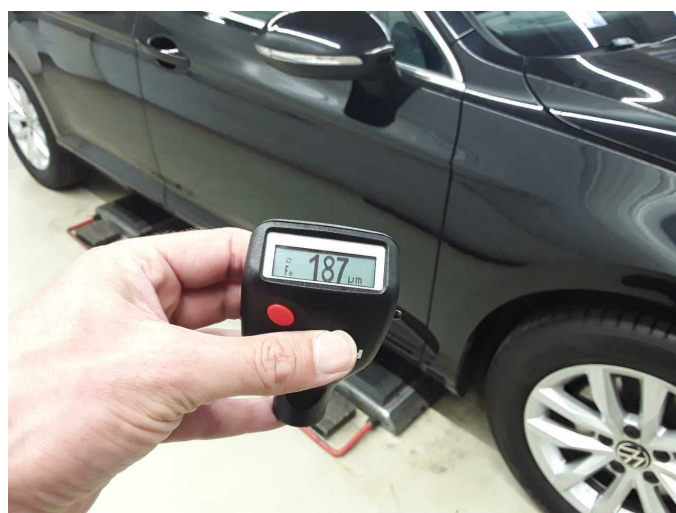
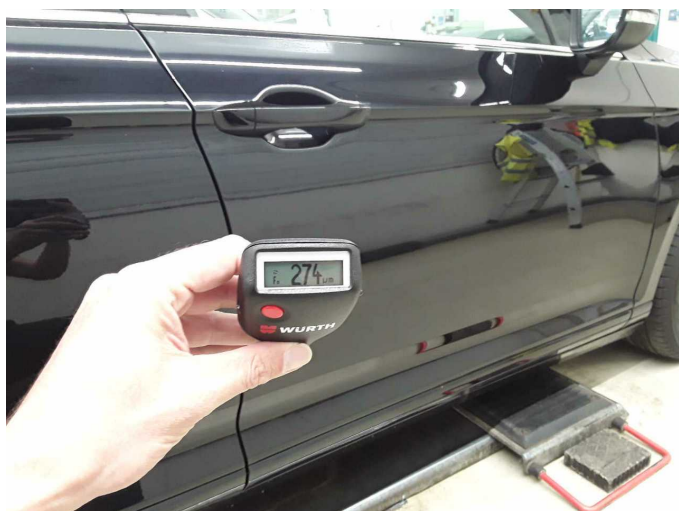
**Door - front right side:** 274 µm

Door - front right side: 274 µm
