Expertise

Protocol number: 46572769  
Order No. / Reference: 26727356  
Inspection date: 16 Jul 2026

Manufacturer: Mercedes-Benz

Model: GLB 200 d 8G-DCT AMG Line

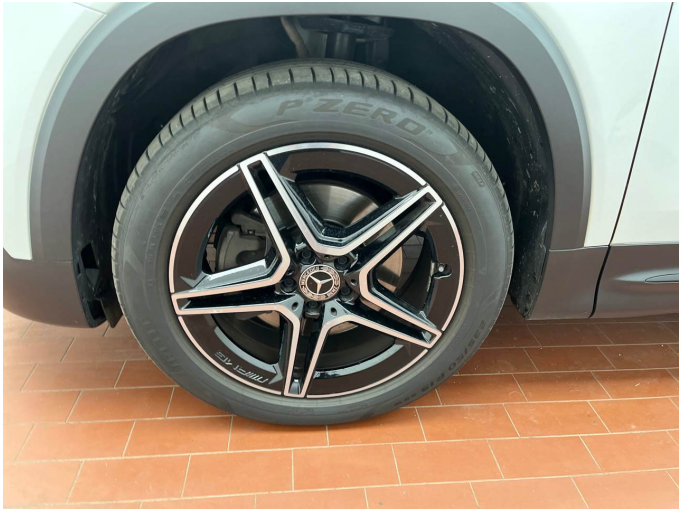
Figure 12: Mounted tyres

| # | Tyre size | Type of tyre | Manufacturer | Tread depth |
|---|---|---|---|---|
| 1) | 235/50 R19 99W | Summer tyres on Light alloy | Pirelli | 6mm / 6mm |
| 2) | 235/50 R19 99W | Summer tyres on Light alloy | Pirelli | 6mm / 6mm |

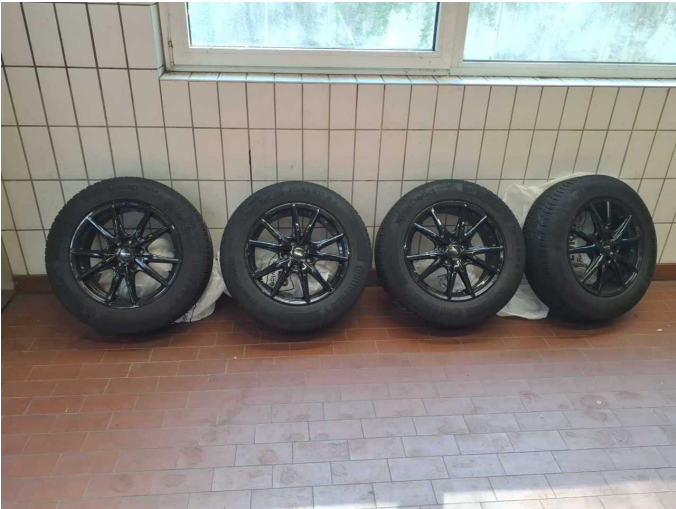
Figure 17: Additional tyres

| # | Tyre size | Type of tyre | Manufacturer | Tread depth |
|---|---|---|---|---|
| 1) | 215/65 R17 99H | Winter tyres on Light alloy | Continental | 5mm / 5mm |
| 2) | 215/65 R17 99H | Winter tyres on Light alloy | Continental | 5mm / 5mm |

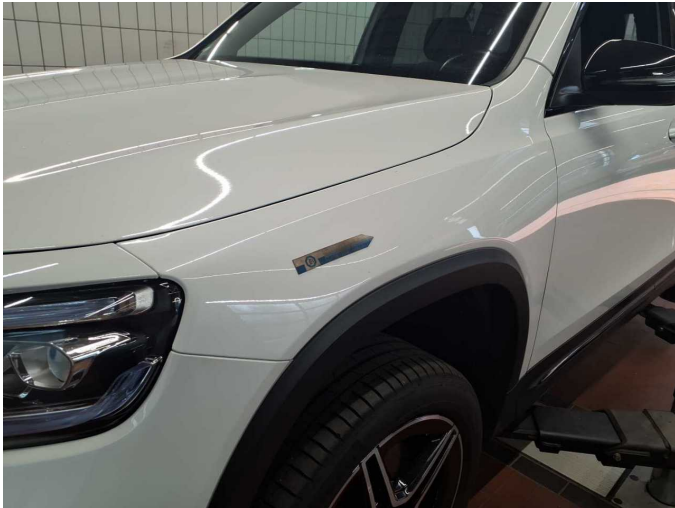
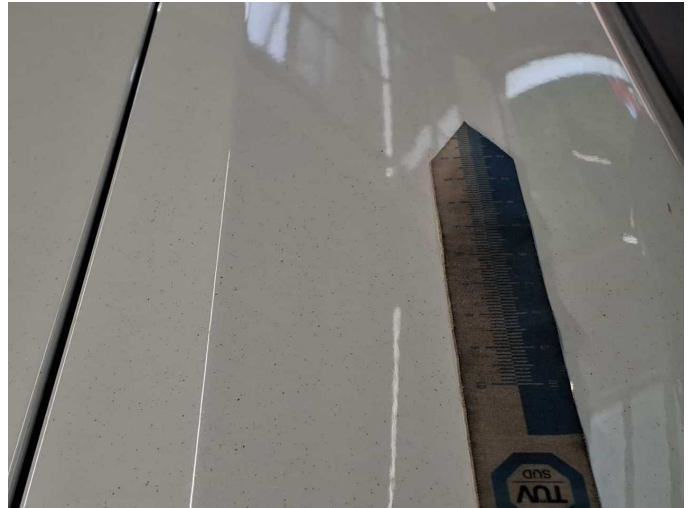
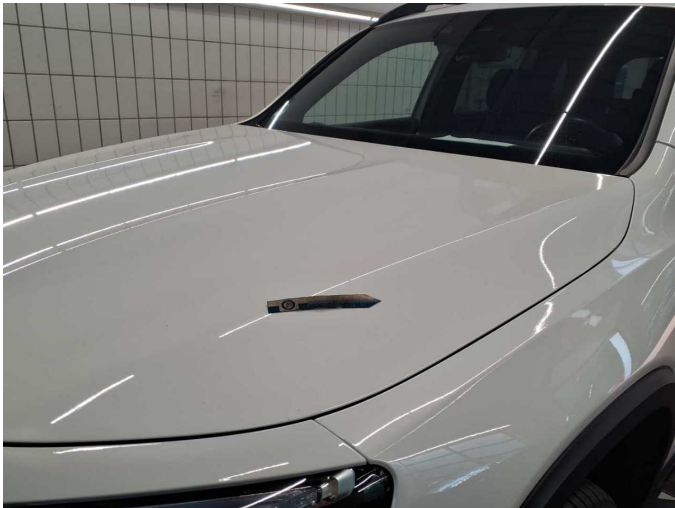
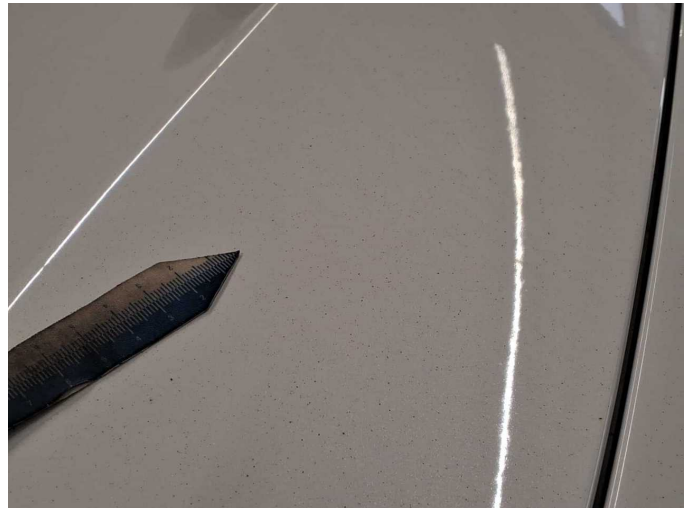
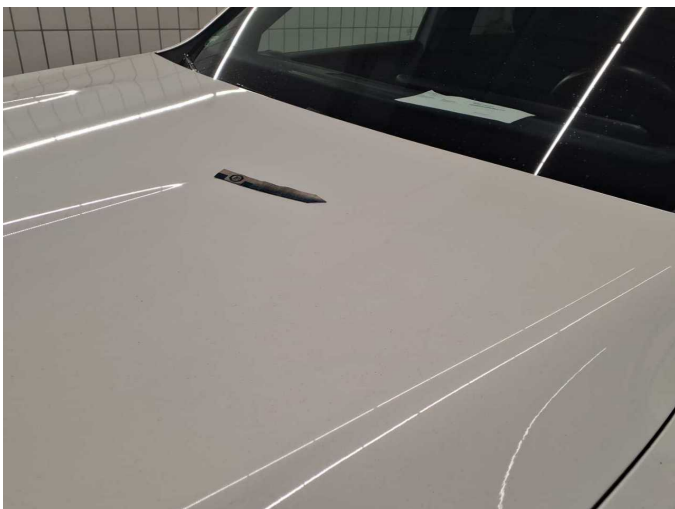
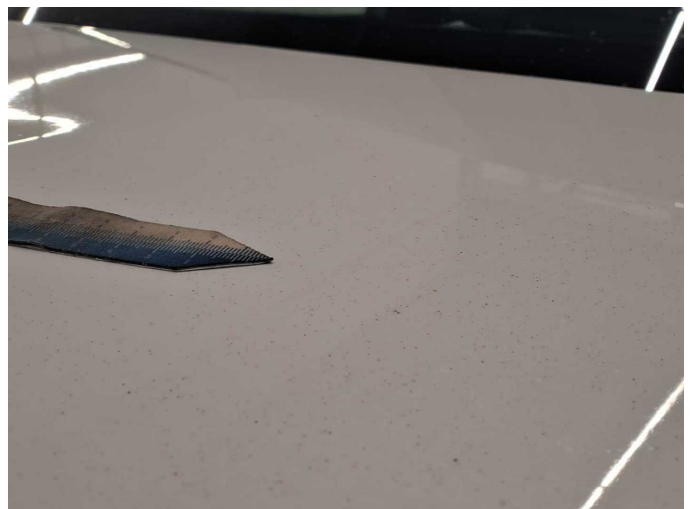
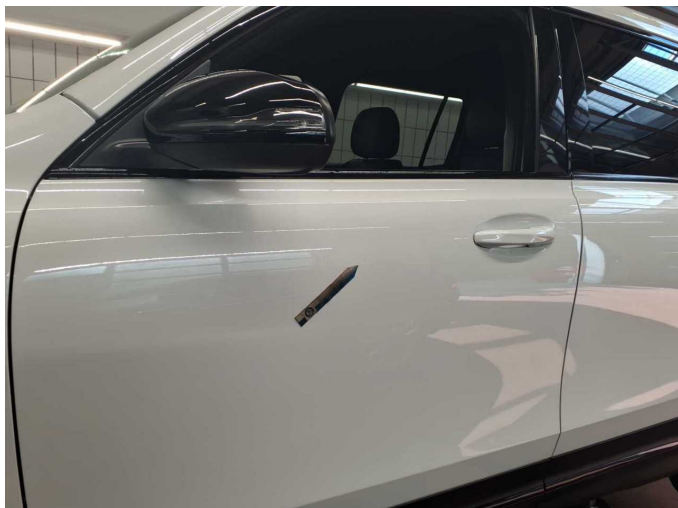
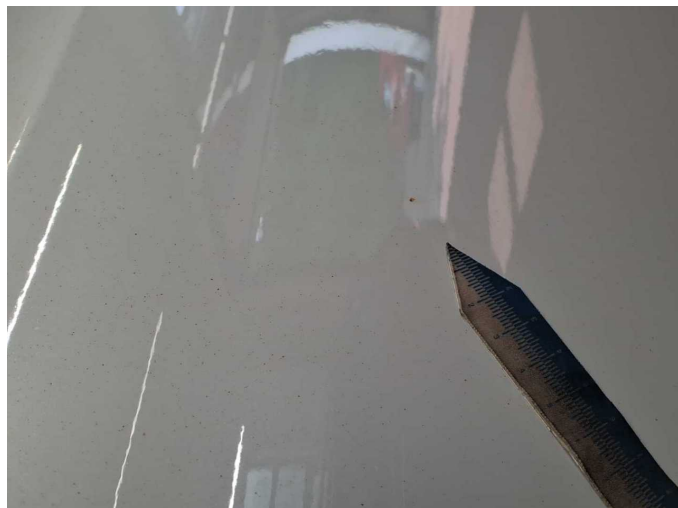
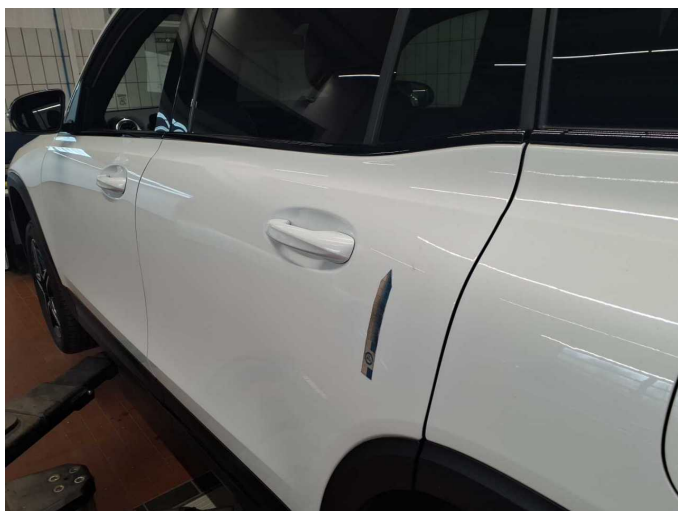
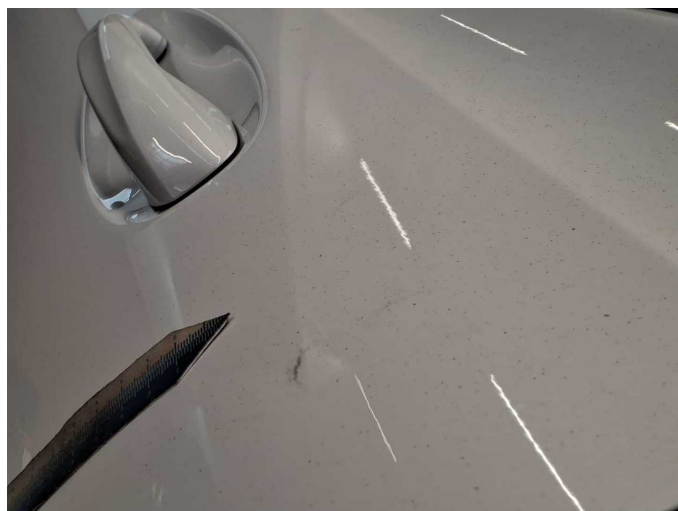
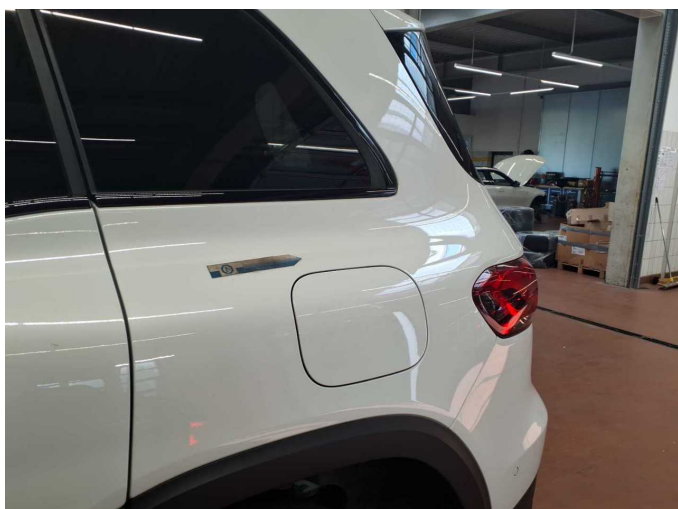
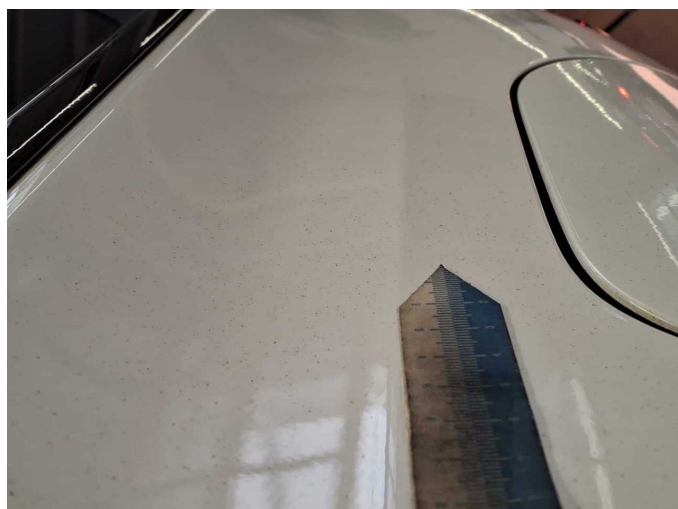
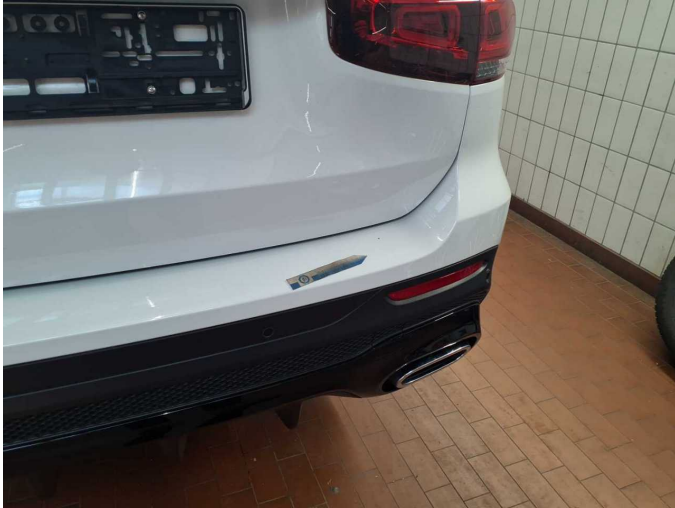
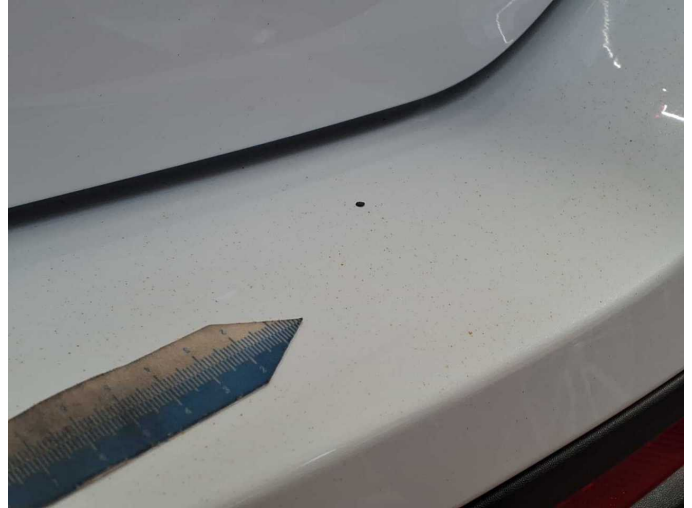
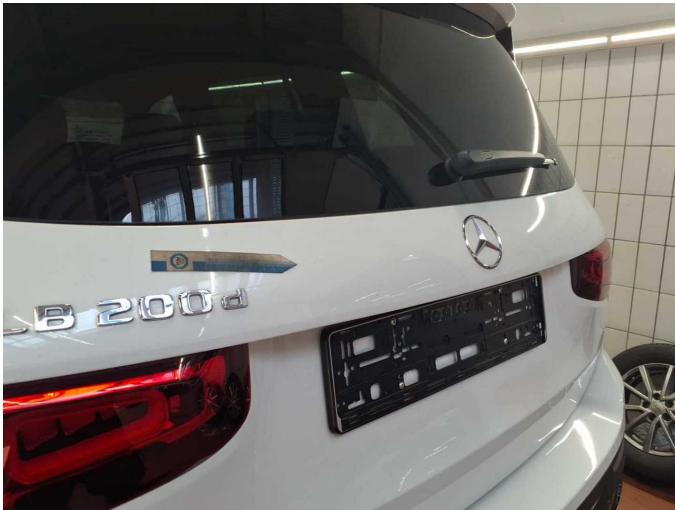
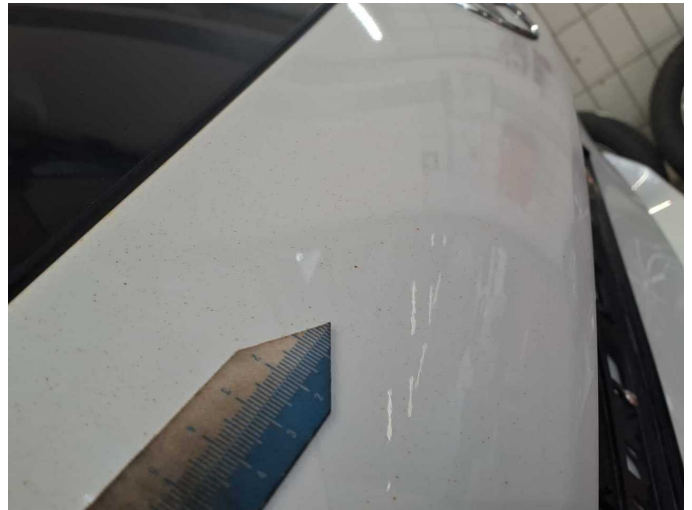
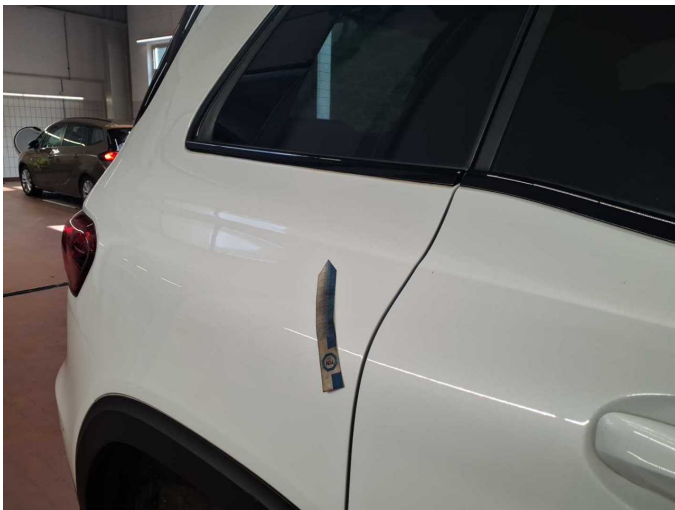
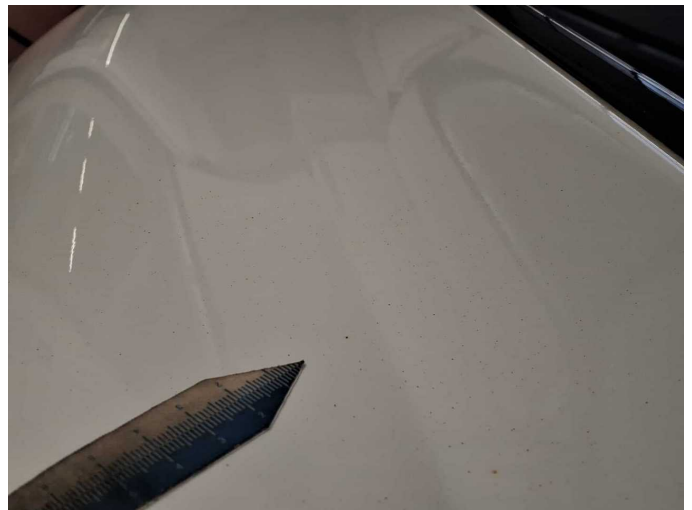
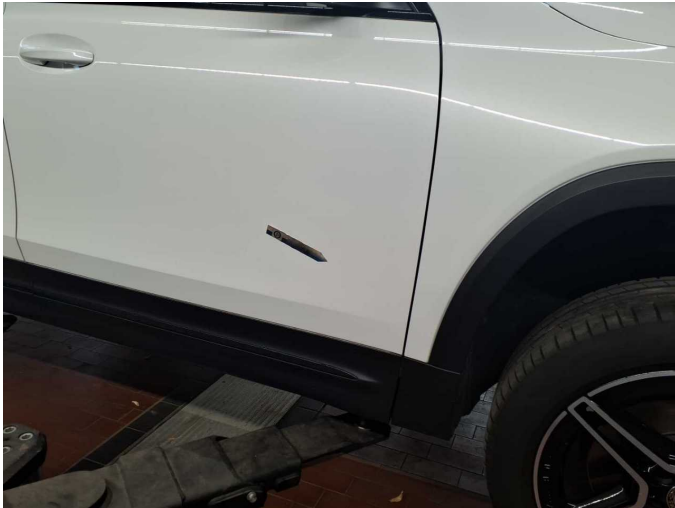
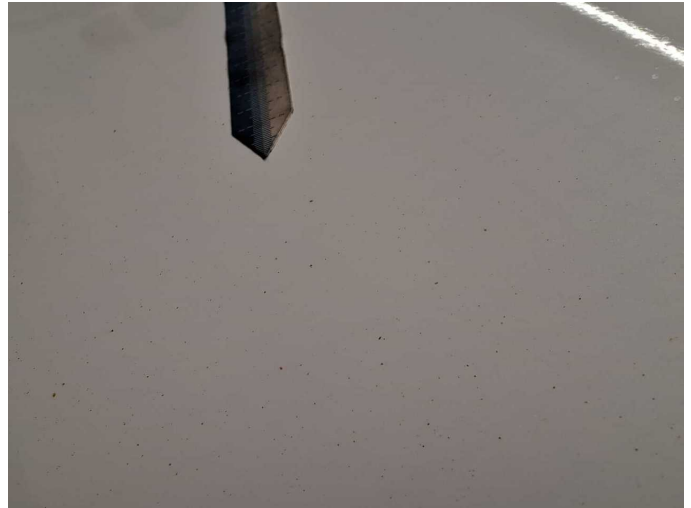
| No. | Component group | Description |
|---|---|---|
| 1 | Body | Body (Flugrost) - Corrosion - Conditioning |

**Damage 1:** Body: Body (Flugrost) - Corrosion - Conditioning

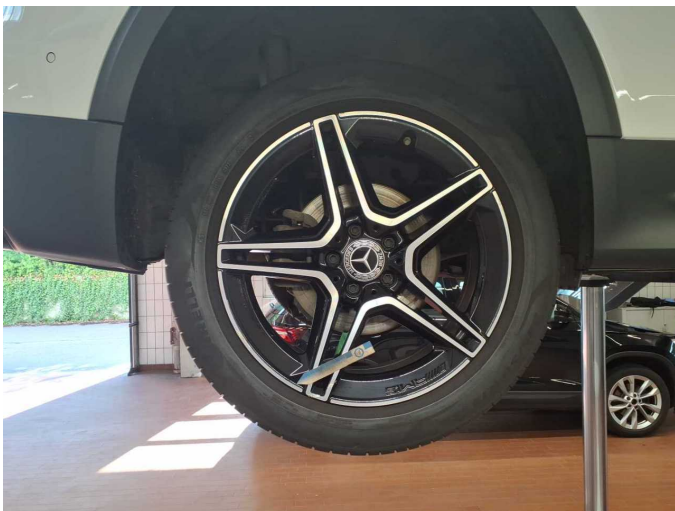
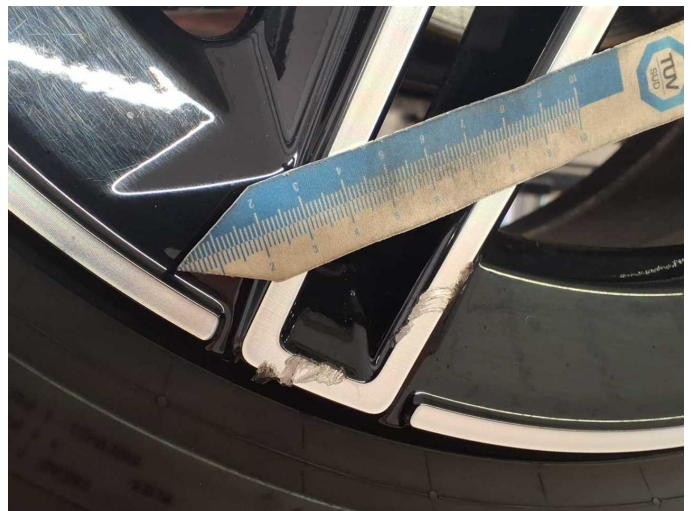
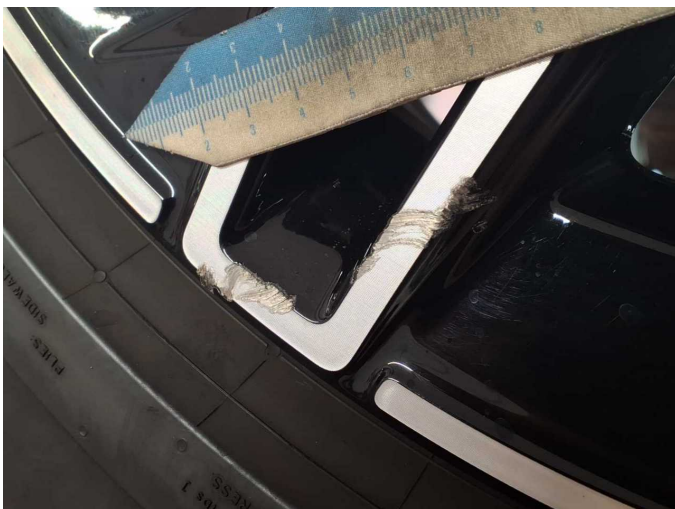
| No. | Component group | Description |
|---|---|---|
| 2 | Wheel / tyres | Alloy rim - rear right side - Scratched - Loss in value |

**Damage 2:** Wheel / tyres: Alloy rim - rear right side - Scratched - Loss in value

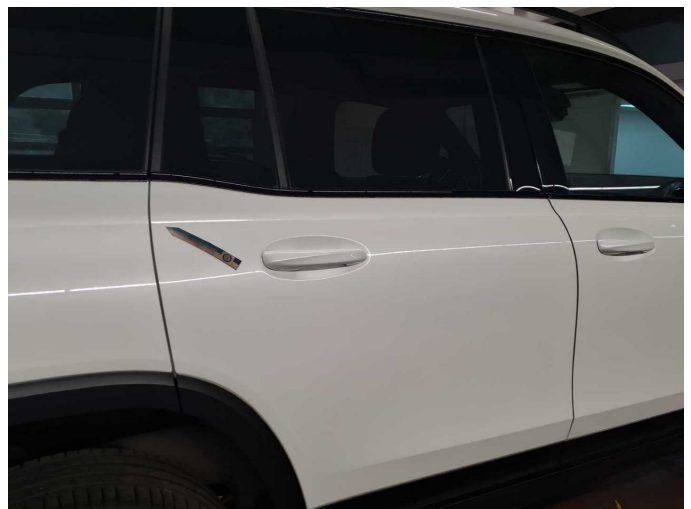
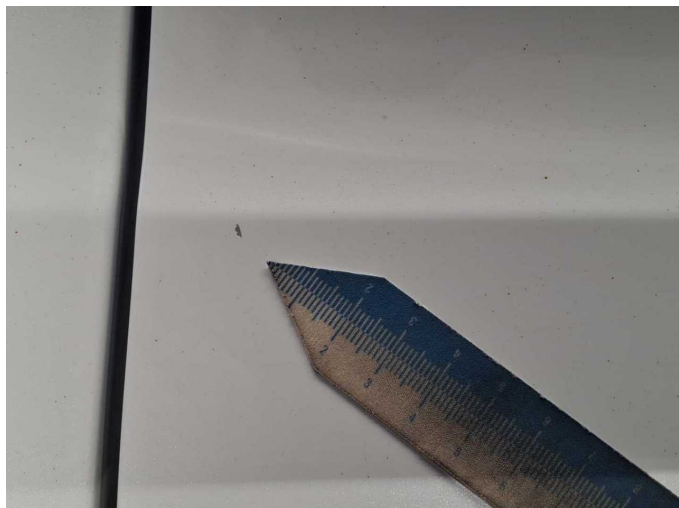
| No. | Component group | Description |
|---|---|---|
| 1 | Door - rear right side | Door - Scratch(es) - No deduction |

**Wear and tear 1:** Door - rear right side: Door - Scratch(es) - No deduction

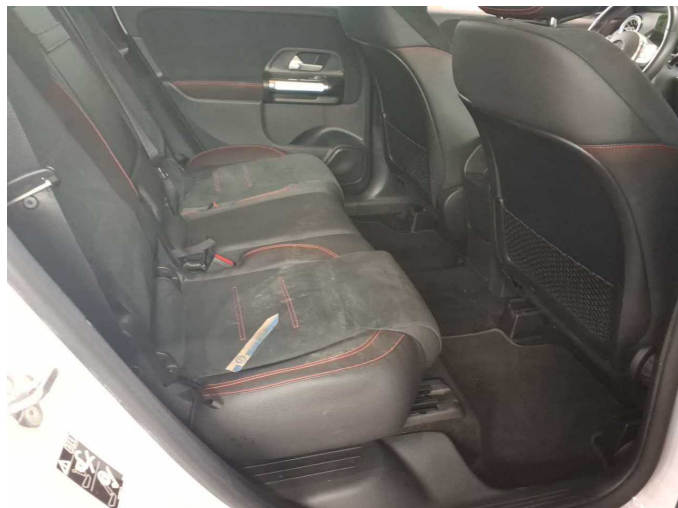
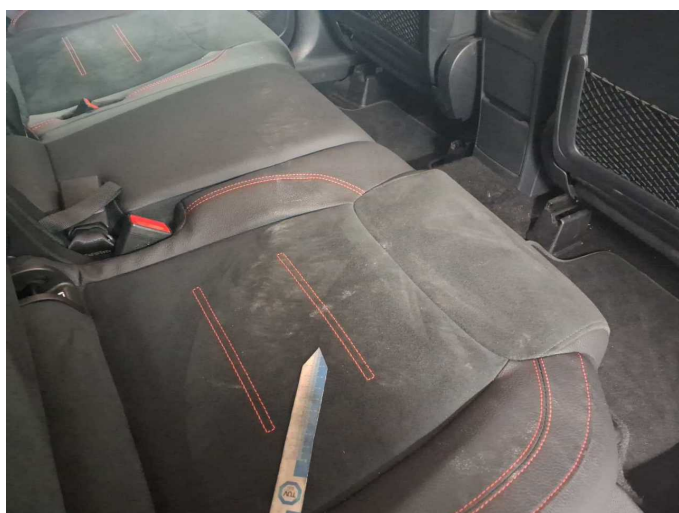
| No. | Component group | Description |
|---|---|---|
| 2 | Seat - rear | Seat cover - 3 seater bench - Soiled - No deduction |

**Wear and tear 2:** Seat - rear: Seat cover - 3 seater bench - Soiled - No deduction

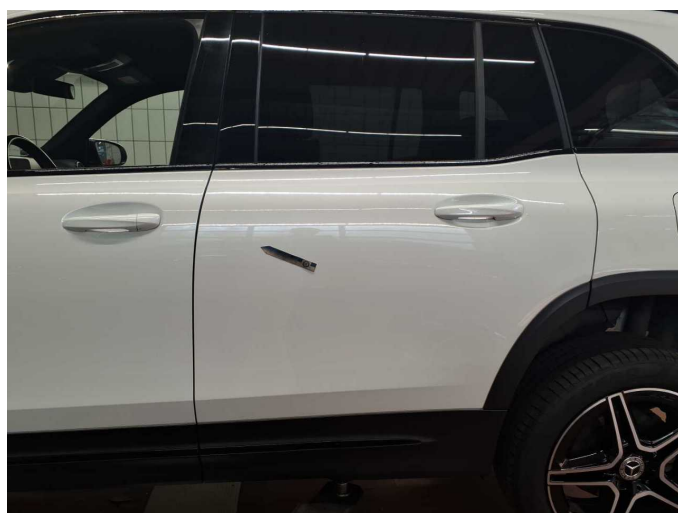
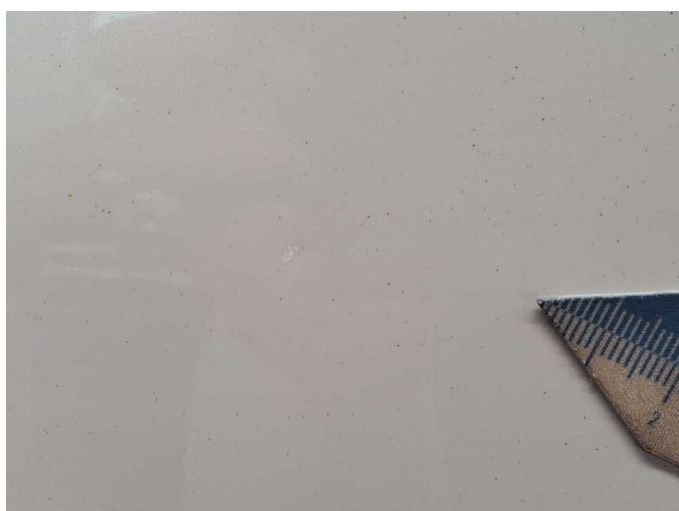
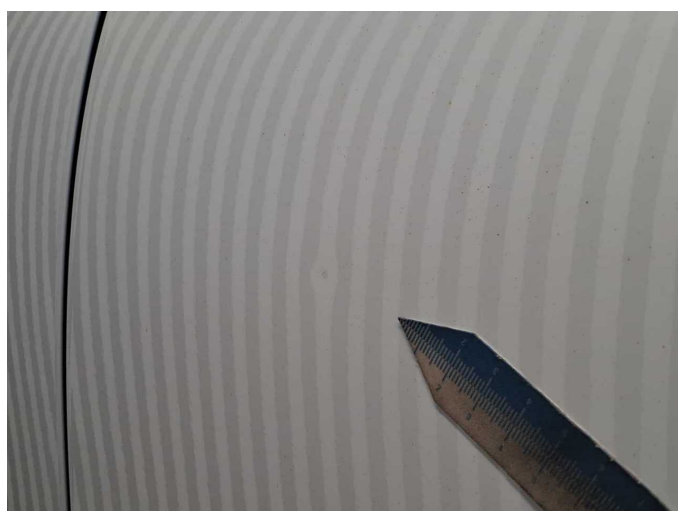
| No. | Component group | Description |
|---|---|---|
| 3 | Door - rear left side | Door - Dent / paintcoat damage - No deduction |

**Wear and tear 3:** Door - rear left side: Door - Dent / paintcoat damage - No deduction

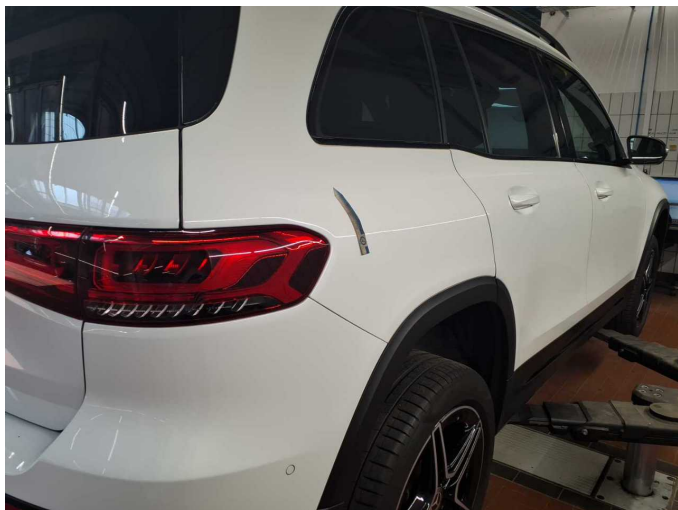
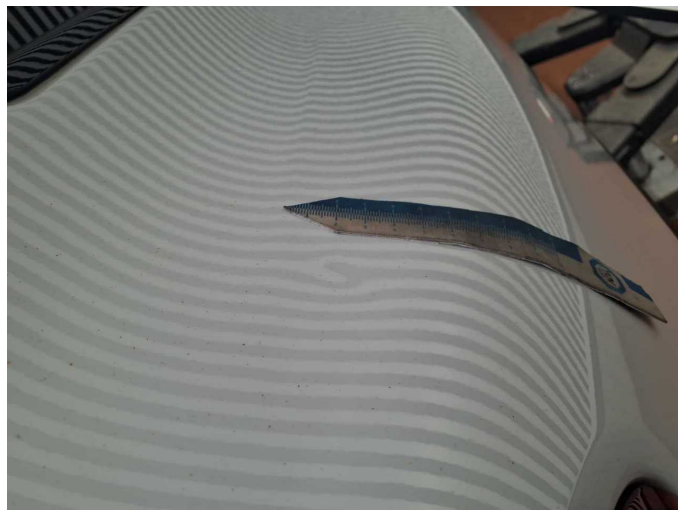
| No. | Component group | Description |
|---|---|---|
| 6 | Side panel - rear right side | Side panel - dent(s) - No deduction |

**Wear and tear 6:** Side panel - rear right side: Side panel - dent(s) - No deduction

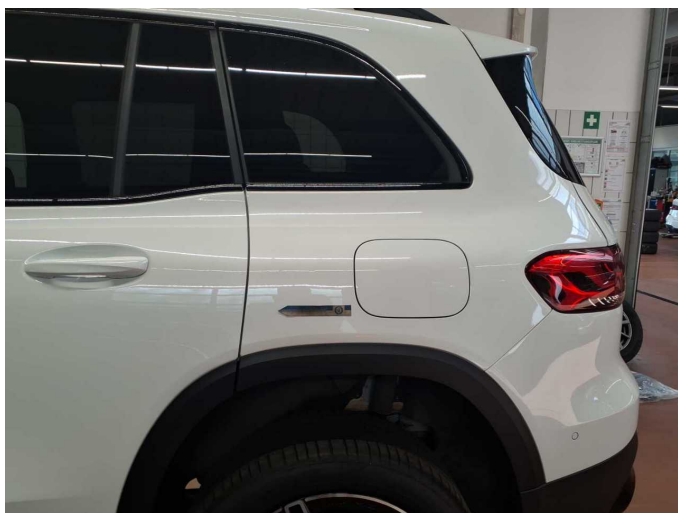
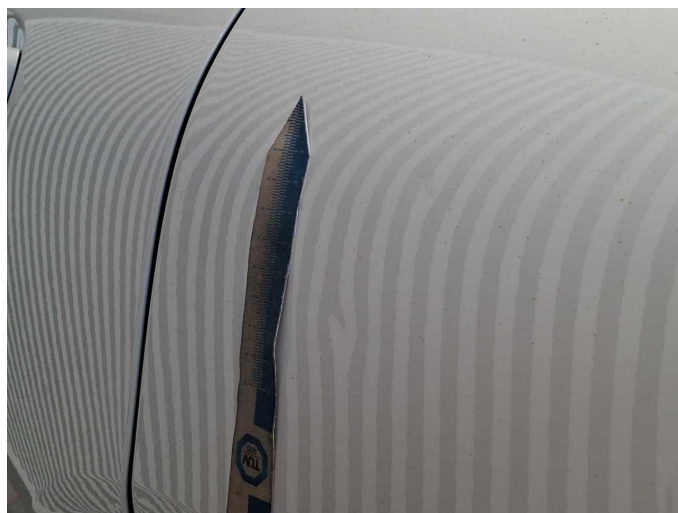
| No. | Component group | Description |
|---|---|---|
| 7 | Side panel - rear left side | Side panel - dent(s) - No deduction |

**Wear and tear 7:** Side panel - rear left side: Side panel - dent(s) - No deduction
