Expertise

Protocol number: 45723553
Order No. / Reference: 26416854
Inspection date: 29 May 2026

Model: GLB 200 d 8G-DCT Style

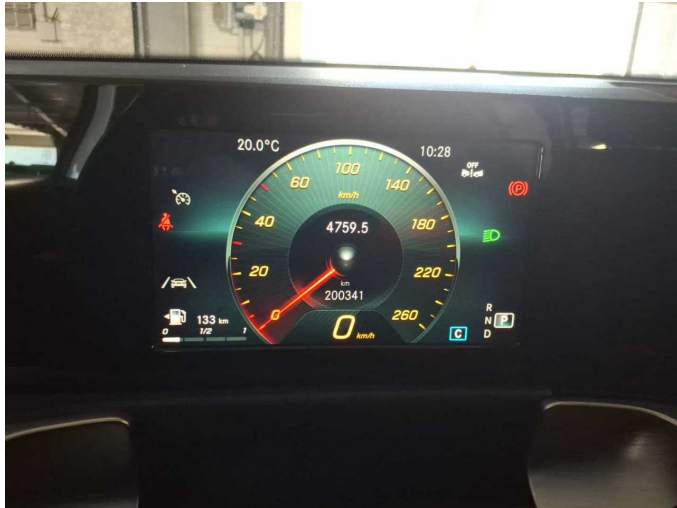
Figure 7: Instrument cluster

Mileage (Read) 200,341 km

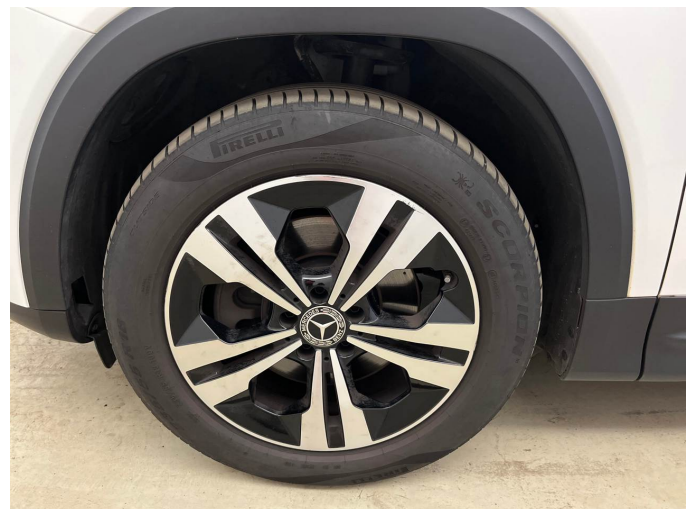
Figure 12: Mounted tyres

Mounted tyres				
#	Tyre size	Type of tyre	Manufacturer	Tread depth
1)	235/55 R18 100W	Summer tyres on Light alloy	Pirelli	5mm / 5mm
2)	235/55 R18 100W	Summer tyres on Light alloy	Pirelli	6mm / 6mm

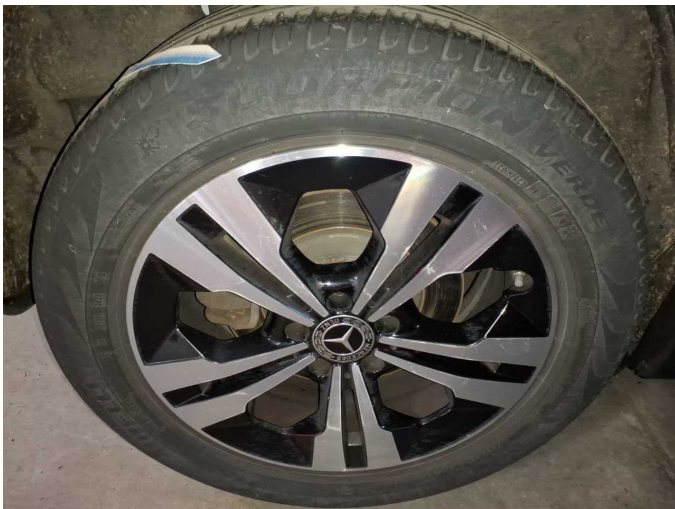
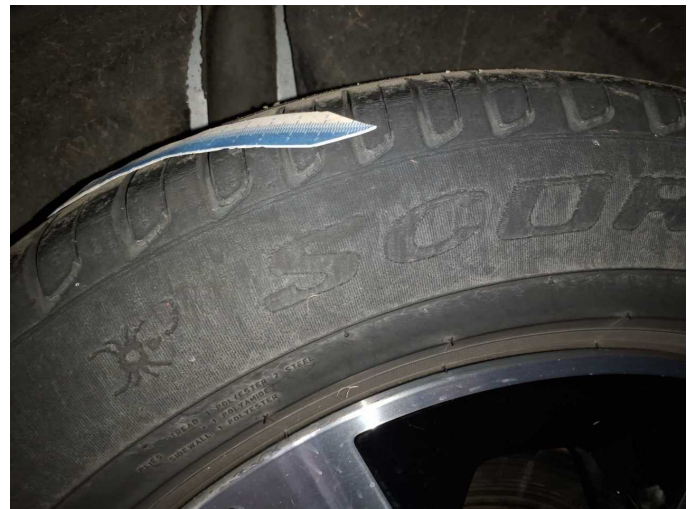
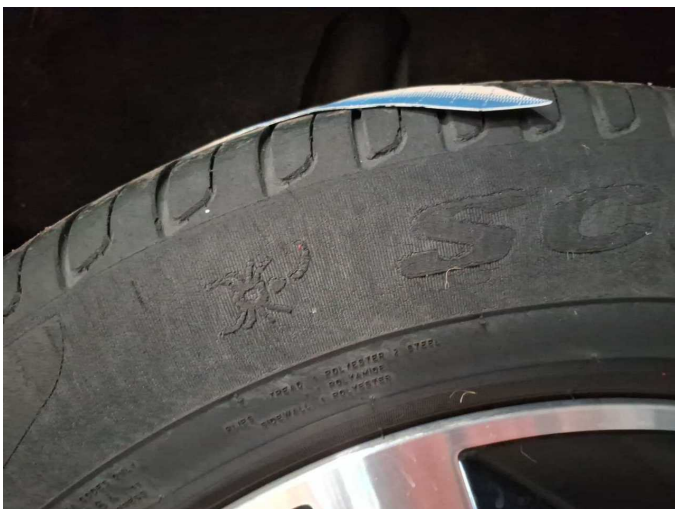
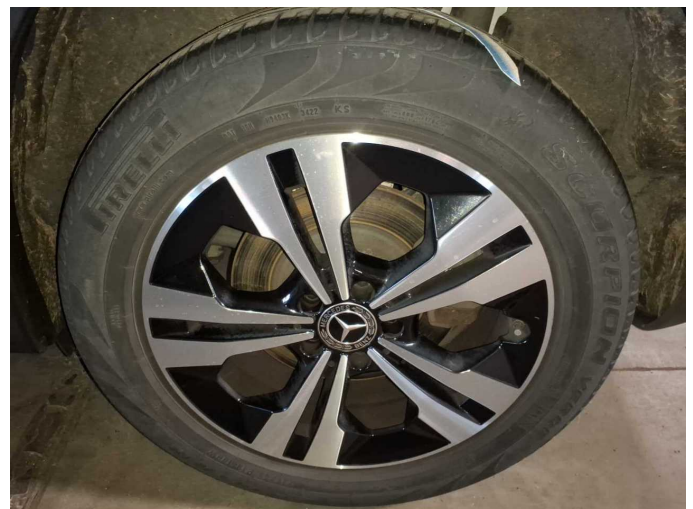
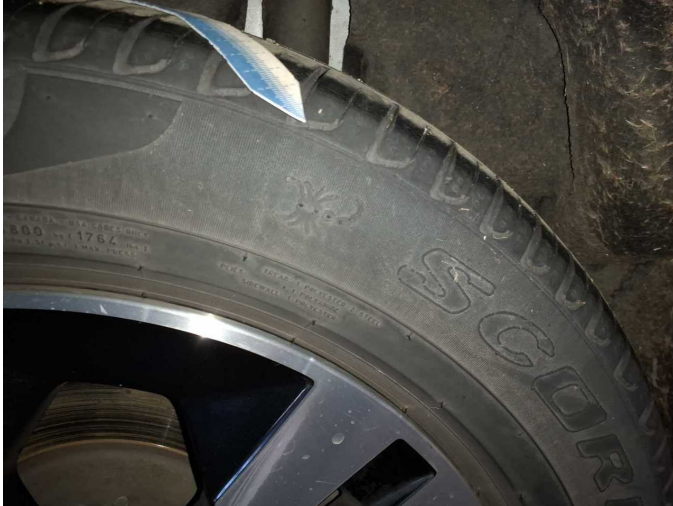
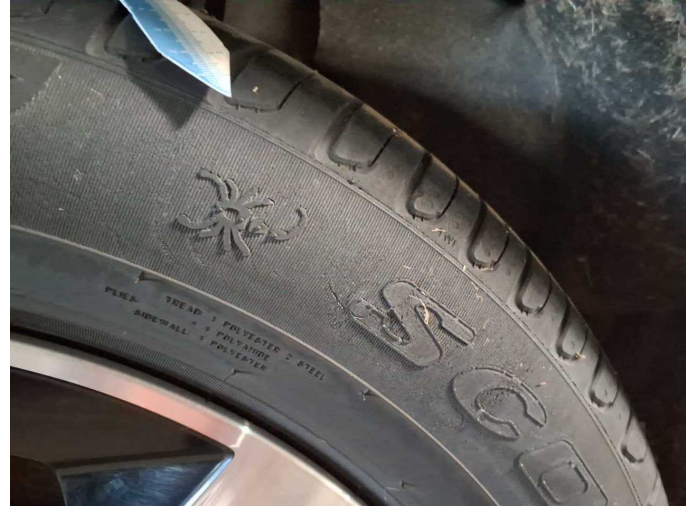
No.	Component group	Description
1	Wheel / tyres	Tyre - right - Broken / torn - Replace
2	Body	Body - Damage by hail - Smooth repair work

Damage 1: Wheel / tyres: Tyre - right - Broken / torn - Replace

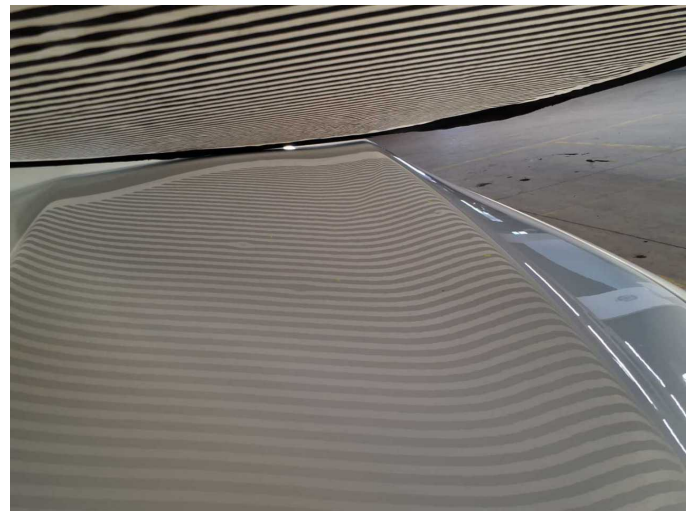
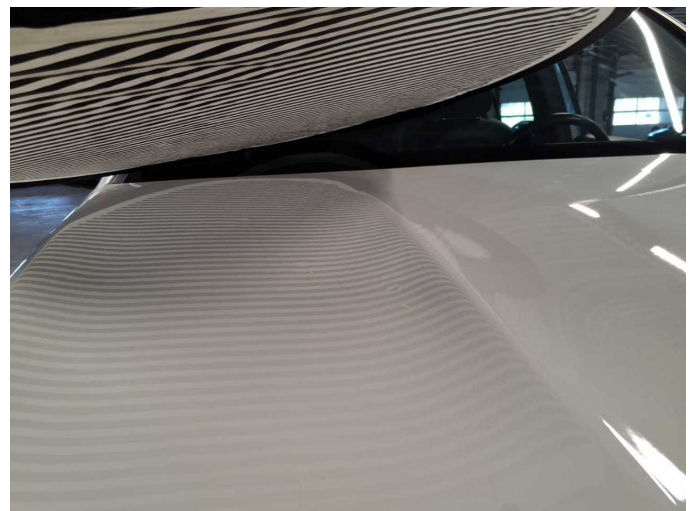
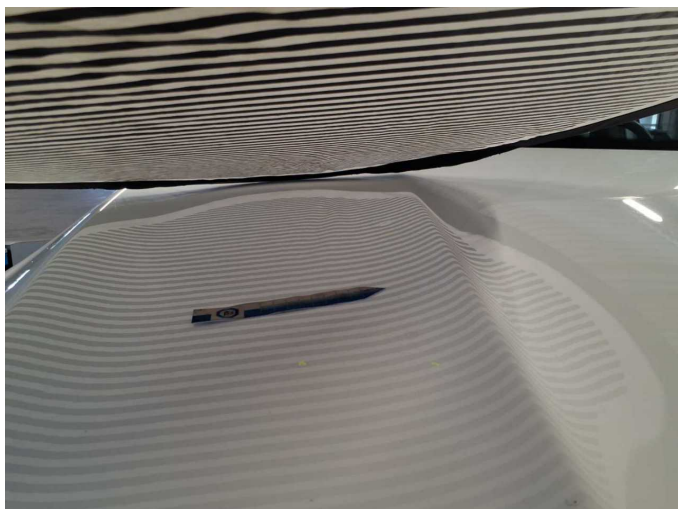
Damage 2: Body: Body - Damage by hail - Smooth repair work
