Expertise

Protocol number: 46898689  
Order No. / Reference: 26746425  
Inspection date: 5 Aug 2026

Manufacturer: Ford

Model: Focus Turnier 1.5 EcoBlue Start-Stopp-System Aut. TITANIUM

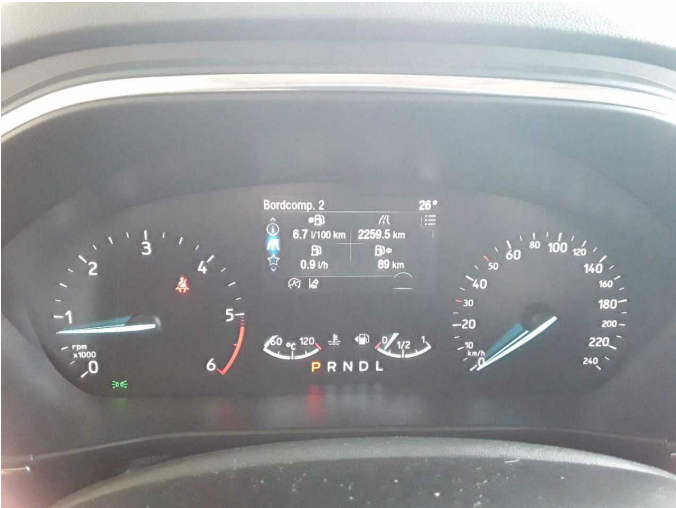
| Vehicle details | |
|---|---|
| Mileage (Read) | 132,756 km |

Figure 7: Instrument cluster

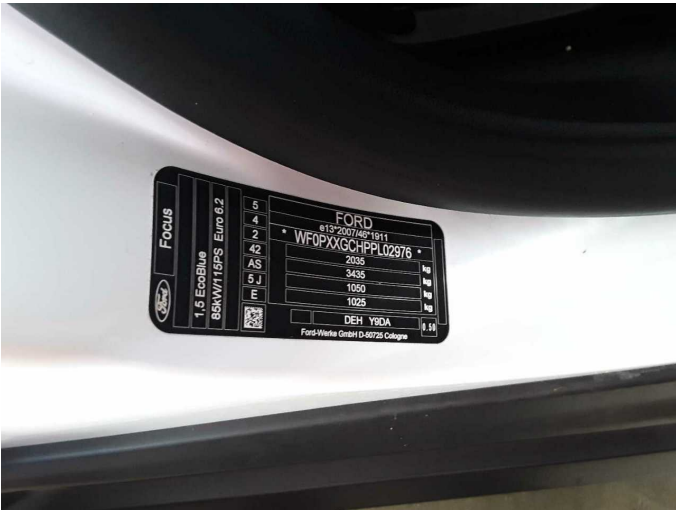
| VIN comparison | The vehicle identification number (VIN) was read from the vehicle and its conformity with the submitted documents was confirmed by the undersigned during the inspection. |

Figure 11: VIN

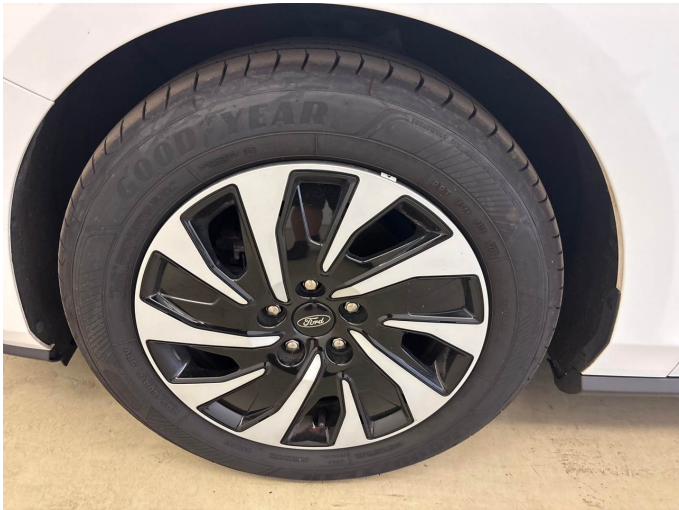
| # | Tyre size | Type of tyre | Manufacturer | Tread depth |
|---|---|---|---|---|
| 1) | 205/60 R16 92V | Summer tyres on Steel rim with wheel cover | Bridgestone | 5mm / 5mm |
| 2) | 205/60 R16 92V | Summer tyres on Steel rim with wheel cover | Bridgestone | 6mm / 6mm |

Figure 12: Mounted tyres

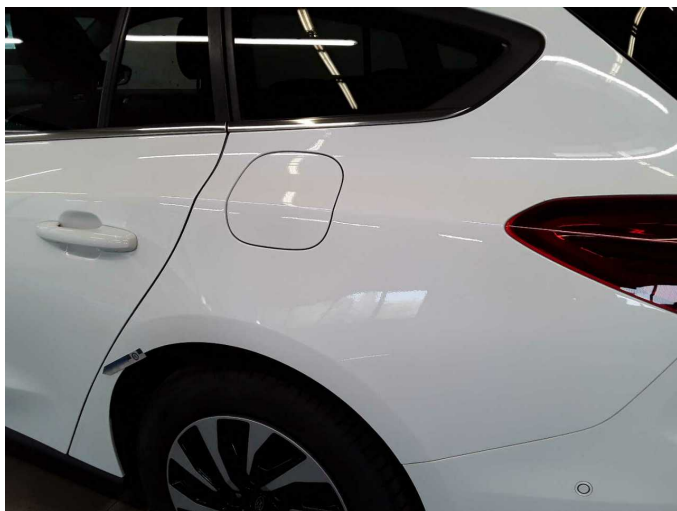
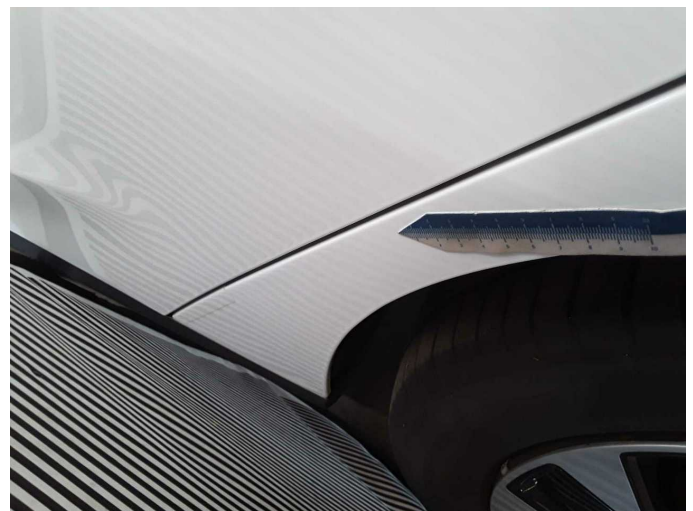
Damage 2: Side panel - rear left side: Side panel - dent(s) - Smooth repair work

| No. | Component group | Description |
|---|---|---|
| 2 | Side panel - rear left side | Side panel - dent(s) - Smooth repair work |

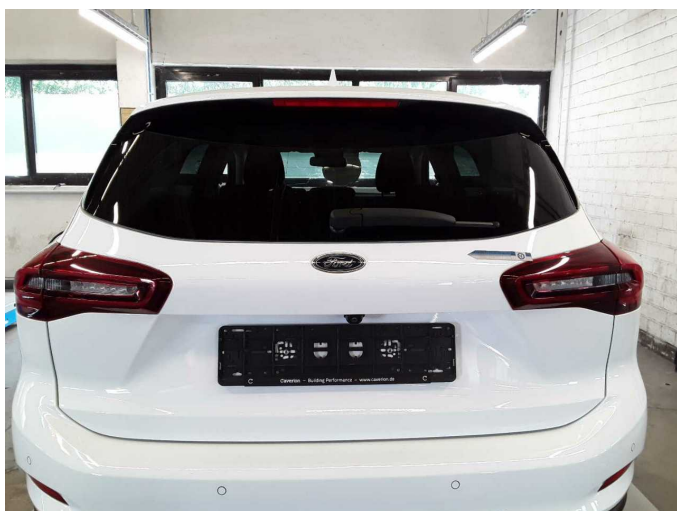
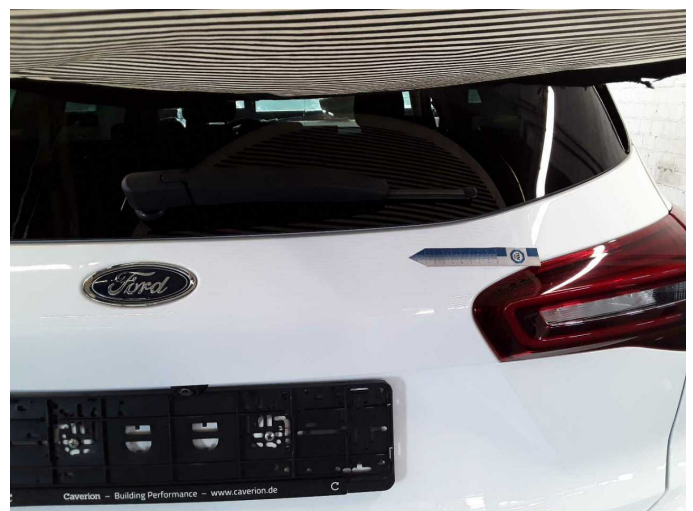
Damage 3: Boot lid / rear door: Boot lid - dent(s) - Smooth repair work

| No. | Component group | Description |
|---|---|---|
| 3 | Boot lid / rear door | Boot lid - dent(s) - Smooth repair work |

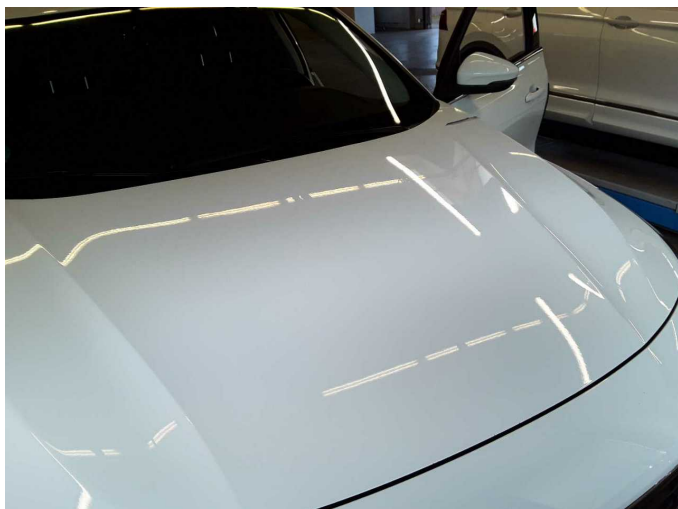
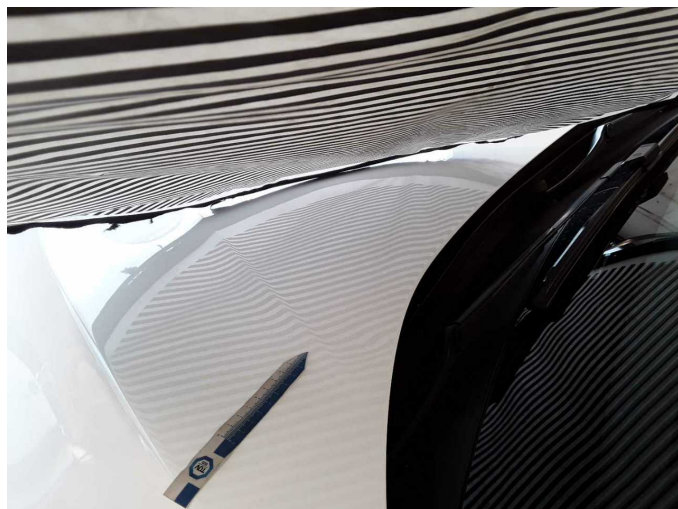
**Damage 4:** Bonnet: Bonnet - dent(s) - Smooth repair work

| No. | Component group | Description |
|---|---|---|
| 4 | Bonnet | Bonnet - dent(s) - Smooth repair work |

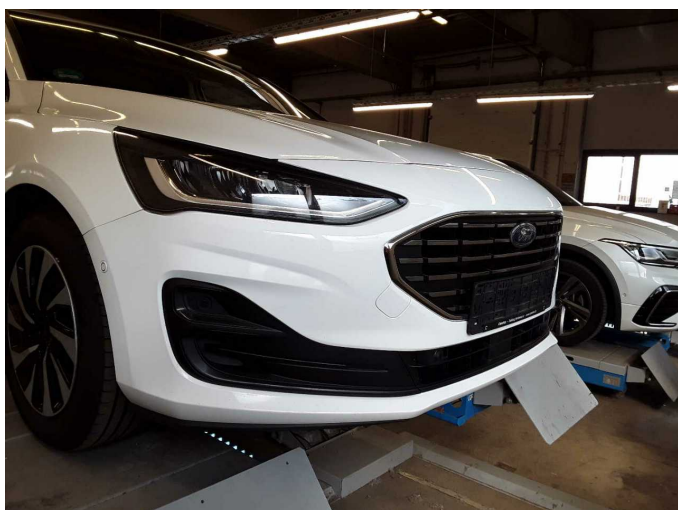
| No. | Component group | Description |
|---|---|---|
| 1 | Front bumper | Front bumper - Stone chips - No deduction |

**Wear and tear 1:** Front bumper: Front bumper - Stone chips - No deduction

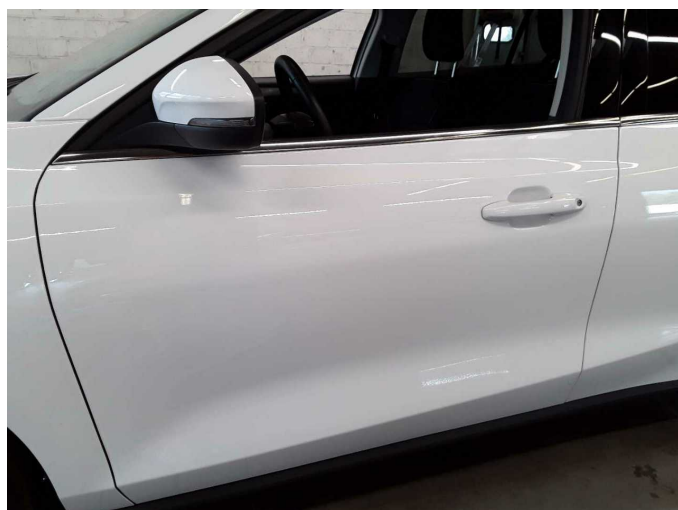
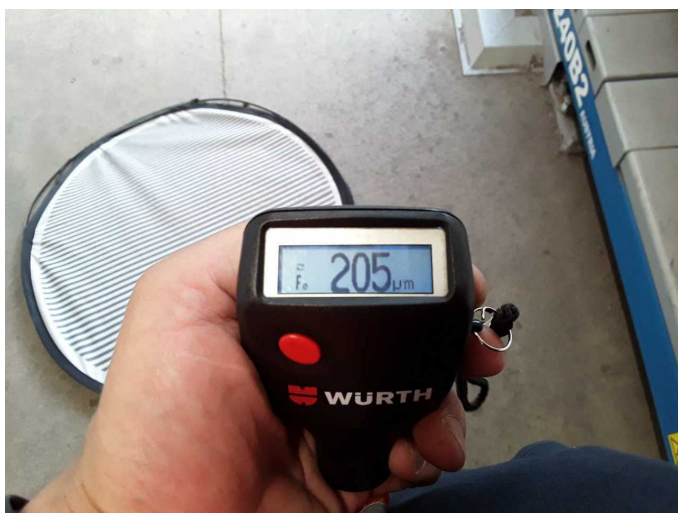
| No. | Repainting |
|---|---|
| 1 | Door - front left side |

| Door - front left side | 206 $\mu\text{m}$ |

**Repainting 1:** Door - front left side
