Expertise

Protocol number: 46197287
Order No. / Reference: 26043031
Inspection date: 22 Jun 2026

Model: Vito 116 CDI 4MATIC Tourer Lang Aut. PRO

VIN: W1VVLFTZ8T4566956

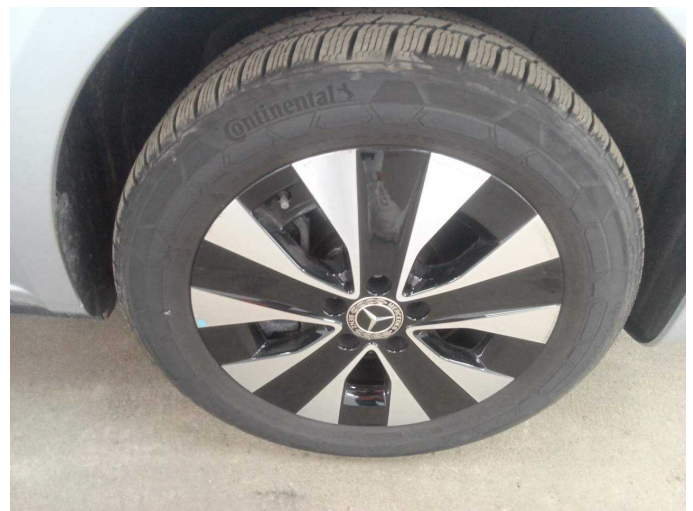
Figure 12: Mounted tyres

#	Tyre size	Type of tyre	Manufacturer	Tread depth
1)	225/55 R17 109T	Winter tyres on Light alloy	Continental	7mm / 7mm
2)	225/55 R17 109T	Winter tyres on Light alloy	Continental	8mm / 8mm

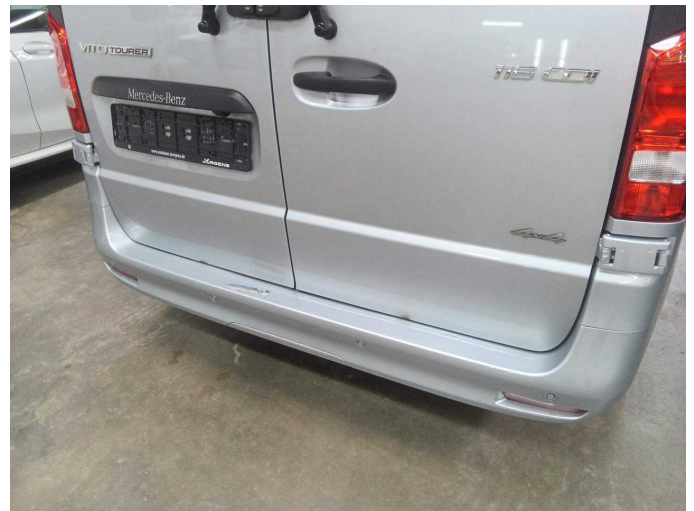
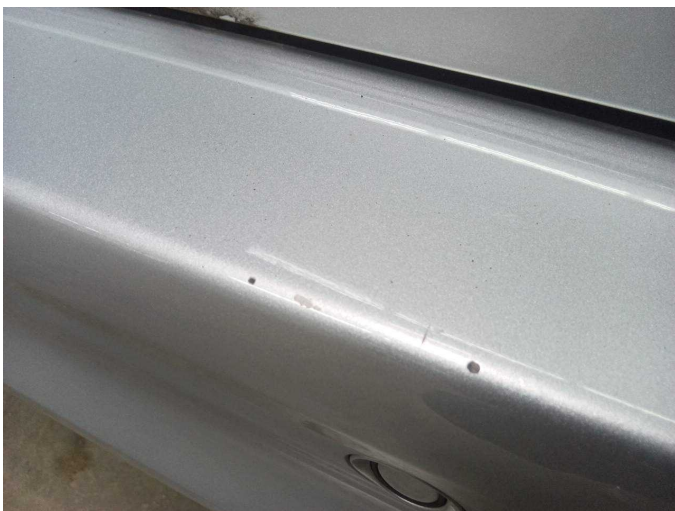
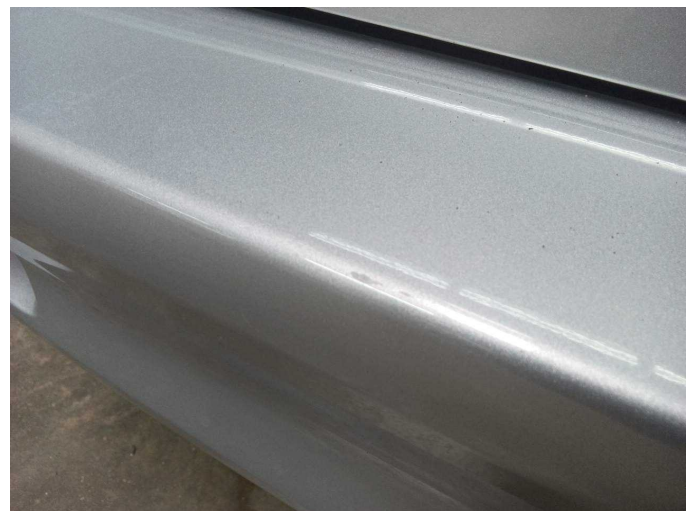
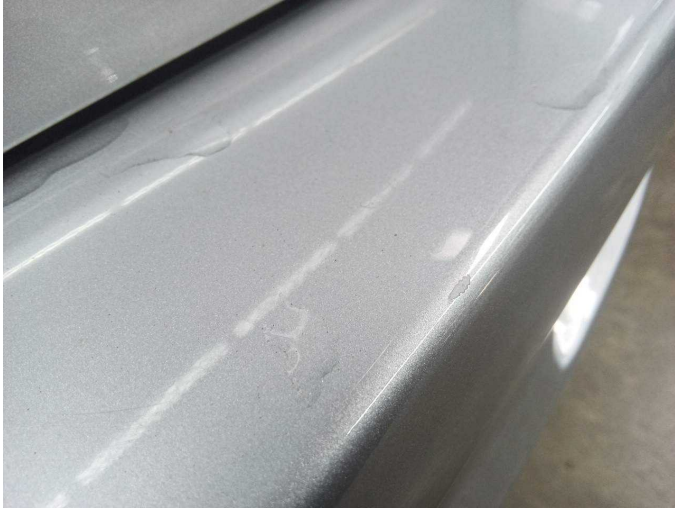
No.	Component group	Description
1	Rear bumper	Rear bumper - Scratch(es) - Paint

Damage 1: Rear bumper: Rear bumper - Scratch(es) - Paint
