Expertise

Protocol number: 46542274  
Order No. / Reference: 26725662-2  
Inspection date: 10 Jul 2026

Manufacturer: Ford

Model: S-Max 2.0 EcoBlue TITANIUM

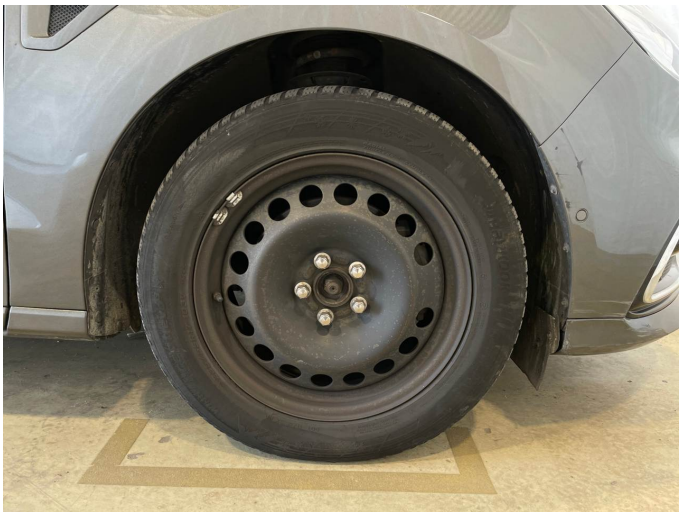
| # | Tyre size | Type of tyre | Manufacturer | Tread depth |
|---|---|---|---|---|
| 1) | 235/55 R17 103V | Winter tyres on Steel | Hankook | 2mm / 2mm |
| 2) | 235/55 R17 103V | Winter tyres on Steel | Hankook | 3mm / 3mm |

Figure 12: Mounted tyres

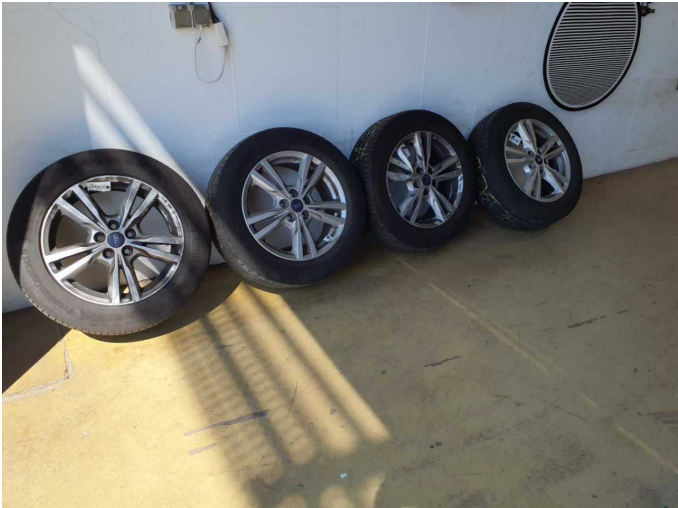
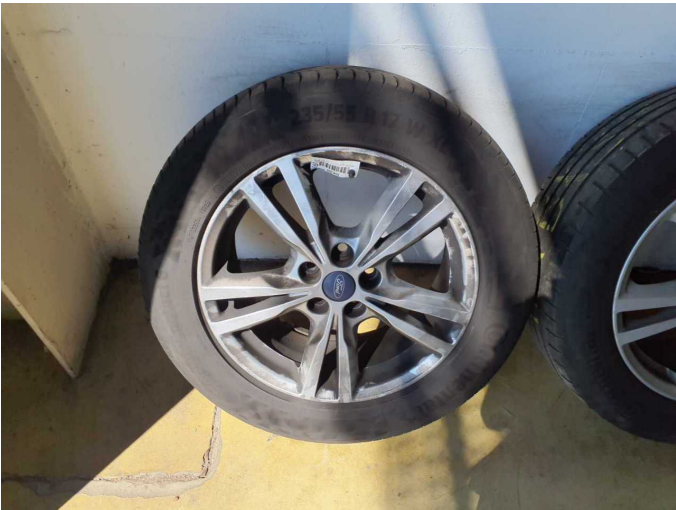
| # | Tyre size | Type of tyre | Manufacturer | Tread depth |
|---|---|---|---|---|
| 1) | 235/55 R17 103W | Summer tyres on Light alloy | Continental | 5mm / 5mm |
| 2) | 235/55 R17 103W | Summer tyres on Light alloy | Continental | 2mm / 2mm |

Figure 16: Additional tyres

Figure 17: Additional tyres

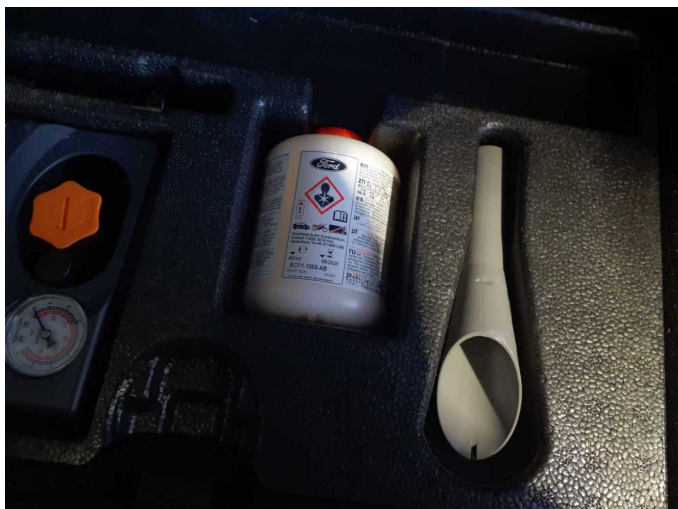
**Damage 1:** Equipment: Tirefit filler - Expired - Replace

| No. | Component group | Description |
|---|---|---|
| 1 | Equipment | Tirefit filler - Expired - Replace |

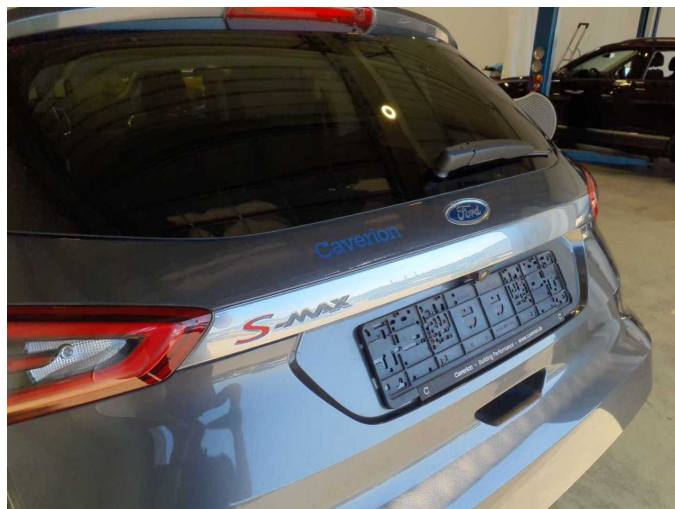
**Damage 2:** Boot lid / rear door: Boot lid - Glued / labelled - De-glue / neutralise

| No. | Component group | Description |
|---|---|---|
| 2 | Boot lid / rear door | Boot lid - Glued / labelled - De-glue / neutralise |

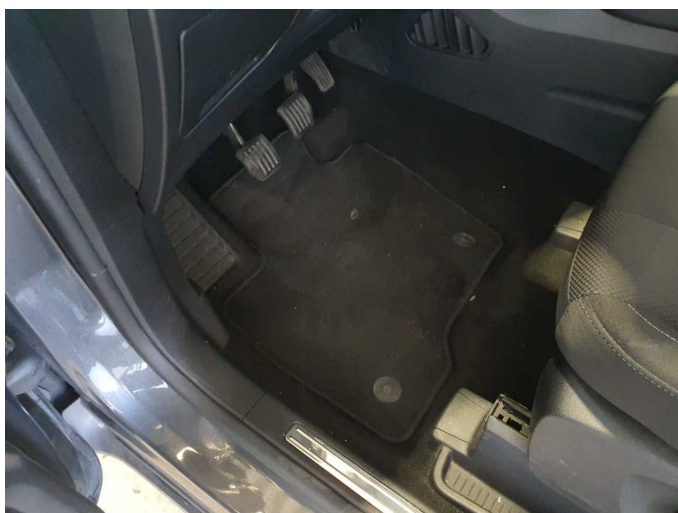
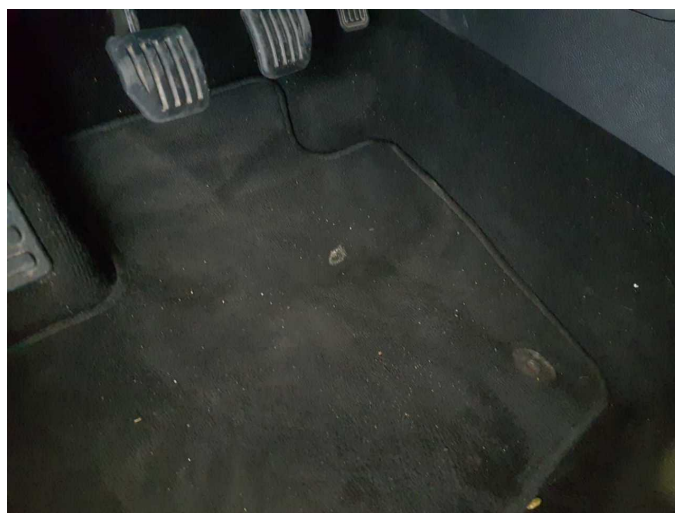
**Damage 3:** Trim / covers: Floor mats - Broken / torn - Replace

| No. | Component group | Description |
|---|---|---|
| 3 | Trim / covers | Floor mats - Broken / torn - Replace |

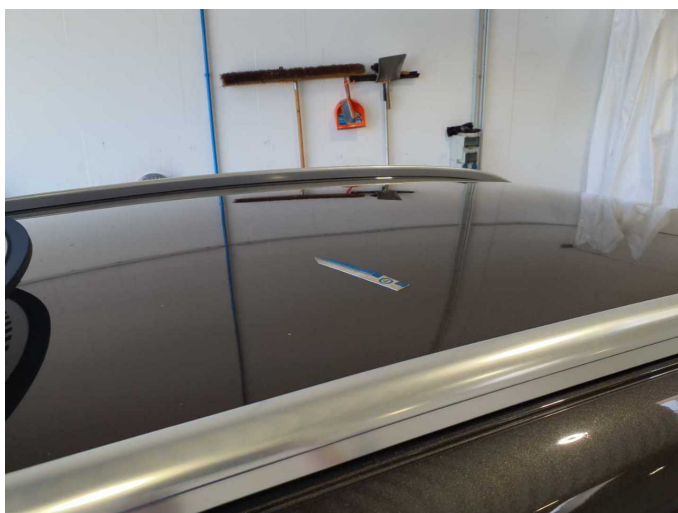
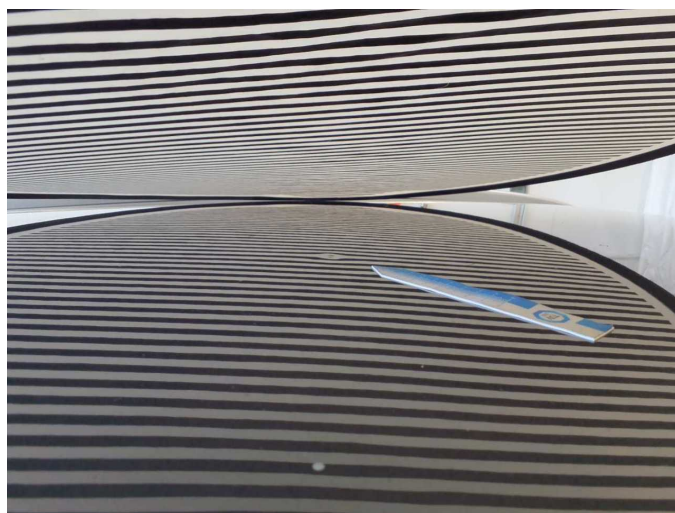
**Damage 4:** Roof: Roof - dent(s) - Smooth repair work

| No. | Component group | Description |
|---|---|---|
| 4 | Roof | Roof - dent(s) - Smooth repair work |

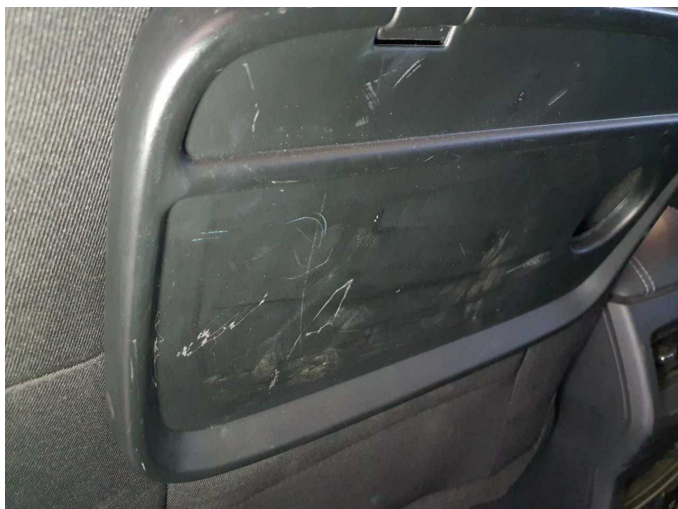
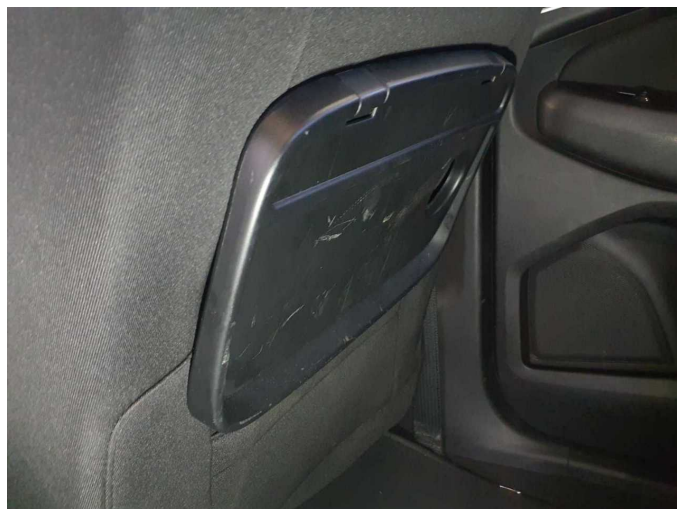
**Damage 5:** Trim / covers: Trim / covers - Scratch(es) - Loss in value

| No. | Component group | Description |
|---|---|---|
| 5 | Trim / covers | Trim / covers - Scratch(es) - Loss in value |

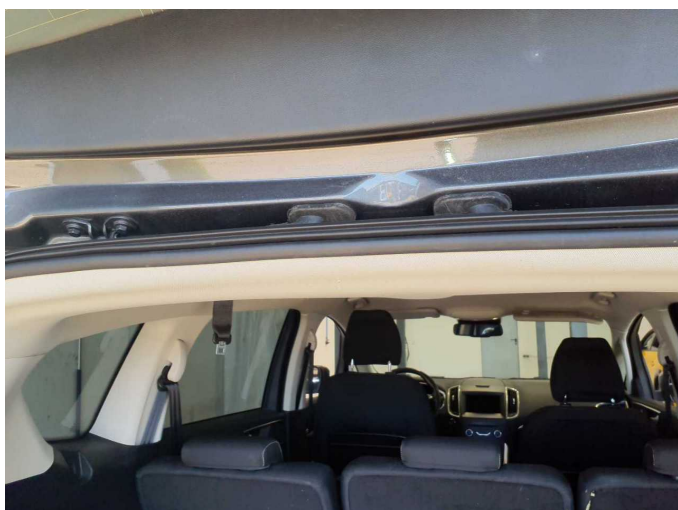
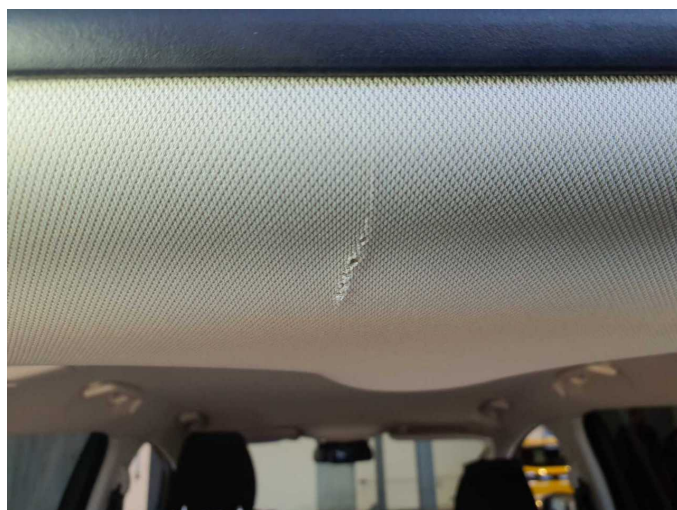
**Damage 6:** Trim / covers: Roof lining - Scratch(es) - Loss in value

| No. | Component group | Description |
|---|---|---|
| 6 | Trim / covers | Roof lining - Scratch(es) - Loss in value |

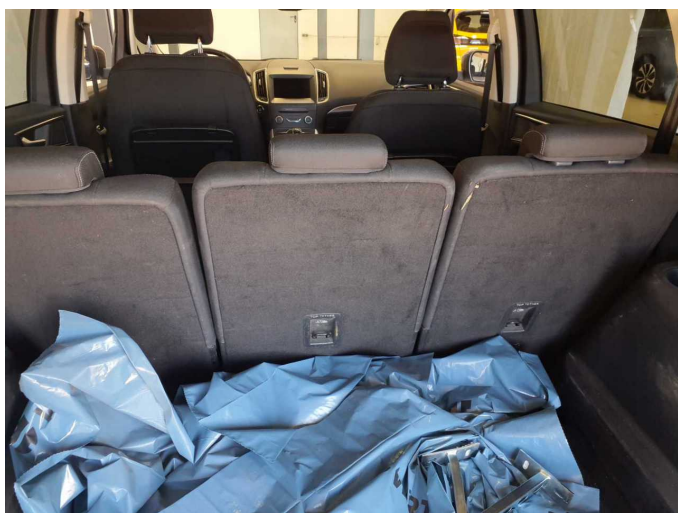
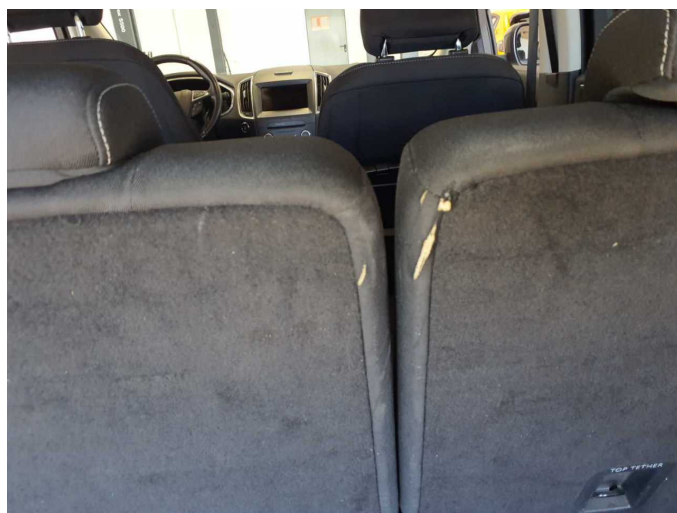
**Damage 7:** Seat - rear: Upholstery - Broken / torn - Smart repair

| No. | Component group | Description |
|---|---|---|
| 7 | Seat - rear | Upholstery - Broken / torn - Smart repair |

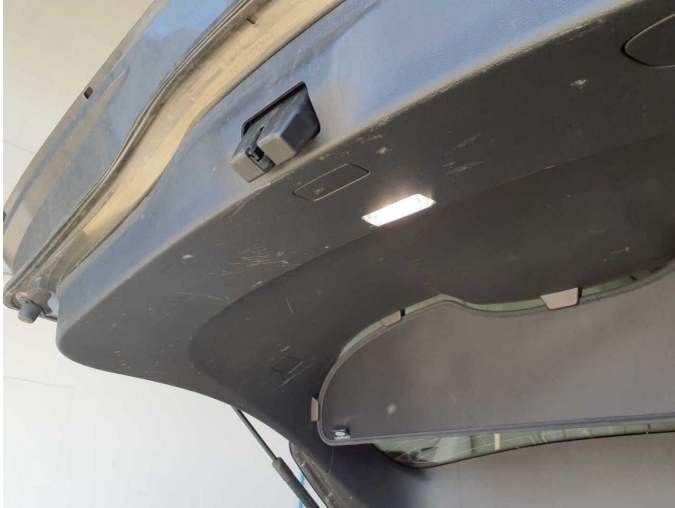
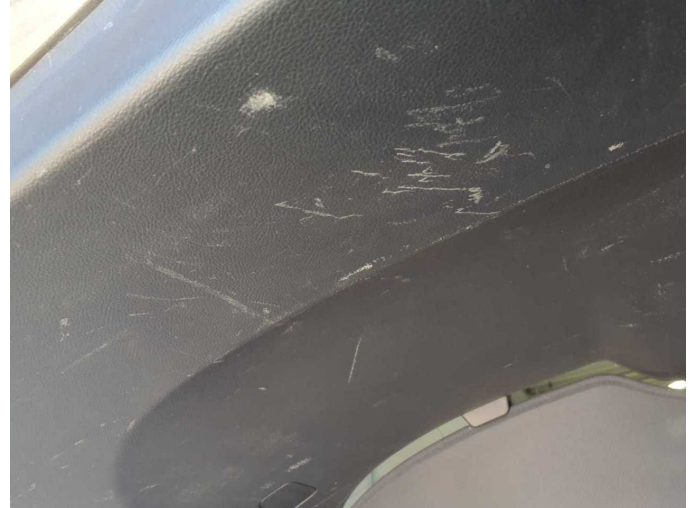
**Damage 9:** Trim / covers: Boot lid - interior trim - Scratch(es) - Loss in value

| No. | Component group | Description |
|---|---|---|
| 9 | Trim / covers | Boot lid - interior trim - Scratch(es) - Loss in value |

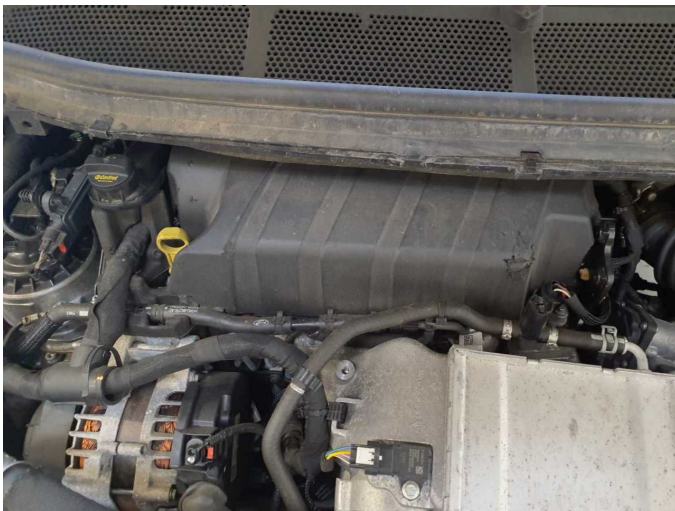
**Damage 10:** Engine: Engine cover - Scratch(es) - Replace

| No. | Component group | Description |
|---|---|---|
| 10 | Engine | Engine cover - Scratch(es) - Replace |

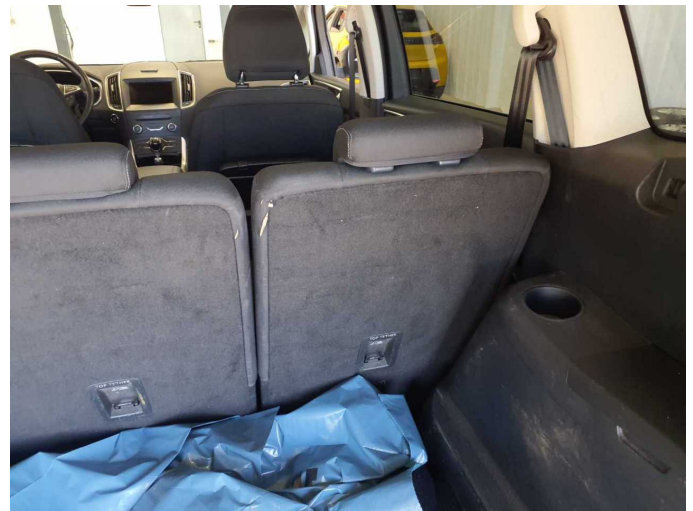
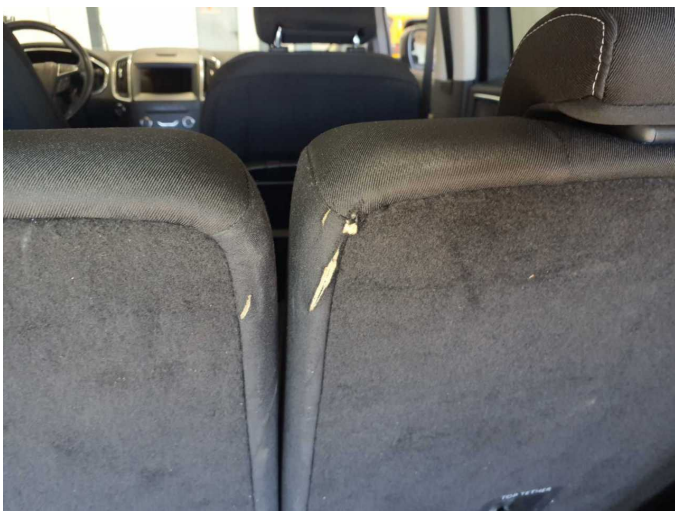
**Damage 11:** Seat - rear: Upholstery - Broken / torn - Replace

| No. | Component group | Description |
|---|---|---|
| 11 | Seat - rear | Upholstery - Broken / torn - Replace |

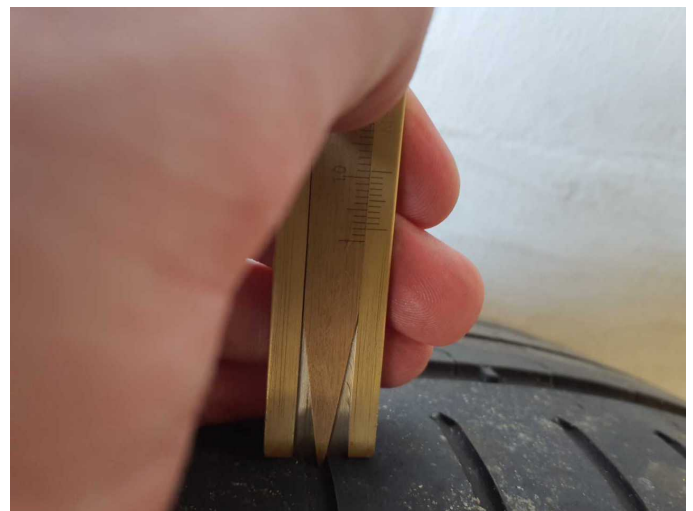
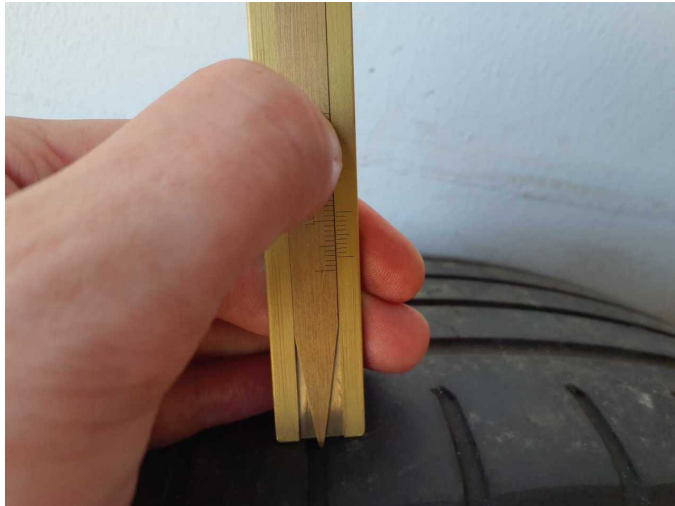
**Damage 12:** 2nd wheel set: 2 tyres - Worn - Replace

| No. | Component group | Description |
|---|---|---|
| 12 | 2nd wheel set | 2 tyres - Worn - Replace |

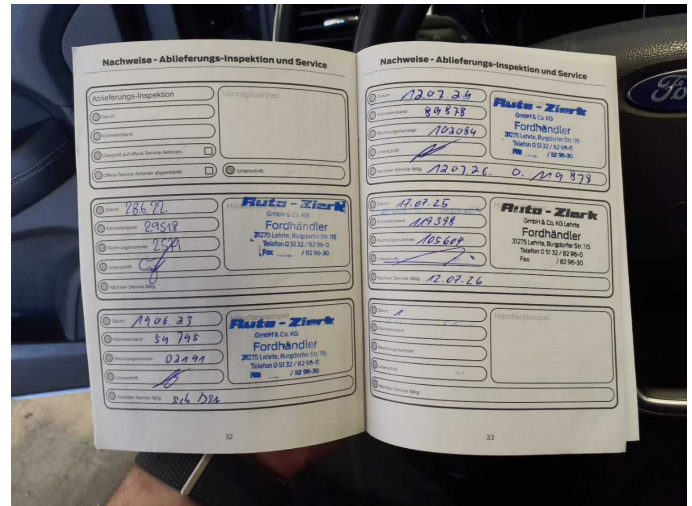
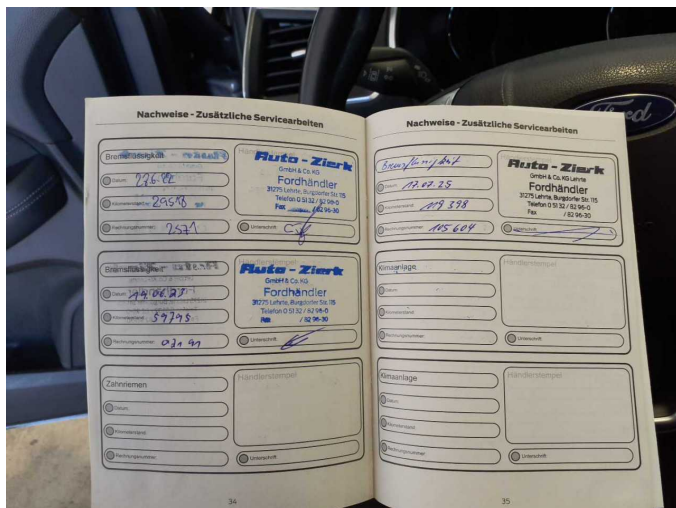
**Damage 13:** Misc.: Inspection / maintenance (12.07.2026) - Due - Perform

| No. | Component group | Description |
|---|---|---|
| 13 | Misc. | Inspection / maintenance (12.07.2026) - Due - Perform |

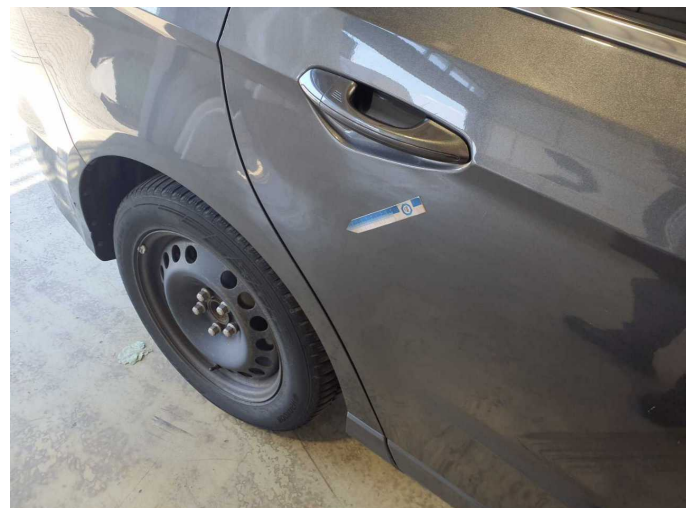
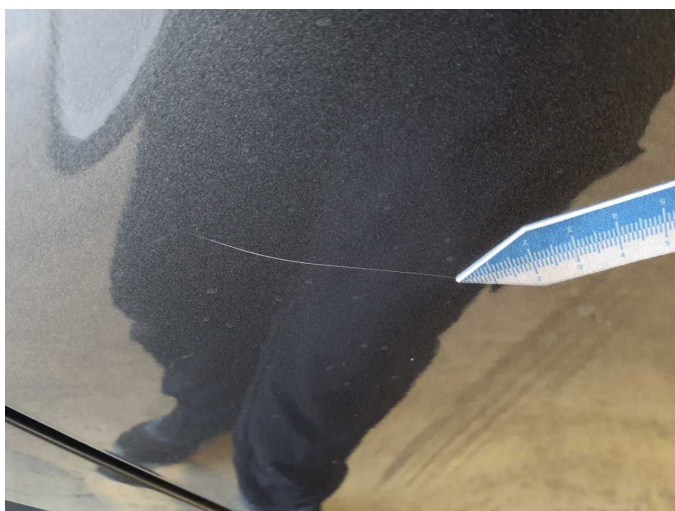
**Damage 14:** Door - rear right side: Door - Scratch(es) - Paint

| No. | Component group | Description |
|---|---|---|
| 14 | Door - rear right side | Door - Scratch(es) - Paint |

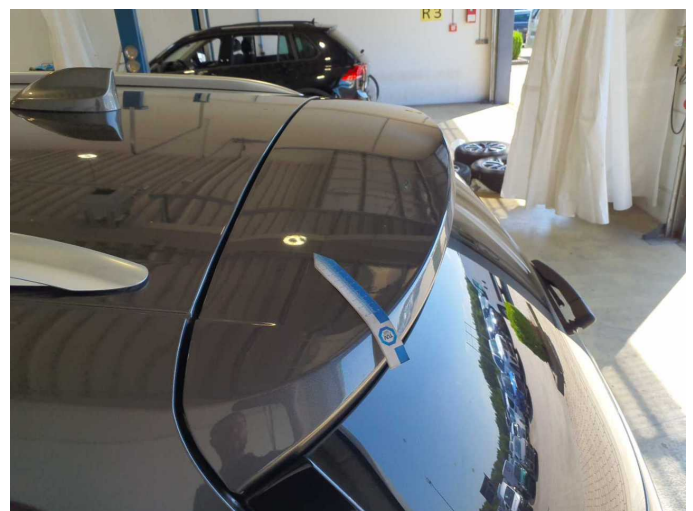
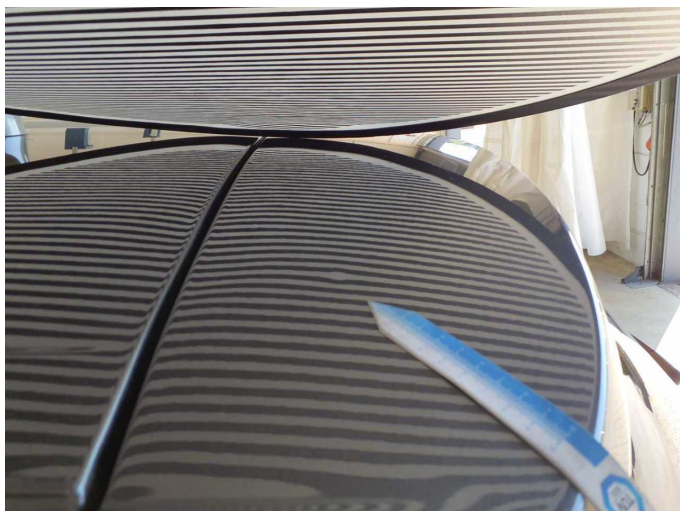
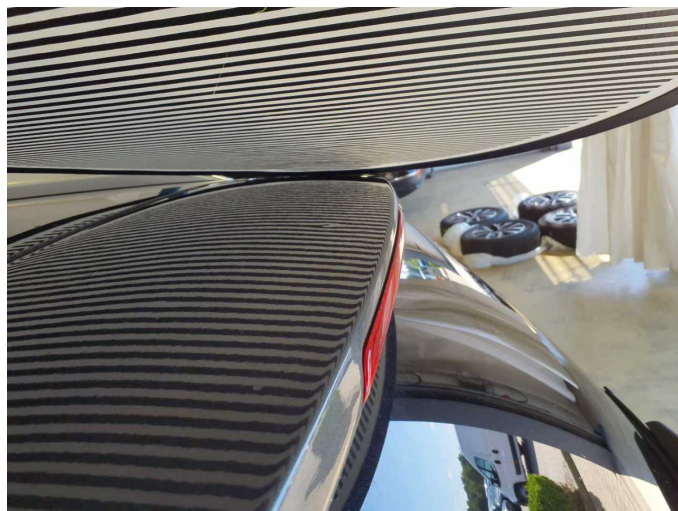
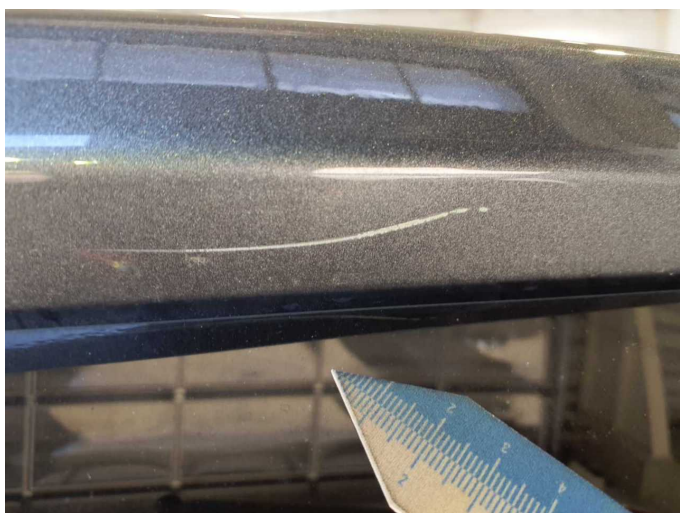
**Damage 15:** Boot lid / rear door: Boot lid - Dent / paintcoat damage - Repair and paint

| No. | Component group | Description |
|---|---|---|
| 15 | Boot lid / rear door | Boot lid - Dent / paintcoat damage - Repair and paint |

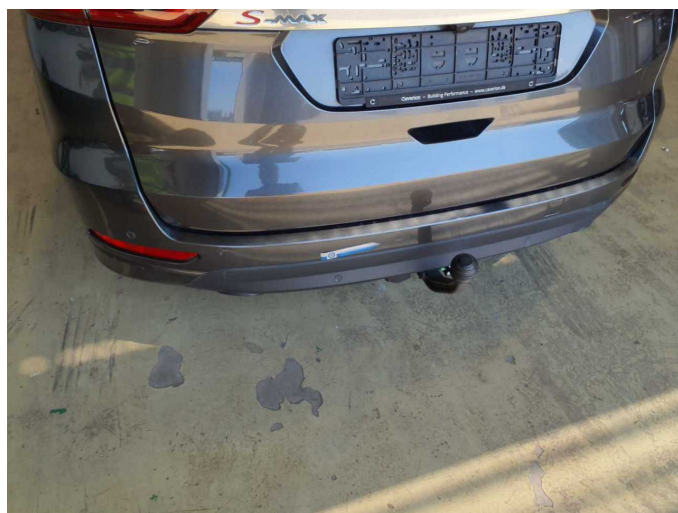
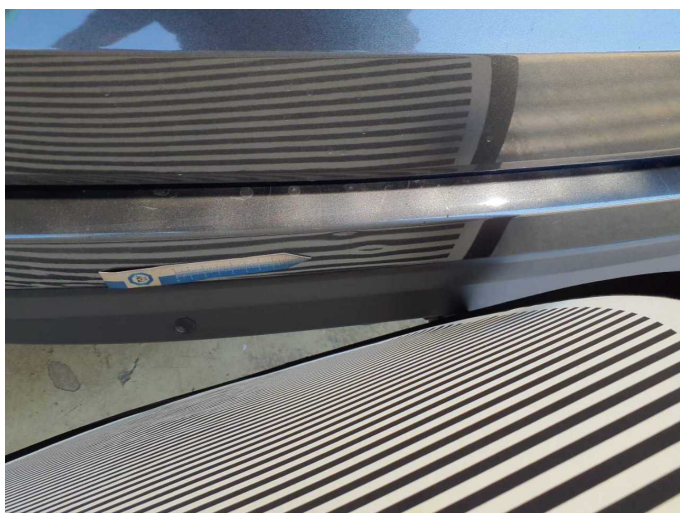
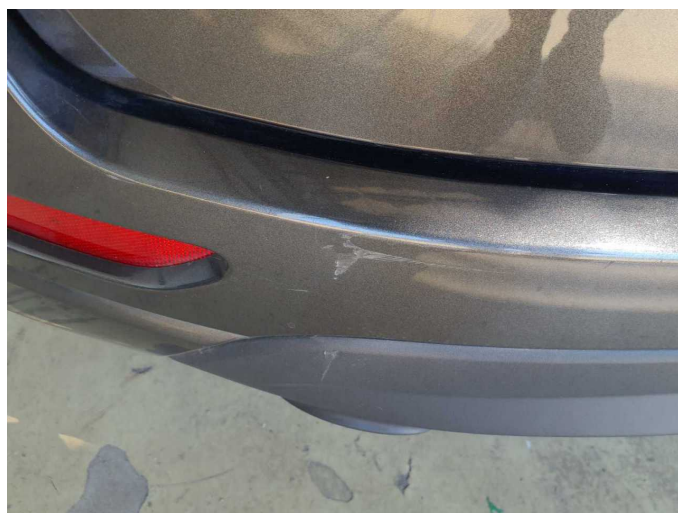
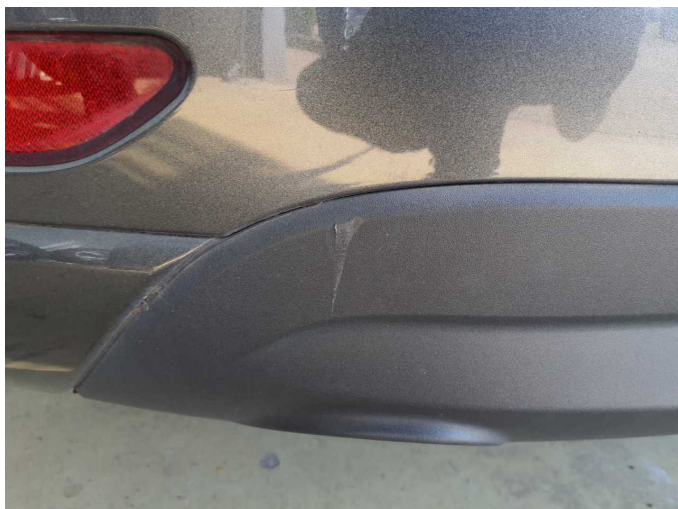
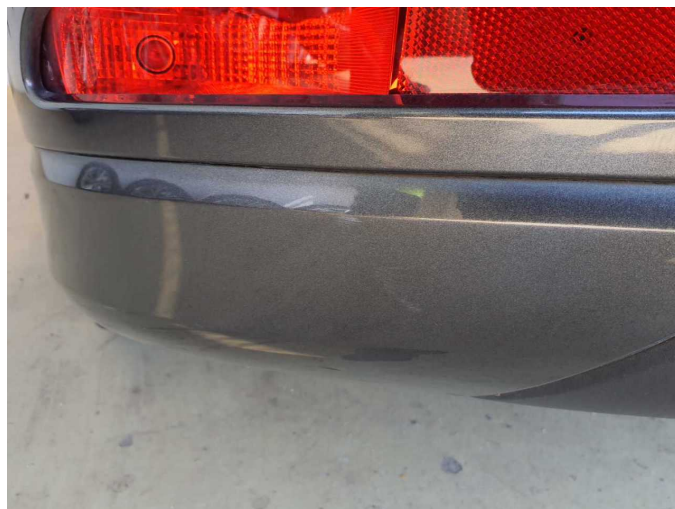
**Damage 16:** Rear bumper: Rear bumper (Inklusive anbauteile) - Dent / paintcoat damage - Repair and paint

| No. | Component group | Description |
|---|---|---|
| 16 | Rear bumper | Rear bumper (Inklusive anbauteile) - Dent / paintcoat damage - Repair and paint |

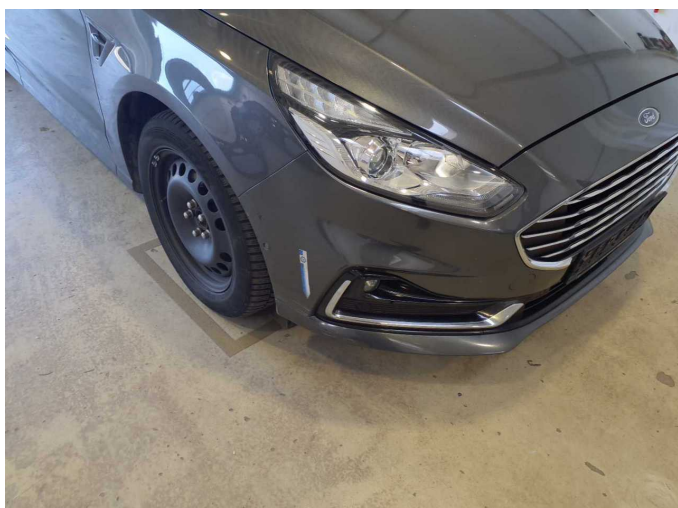
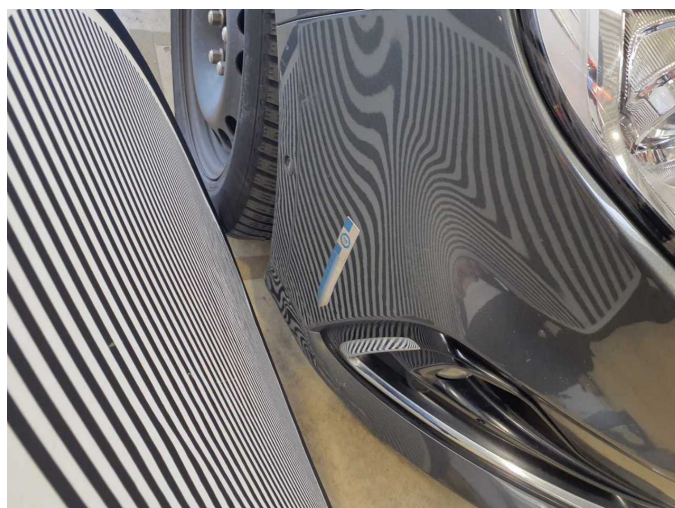
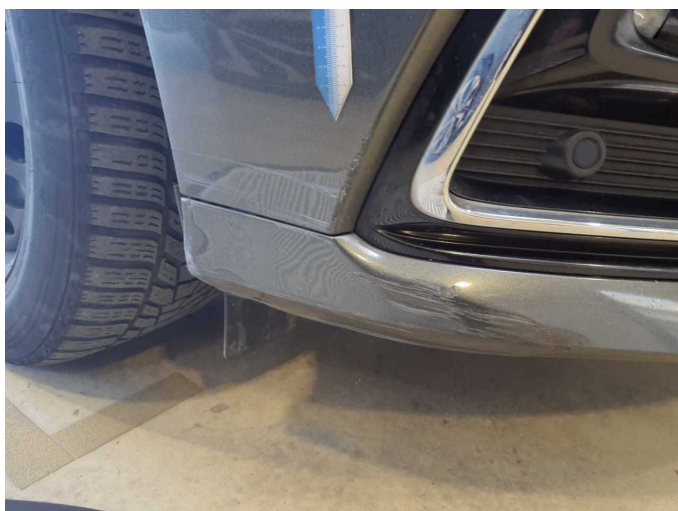
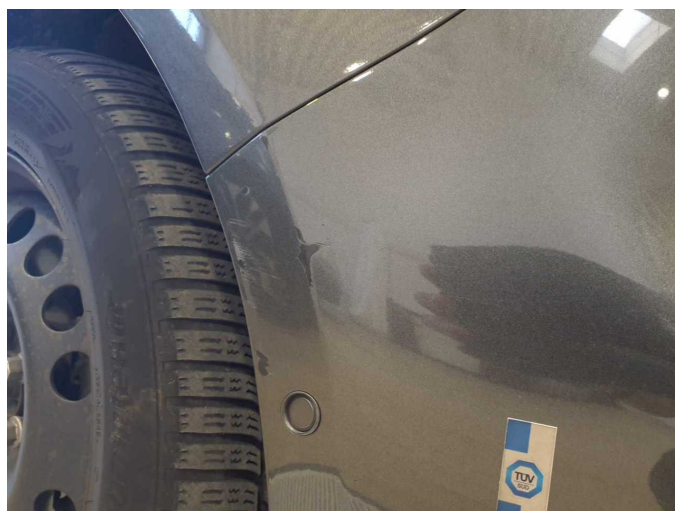
**Damage 17:** Front bumper: Front bumper (Inklusive anbauteile) - Dent / paintcoat damage - Repair and paint

| No. | Component group | Description |
|---|---|---|
| 17 | Front bumper | Front bumper (Inklusive anbauteile) - Dent / paintcoat damage - Repair and paint |

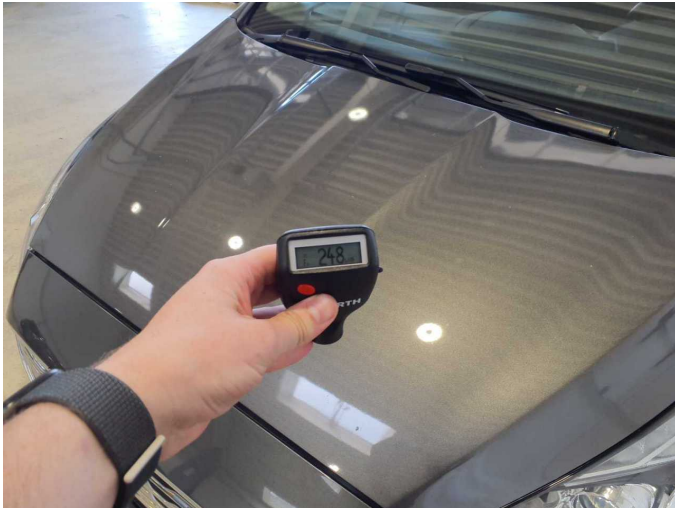
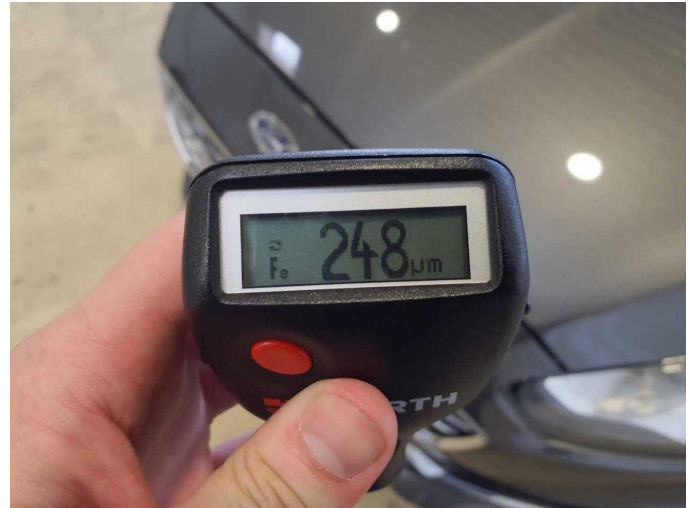
**Repainting 1: Bonnet**

| No. | Repainting |
|---|---|
| 1 | Bonnet, Professionally carried out, Invoice of repair done Non-existent |

| Bonnet | 248 µm | Door - front right side | 163 µm |

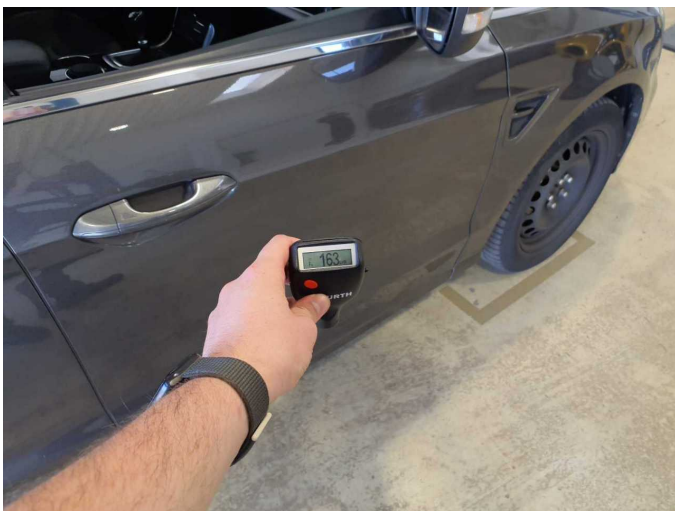
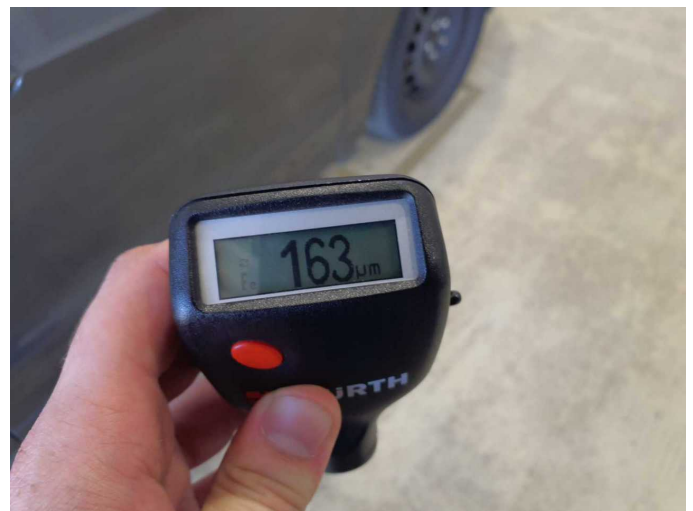
**Repainting 2: Door - front right side**

| No. | Repainting |
|---|---|
| 2 | Door - front right side, Professionally carried out, Invoice of repair done Non-existent |
