Expertise

Protocol number: 46905288  
Order No. / Reference: 26847842  
Inspection date: 4 Aug 2026

Manufacturer: Ford

Model: Kuga 2.5 Duratec FHEV 4x4 TITANIUM X

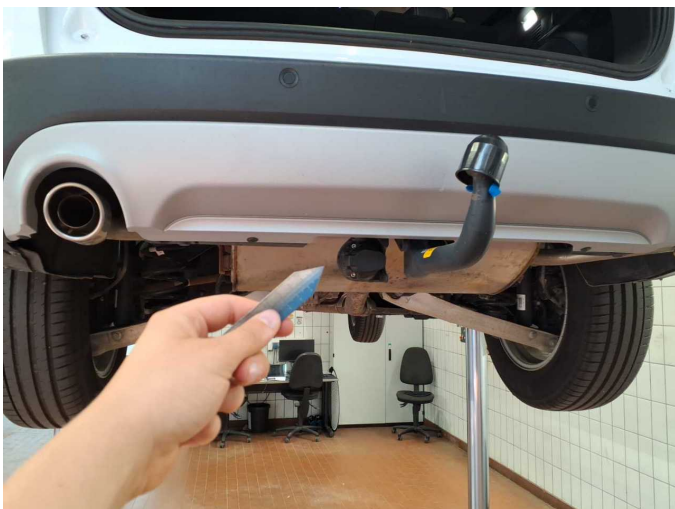
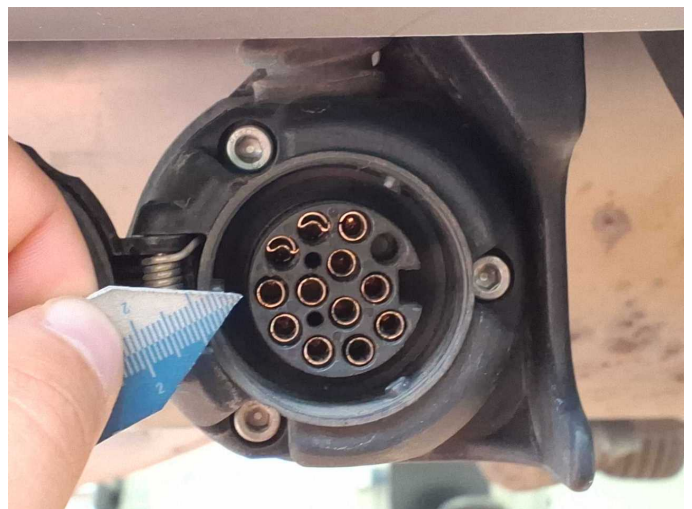
**Damage 1:** Trailer hitch: Electrical connection socket (Pins Verformt) - Deformed - Replace

| No. | Component group | Description |
|---|---|---|
| 1 | Trailer hitch | Electrical connection socket (Pins Verformt) - Deformed - Replace |

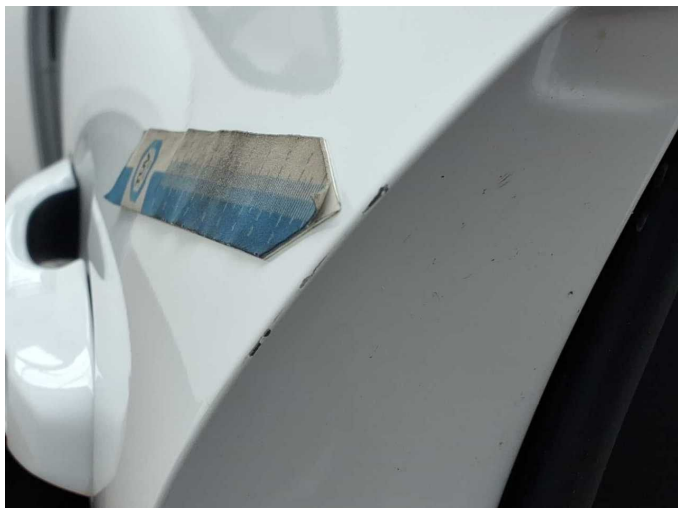
**Damage 2:** Door - front left side: Door edge - Scratch(es) - Smart repair

| No. | Component group | Description |
|---|---|---|
| 2 | Door - front left side | Door edge - Scratch(es) - Smart repair |

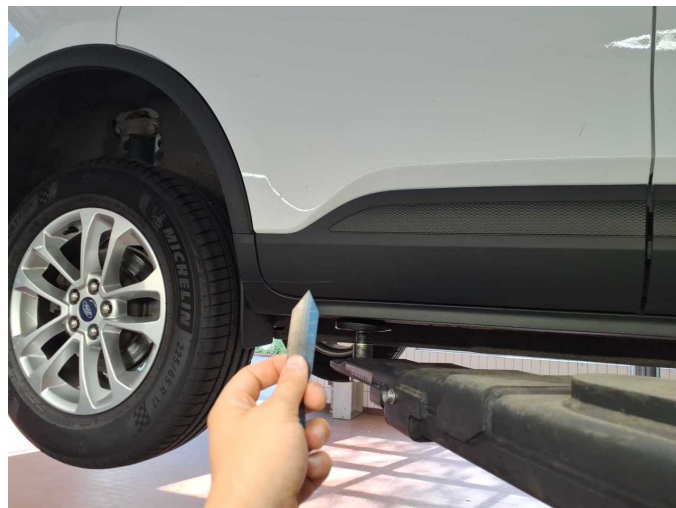
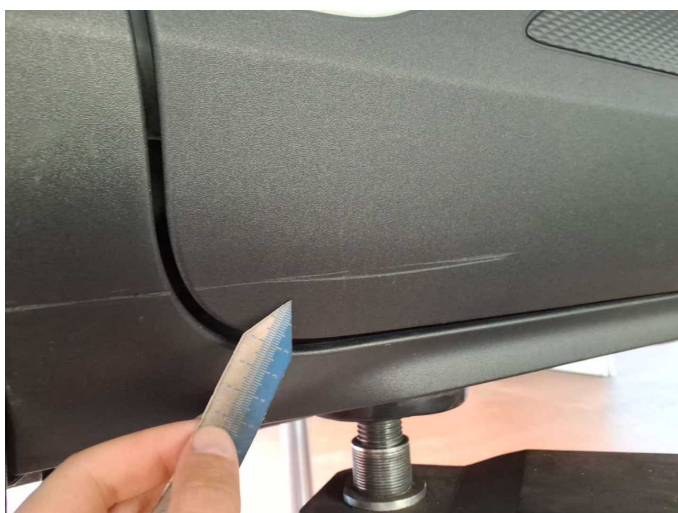
**Damage 3:** Door - rear right side: Brightware - lower - Scratched - Replace

| No. | Component group | Description |
|---|---|---|
| 3 | Door - rear right side | Brightware - lower - Scratched - Replace |

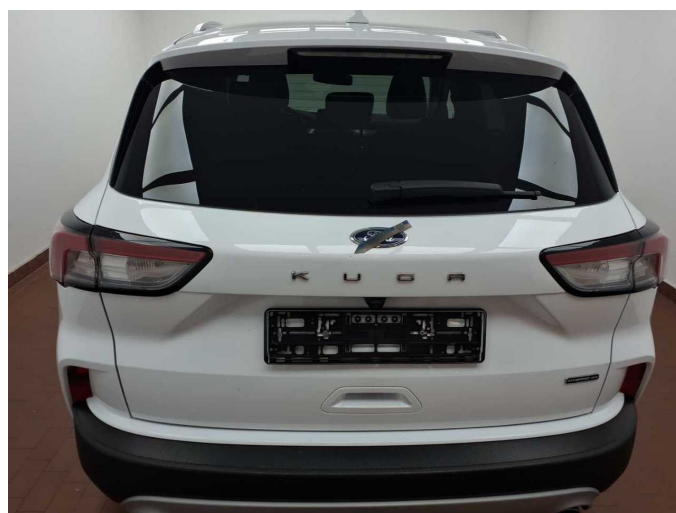
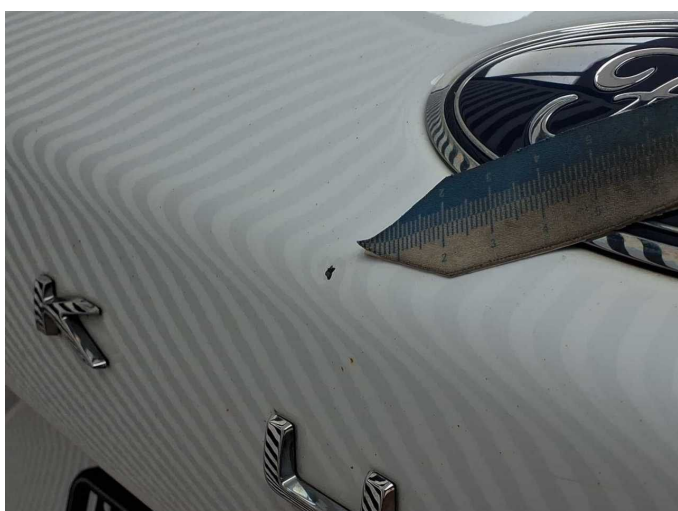
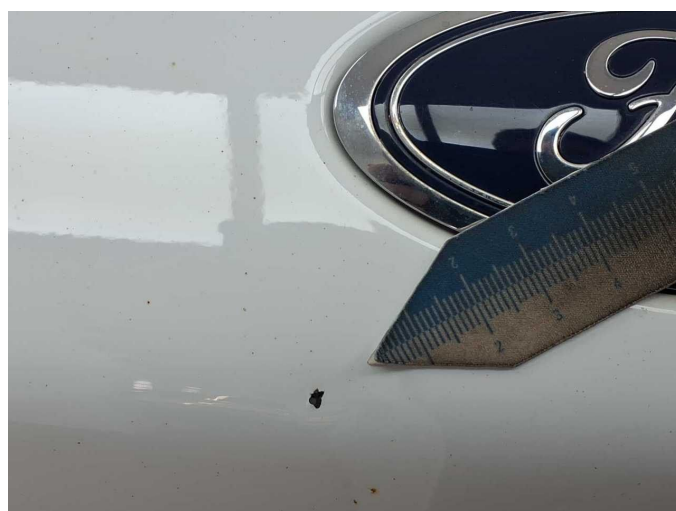
**Damage 4:** Boot lid / rear door: Boot lid - Dent / paintcoat damage - Smart repair

| No. | Component group | Description |
|---|---|---|
| 4 | Boot lid / rear door | Boot lid - Dent / paintcoat damage - Smart repair |

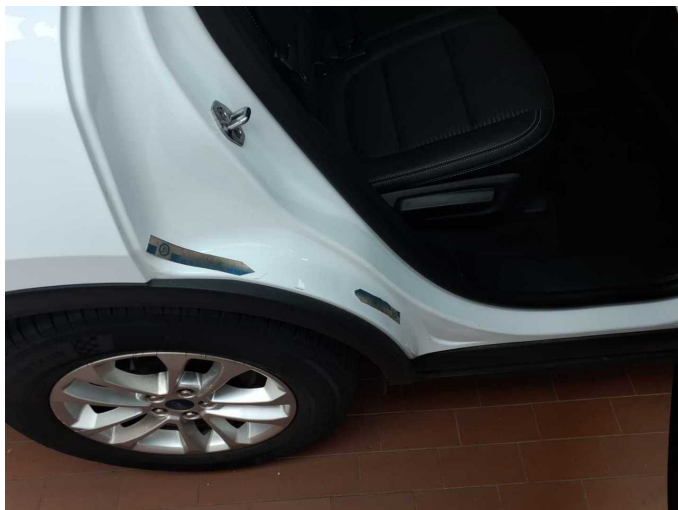
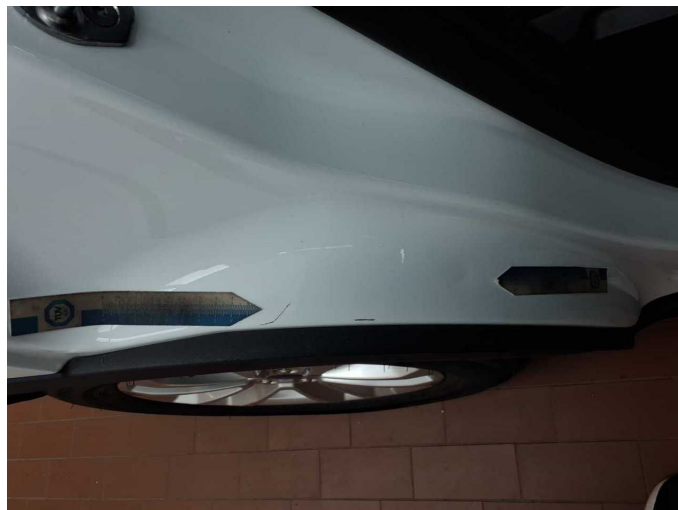
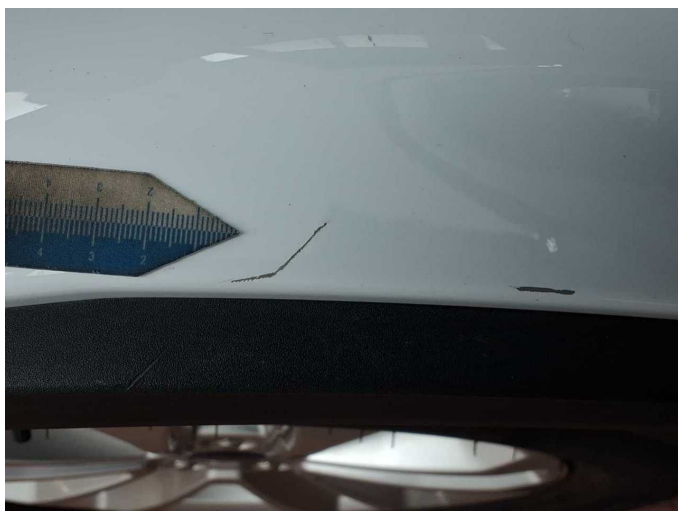
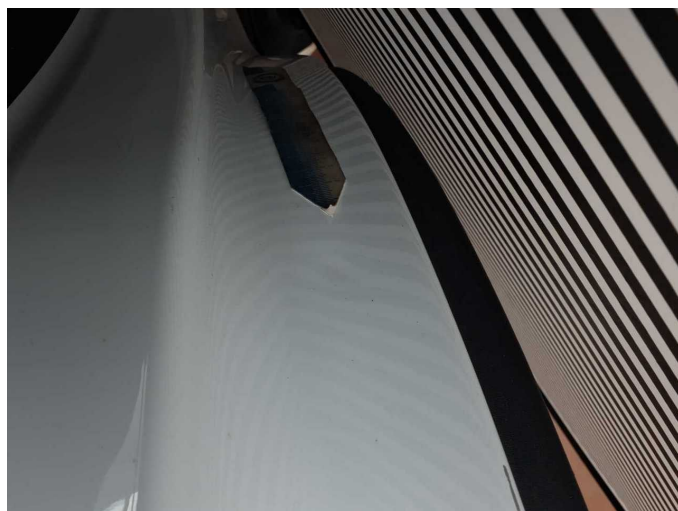
**Damage 5:** Side panel - rear right side: Sill - Dent / paintcoat damage - Smart repair

| No. | Component group | Description |
|---|---|---|
| 5 | Side panel - rear right side | Sill - Dent / paintcoat damage - Smart repair |

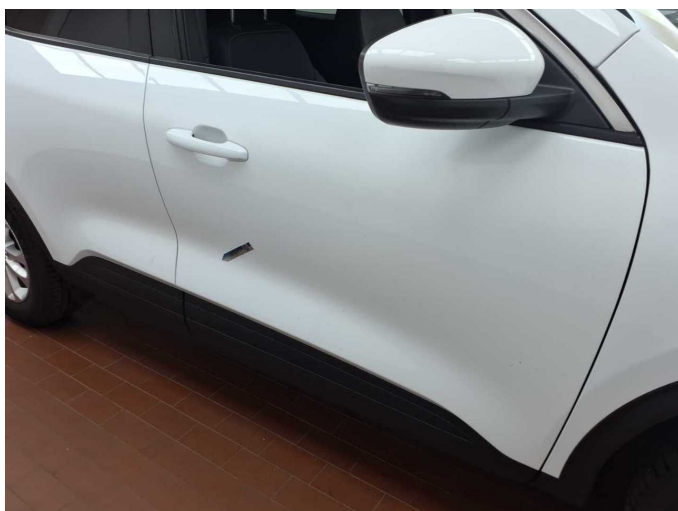
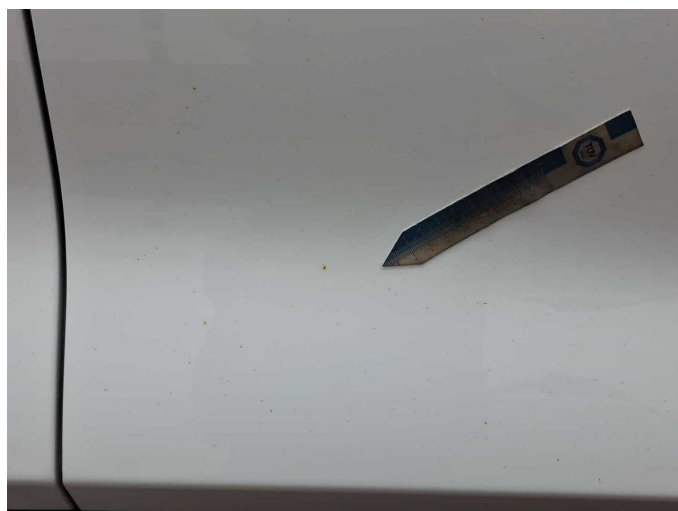
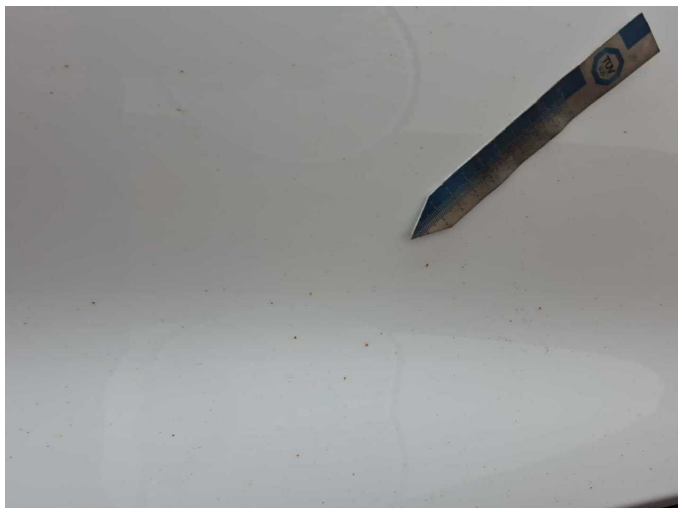
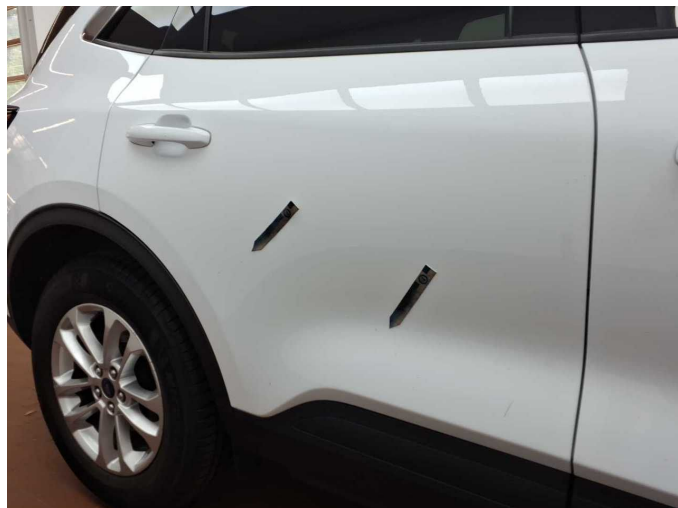
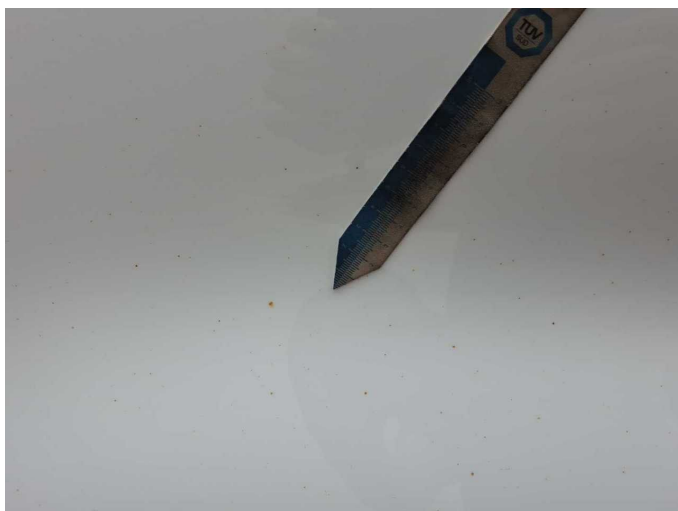
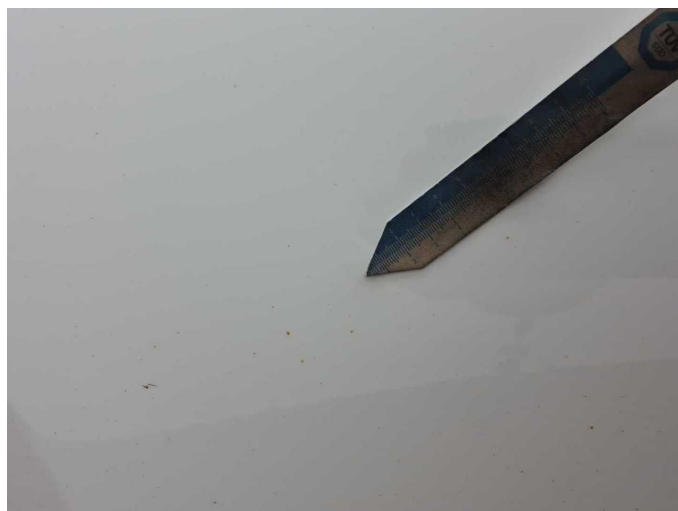
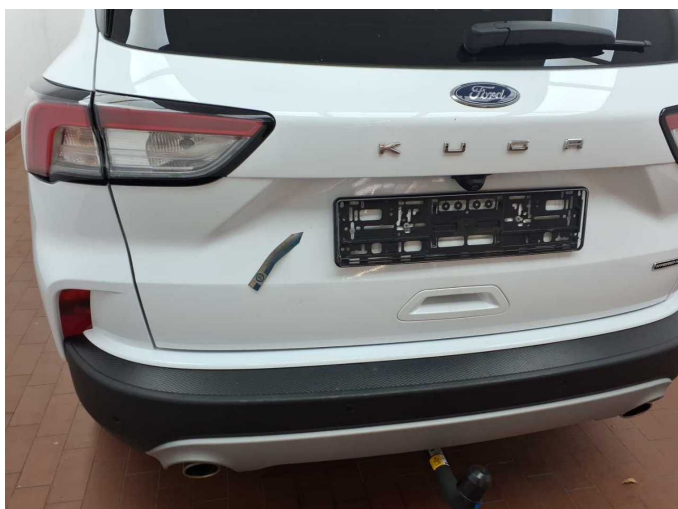
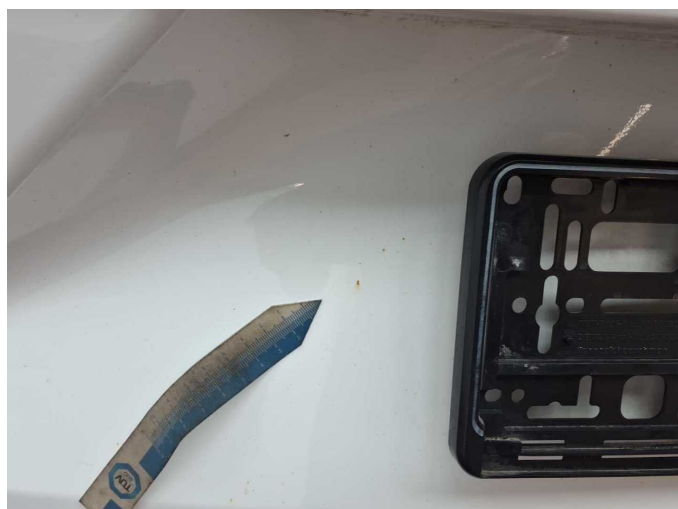
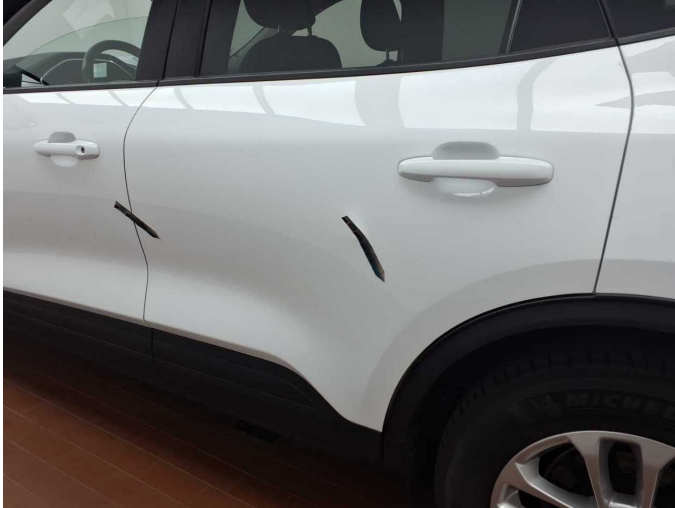
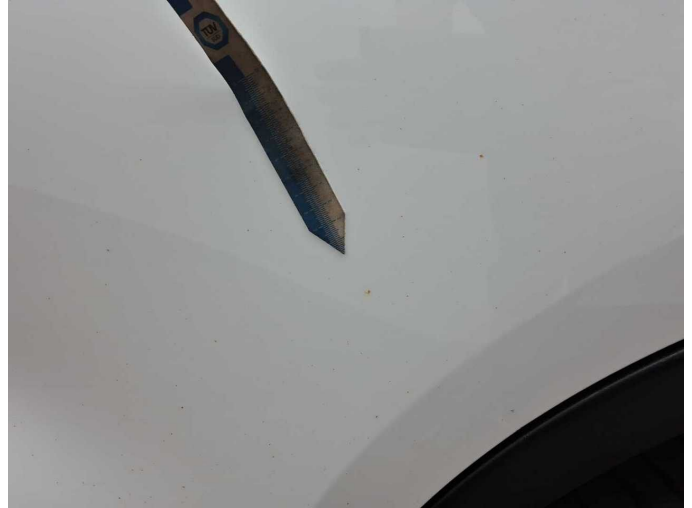
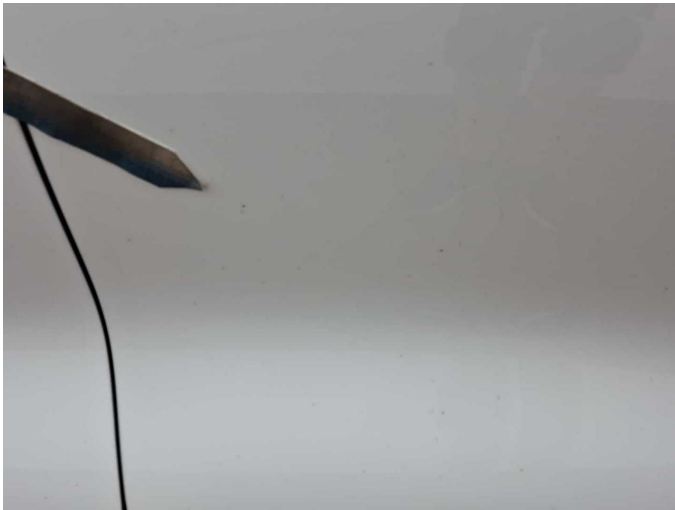
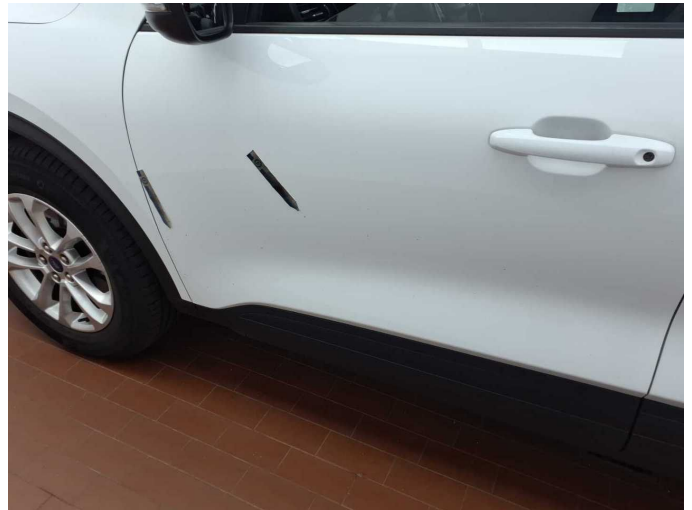
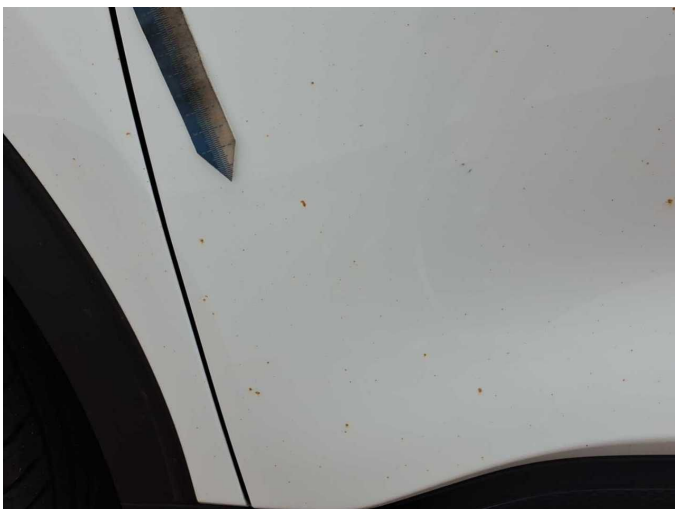
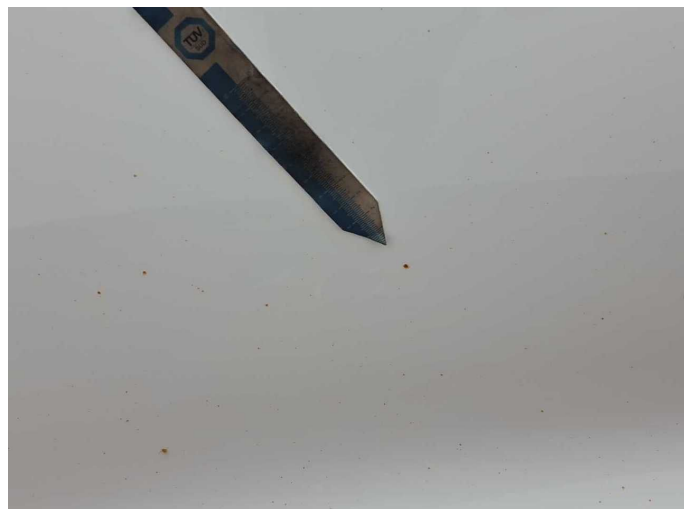
**Damage 6:** Body: Body (Flugrost) - Corrosion - Conditioning

| No. | Component group | Description |
|---|---|---|
| 6 | Body | Body (Flugrost) - Corrosion - Conditioning |

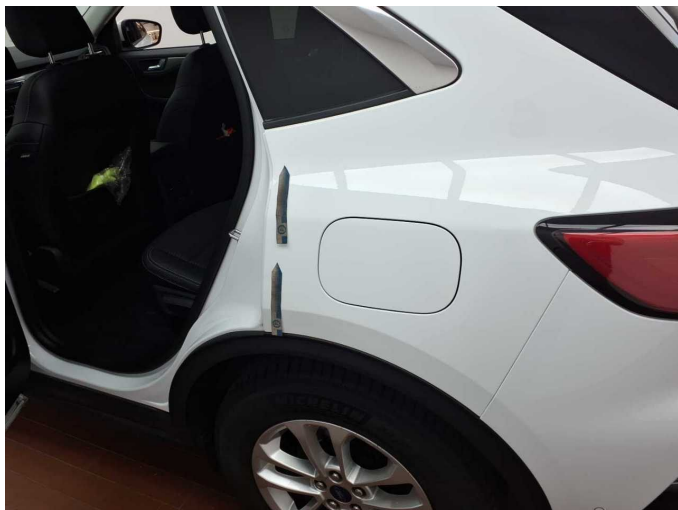
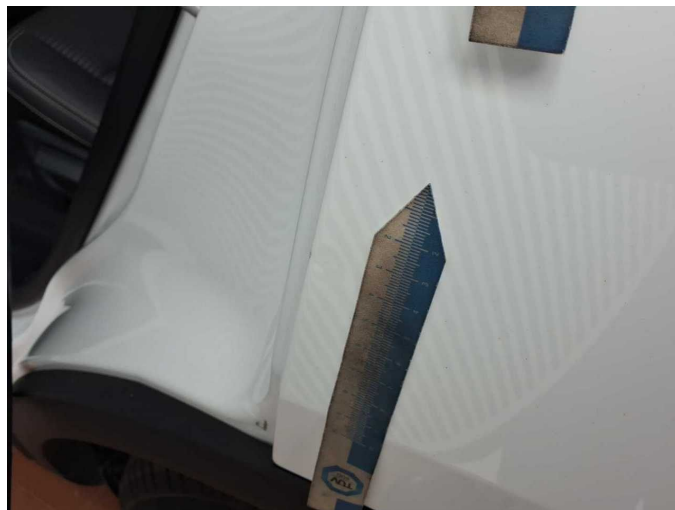
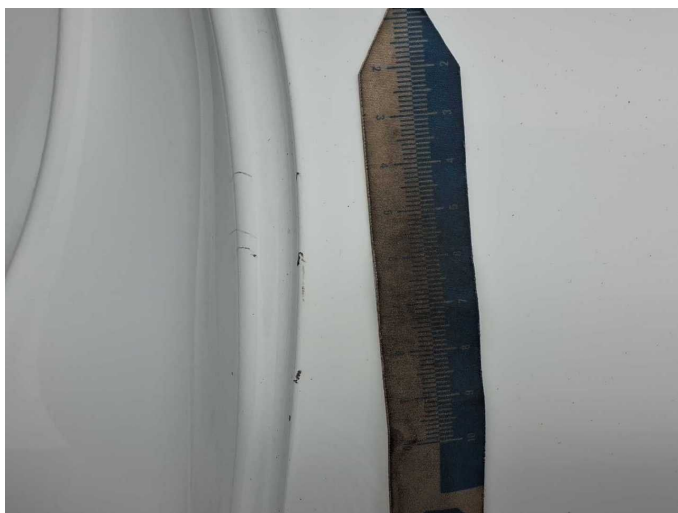
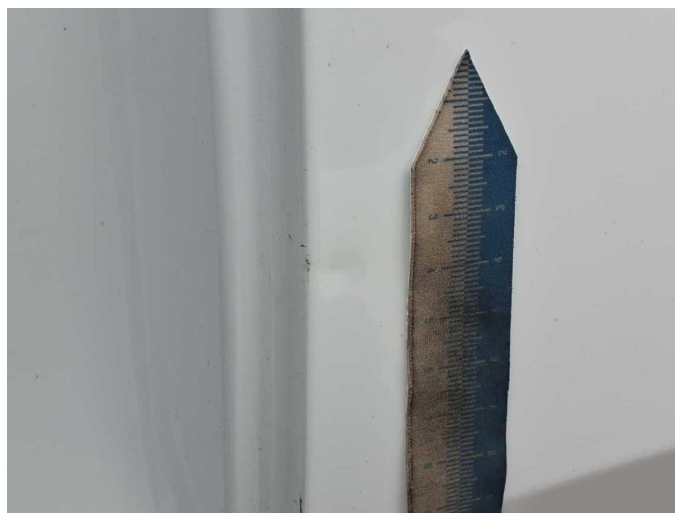
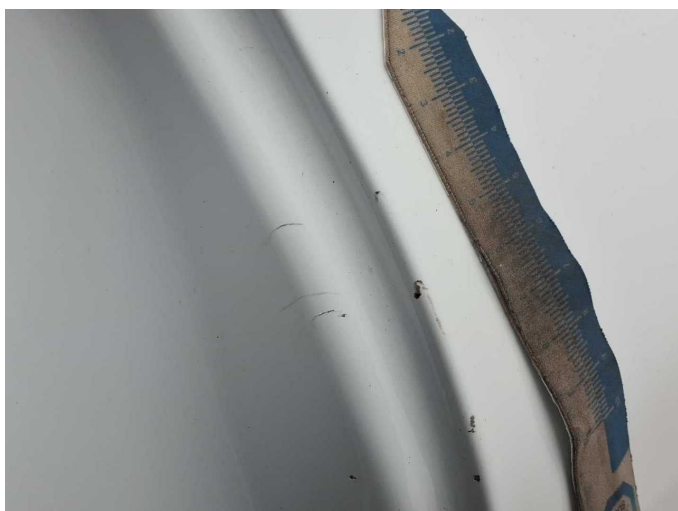
**Damage 7:** Side panel - rear left side: Sill - Dent / paintcoat damage - Smart repair

| No. | Component group | Description |
|---|---|---|
| 7 | Side panel - rear left side | Sill - Dent / paintcoat damage - Smart repair |

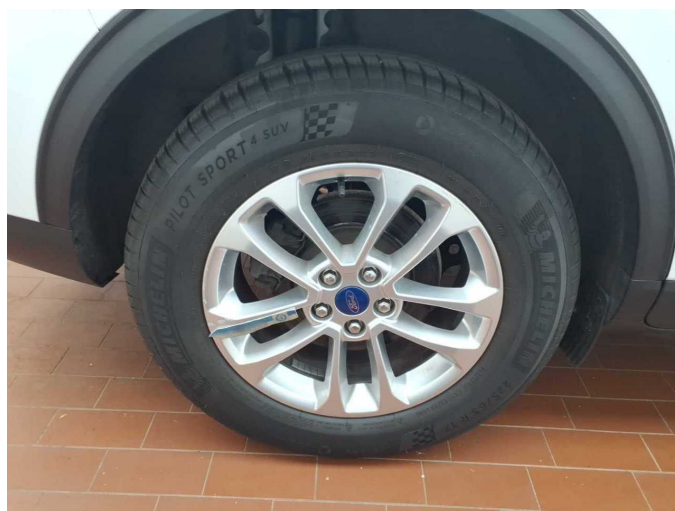
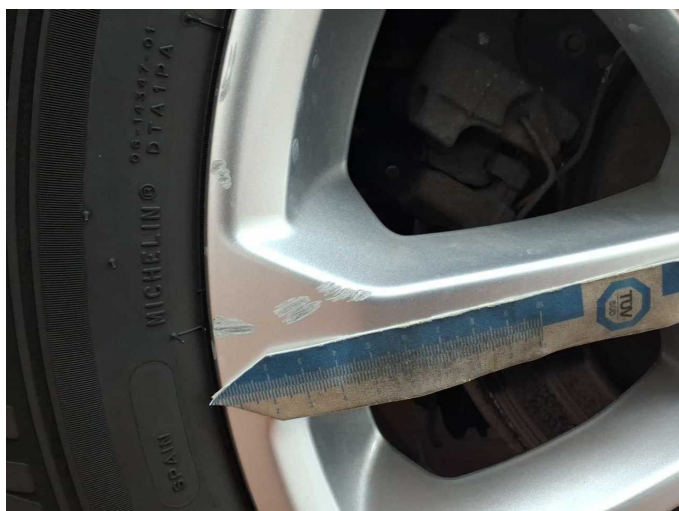
**Damage 8:** Wheel / tyres: Alloy rim - rear right side - Scratched - Loss in value

| No. | Component group | Description |
|---|---|---|
| 8 | Wheel / tyres | Alloy rim - rear right side - Scratched - Loss in value |

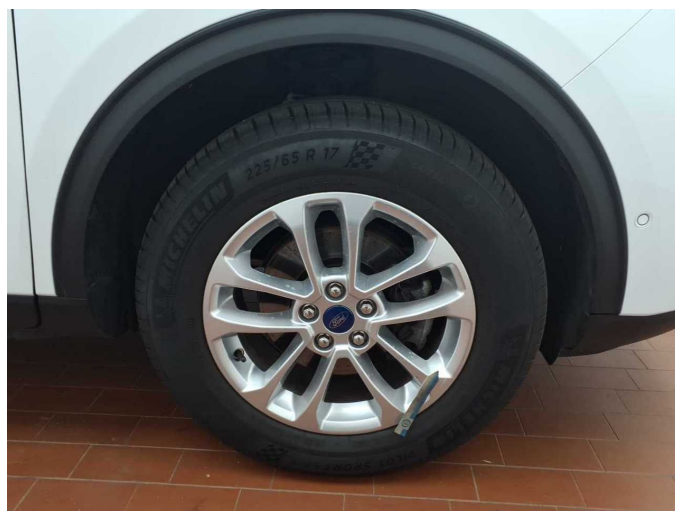
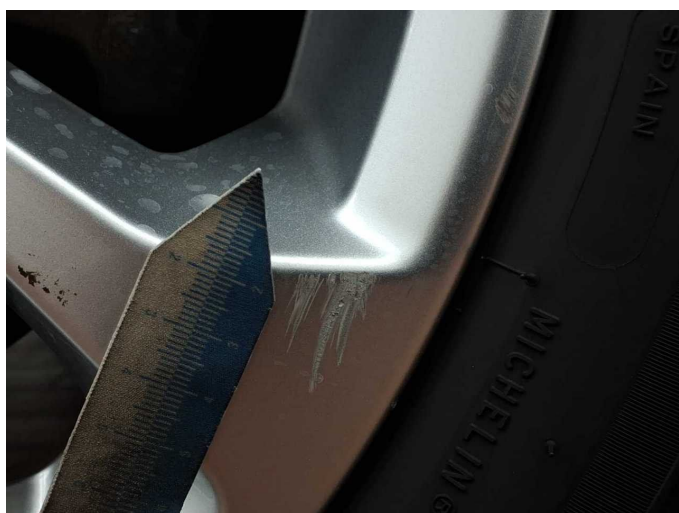
**Damage 9:** Wheel / tyres: Alloy rim - front right side - Scratched - Loss in value

| No. | Component group | Description |
|---|---|---|
| 9 | Wheel / tyres | Alloy rim - front right side - Scratched - Loss in value |

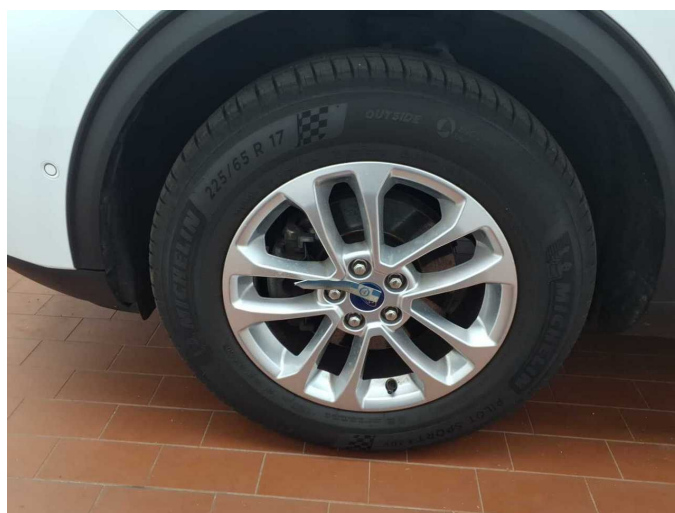
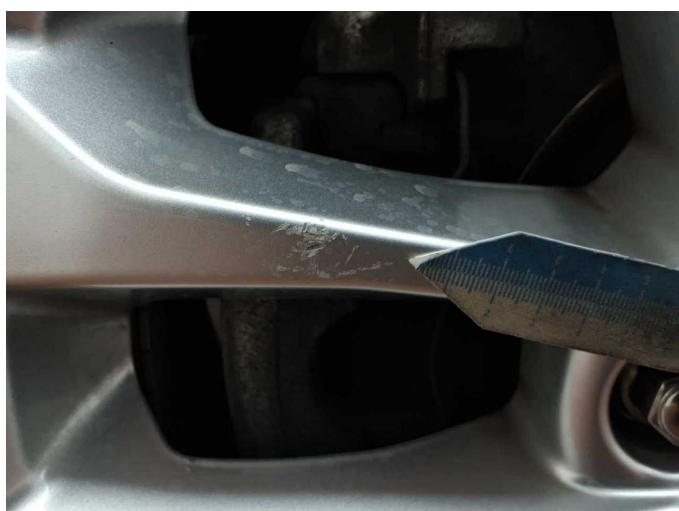
**Damage 10:** Wheel / tyres: Alloy rim - front left side - Scratched - Loss in value

| No. | Component group | Description |
|---|---|---|
| 10 | Wheel / tyres | Alloy rim - front left side - Scratched - Loss in value |

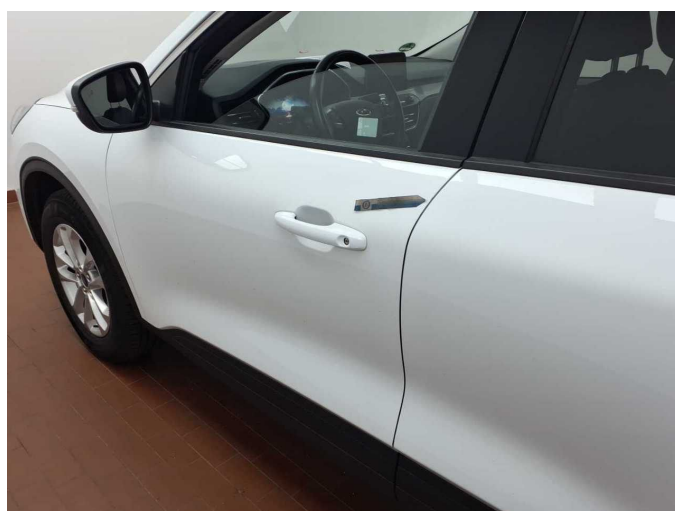
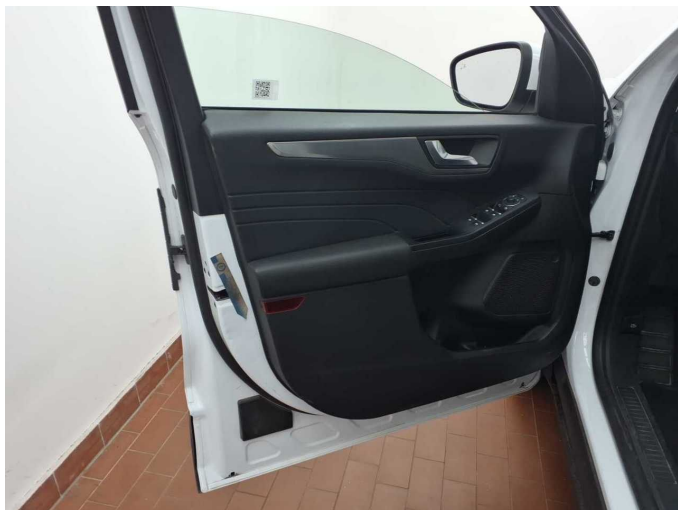
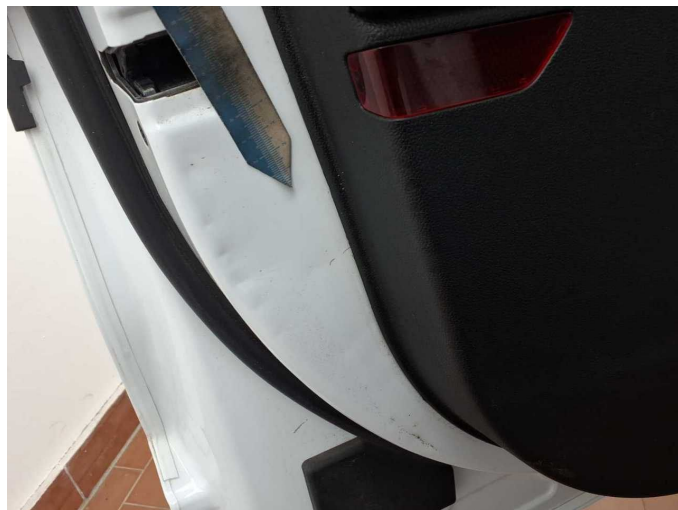
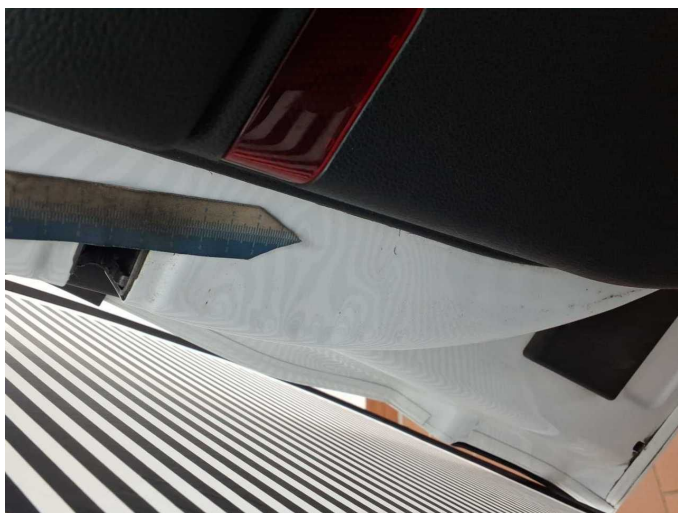
**Damage 11:** Door - front left side: Door (innen) - Dent / paintcoat damage - Smart repair

**Damage 11:** Door - front left side: Door (innen) - Dent / paintcoat damage  
- Smart repair

| No. | Component group | Description |
|---|---|---|
| 11 | Door - front left side | Door (innen) - Dent / paintcoat damage - Smart repair |

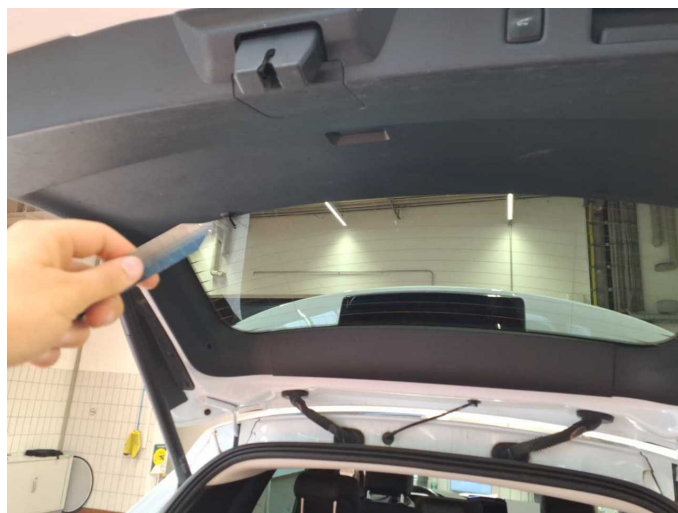
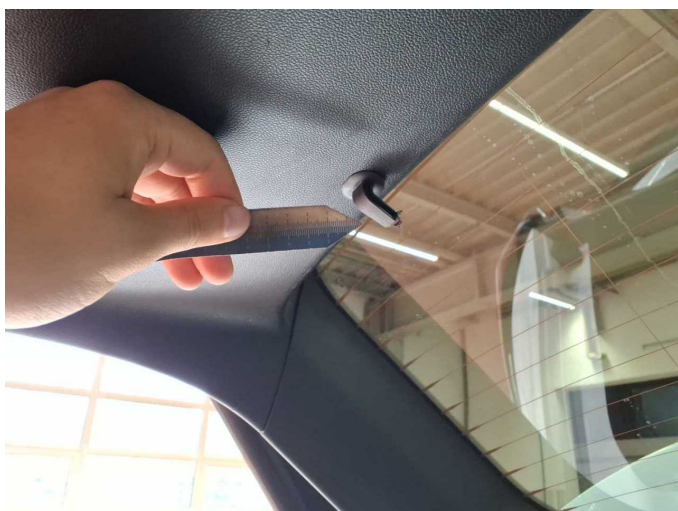
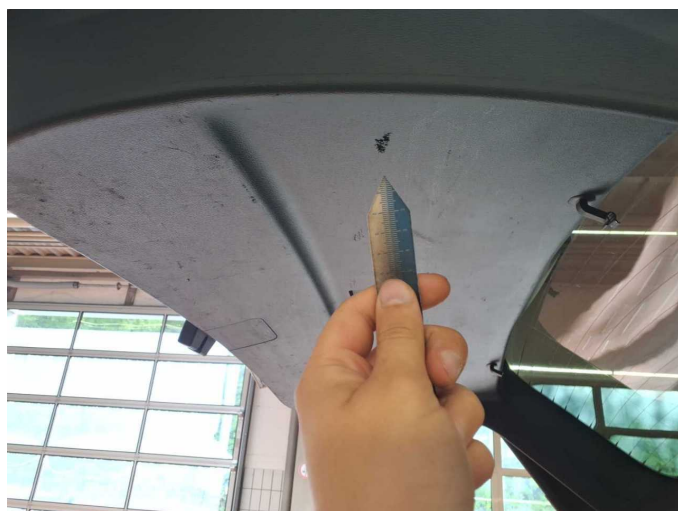
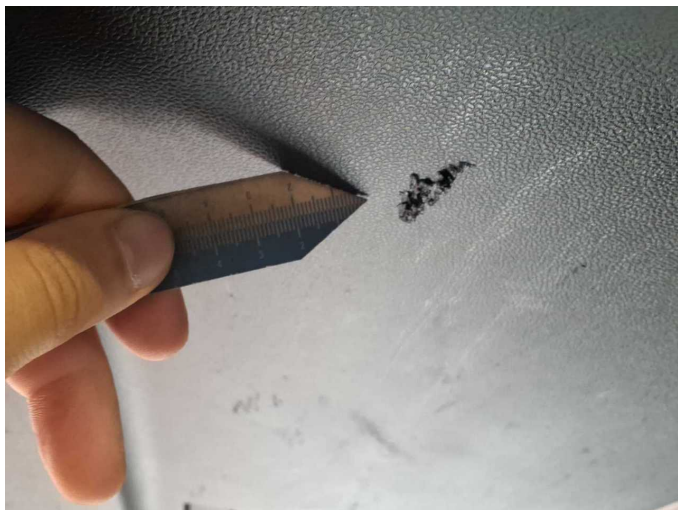
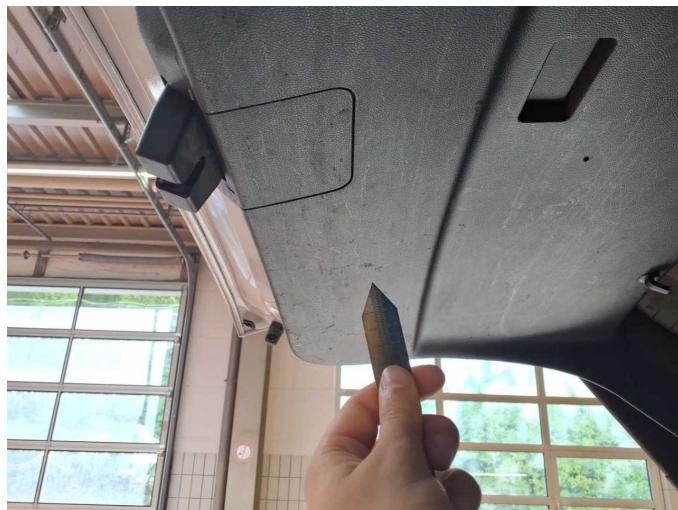
**Damage 12:** Trim / covers: Boot lid - interior trim (Halierung für  
Hutablage) - Scratched - Replace

**Damage 12:** Trim / covers: Boot lid - interior trim (Halterung für Hutablage) - Scratched - Replace

| No. | Component group | Description |
|---|---|---|
| 12 | Trim / covers | Boot lid - interior trim (Halterung für Hutablage) - Scratched - Replace |

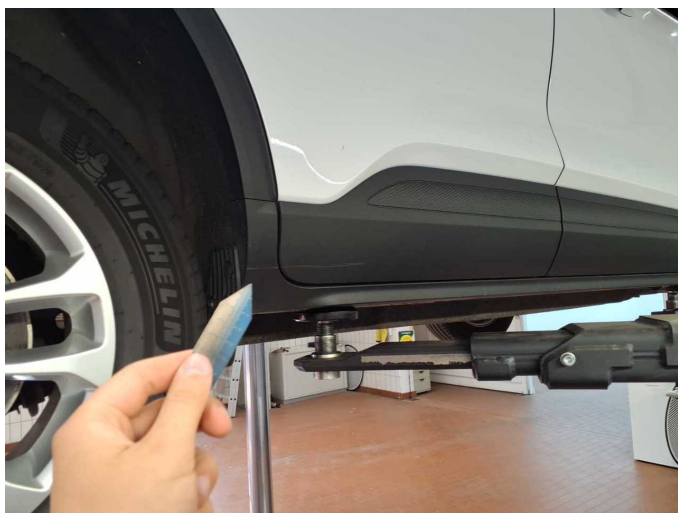
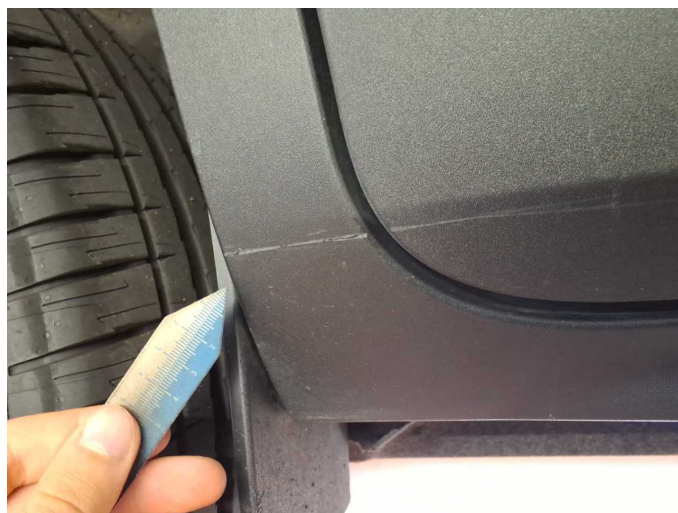
**Damage 13:** Sill - right side: Trim - Scratched - Replace

| No. | Component group | Description |
|---|---|---|
| 13 | Sill - right side | Trim - Scratched - Replace |

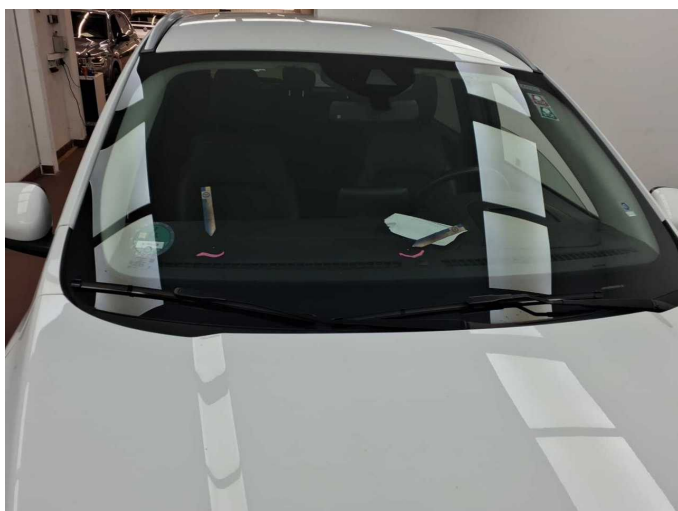
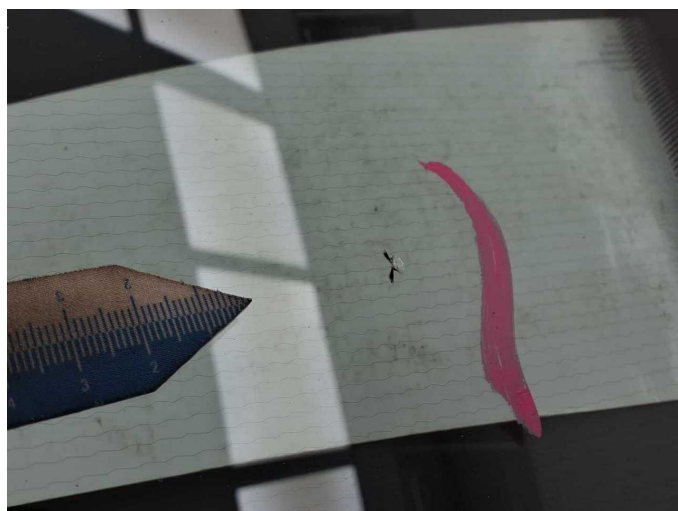
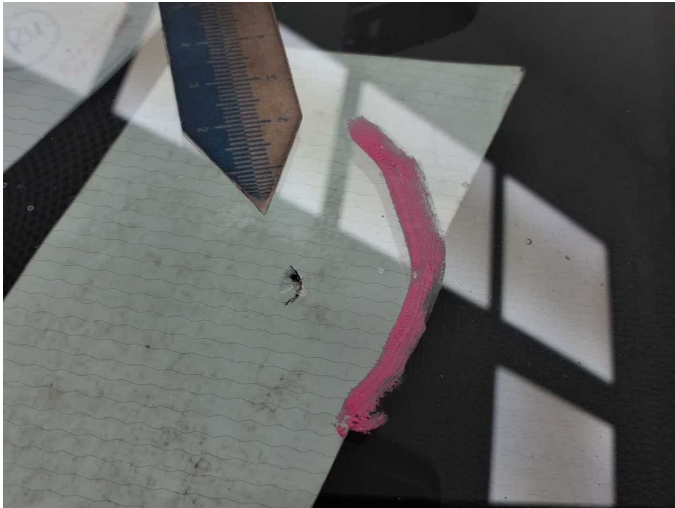
**Damage 14:** Vehicle glazing: Windscreen (mit Heizung) - Stone chips - repair according to calculation

| No. | Component group | Description |
|---|---|---|
| 14 | Vehicle glazing | Windscreen (mit Heizung) - Stone chips - repair according to calculation |

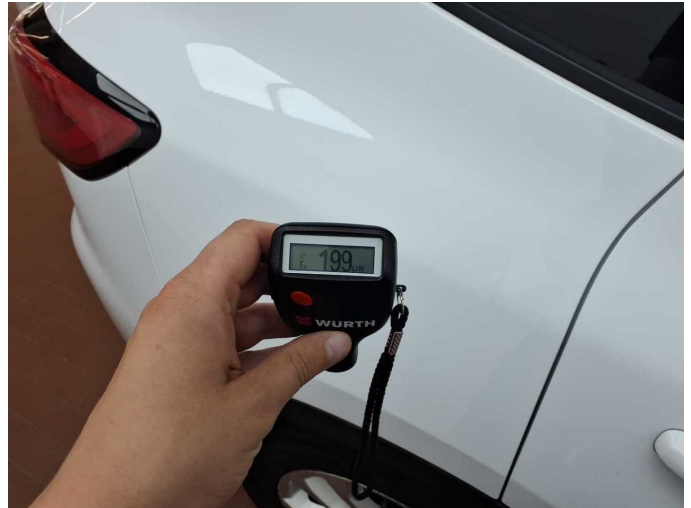
| No. | Repainting |
|---|---|
| 1 | Side panel - rear right side, Professionally carried out, Invoice of repair done Non-existent |

| Side panel - rear right side | 199 µm | Door - rear right side | 221 µm |

**Repainting 1:** Side panel - rear right side

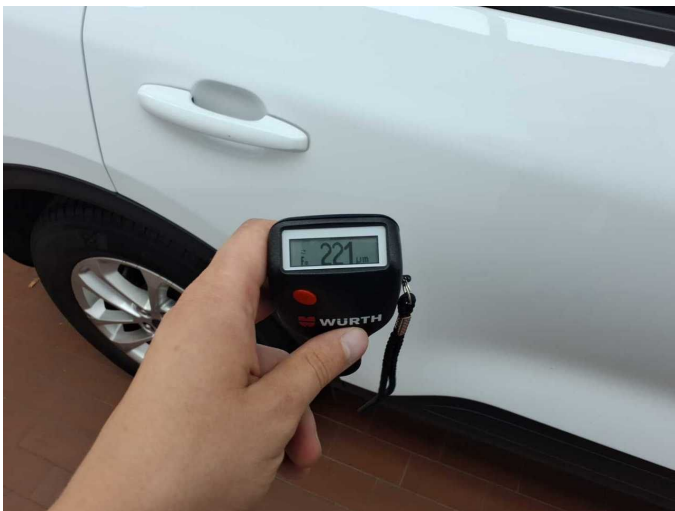
**Repainting 2:** Door - rear right side

| No. | Repainting |
|---|---|
| 2 | Door - rear right side, Professionally carried out, Invoice of repair done Non-existent |

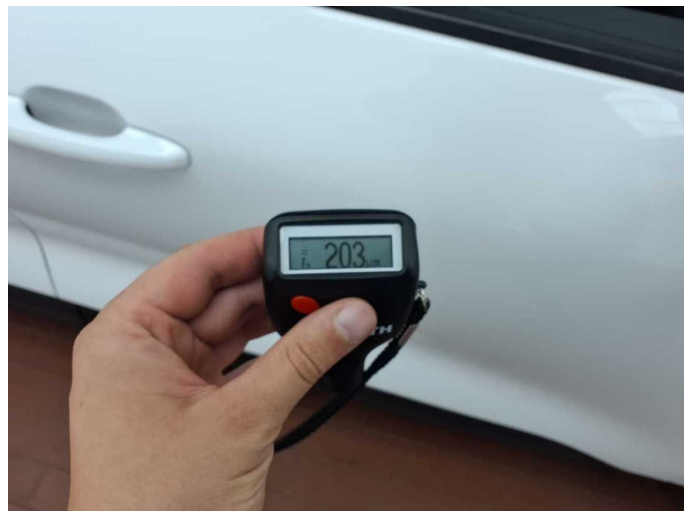
| No. | Repainting |
|---|---|
| 3 | Door - front right side, Professionally carried out, Invoice of repair done Non-existent |

| Door - front right side | 203 µm | | |

**Repainting 3:** Door - front right side
