Expertise

Protocol number: 46403606  
Order No. / Reference: 26360170  
Inspection date: 6 Jul 2026

Manufacturer: Mercedes-Benz  
VIN: W1KAH0DB8PF094604

Model: C 200 d T 9G-TRONIC Avantgarde

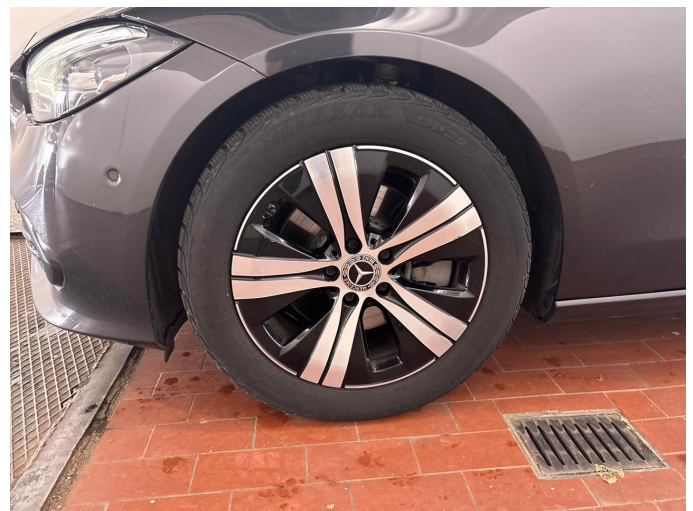
Figure 12: Mounted tyres

| # | Tyre size | Type of tyre | Manufacturer | Tread depth |
|---|---|---|---|---|
| 1) | 225/50 R17 94H | Winter tyres on Light alloy | Bridgestone | 5mm / 5mm |
| 2) | 225/50 R17 94H | Winter tyres on Light alloy | Bridgestone | 8mm / 8mm |

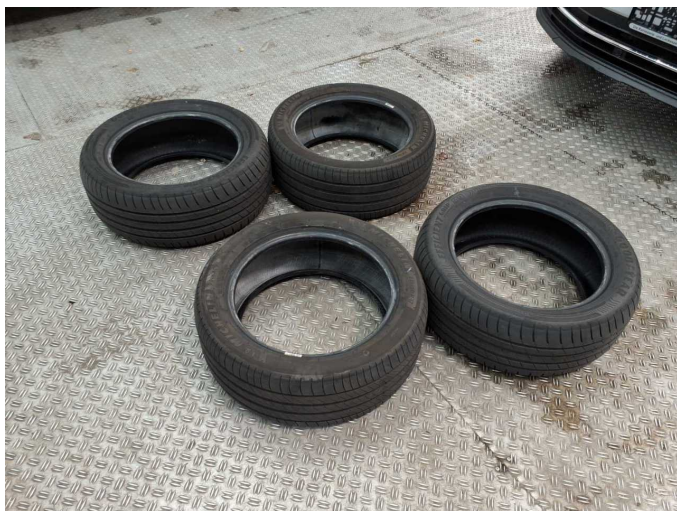
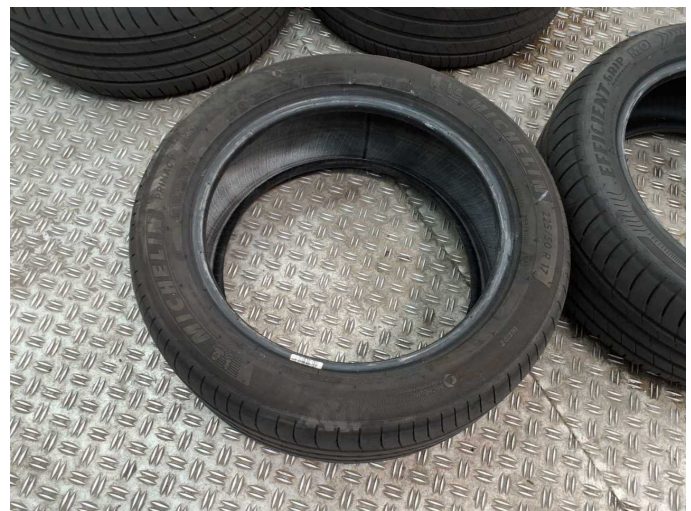
Figure 15: Additional tyres

| # | Tyre size | Type of tyre | Manufacturer | Tread depth |
|---|---|---|---|---|
| 1) | 225/50 R17 94Y | Summer tyres (Without wheel rim) | Michelin | 5mm / 5mm |
| 2) | 225/50 R17 94Y | Summer tyres (Without wheel rim) | Goodyear | 5mm / 5mm |

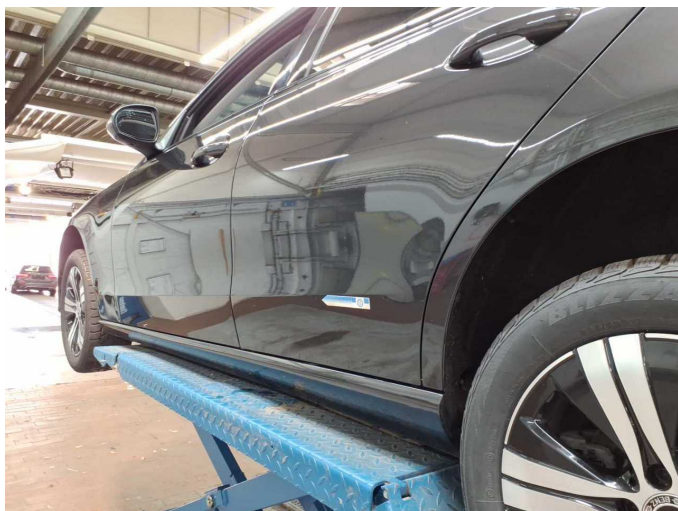
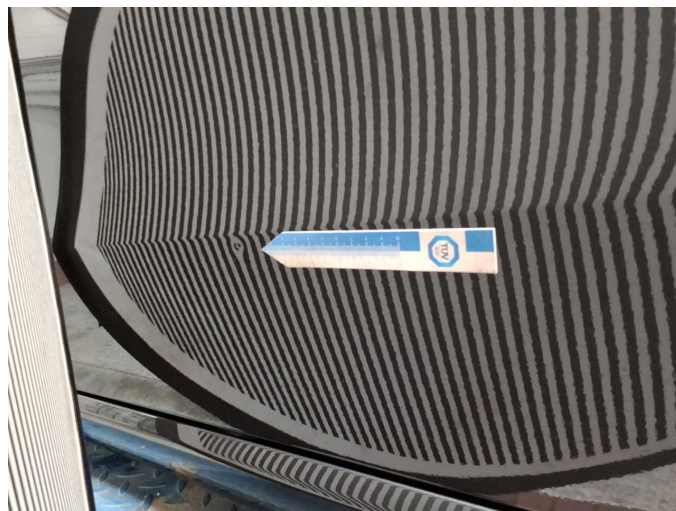
| No. | Component group | Description |
|---|---|---|
| 1 | Door - rear left side | Door - dent(s) - Smart repair |

**Damage 1:** Door - rear left side: Door - dent(s) - Smart repair

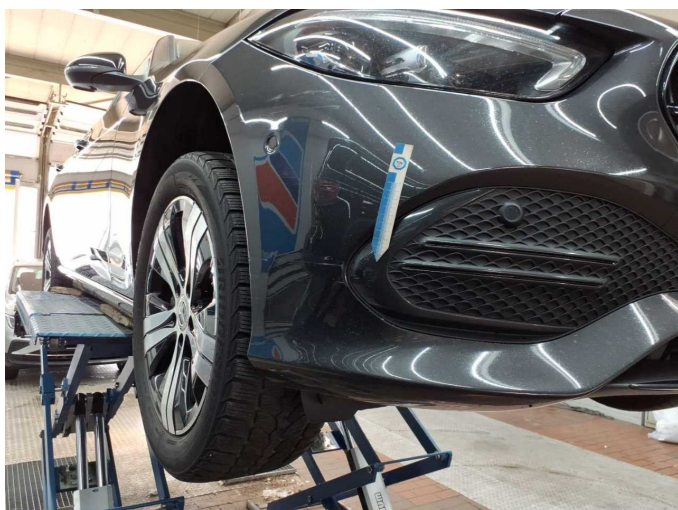
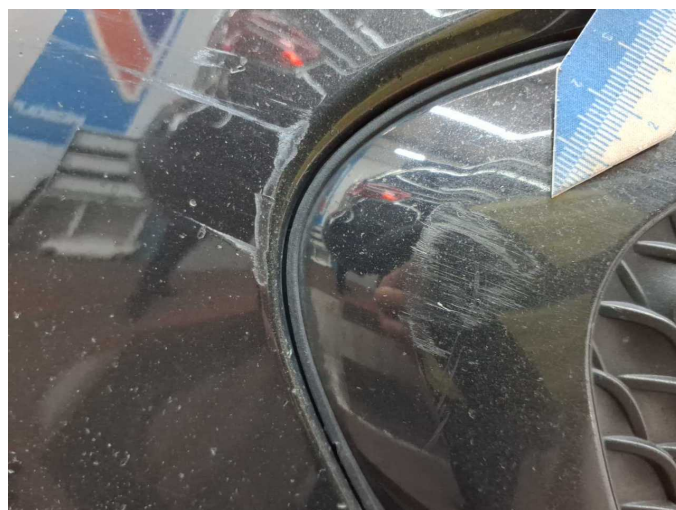
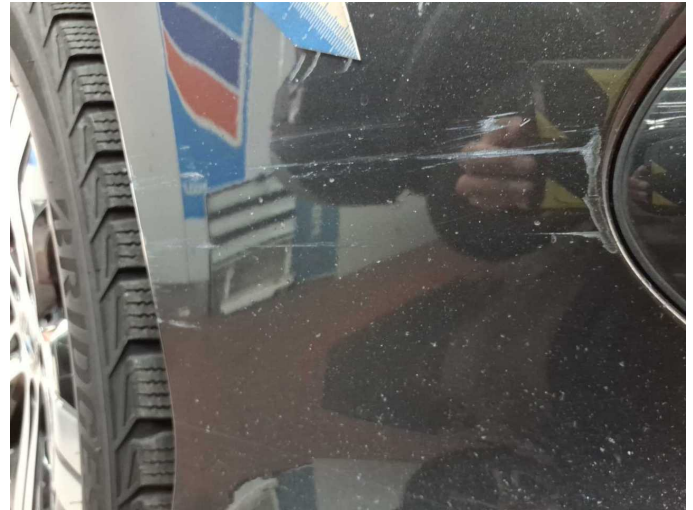
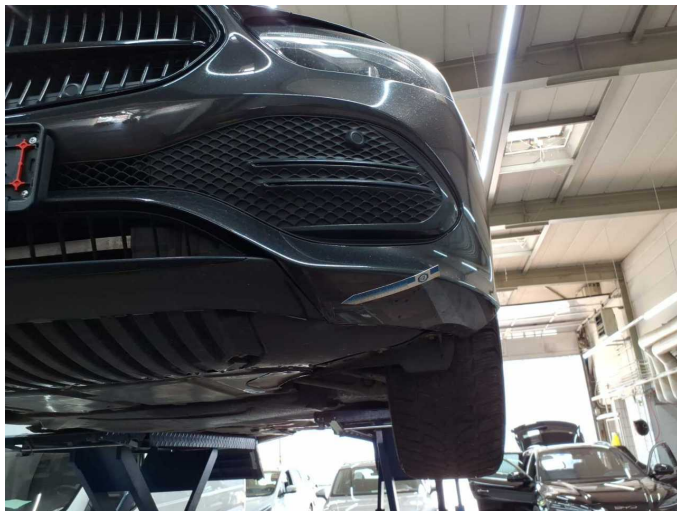
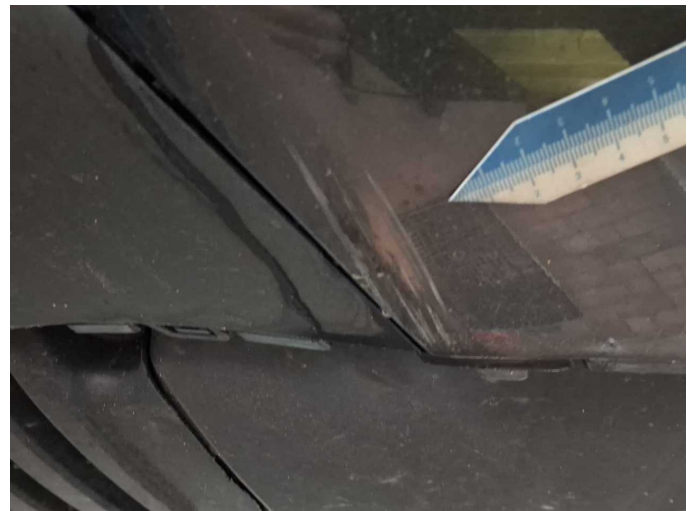
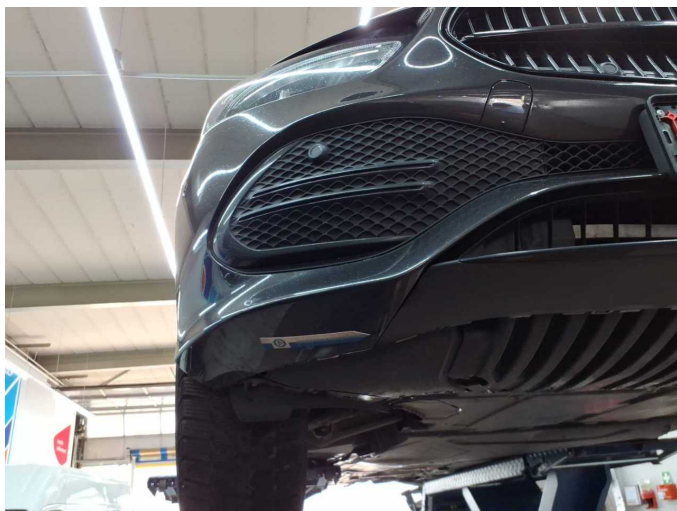
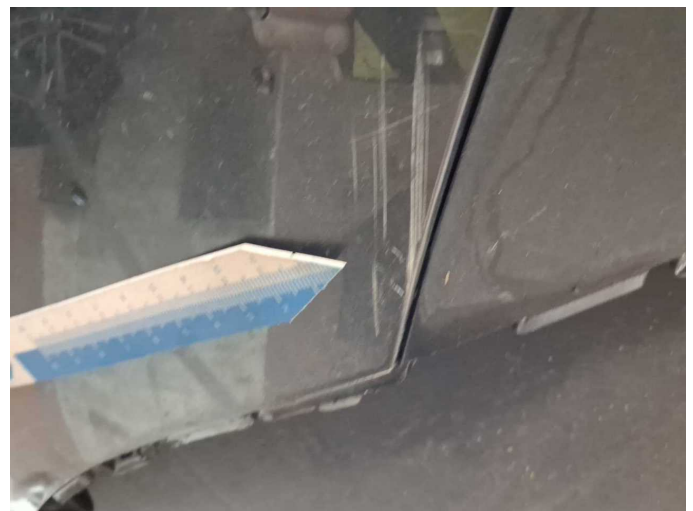
| No. | Component group | Description |
|---|---|---|
| 2 | Front bumper | Front bumper (inkl. Zierblende rechts erneuern) - Scratched - Repair and paint |

**Damage 2:** Front bumper: Front bumper (inkl. Zierblende rechts erneuern) - Scratched - Repair and paint

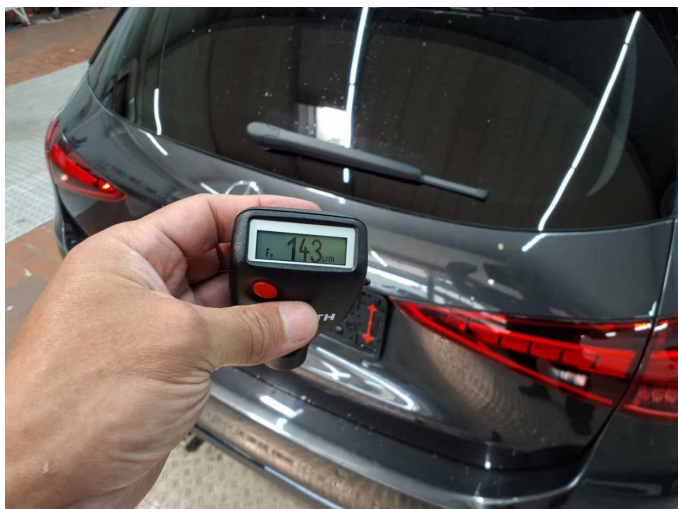
| 1 | Boot lid / rear door, Professionally carried out |

| Boot lid / rear door | 143 µm |

**Repainting 1:** Boot lid / rear door
