Expertise

Protocol number: 46545324  
Order No. / Reference: 26517949  
Inspection date: 8 Jul 2026

Model: A 200 d 8G-DCT Progressive

VIN: W1K1771121J246202

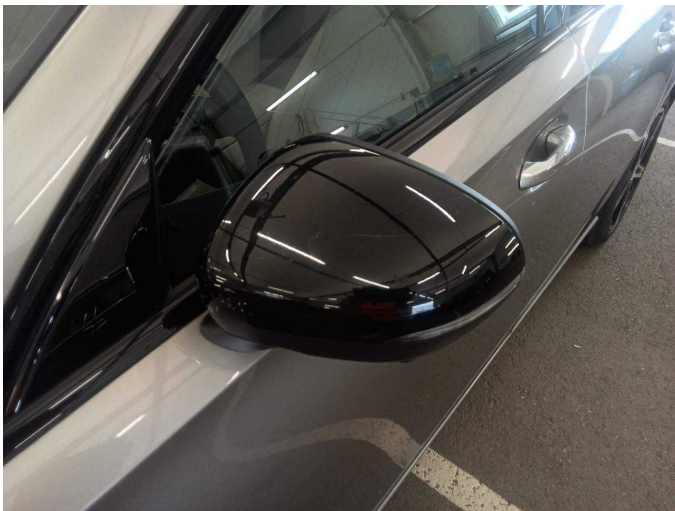
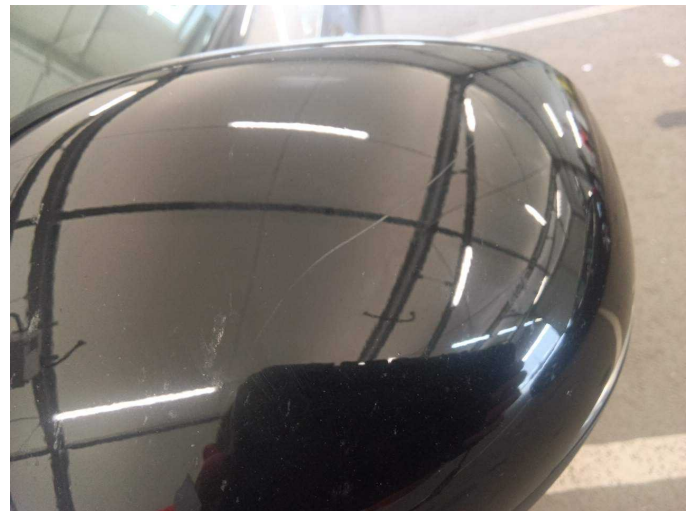
| No. | Component group | Description |
|---|---|---|
| 2 | Wing mirror - left side | Cap - Scratch(es) - Smart repair |

**Damage 2:** Wing mirror - left side: Cap - Scratch(es) - Smart repair

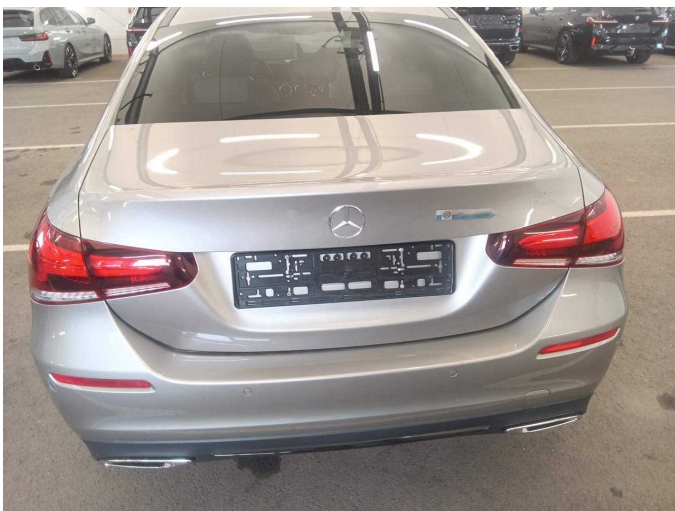
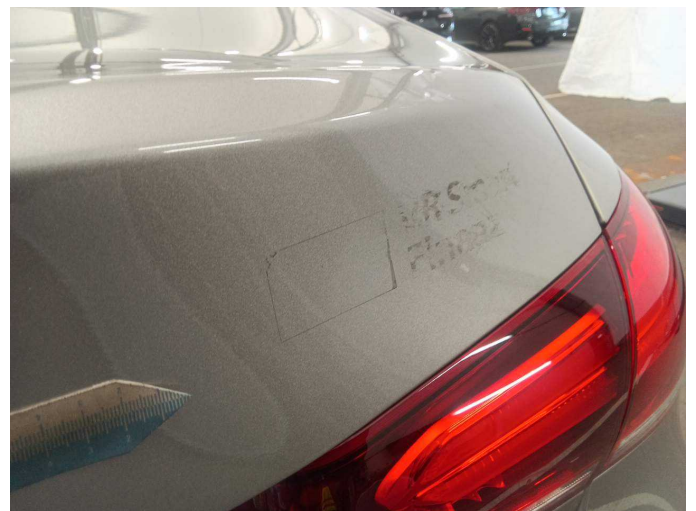
| No. | Component group | Description |
|---|---|---|
| 3 | Boot lid / rear door | Boot lid (Kleberreste) - Glued / labelled - De-glue / neutralise |

**Damage 3:** Boot lid / rear door: Boot lid (Kleberreste) - Glued / labelled - De-glue / neutralise

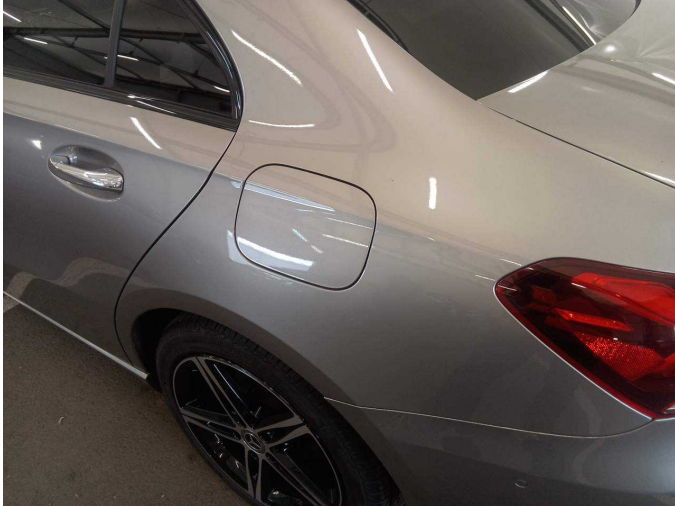
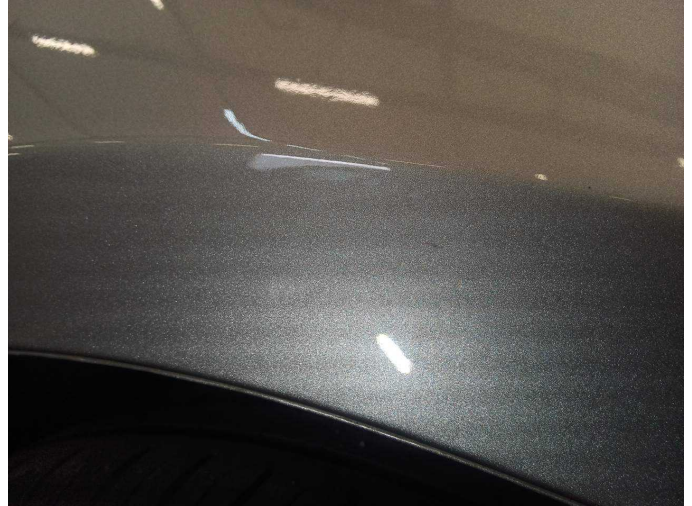
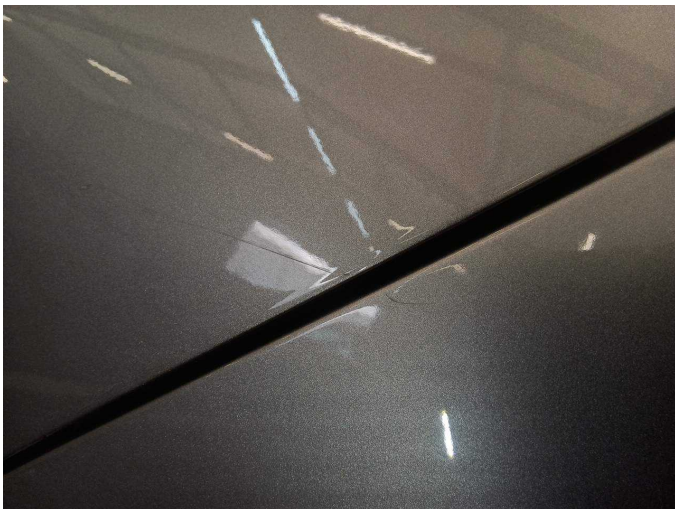
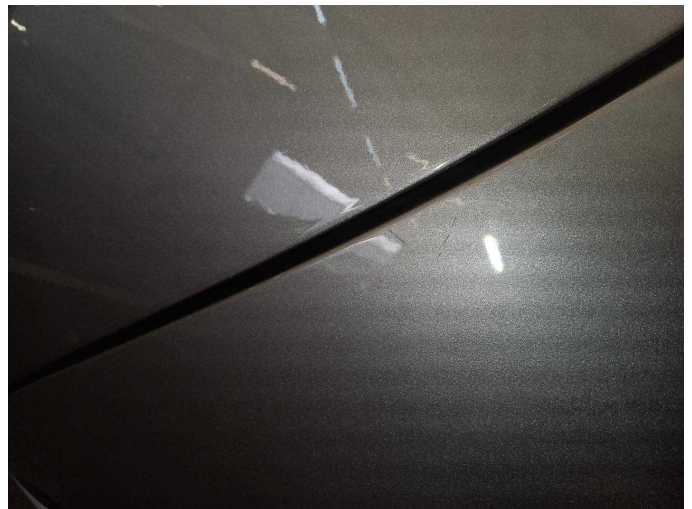
| No. | Component group | Description |
|---|---|---|
| 4 | Side panel - rear left side | Mudguard - rear left side - Scratch(es) - Smart repair |

**Damage 4:** Side panel - rear left side: Mudguard - rear left side - Scratch(es) - Smart repair

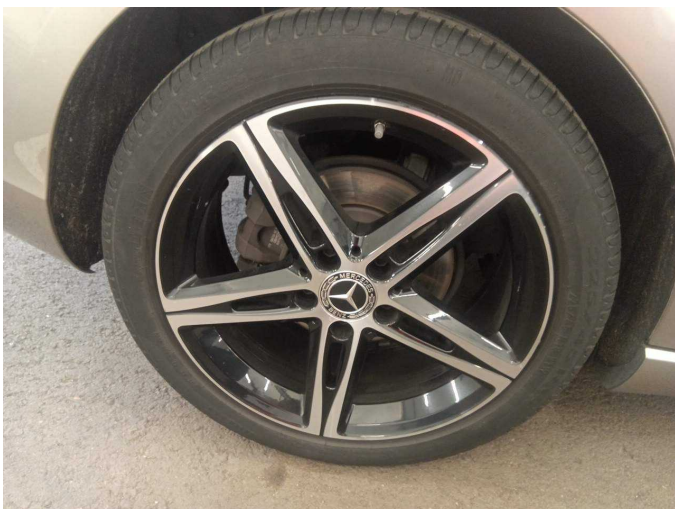
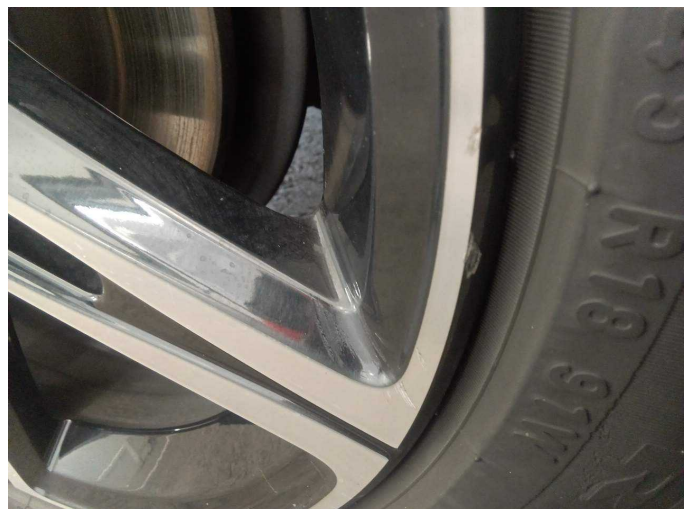
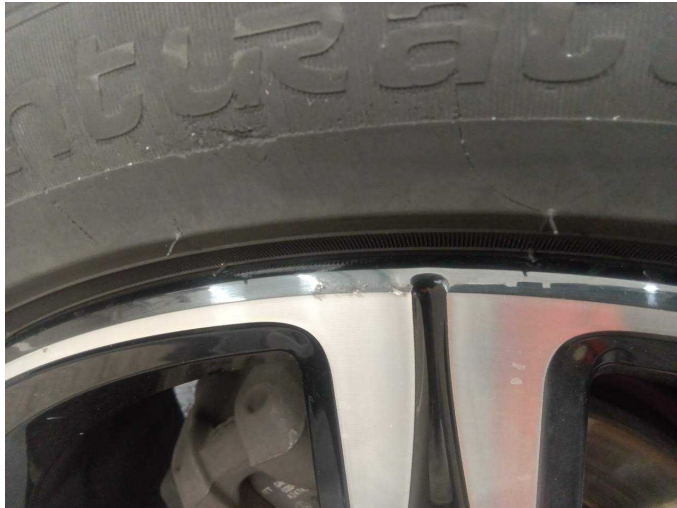
| No. | Component group | Description |
|---|---|---|
| 5 | Wheel / tyres | Alloy rim - rear right side - Scratch(es) - Loss in value |

**Damage 5:** Wheel / tyres: Alloy rim - rear right side - Scratch(es) - Loss in value

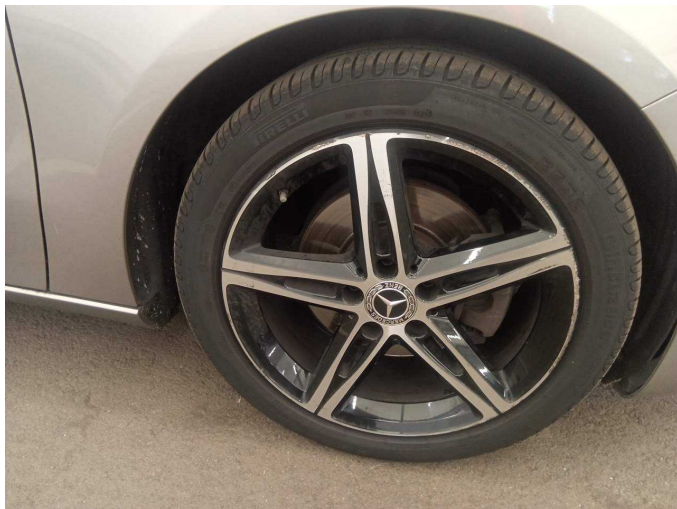
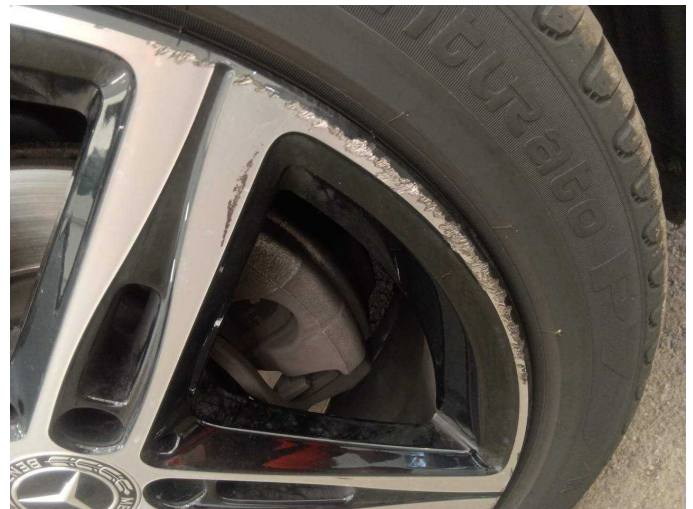
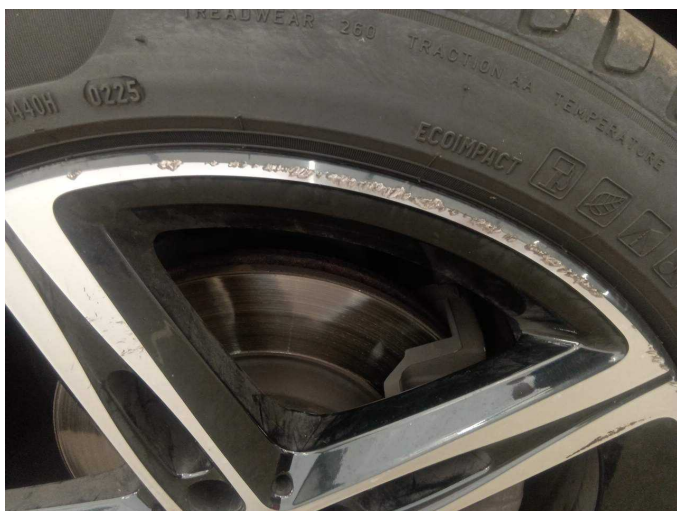
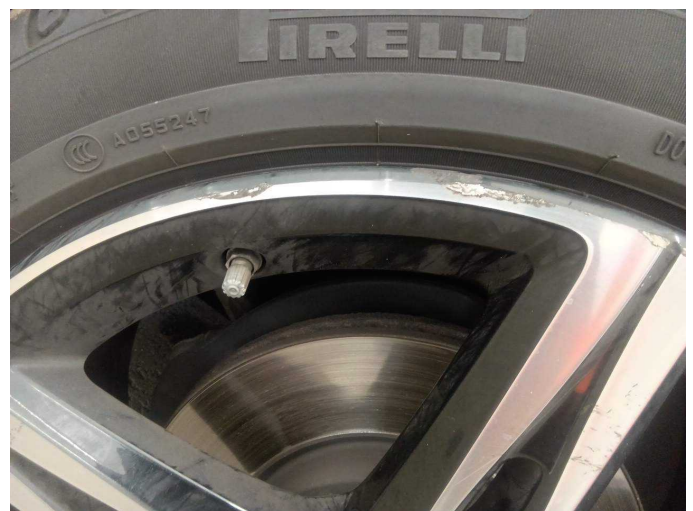
| No. | Component group | Description |
|---|---|---|
| 7 | Wheel / tyres | Alloy rim - front right side (Großflächig verkratzt) - Scratch(es) - Replace |

**Damage 7:** Wheel / tyres: Alloy rim - front right side (Großflächig verkratzt) - Scratch(es) - Replace

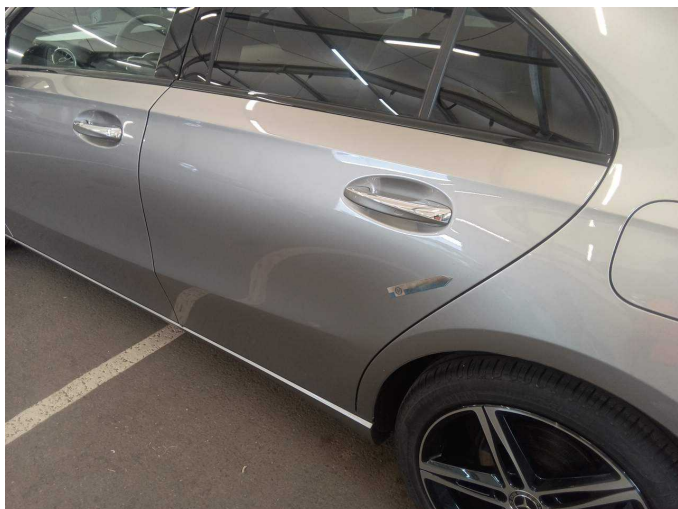
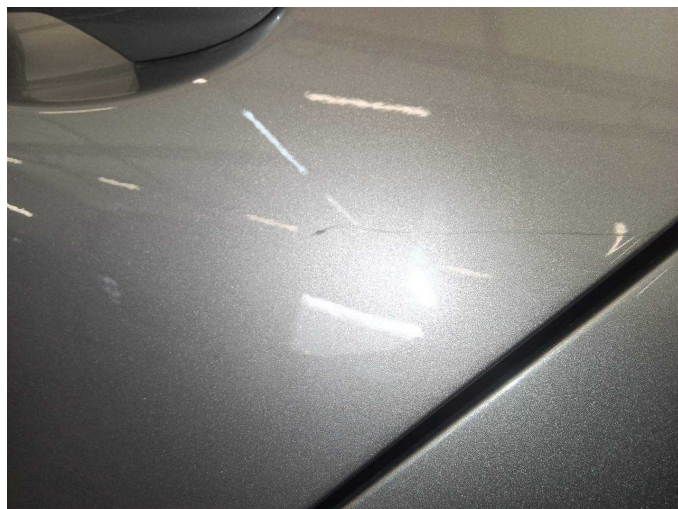
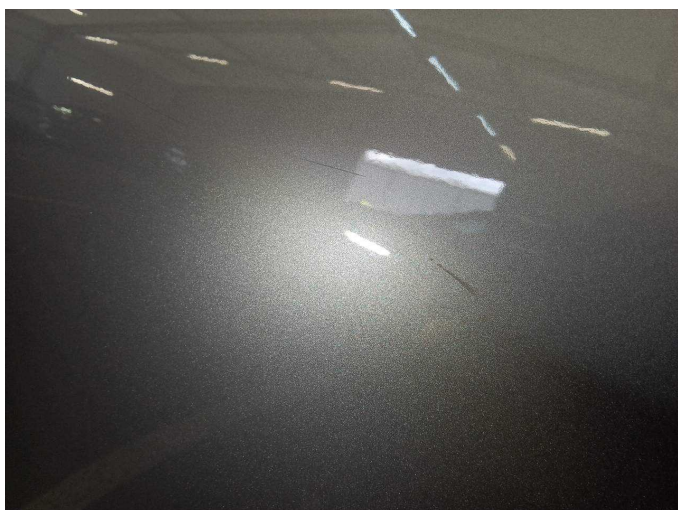
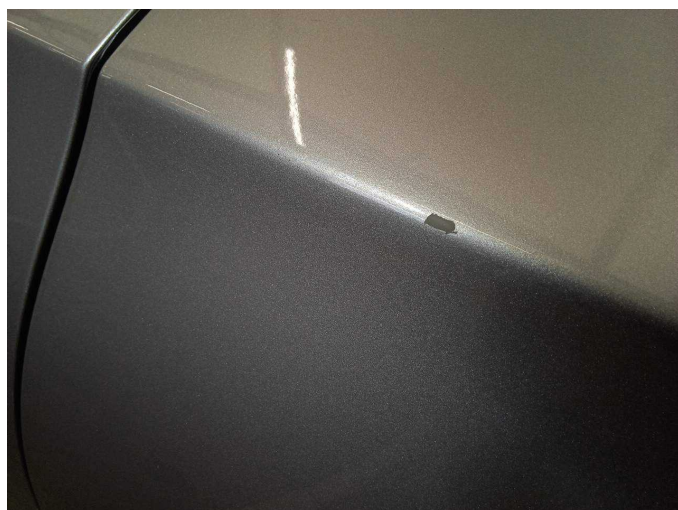
| No. | Component group | Description |
|---|---|---|
| 8 | Door - rear left side | Door - Scratch(es) - Paint |

**Damage 8:** Door - rear left side: Door - Scratch(es) - Paint

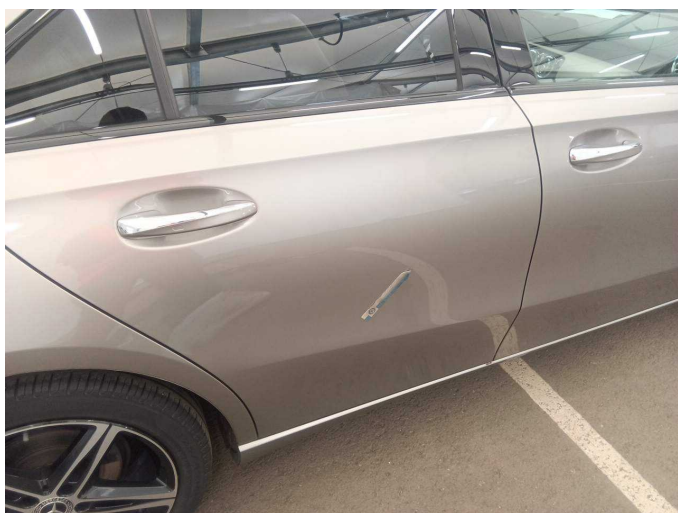
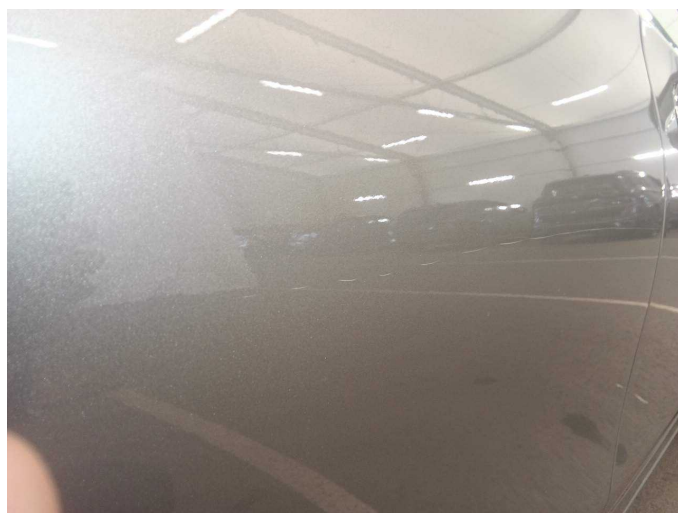
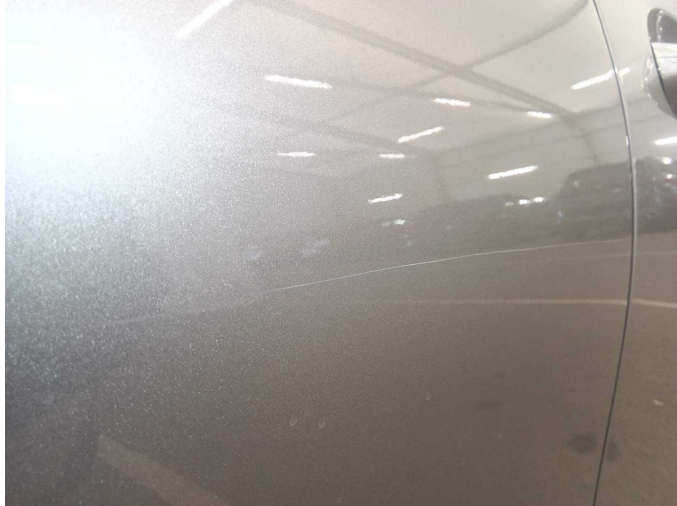
| No. | Component group | Description |
|---|---|---|
| 9 | Door - rear right side | Door - Scratch(es) - Paint |

**Damage 9:** Door - rear right side: Door - Scratch(es) - Paint

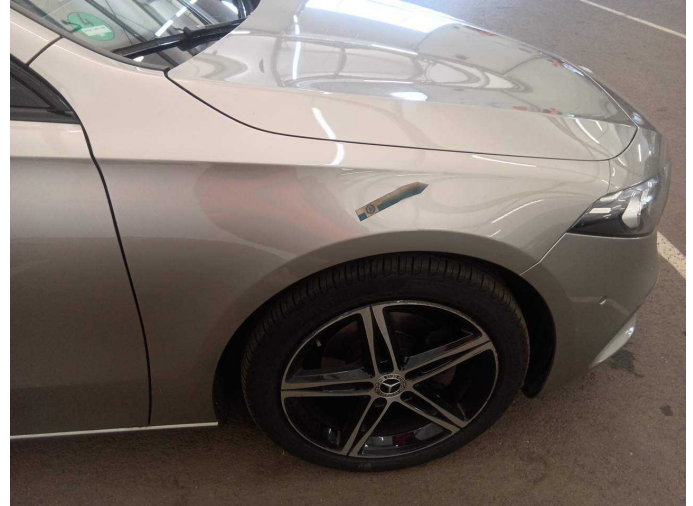
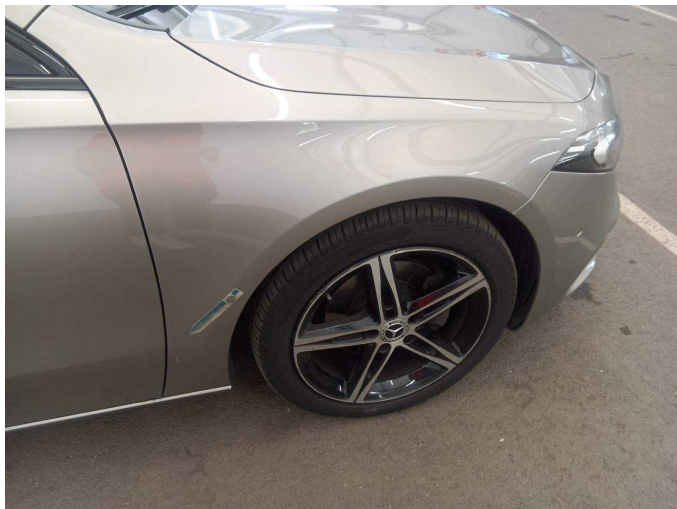
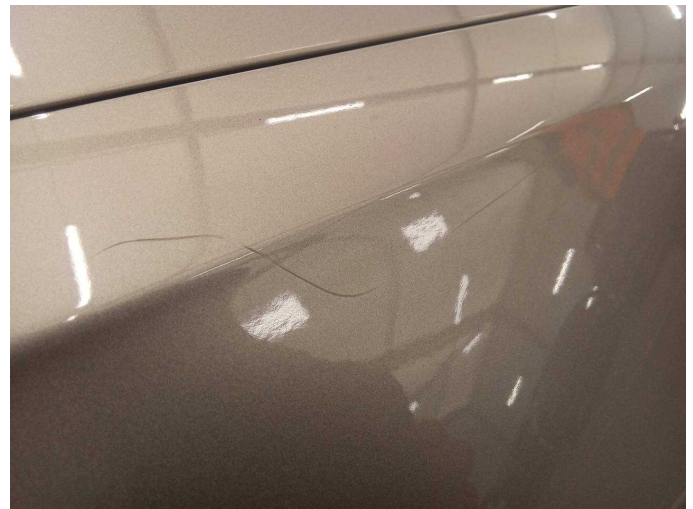
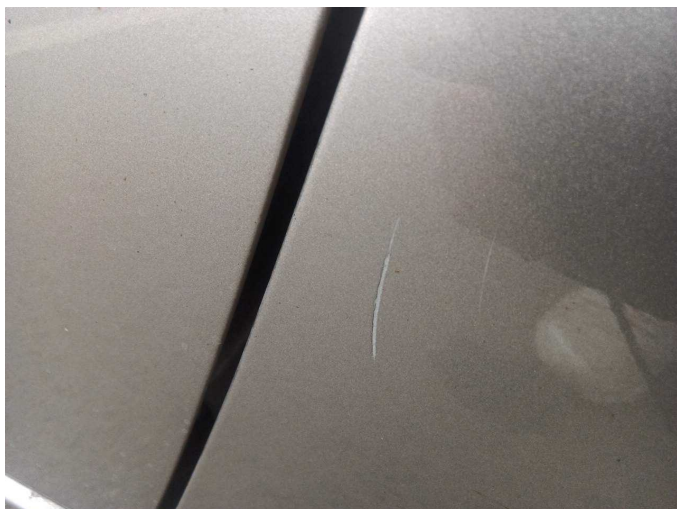
| No. | Component group | Description |
|---|---|---|
| 10 | Mudguard - right side | Mudguard - right side - Scratch(es) - Paint |

**Damage 10:** Mudguard - right side: Mudguard - right side - Scratch(es) - Paint

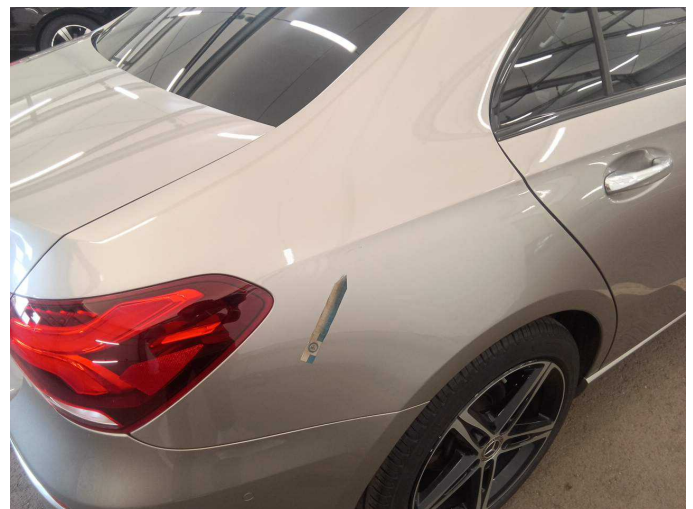
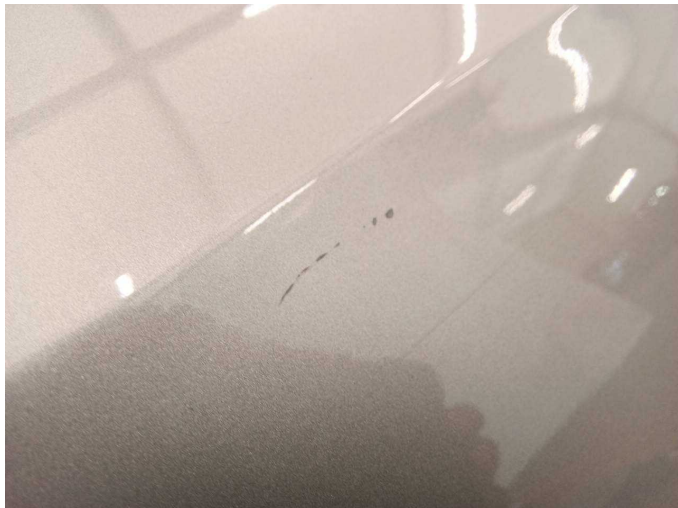
| No. | Component group | Description |
|---|---|---|
| 11 | Side panel - rear right side | Side panel - Scratch(es) - Paint |

**Damage 11:** Side panel - rear right side: Side panel - Scratch(es) - Paint

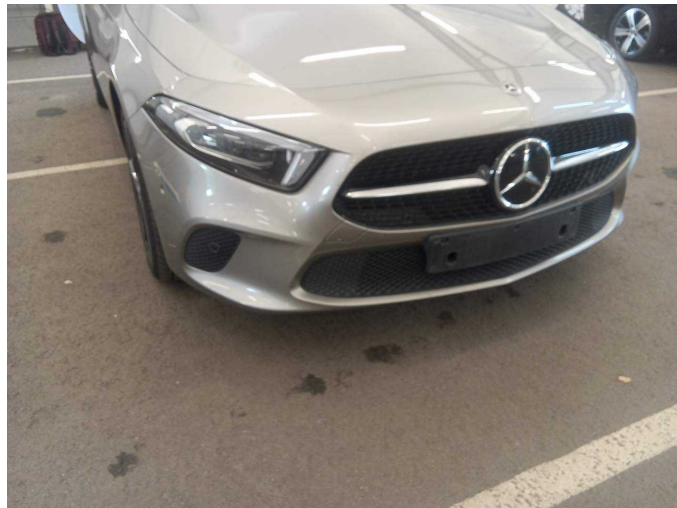
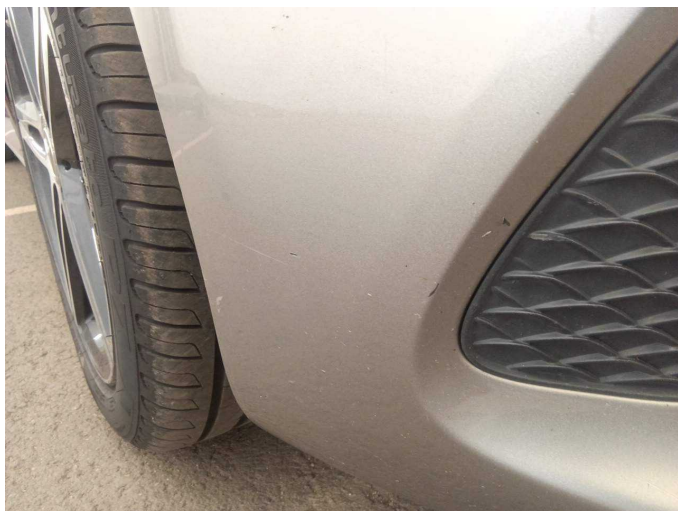
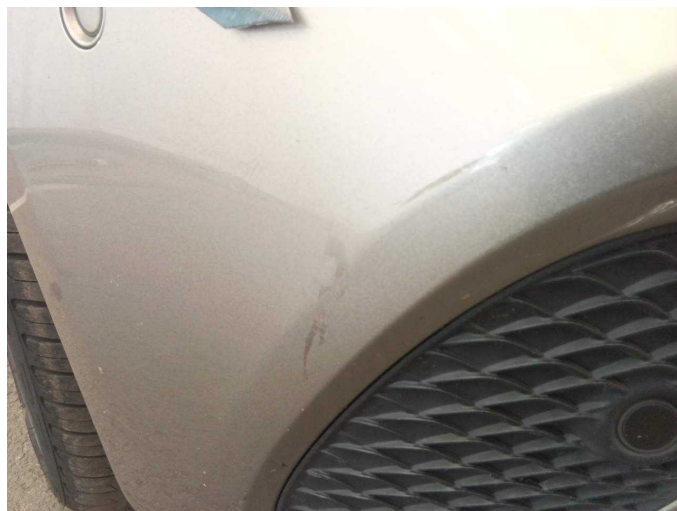
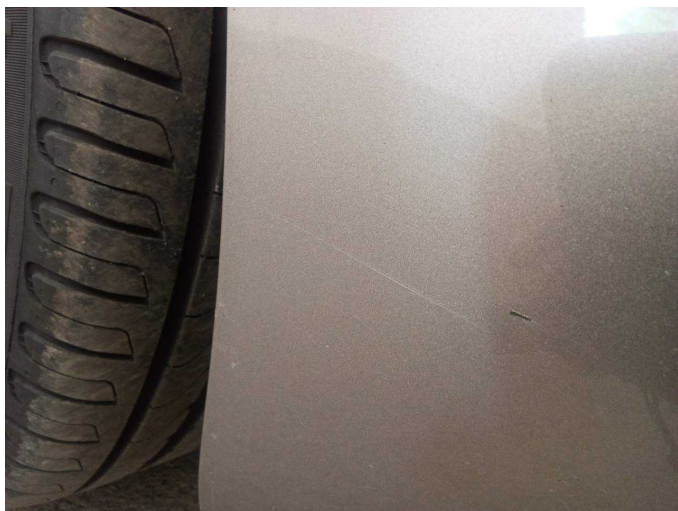
| No. | Component group | Description |
|---|---|---|
| 12 | Front bumper | Front bumper - Scratch(es) - Paint |

**Damage 12:** Front bumper: Front bumper - Scratch(es) - Paint

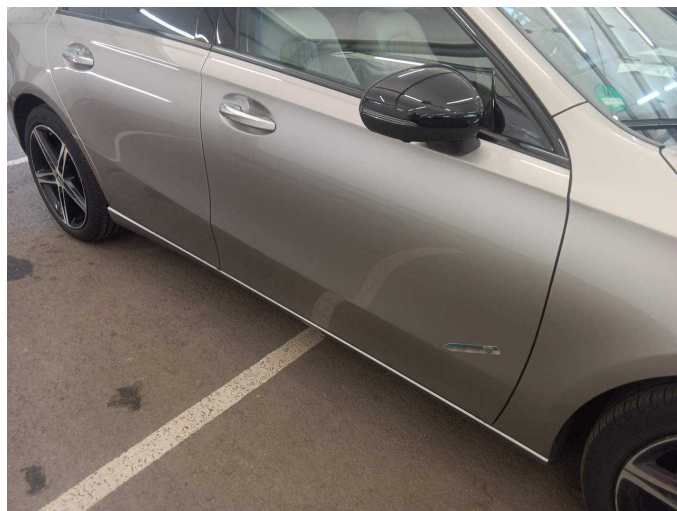
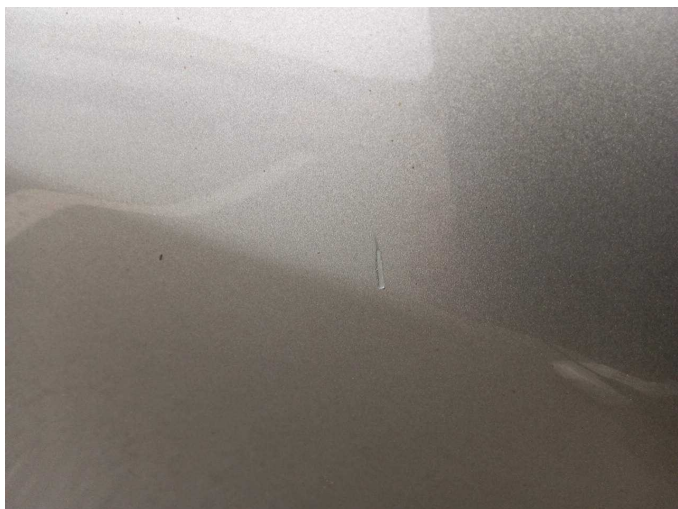
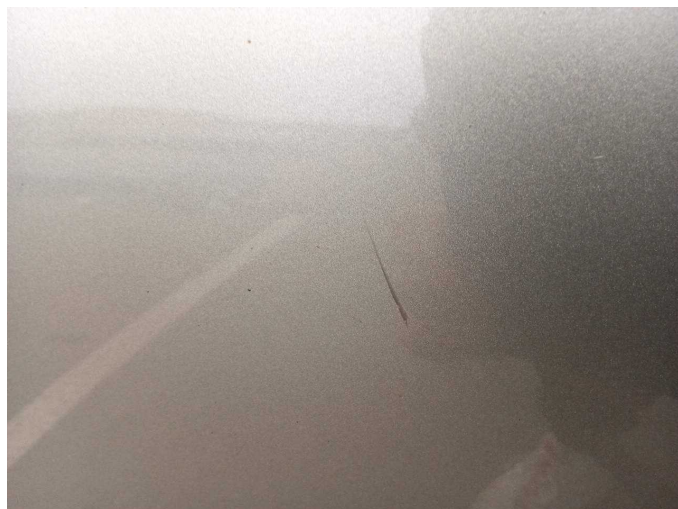
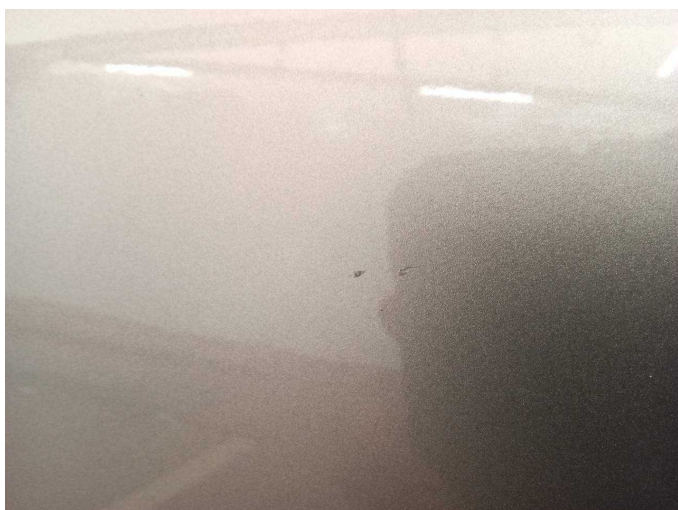
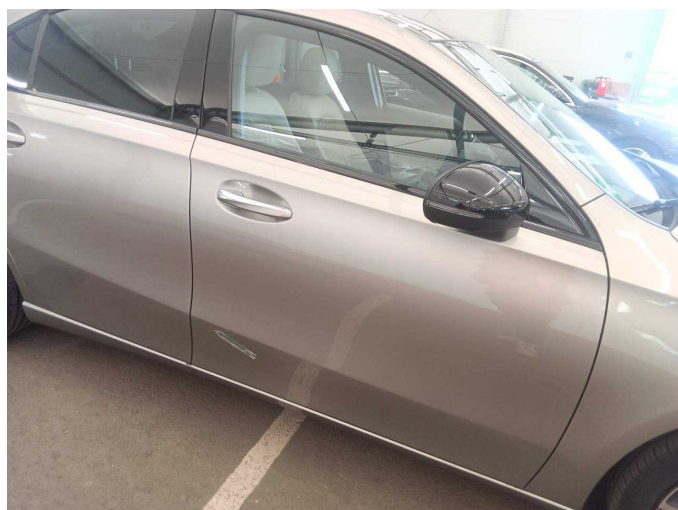
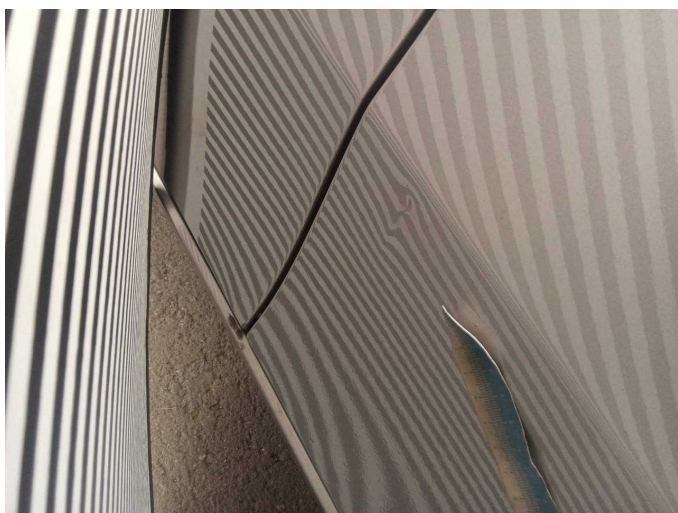
| No. | Component group | Description |
|---|---|---|
| 13 | Door - front right side | Door - Dent / paintcoat damage - Repair and paint |

**Damage 13:** Door - front right side: Door - Dent / paintcoat damage - Repair and paint

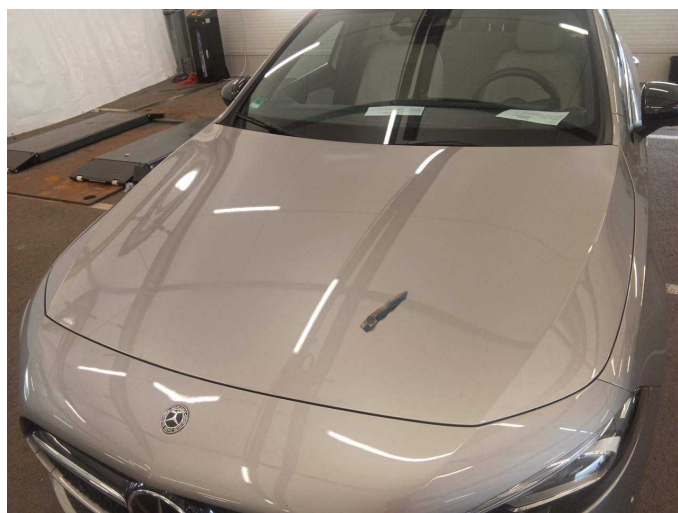
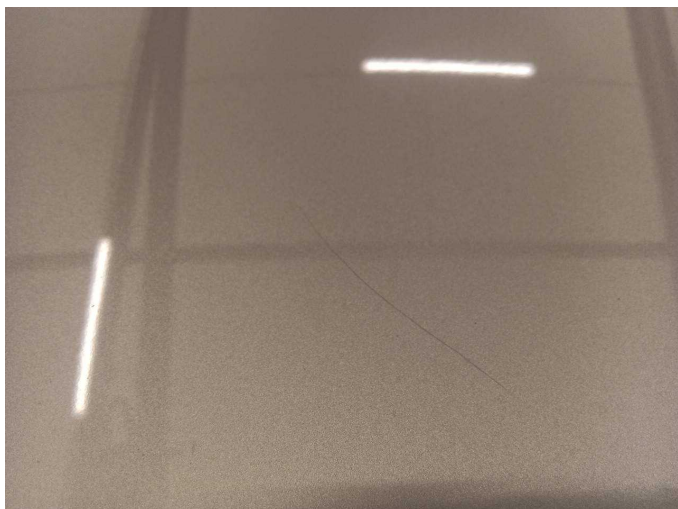
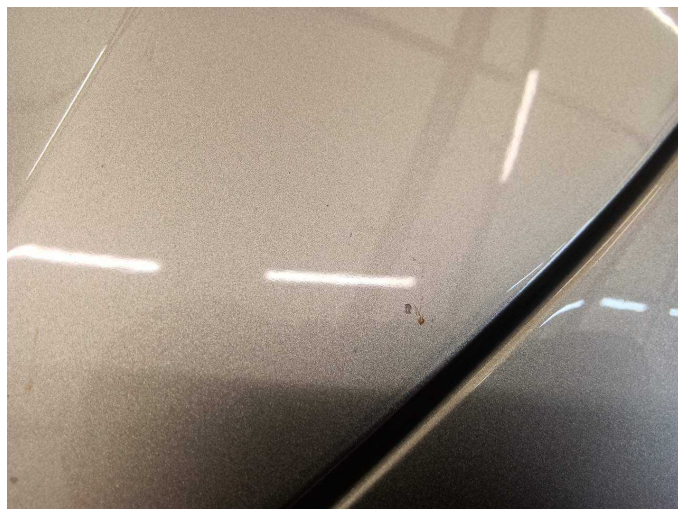
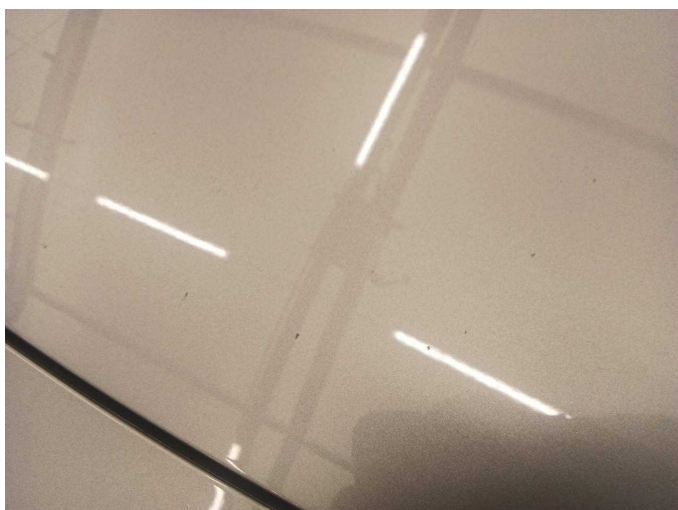
| No. | Component group | Description |
|---|---|---|
| 14 | Bonnet | Bonnet (Übermäßige Steinschläge) - Stone chips - Paint |

**Damage 14:** Bonnet: Bonnet (Übermäßige Steinschläge) - Stone chips - Paint

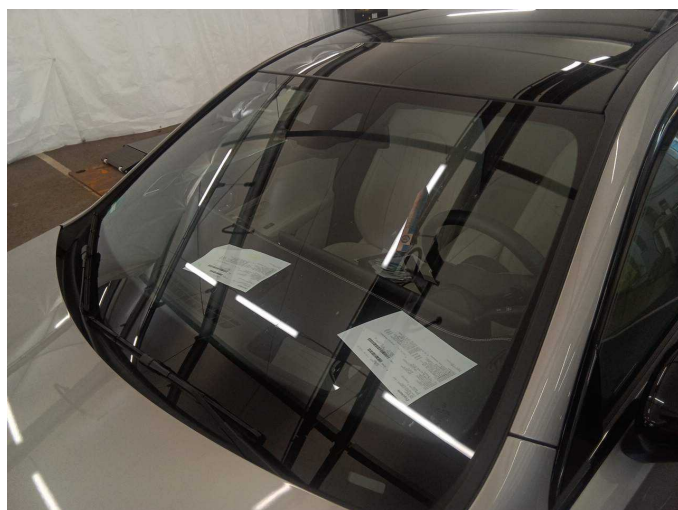
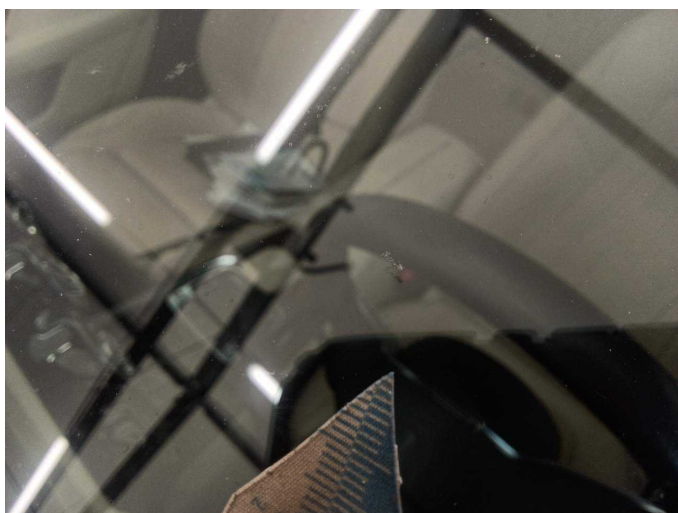
| No. | Component group | Description |
|---|---|---|
| 1 | Vehicle glazing | Windscreen - Stone chips - No deduction |

**Wear and tear 1:** Vehicle glazing: Windscreen - Stone chips - No deduction

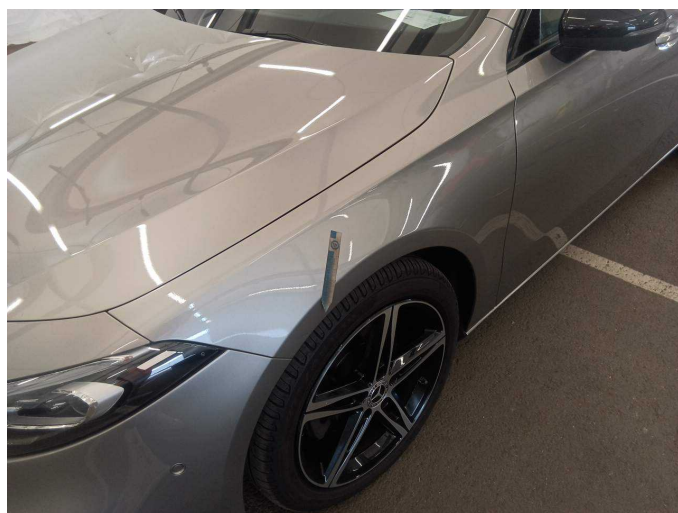
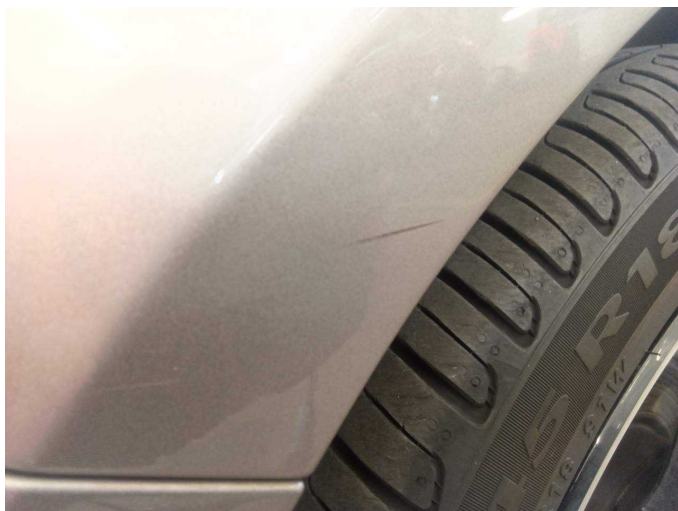
| No. | Component group | Description |
|---|---|---|
| 2 | Mudguard - left side | Mudguard - left side - Scratch(es) - No deduction |

**Wear and tear 2:** Mudguard - left side: Mudguard - left side - Scratch(es) - No deduction

**Wear and tear 2:** Mudguard - left side: Mudguard - left side - Scratch(es)  
- No deduction

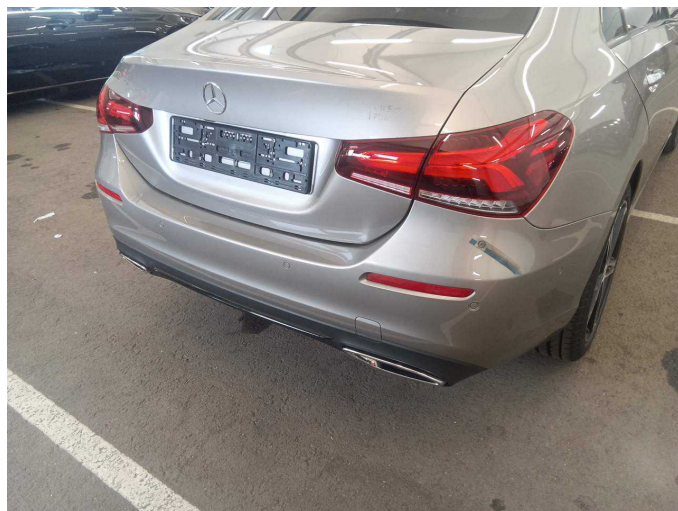
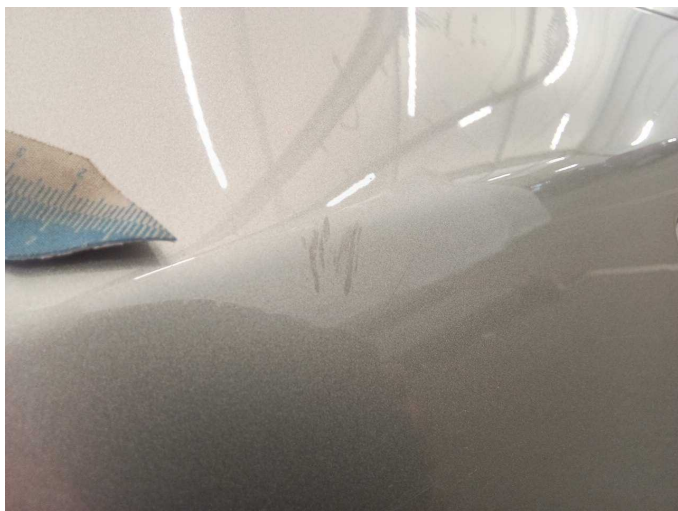
| No. | Component group | Description |
|---|---|---|
| 3 | Rear bumper | Rear bumper - Scratch(es) - No deduction |

**Wear and tear 3:** Rear bumper: Rear bumper - Scratch(es) - No deduction
