Expertise

Protocol number: 46028326  
Order No. / Reference: 26472575  
Inspection date: 18 Jun 2026

Manufacturer: Audi

Model: A4 Avant 45 TFSI quattro S tronic advanced

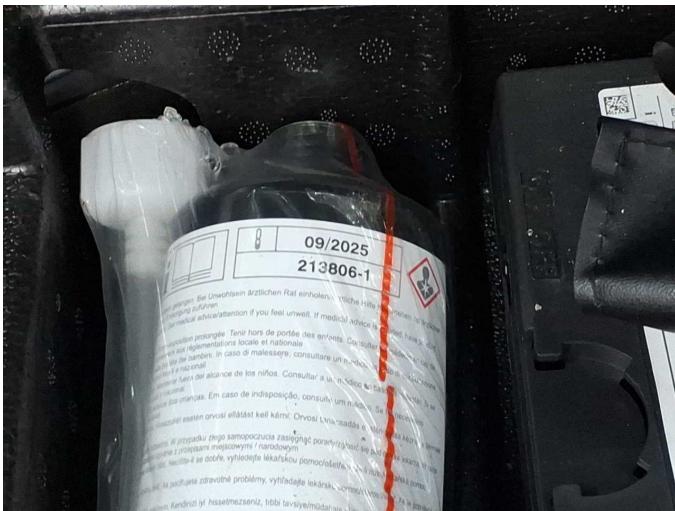
| No. | Component group | Description |
|---|---|---|
| 1 | Equipment | Tirefit filler - Expired - Replace |

**Damage 1:** Equipment: Tirefit filler - Expired - Replace

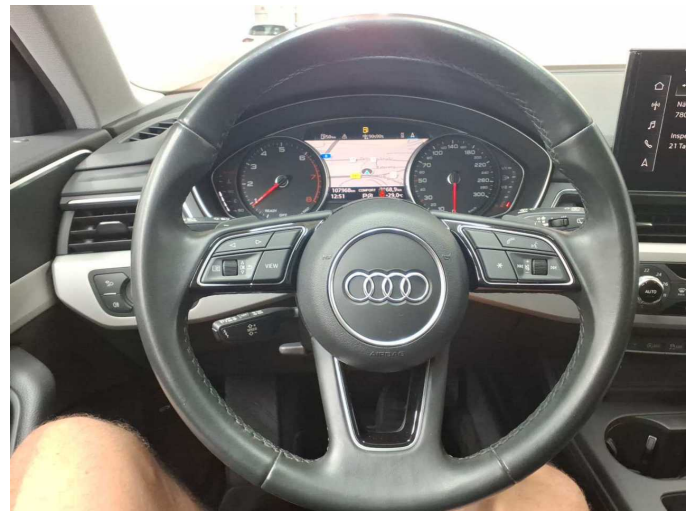
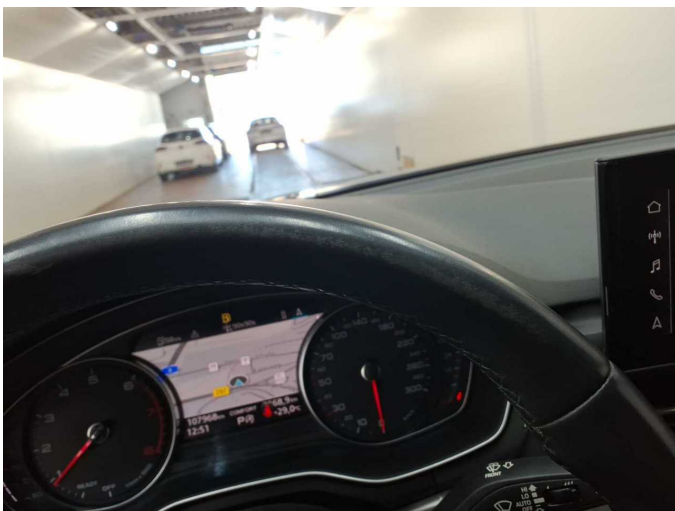
| No. | Component group | Description |
|---|---|---|
| 2 | Steering system | Steering wheel - Abrasion - Loss in value |

**Damage 2:** Steering system: Steering wheel - Abrasion - Loss in value

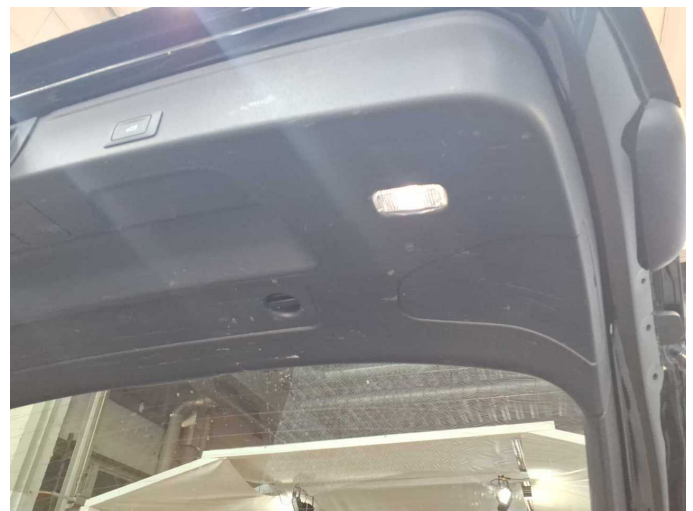
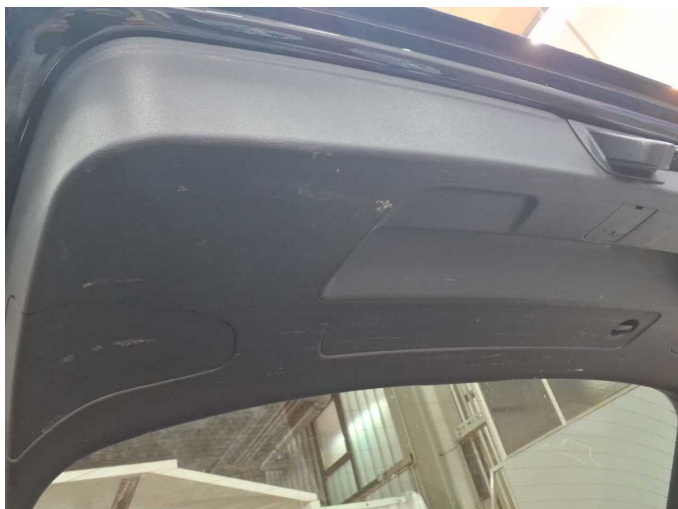
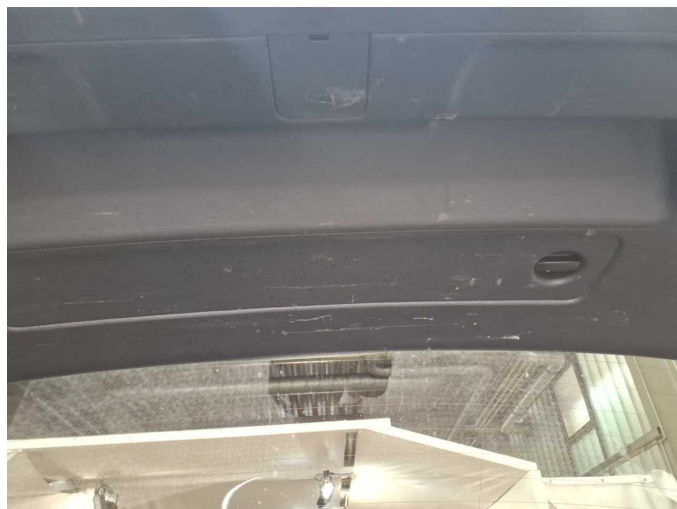
| No. | Component group | Description |
|---|---|---|
| 3 | Trim / covers | Boot lid - interior trim - Scratch(es) - Loss in value |

**Damage 3:** Trim / covers: Boot lid - interior trim - Scratch(es) - Loss in value

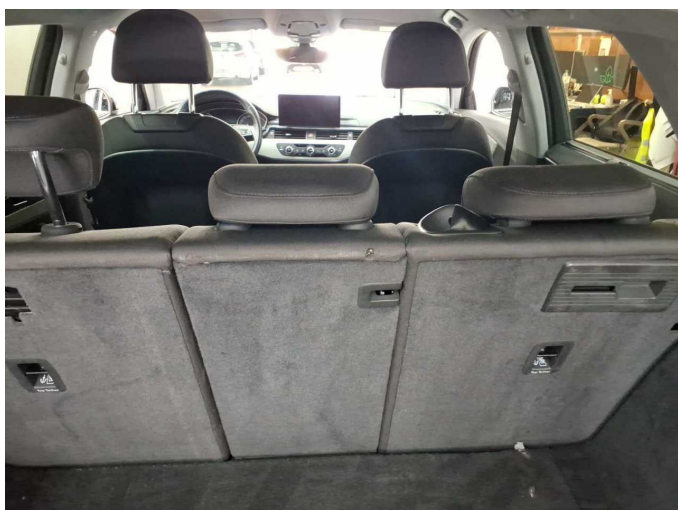
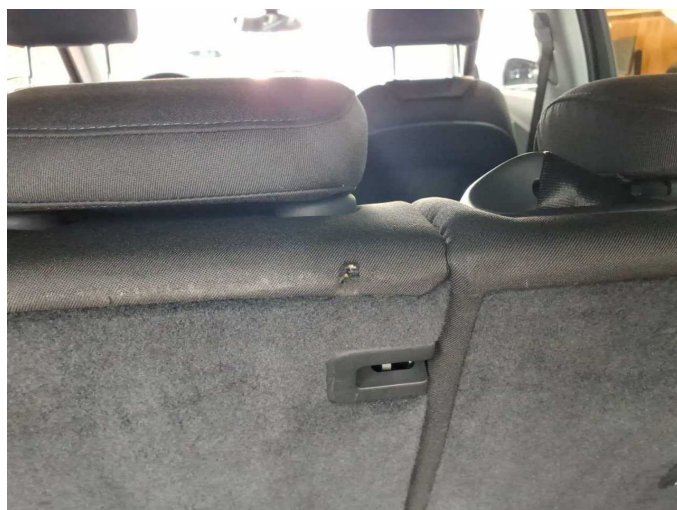
| No. | Component group | Description |
|---|---|---|
| 4 | Seat - rear | Upholstery - Holes - Loss in value |

**Damage 4:** Seat - rear: Upholstery - Holes - Loss in value

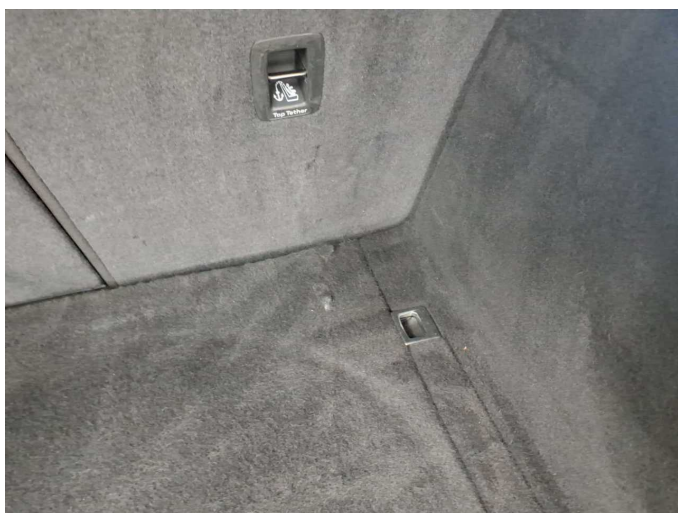
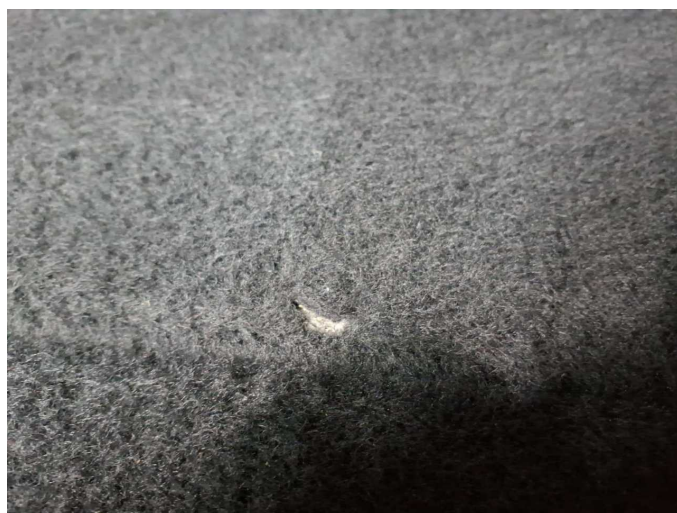
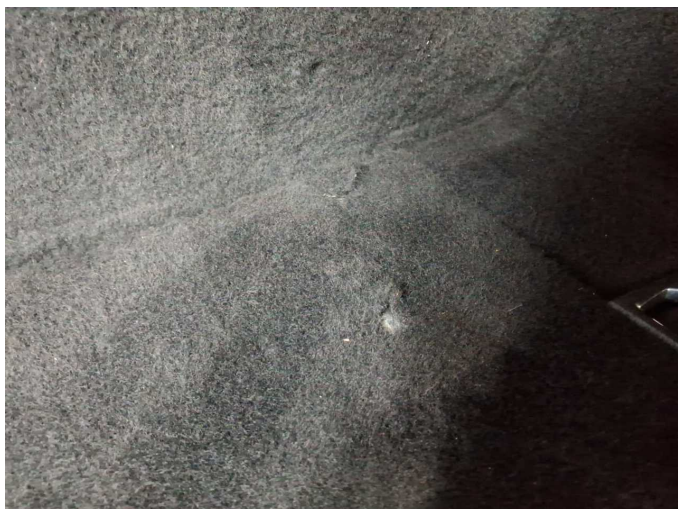
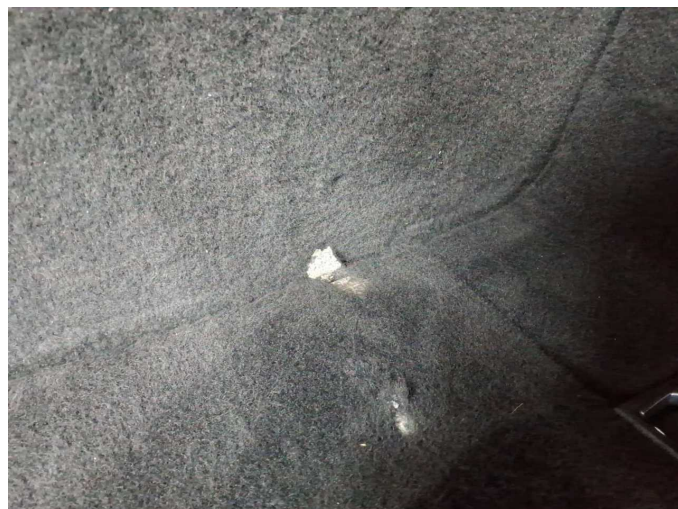
| No. | Component group | Description |
|---|---|---|
| 5 | Interior | Cargo area floor - Holes - Replace |

**Damage 5:** Interior: Cargo area floor - Holes - Replace

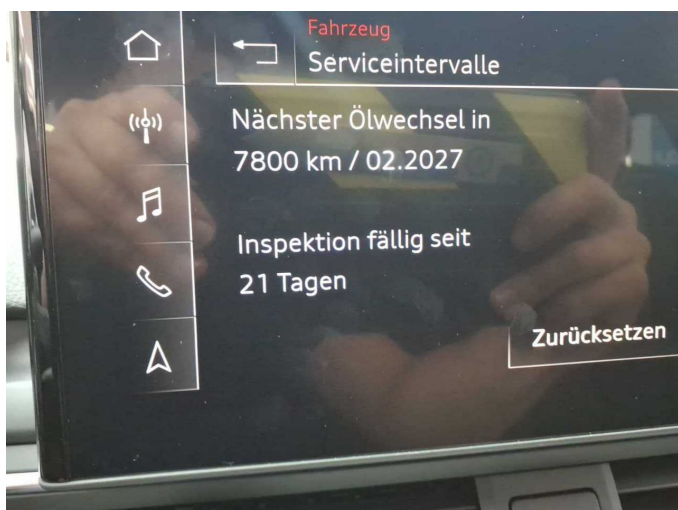
| No. | Component group | Description |
|---|---|---|
| 6 | Misc. | Inspection / maintenance (Kein Nachweis) - Due - Perform |

**Damage 6:** Misc.: Inspection / maintenance (Kein Nachweis) - Due - Perform

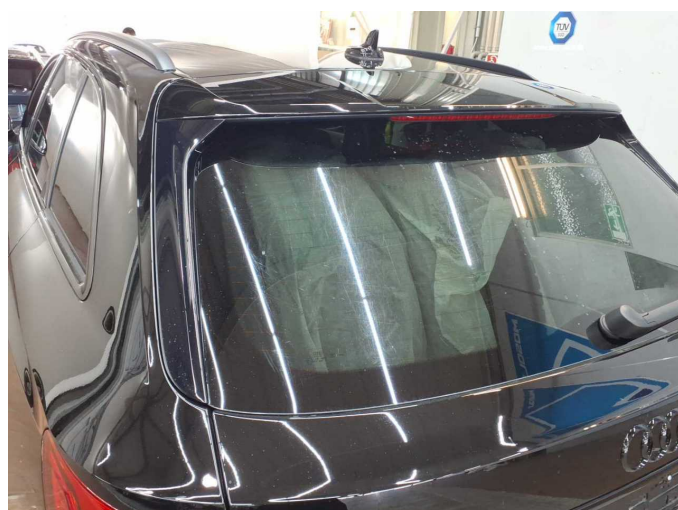
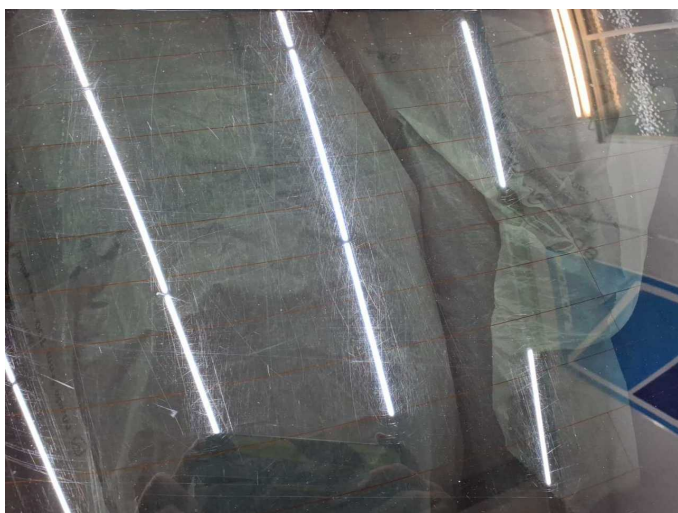
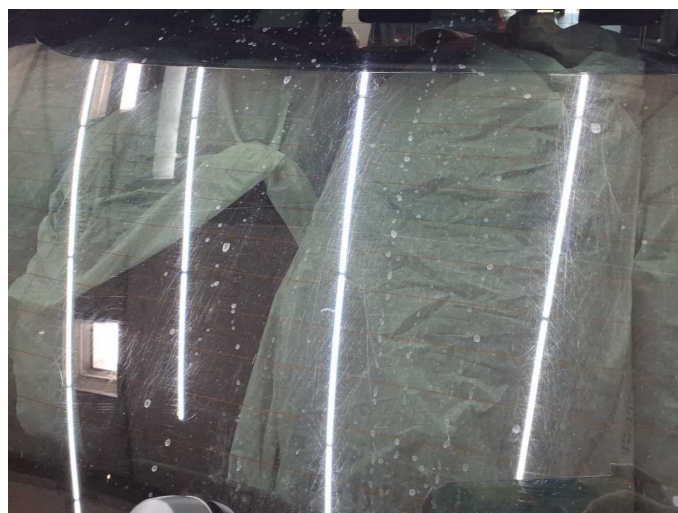
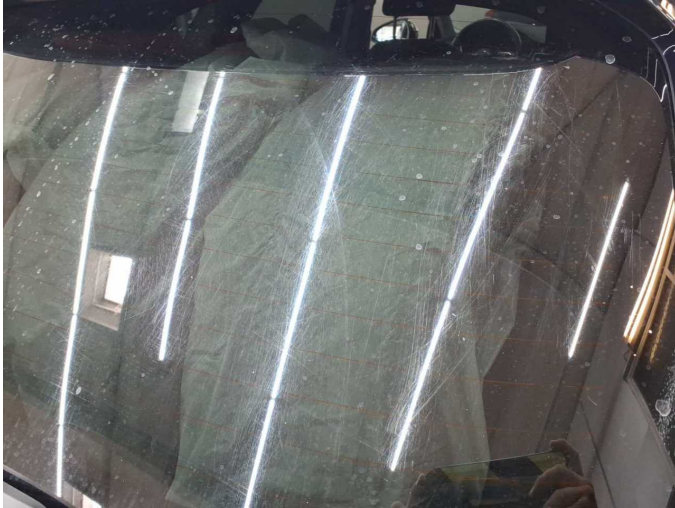
| No. | Component group | Description |
|---|---|---|
| 7 | Vehicle glazing | Rear window - Scratch(es) - Replace |

**Damage 7:** Vehicle glazing: Rear window - Scratch(es) - Replace

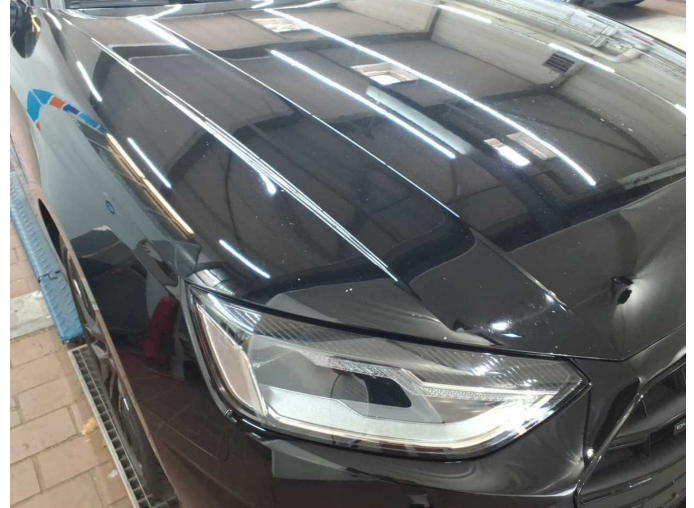
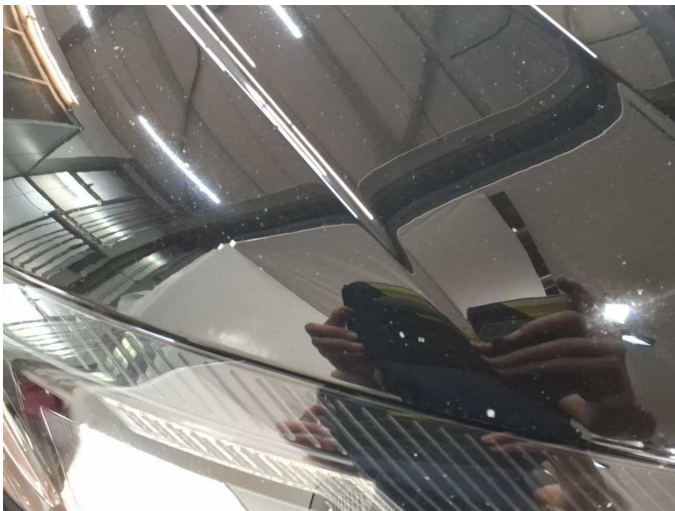
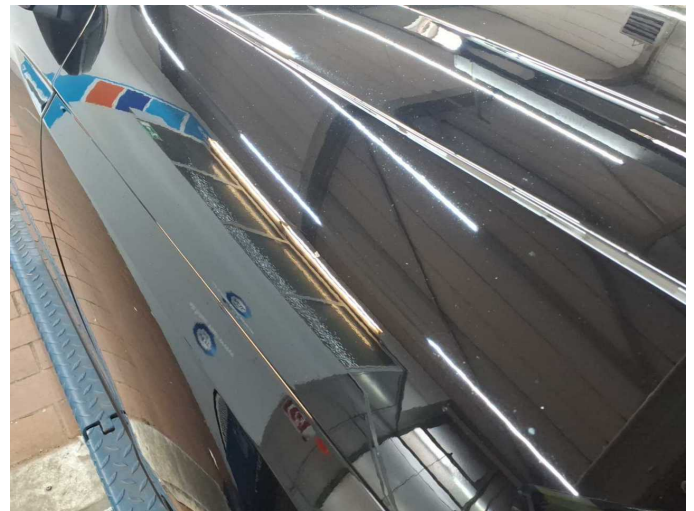
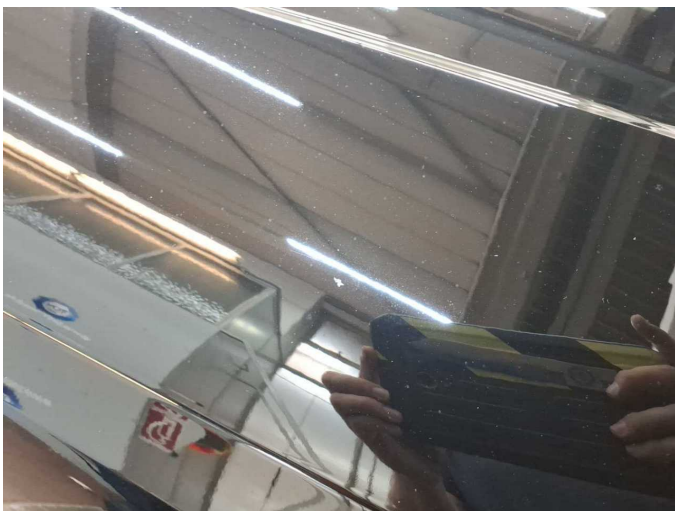
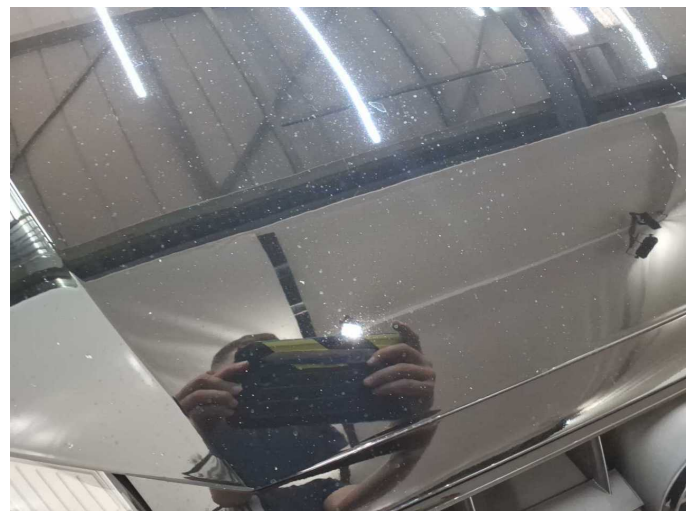
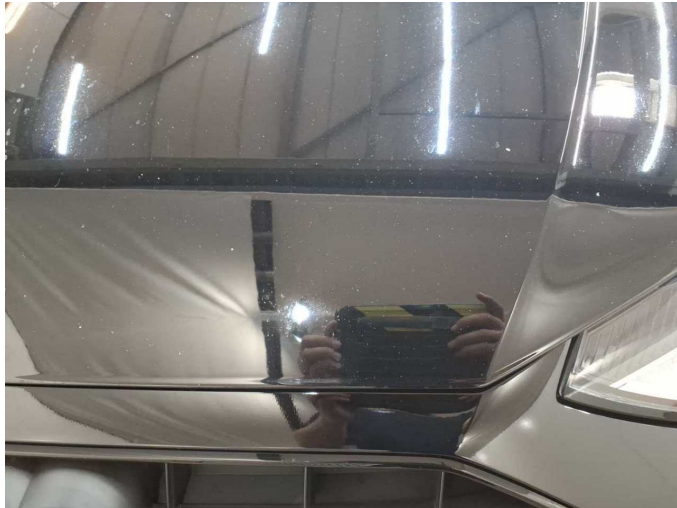
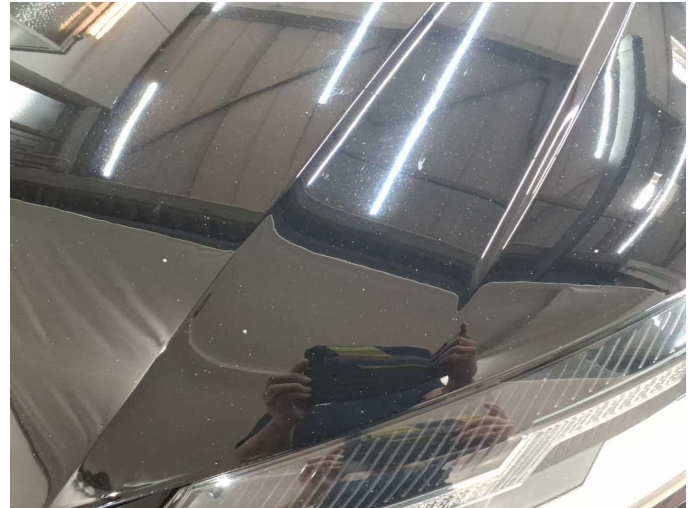
| No. | Component group | Description |
|---|---|---|
| 8 | Bonnet | Bonnet - Stone chips - Paint |

**Damage 8:** Bonnet: Bonnet - Stone chips - Paint

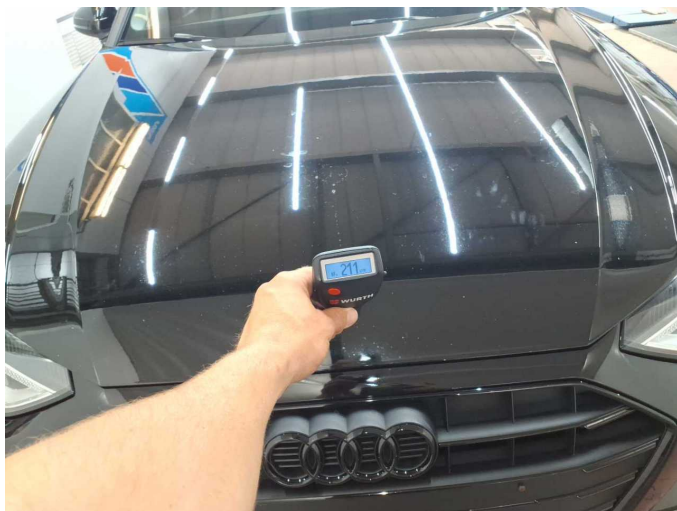
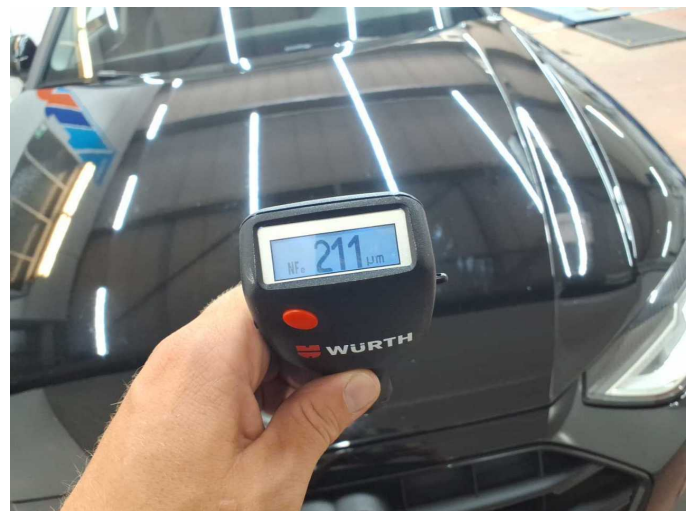
| No. | Repainting |
|---|---|
| 1 | Bonnet, Professionally carried out, Invoice of repair done Non-existent |

| Bonnet | 211 µm |

**Repainting 1:** Bonnet
