## Expertise

Protocol number: 45791194  
Order No. / Reference: 26310478  
Inspection date: 5 Jun 2026

Model: Astra Sports Tourer 1.2 Turbo Automatik GS

VIN: VXXFRHNS4R1089956

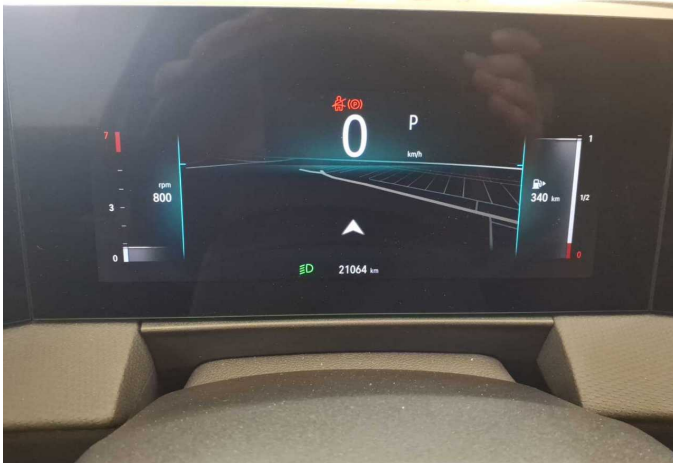
Figure 7: Instrument cluster

**Mileage (Read)** 21,064 km

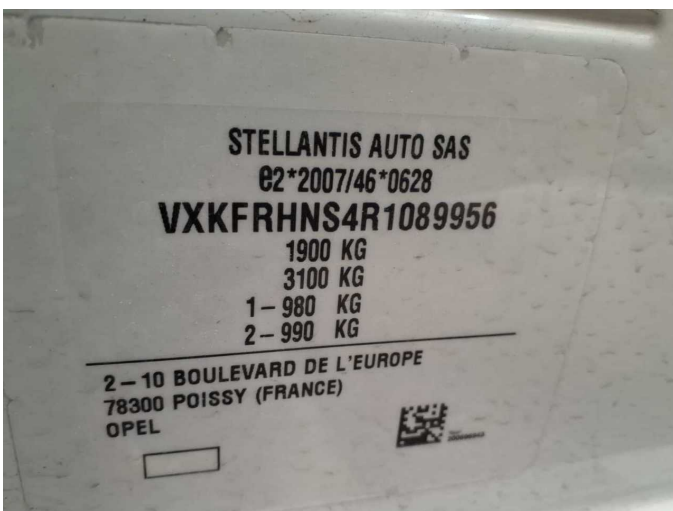
Figure 11: VIN

Documents submitted	At the time of the inspection, the vehicle registration certificate Part 2 (title) was available, but the vehicle registration certificate Part 1 (document) was not. (Copy)
VIN comparison	The vehicle identification number (VIN) was read from the vehicle and its conformity with the submitted documents was confirmed by the undersigned during the inspection.
Inspection	The inspection conditions were sufficient for the assessment of the vehicle. No lifting equipment or pit was available for inspecting the vehicle. Therefore, inspection of the vehicle's underside was only possible to a limited extent.
Test drive	No test drive/shunting maneuver was carried out during the inspection of the vehicle.
Engine function test	An engine test run was performed.

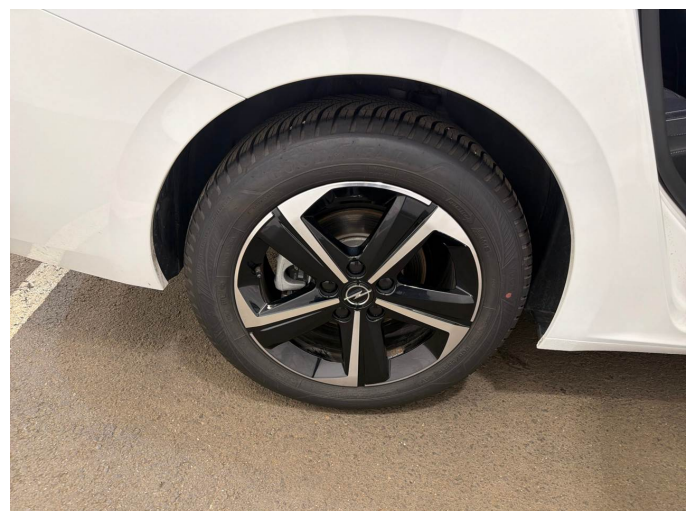
Figure 12: Mounted tyres

#	Tyre size	Type of tyre	Manufacturer	Tread depth
1)	205/55 R16 94V	All-season tyres on Light alloy	Goodyear	5mm / 5mm
2)	205/55 R16 94V	All-season tyres on Light alloy	Goodyear	6mm / 6mm

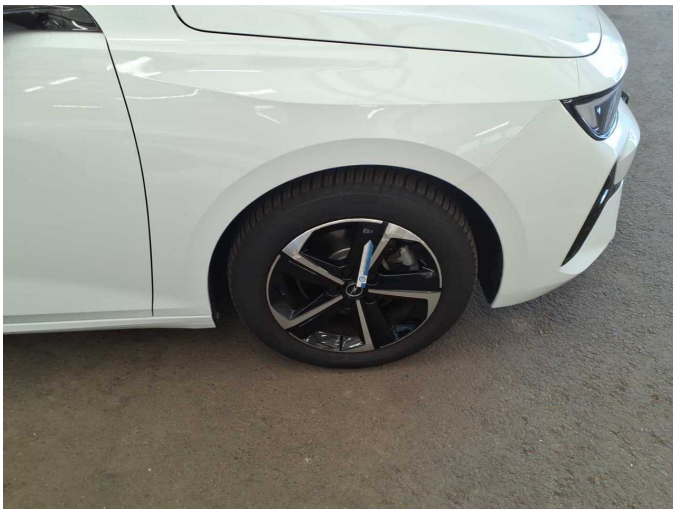
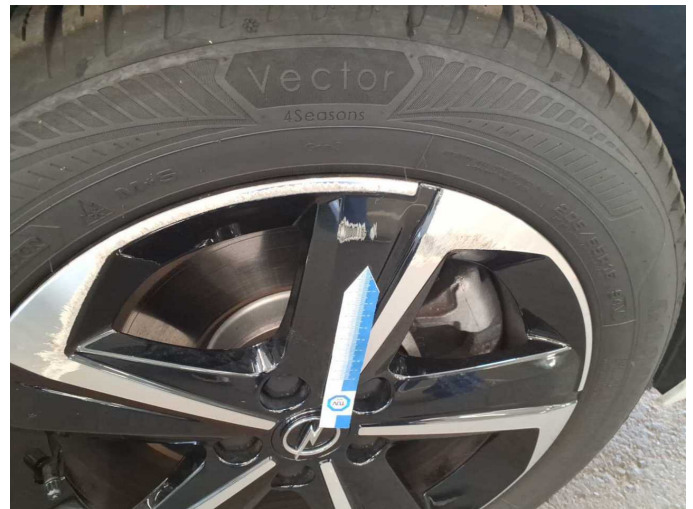
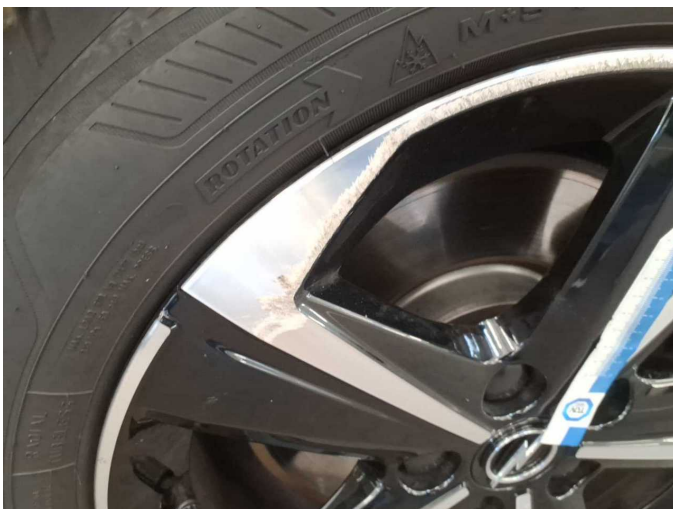
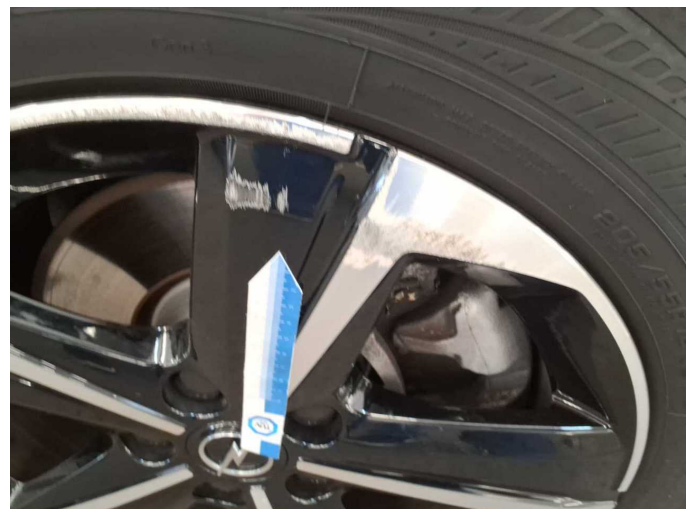
No.	Component group	Description
1	Wheel / tyres	Alloy rim - front right side (Großflächig verkratzt) - Scratched - Replace

Damage 1: Wheel / tyres: Alloy rim - front right side (Großflächig verkratzt) - Scratched - Replace

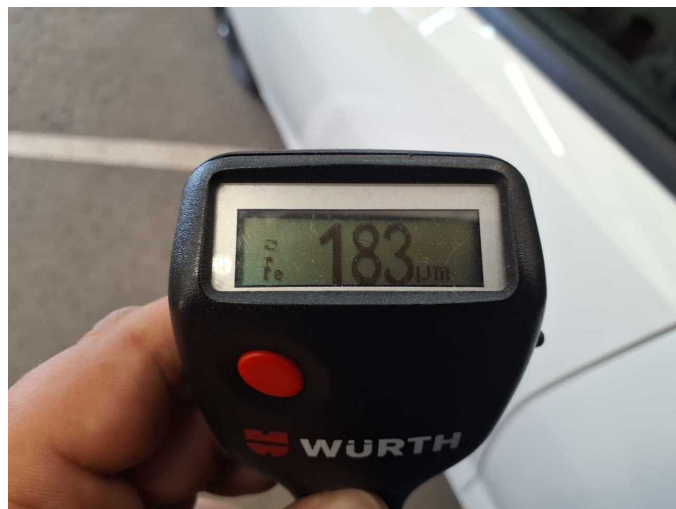
No.	Repainting
1	Door - front left side, Professionally carried out, Invoice of repair done Non-existent

Door - front left side	183 µm
------------------------	--------

**Repainting 1:** Door - front left side
