Expertise

Protocol number: 46168022  
Order No. / Reference: 26510107  
Inspection date: 24 Jun 2026

Manufacturer: Skoda  
VIN: TMBJJ7NS0N8021718

Model: Kodiaq 2.0 TDI DSG Clever

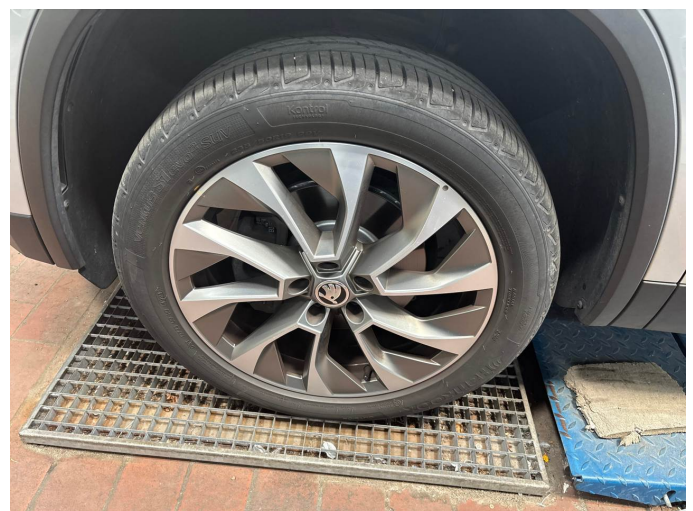
Figure 12: Mounted tyres

| # | Tyre size | Type of tyre | Manufacturer | Tread depth |
|---|---|---|---|---|
| 1) | 235/50 R19 99V | Summer tyres on Light alloy | Goodyear | 3mm / 3mm |
| 2) | 235/50 R19 99V | Summer tyres on Light alloy | Goodyear | 3mm / 3mm |

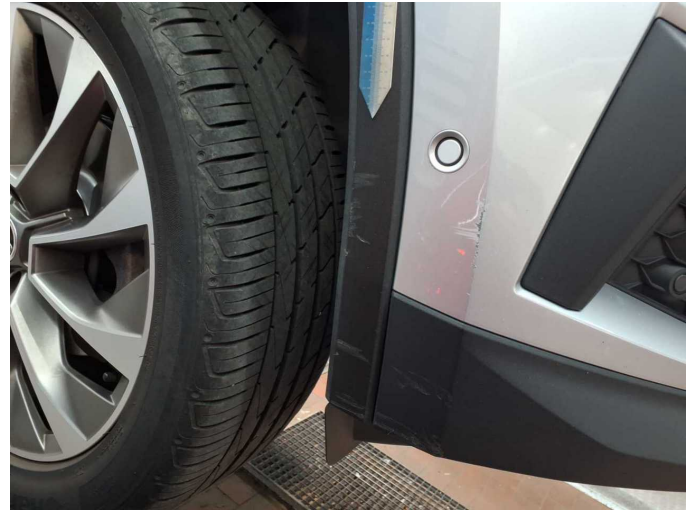
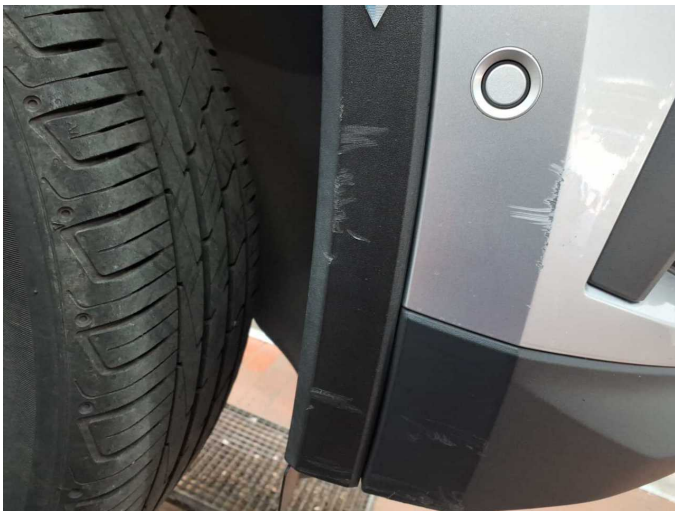
| No. | Component group | Description |
|---|---|---|
| 1 | Mudguard - right side | Wheel well extension - Scratch(es) - Smart repair |

**Damage 1:** Mudguard - right side: Wheel well extension - Scratch(es) - Smart repair

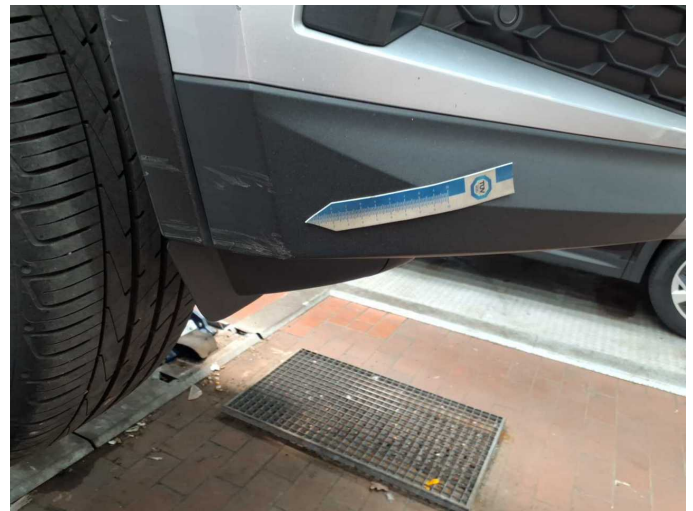
| No. | Component group | Description |
|---|---|---|
| 2 | Front bumper | Spoiler - Scratch(es) - Smart repair |

**Damage 2:** Front bumper: Spoiler - Scratch(es) - Smart repair

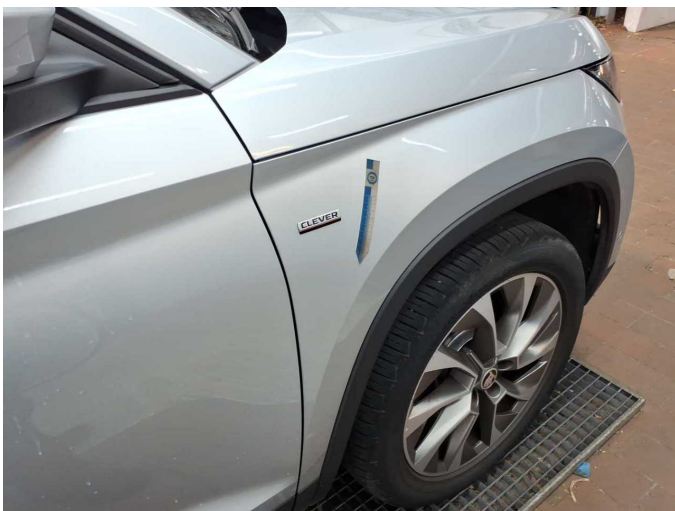
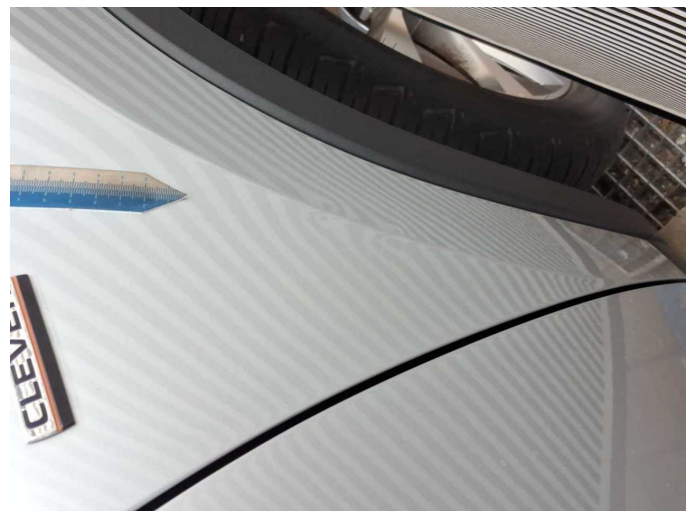
| No. | Component group | Description |
|---|---|---|
| 3 | Mudguard - right side | Mudguard - right side - dent(s) - Smooth repair work |

**Damage 3:** Mudguard - right side: Mudguard - right side - dent(s) - Smooth repair work

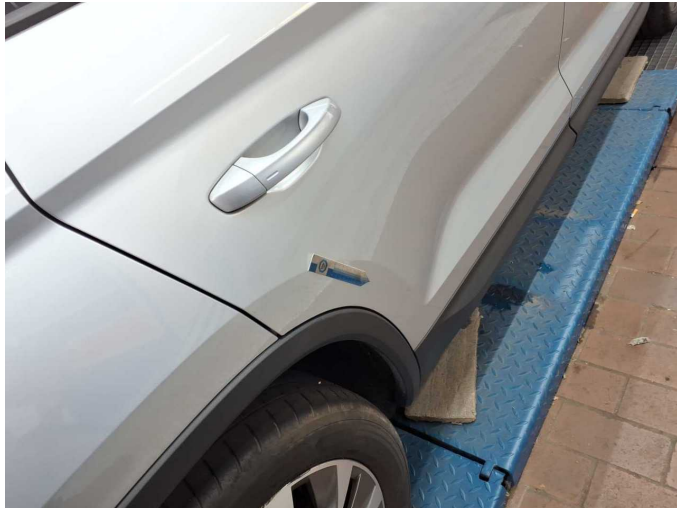
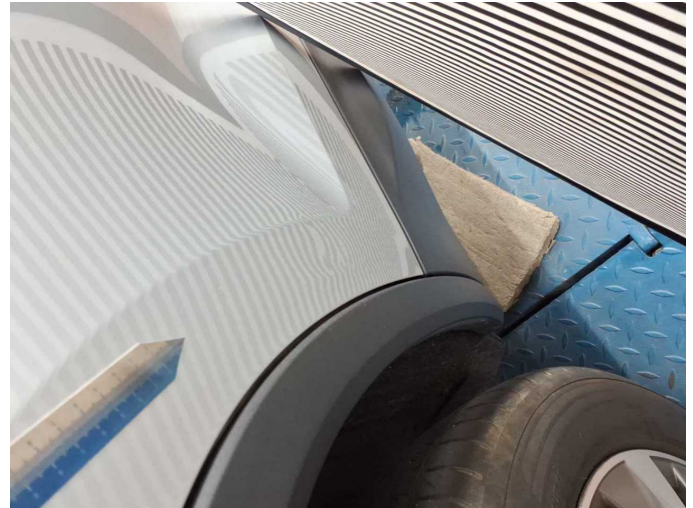
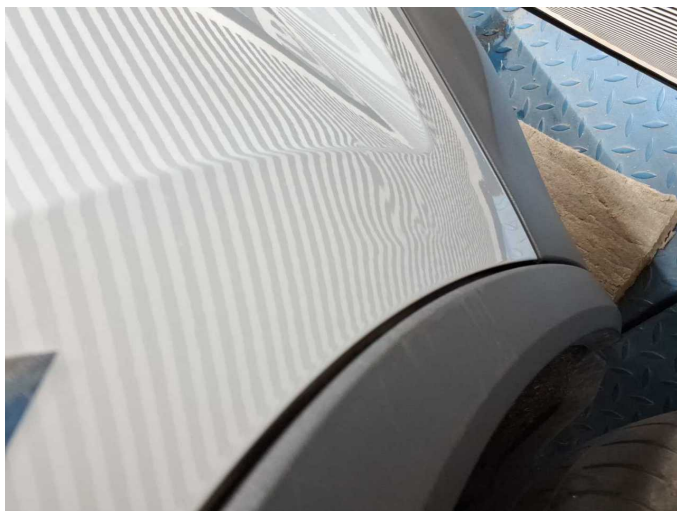
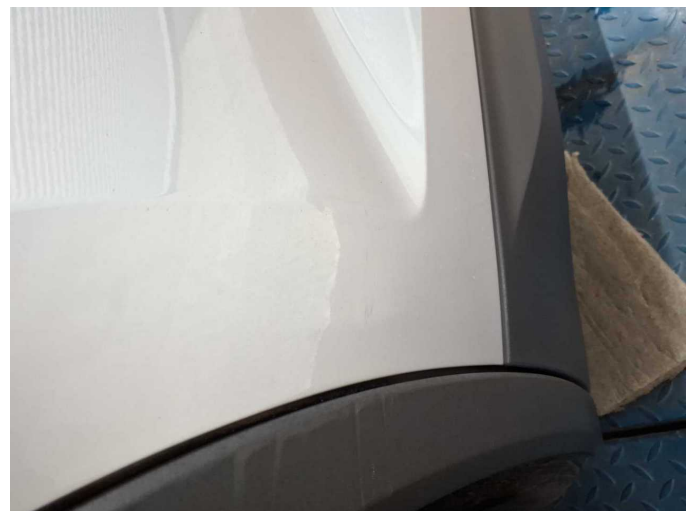
| No. | Component group | Description |
|---|---|---|
| 4 | Door - rear right side | Door - dent(s) - Smart repair |

**Damage 4:** Door - rear right side: Door - dent(s) - Smart repair

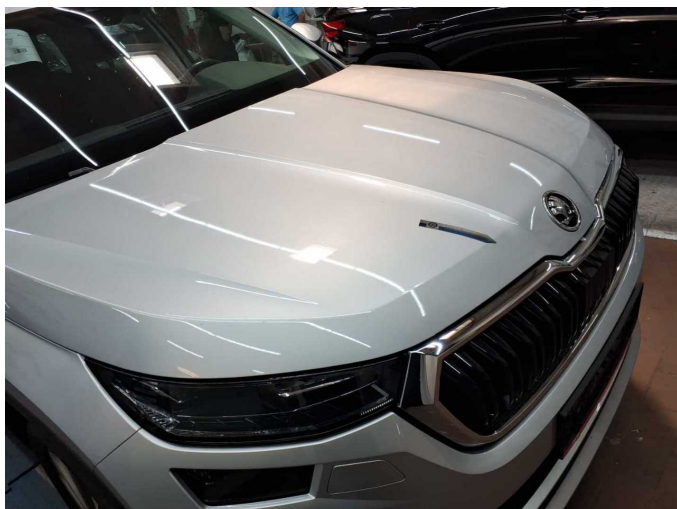
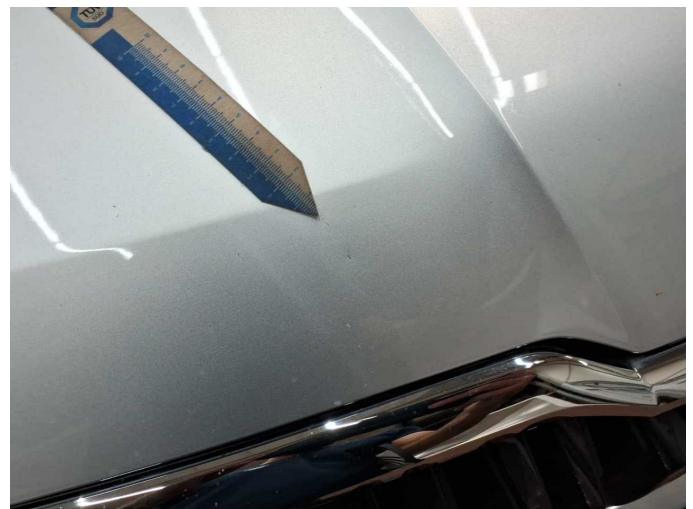
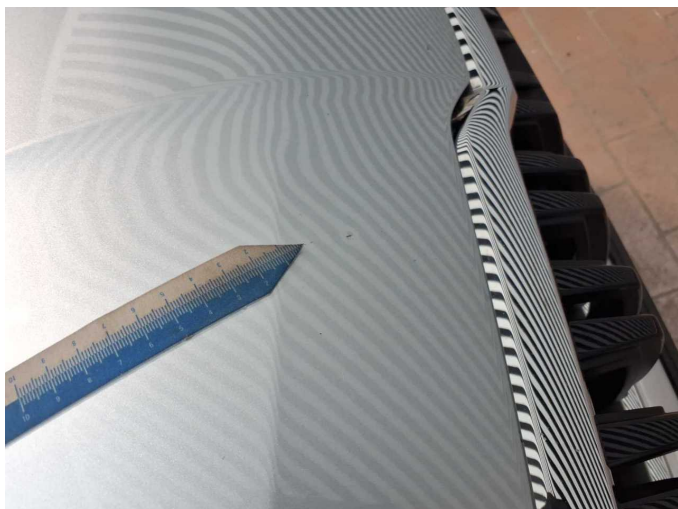
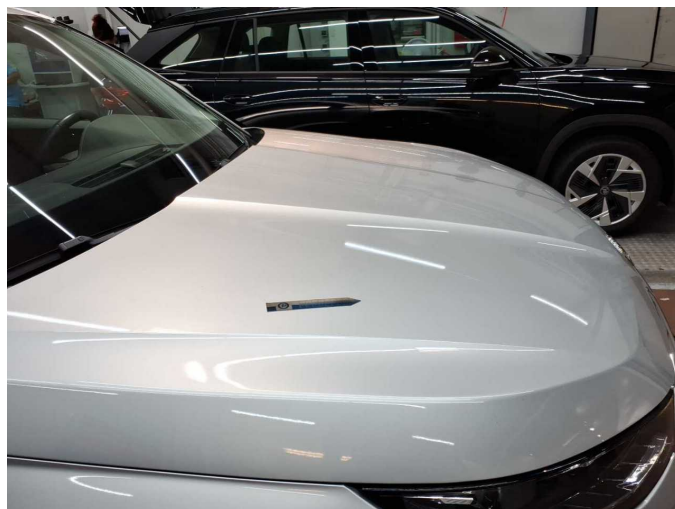
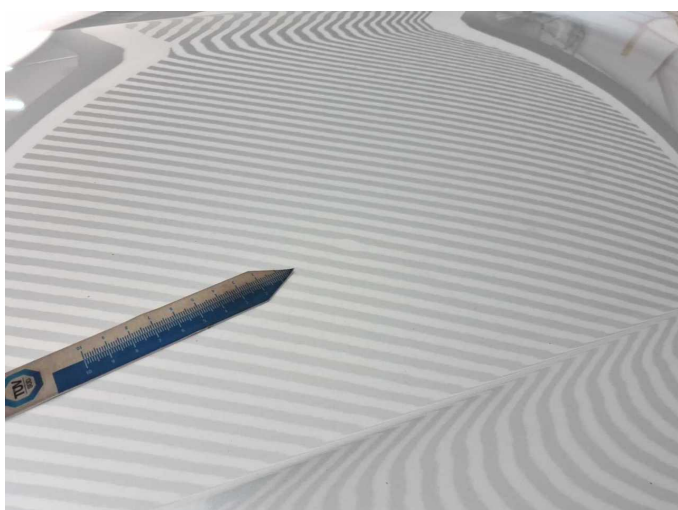
| No. | Component group | Description |
|---|---|---|
| 5 | Bonnet | Bonnet - Dent / paintcoat damage - Repair and paint |

**Damage 5:** Bonnet: Bonnet - Dent / paintcoat damage - Repair and paint

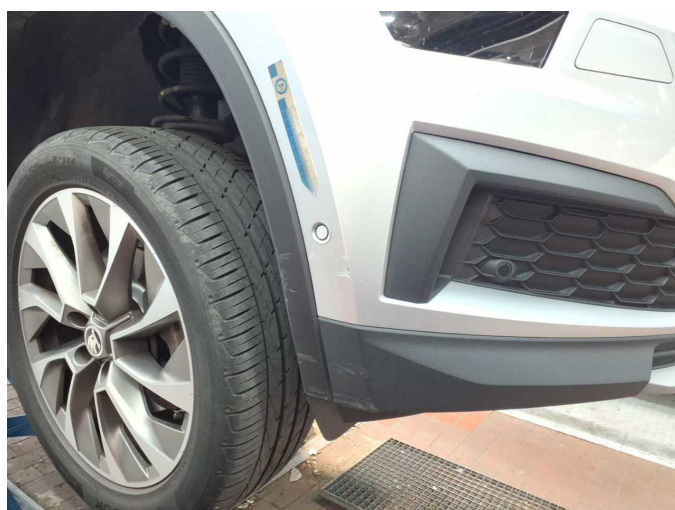
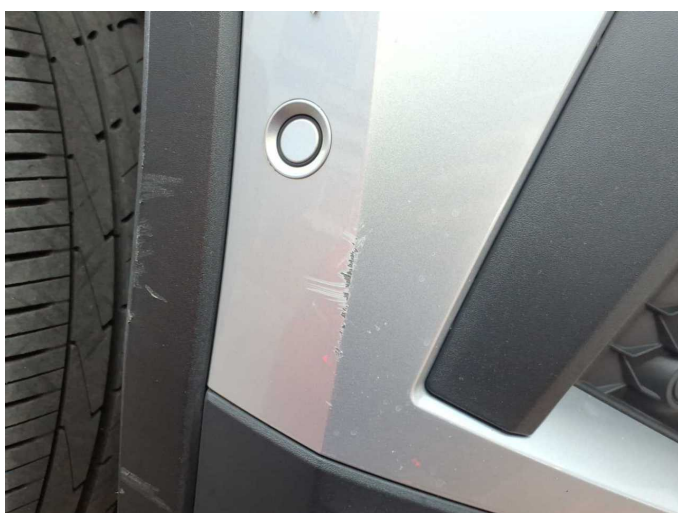
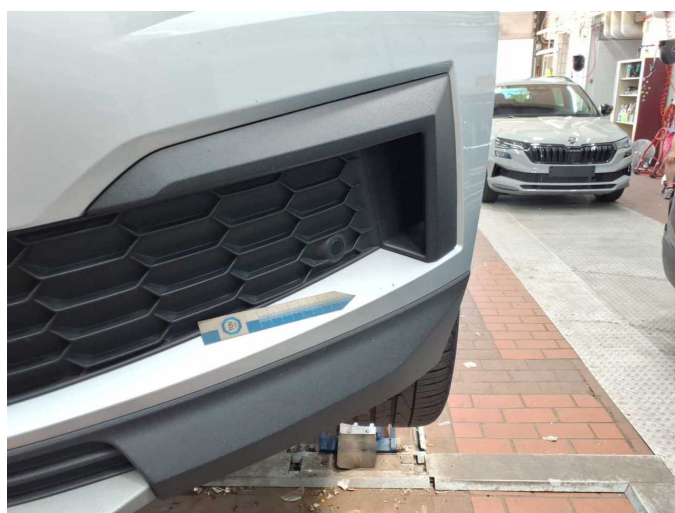
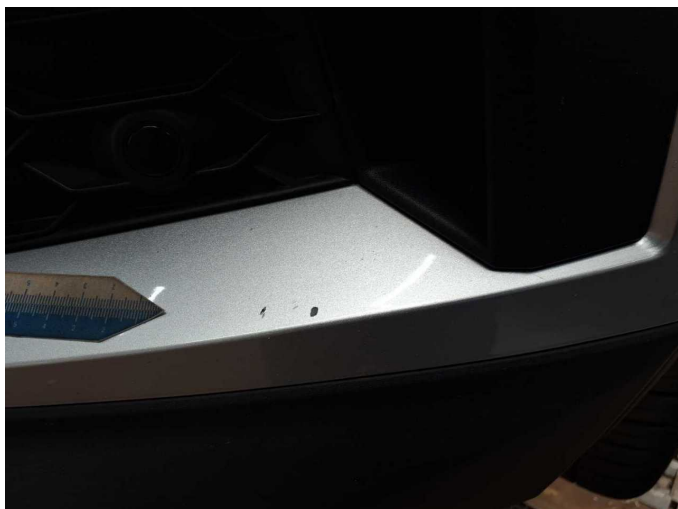
| No. | Component group | Description |
|---|---|---|
| 6 | Front bumper | Front bumper (inkl. Radlauf re.) - Scratch(es) - Paint |

**Damage 6:** Front bumper: Front bumper (inkl. Radlauf re.) - Scratch(es) - Paint

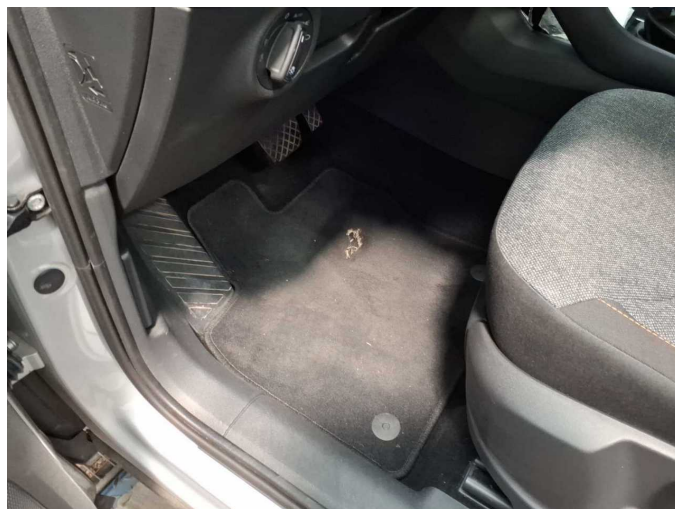
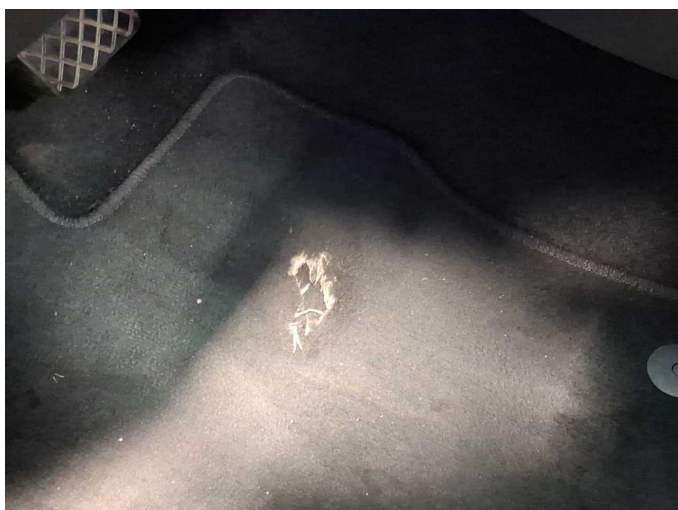
| No. | Component group | Description |
|---|---|---|
| 2 | Trim / covers | Floor mats - Holes - No deduction |

**Wear and tear 2:** Trim / covers: Floor mats - Holes - No deduction

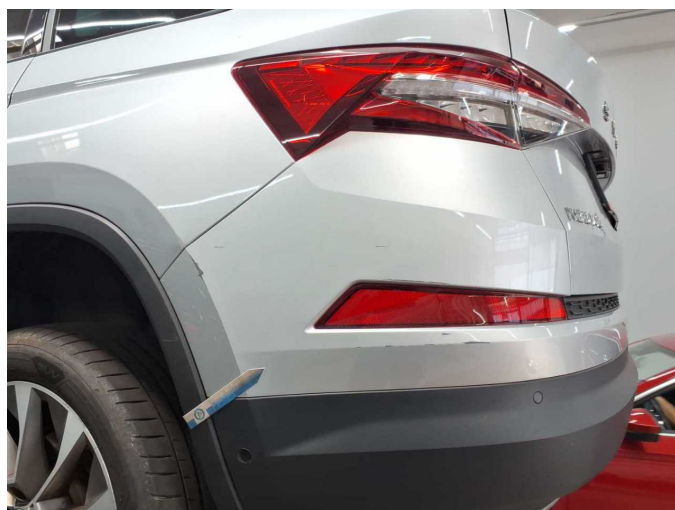
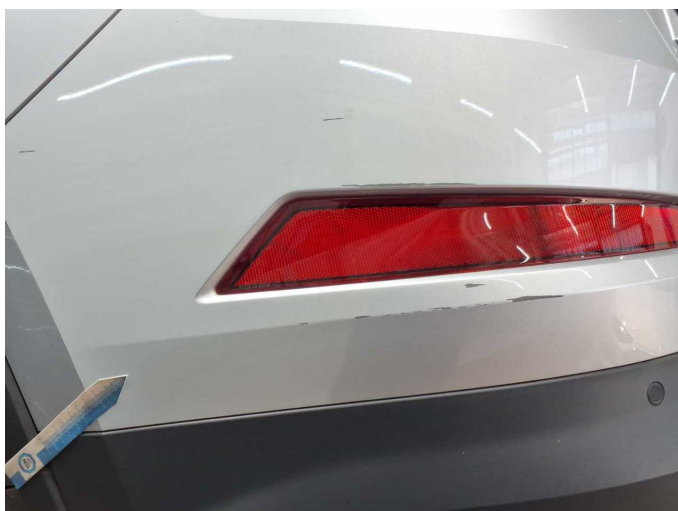
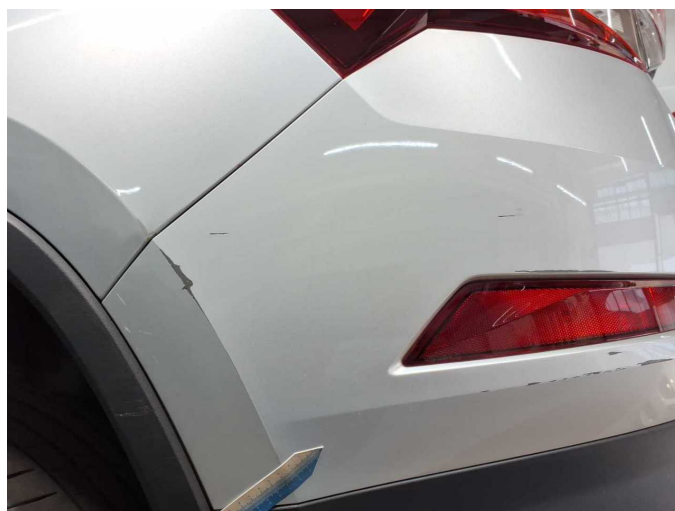
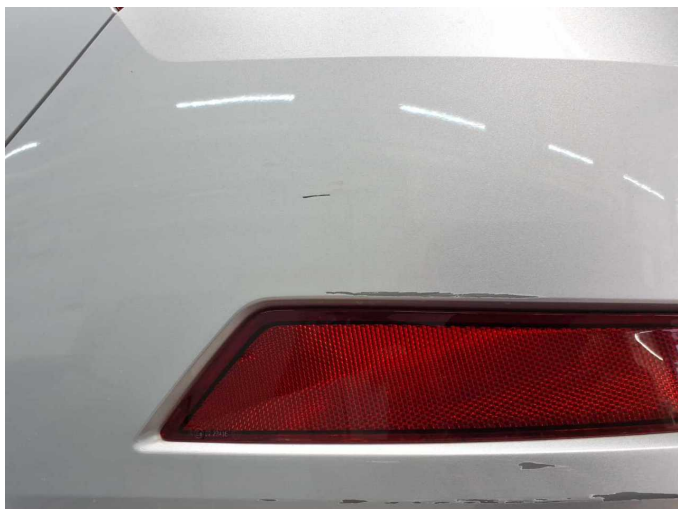
| No. | Accident |
|---|---|
| 1 | Rear, Side - left |

**Accident 1:** Rear, Side - left

Non-repaired previous damages were found at the vehicle. The necessary repair costs are listed in the expert report or if necessary, are listed in detail in a separately enclosed repair cost calculation.
