Expertise

Protocol number: 46233713
Order No. / Reference: 26562194
Inspection date: 29 Jun 2026

Model: S-Max 2.5 Duratec FHEV TITANIUM

VIN: WF0JXXWPCHPD51308

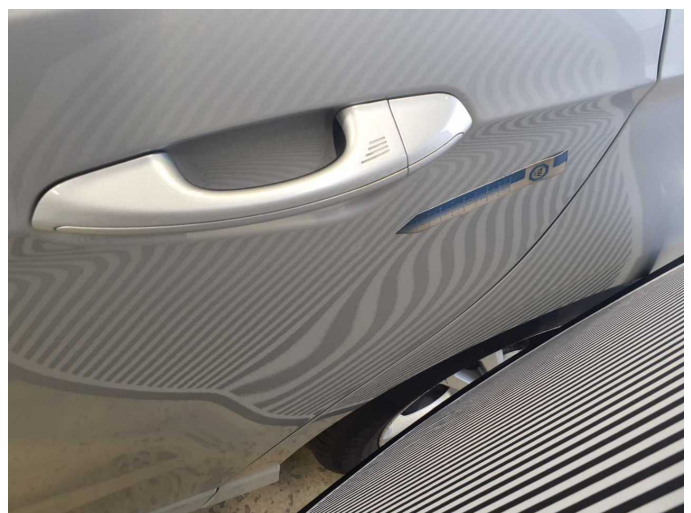
| No. | Component group | Description |
|---|---|---|
| 1 | Door - rear left side | Door - dent(s) - Smooth repair work |

Damage 1: Door - rear left side: Door - dent(s) - Smooth repair work

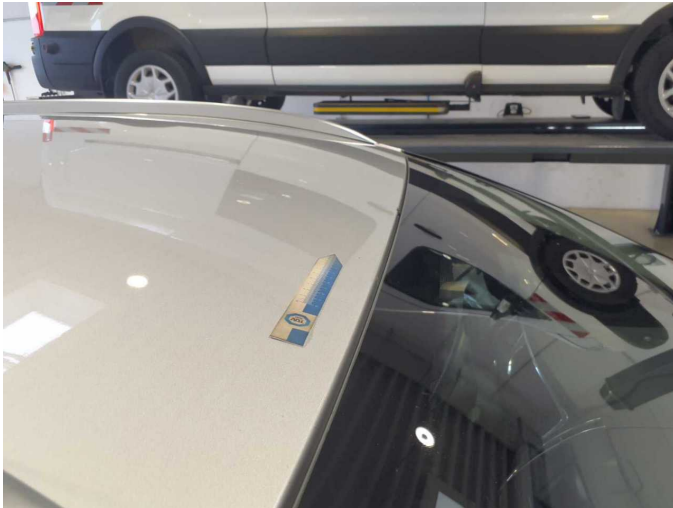
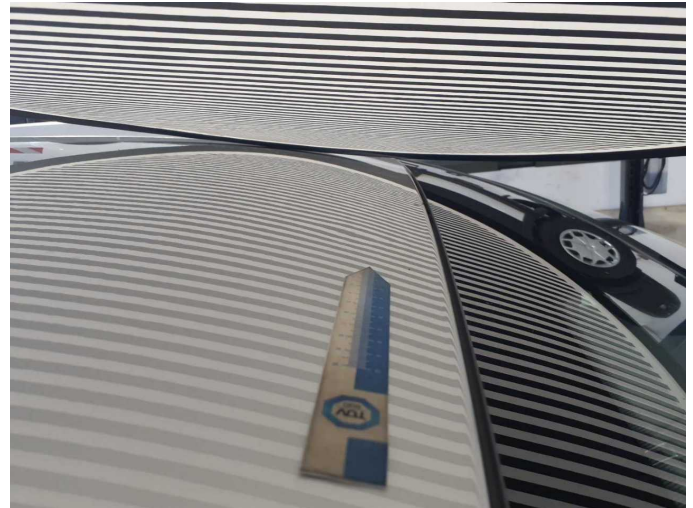
| No. | Component group | Description |
|---|---|---|
| 2 | Roof | Roof - dent(s) - Smooth repair work |

Damage 2: Roof: Roof - dent(s) - Smooth repair work

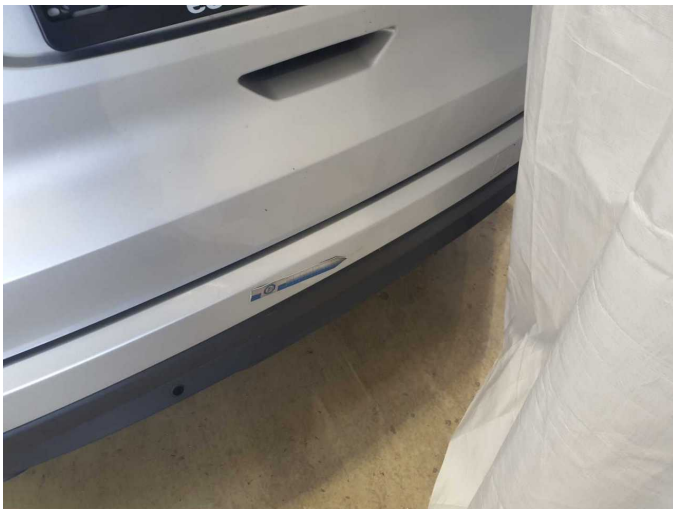
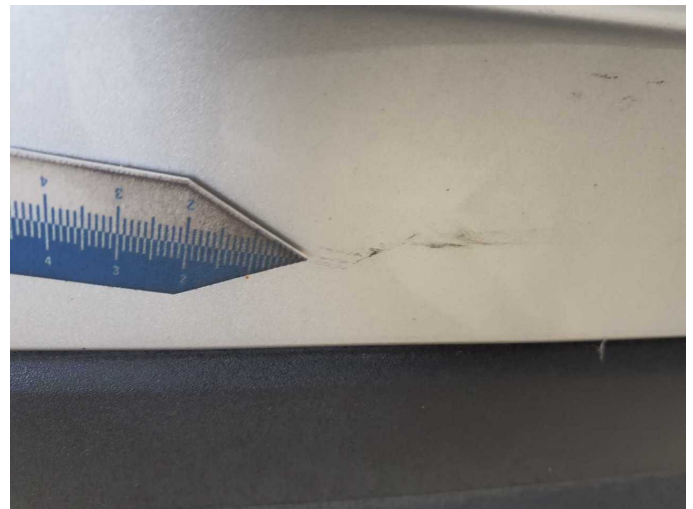
| No. | Component group | Description |
|---|---|---|
| 3 | Rear bumper | Rear bumper - Scratch(es) - Smart repair |

Damage 3: Rear bumper: Rear bumper - Scratch(es) - Smart repair

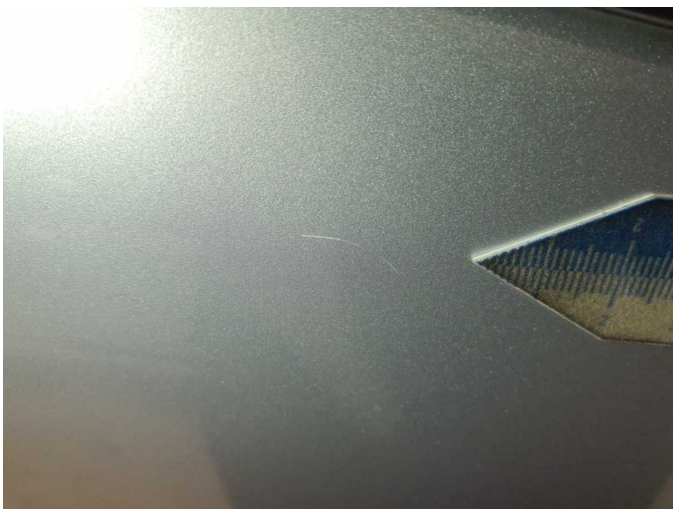
| No. | Component group | Description |
|---|---|---|
| 4 | Door - front right side | Door - Scratch(es) - Smart repair |

Damage 4: Door - front right side: Door - Scratch(es) - Smart repair
