Expertise

Protocol number: 46130348  
Order No. / Reference: 26484964  
Inspection date: 24 Jun 2026

Manufacturer: Audi

Model: Q5 50 TFSIe quattro S tronic S line

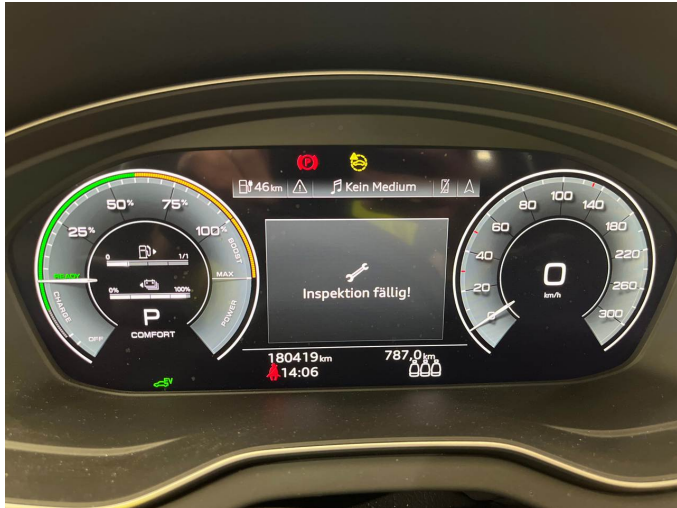
| Vehicle details | |
|---|---|
| Mileage (Read) | 180,419 km |

Figure 7: Instrument cluster

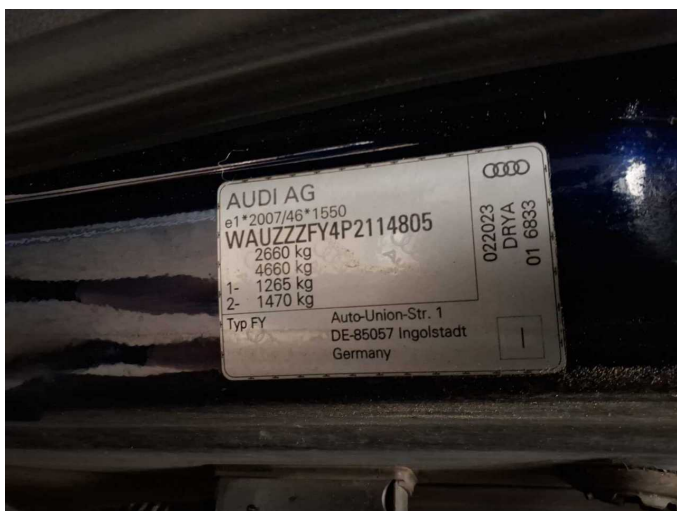
| VIN comparison | The vehicle identification number (VIN) was read from the vehicle and its conformity with the submitted documents was confirmed by the undersigned during the inspection. |

Figure 11: VIN

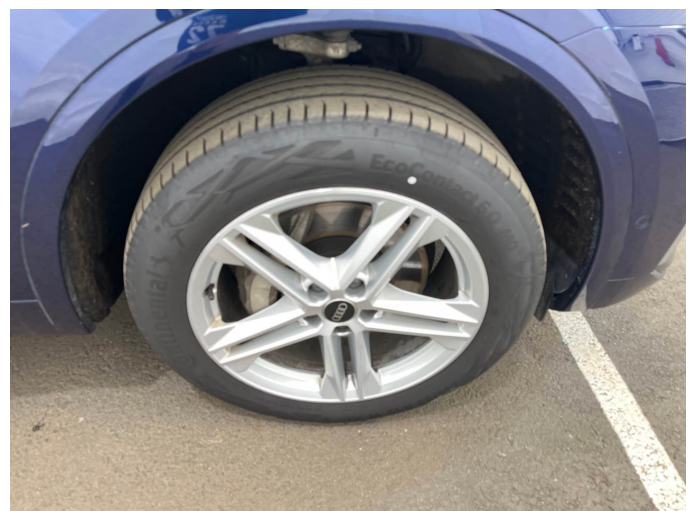
| # | Tyre size | Type of tyre | Manufacturer | Tread depth |
|---|---|---|---|---|
| 1) | 235/55 R19 105W | Summer tyres on Light alloy | Continental | 6mm / 6mm |
| 2) | 235/55 R19 105W | Summer tyres on Light alloy | Continental | 6mm / 6mm |

Figure 12: Mounted tyres

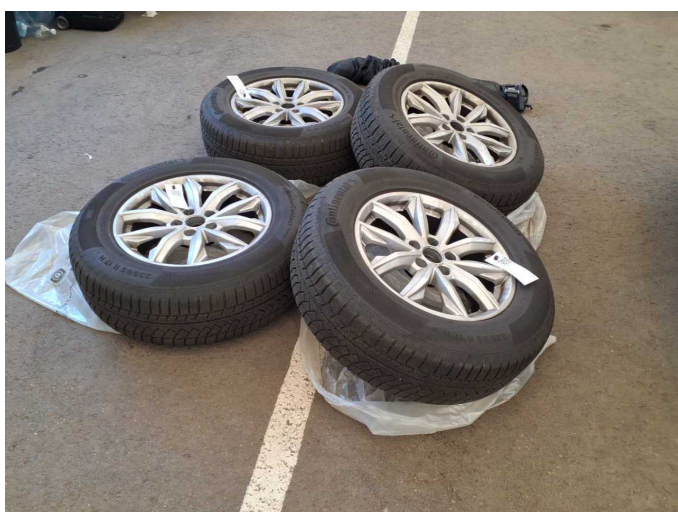
| # | Tyre size | Type of tyre | Manufacturer | Tread depth |
|---|---|---|---|---|
| 1) | 235/65 R17 104H | Winter tyres on Light alloy | Continental | 7mm / 7mm |
| 2) | 235/65 R17 104H | Winter tyres on Light alloy | Continental | 7mm / 7mm |

Figure 15: Additional tyres

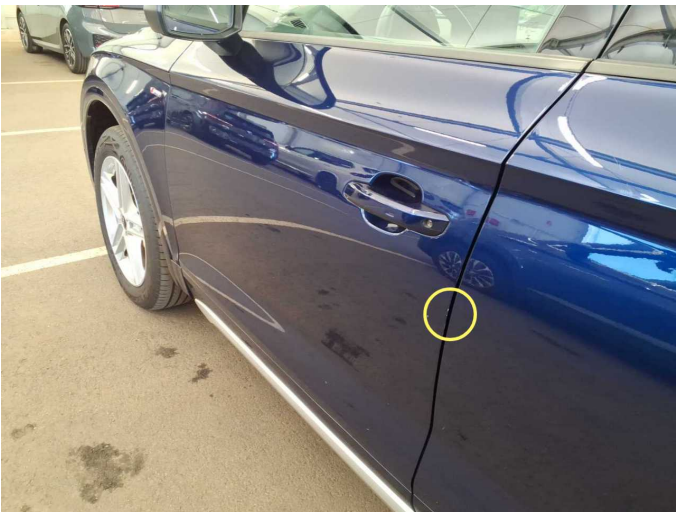
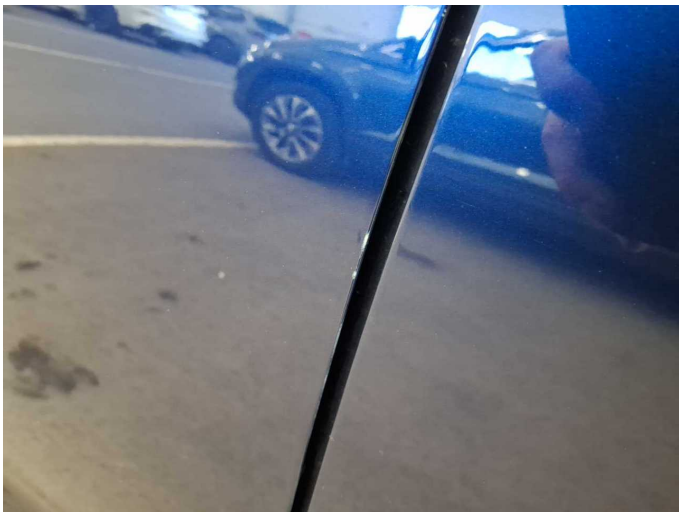
| No. | Component group | Description |
|---|---|---|
| 1 | Door - front left side | Door edge - Scratch(es) - Smart repair |

Damage 1: Door - front left side: Door edge - Scratch(es) - Smart repair

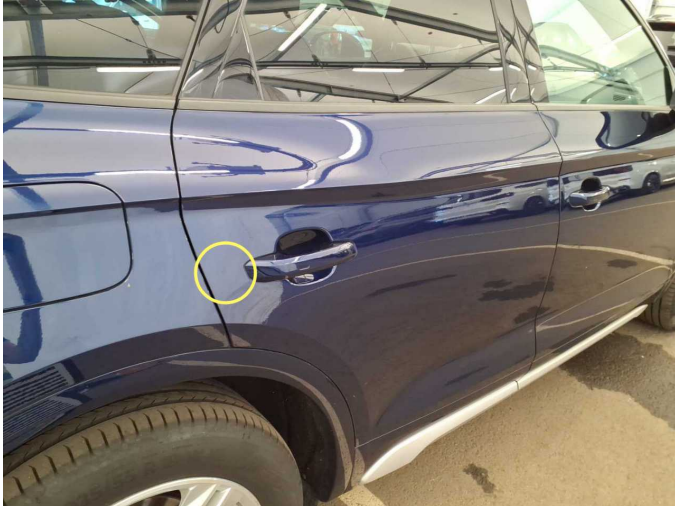
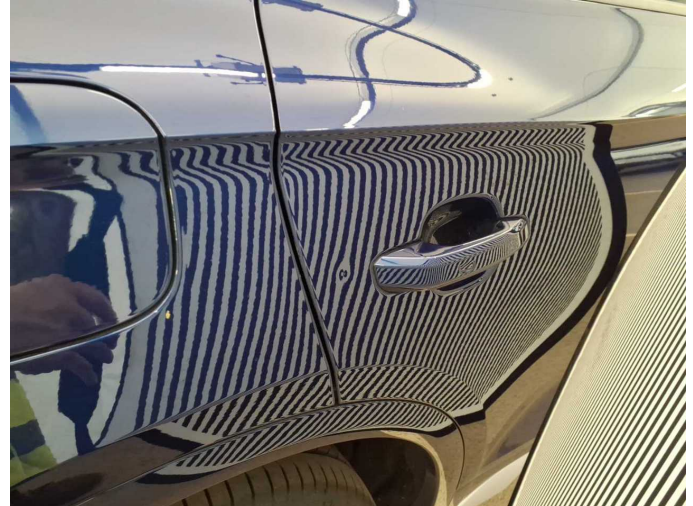
| No. | Component group | Description |
|---|---|---|
| 2 | Door - rear right side | Door - dent(s) - Smooth repair work |

**Damage 2:** Door - rear right side: Door - dent(s) - Smooth repair work

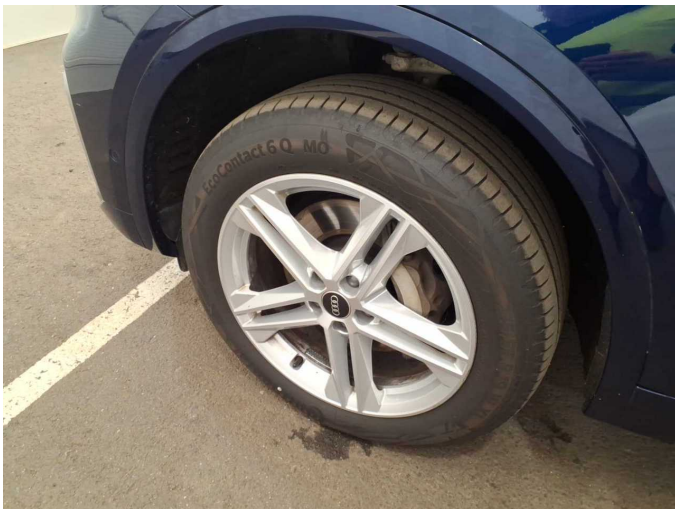
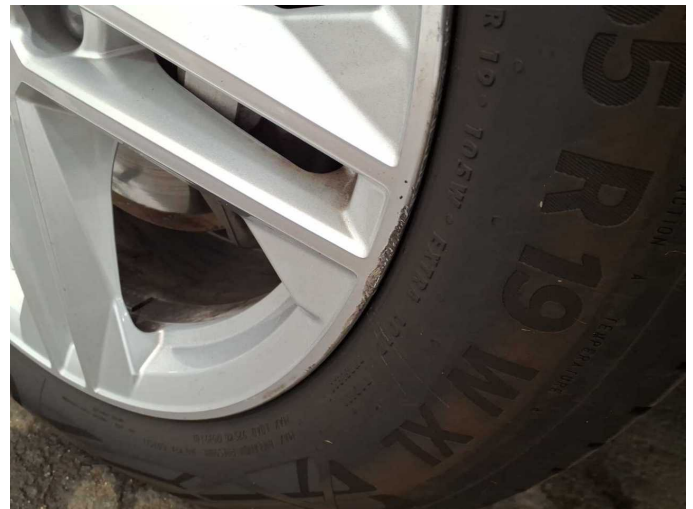
| No. | Component group | Description |
|---|---|---|
| 3 | Wheel / tyres | Alloy rim - front left side - Scratched - Loss in value |

**Damage 3:** Wheel / tyres: Alloy rim - front left side - Scratched - Loss in value

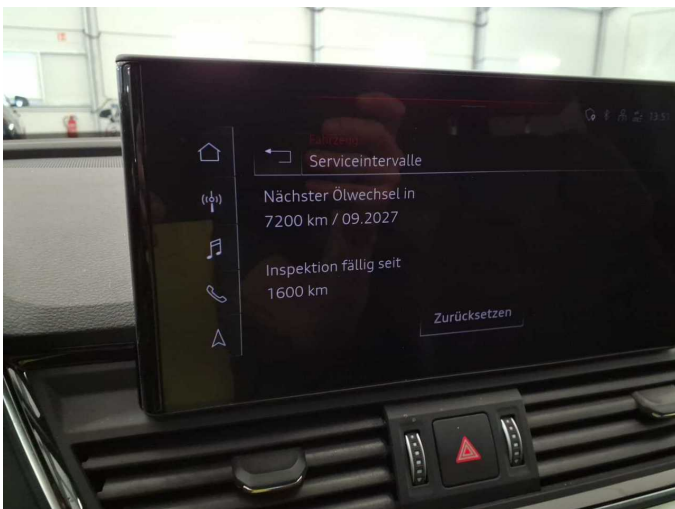
| <b>Maintenance booklet / proof</b> | digital evidence / incomplete | <b>Next maintenance in</b> | -1,600 km |

| No. | Component group | Description |
|---|---|---|
| 4 | Misc. | Inspection / maintenance - Due - Perform |

**Damage 4:** Misc.: Inspection / maintenance - Due - Perform

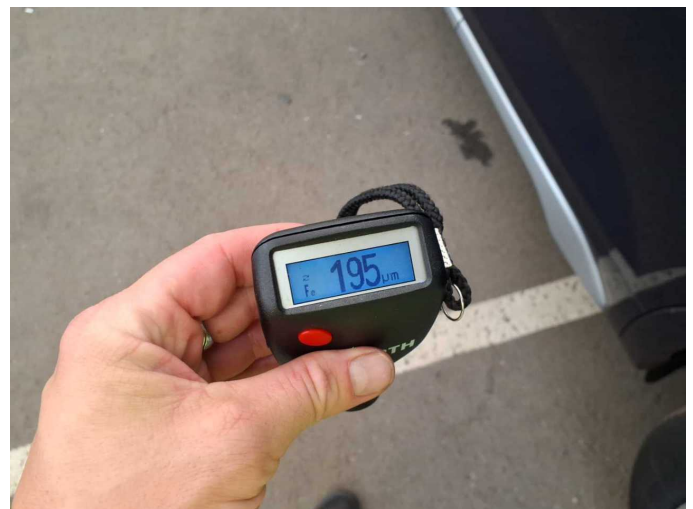
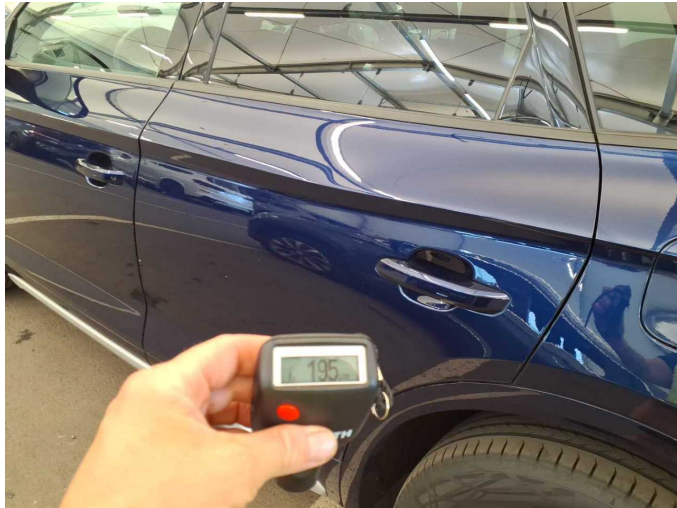
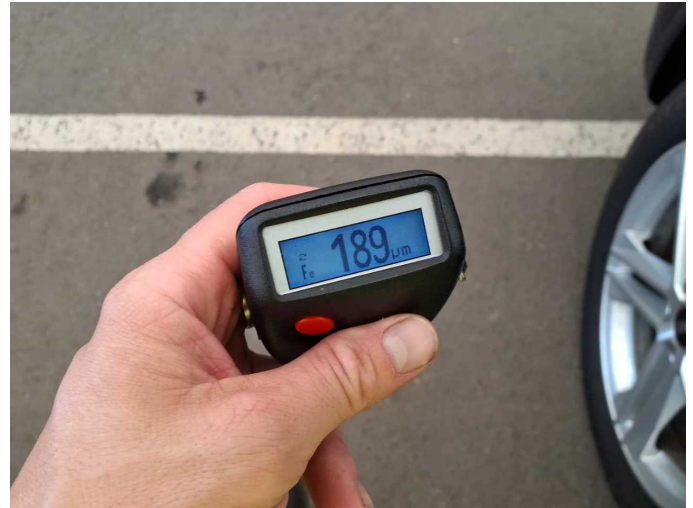
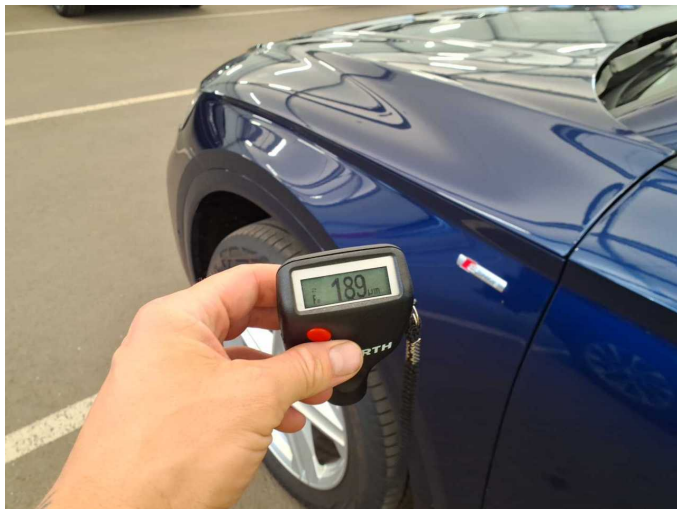
| 1 | Mudguard - left side, Door - rear left side, Professionally carried out, Invoice of repair done Non-existent |

| Mudguard - left side | 189 µm | Door - rear left side | 195 µm |

**Repainting 1:** Mudguard - left side, Door - rear left side
