Expertise

Protocol number: 46144922  
Order No. / Reference: 26528510  
Inspection date: 23 Jun 2026

Model: GLA 220 d 8G-DCT AMG Line

VIN: W1N4N1EB0PJ507643

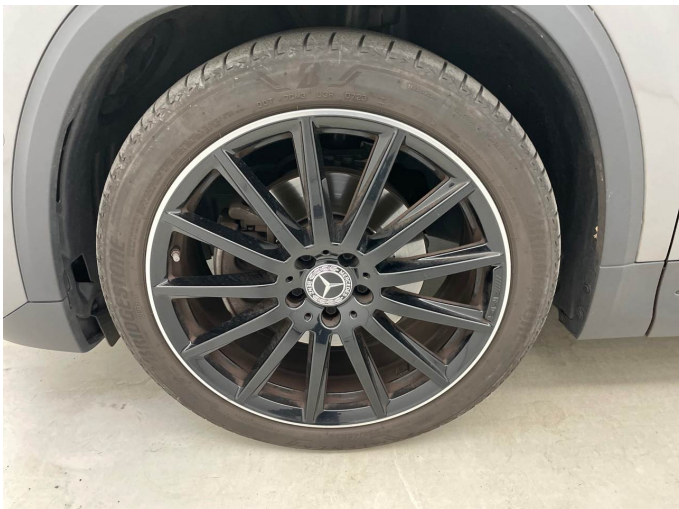
Figure 12: Mounted tyres

| # | Tyre size | Type of tyre | Manufacturer | Tread depth |
|---|---|---|---|---|
| 1) | 235/45 R20 96W | Summer tyres on Light alloy | Bridgestone | 4mm / 4mm |
| 2) | 235/45 R20 96W | Summer tyres on Light alloy | Bridgestone | 6mm / 6mm |

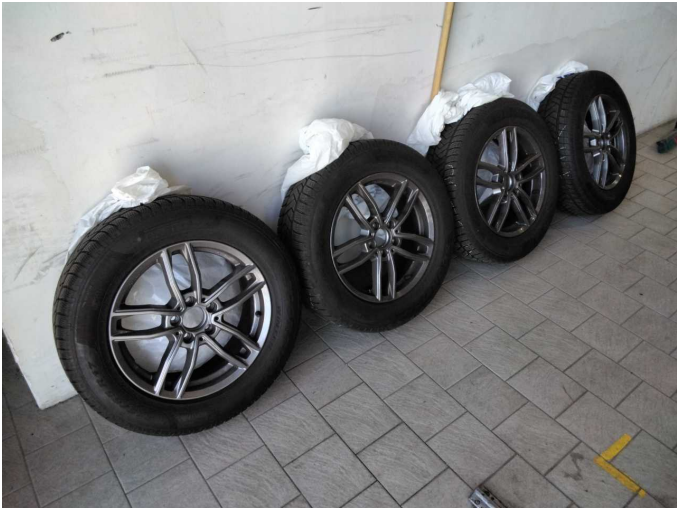
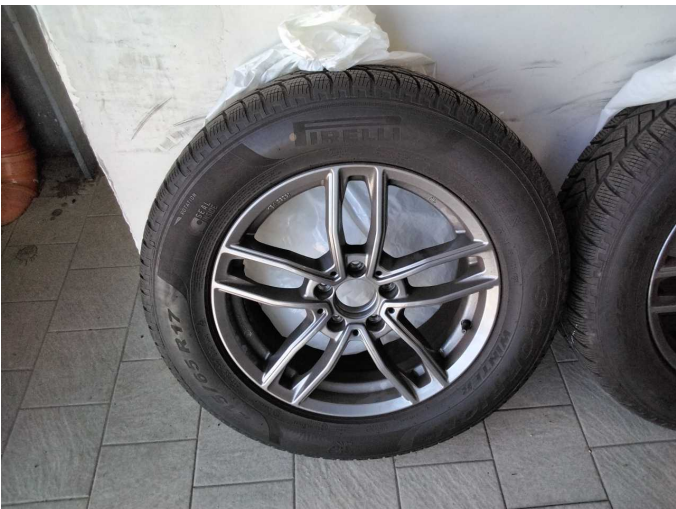
| # | Tyre size | Type of tyre | Manufacturer | Tread depth |
|---|---|---|---|---|
| 1) | 215/65 R17 99H | Winter tires (with run-flat tires) on Light alloy | Pirelli | 5mm / 5mm |
| 2) | 215/65 R17 99H | Winter tires (with run-flat tires) on Light alloy | Pirelli | 7mm / 7mm |

Figure 16: Additional tyres

Figure 17: Additional tyres

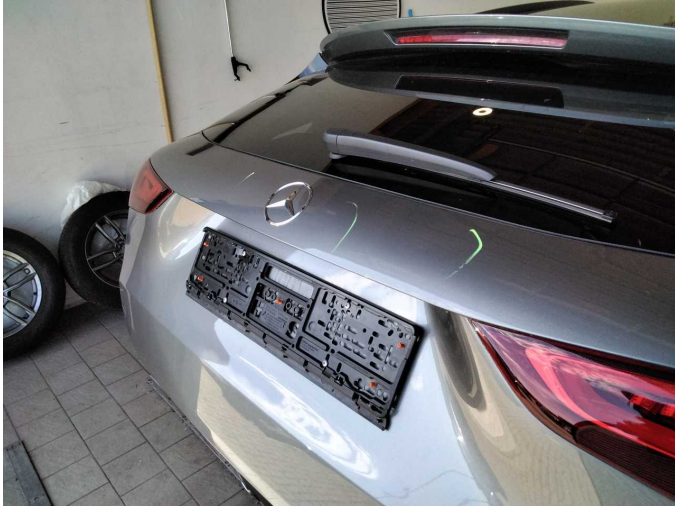
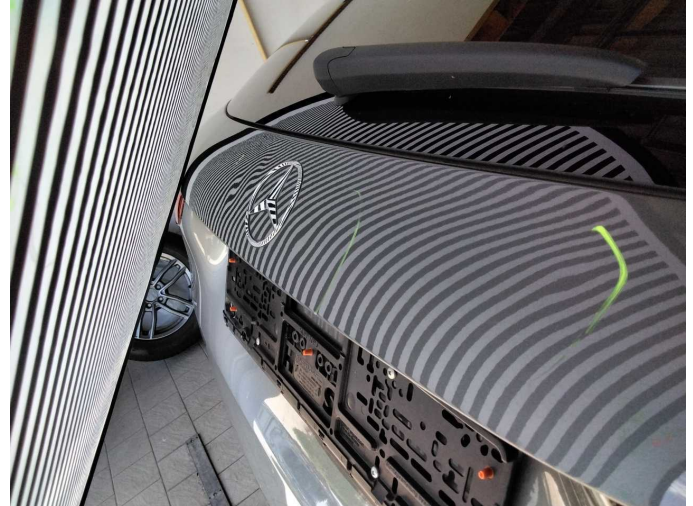
| No. | Component group | Description |
|---|---|---|
| 1 | Boot lid / rear door | Boot lid - dent(s) - Smooth repair work |

**Damage 1:** Boot lid / rear door: Boot lid - dent(s) - Smooth repair work

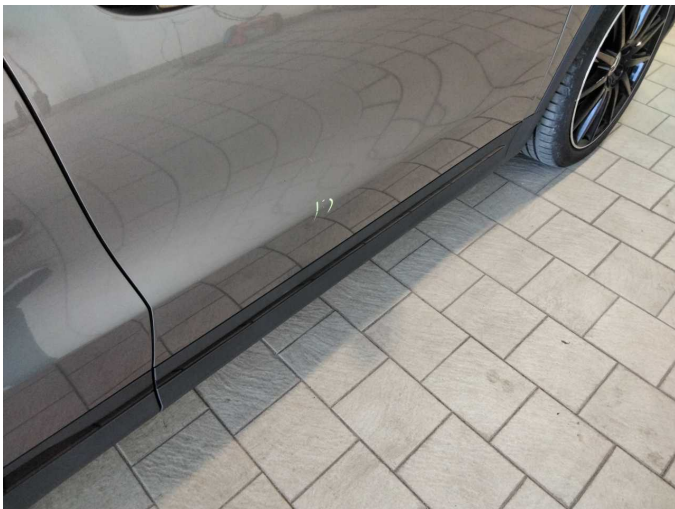
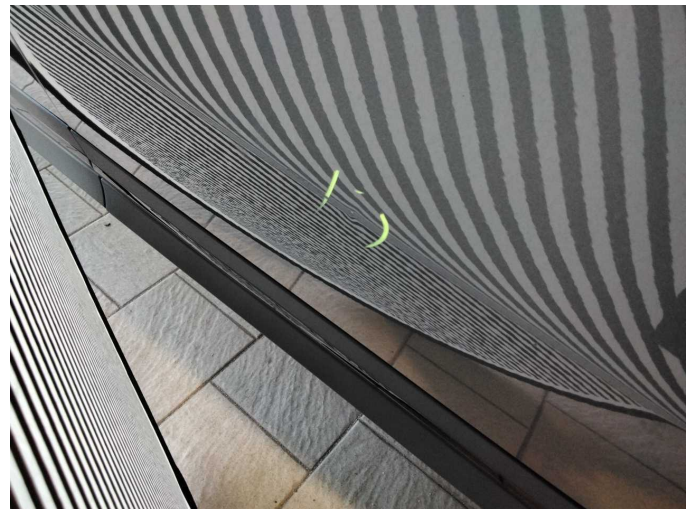
| No. | Component group | Description |
|---|---|---|
| 2 | Door - front right side | Door - Dent / paintcoat damage - Smart repair |

**Damage 2:** Door - front right side: Door - Dent / paintcoat damage - Smart repair

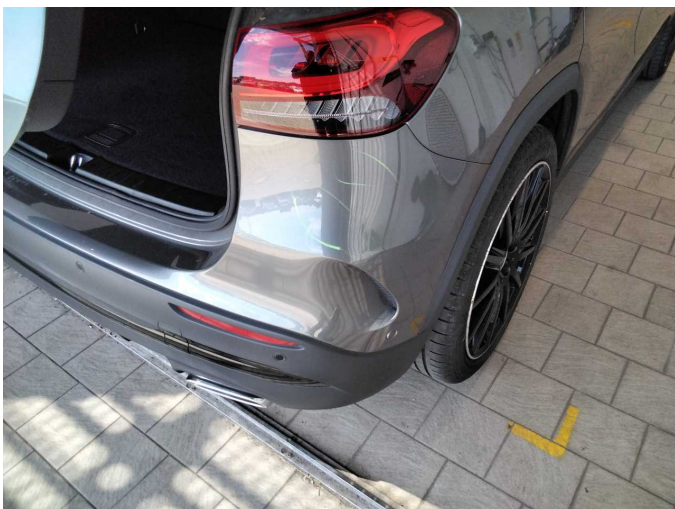
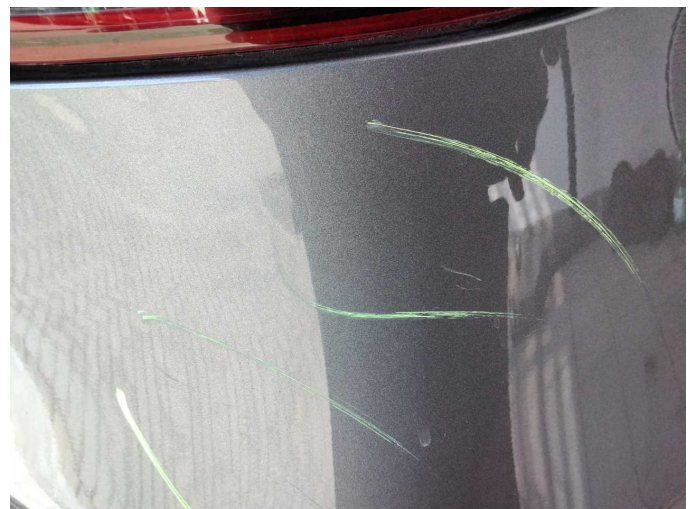
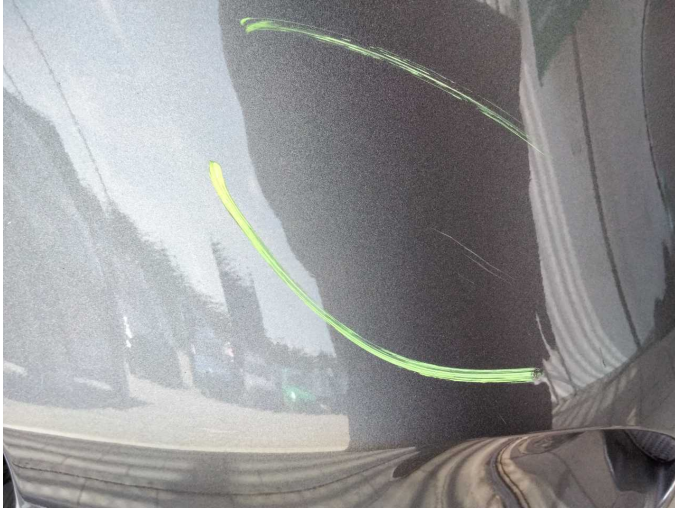
| No. | Component group | Description |
|---|---|---|
| 3 | Rear bumper | Bumper - rear right side - Scratch(es) - Smart repair |

**Damage 3:** Rear bumper: Bumper - rear right side - Scratch(es) - Smart repair

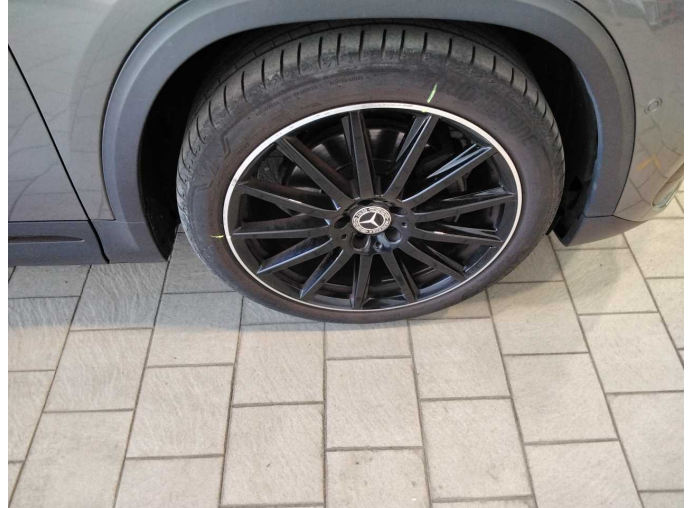
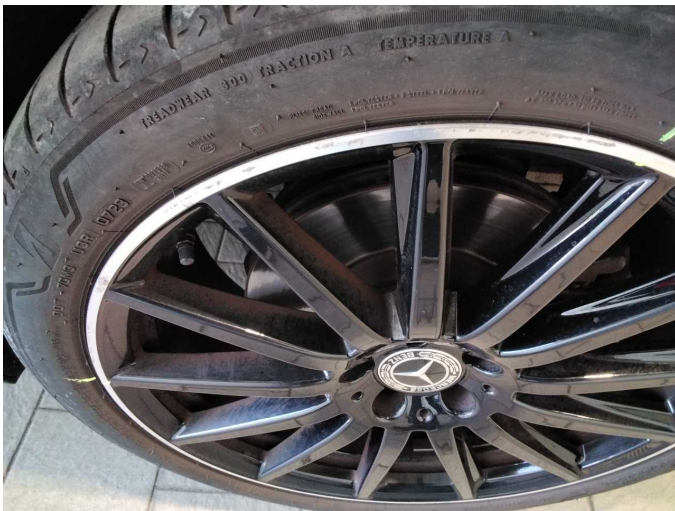
| No. | Component group | Description |
|---|---|---|
| 4 | Wheel / tyres | Alloy rim - front right side - Scratch(es) - Replace |

**Damage 4:** Wheel / tyres: Alloy rim - front right side - Scratch(es) - Replace

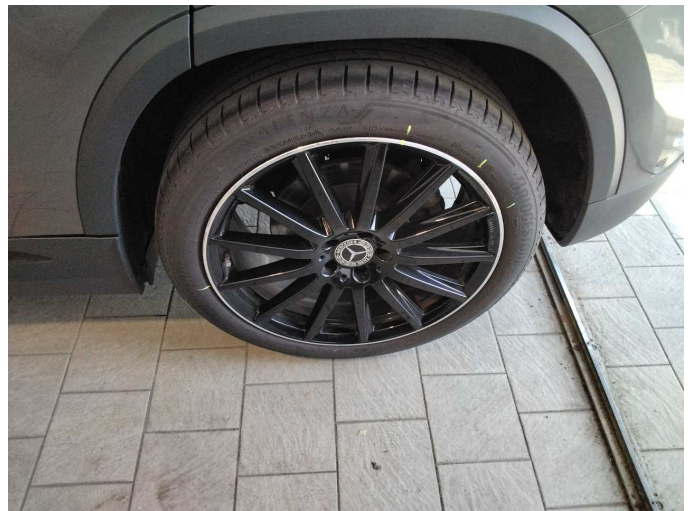
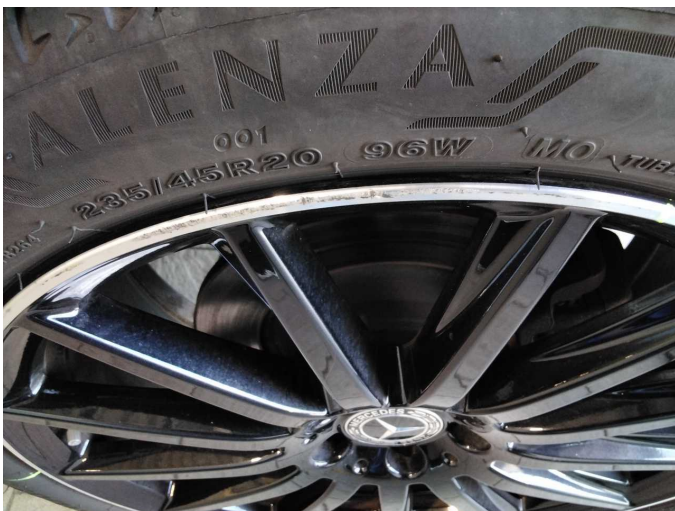
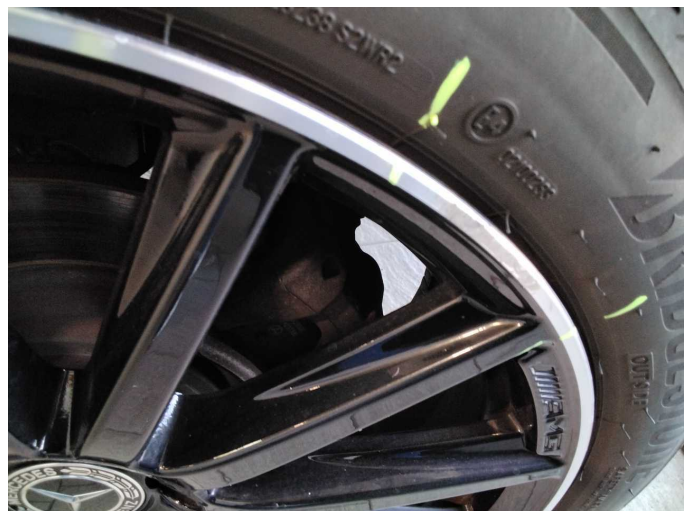
| No. | Component group | Description |
|---|---|---|
| 5 | Wheel / tyres | Alloy rim - rear left side - Scratch(es) - Loss in value |

**Damage 5:** Wheel / tyres: Alloy rim - rear left side - Scratch(es) - Loss in value

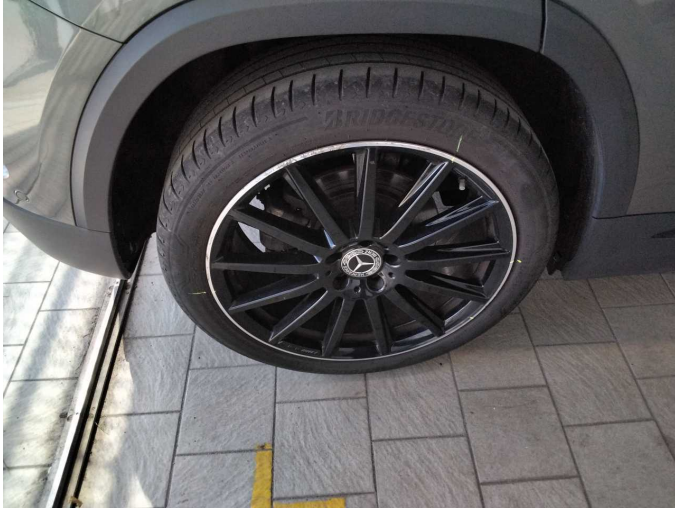
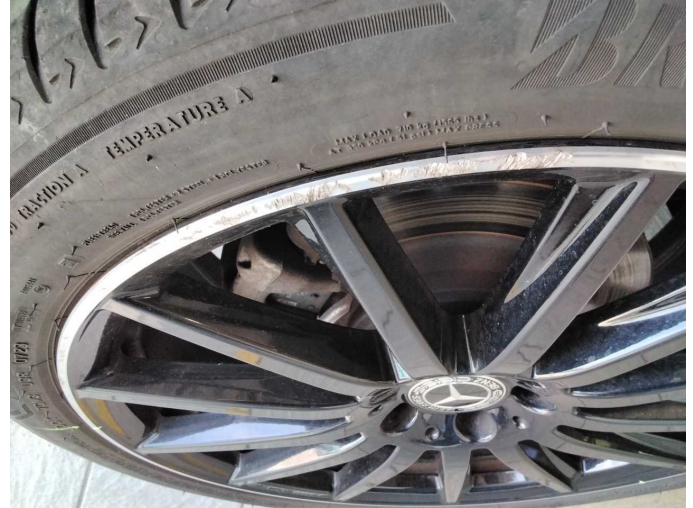
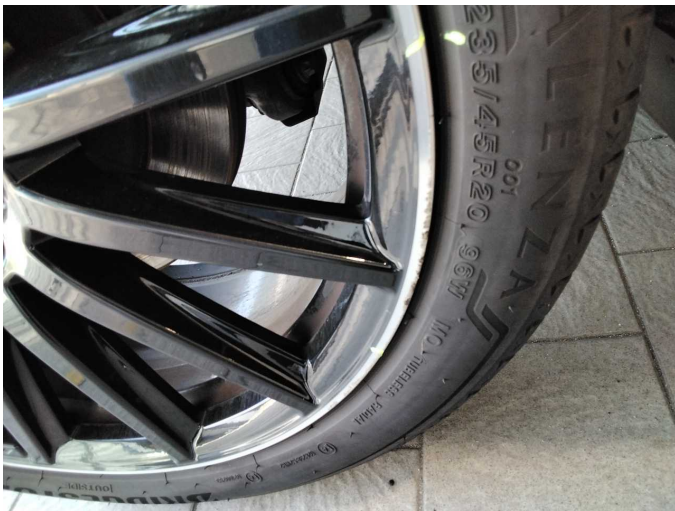
| No. | Component group | Description |
|---|---|---|
| 6 | Wheel / tyres | Alloy rim - rear right side - Scratch(es) - Replace |

**Damage 6:** Wheel / tyres: Alloy rim - rear right side - Scratch(es) - Replace

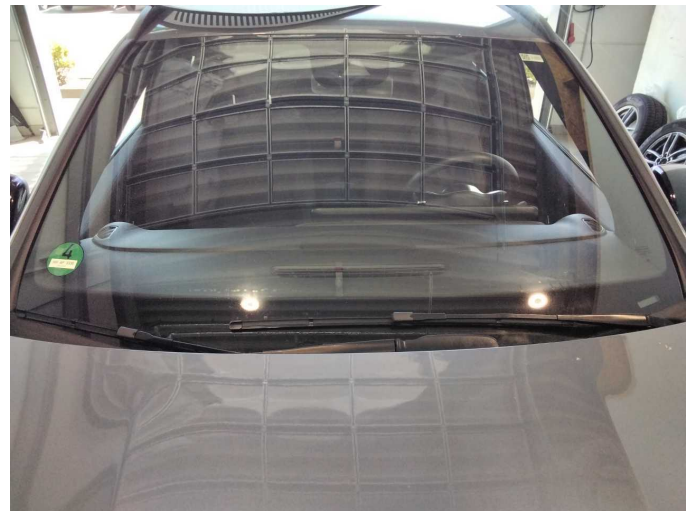
| No. | Component group | Description |
|---|---|---|
| 1 | Vehicle glazing | Windscreen - Stone chips - No deduction |

**Wear and tear 1:** Vehicle glazing: Windscreen - Stone chips - No deduction

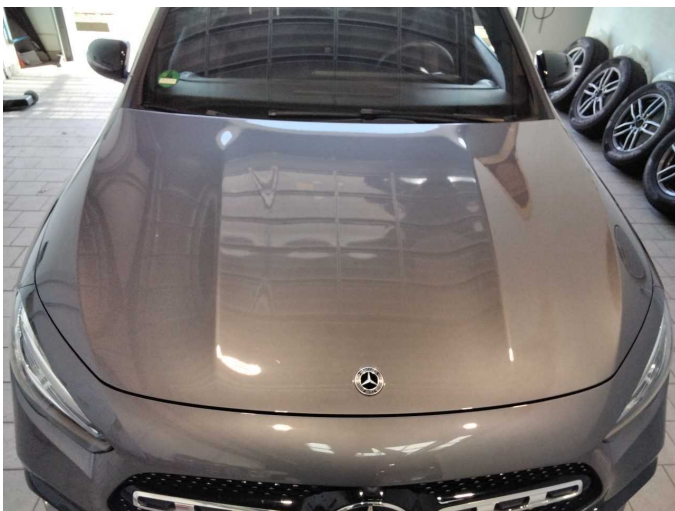
| No. | Component group | Description |
|---|---|---|
| 2 | Bonnet | Bonnet - Stone chips - No deduction |

**Wear and tear 2:** Bonnet: Bonnet - Stone chips - No deduction

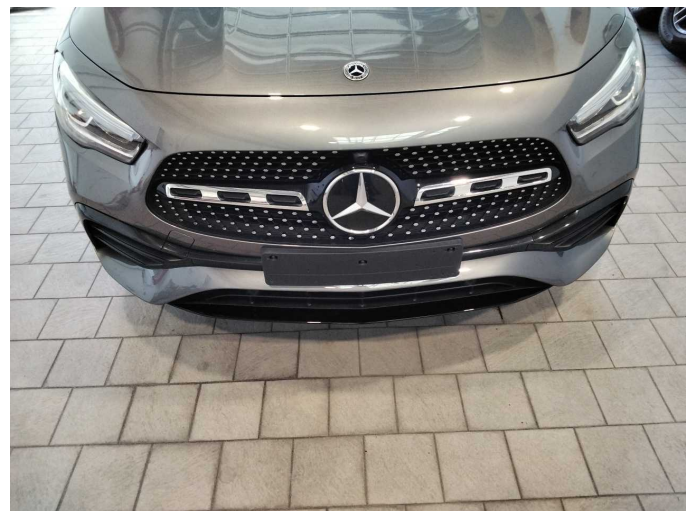
| No. | Component group | Description |
|---|---|---|
| 3 | Front bumper | Front bumper - Stone chips - No deduction |

**Wear and tear 3:** Front bumper: Front bumper - Stone chips - No deduction

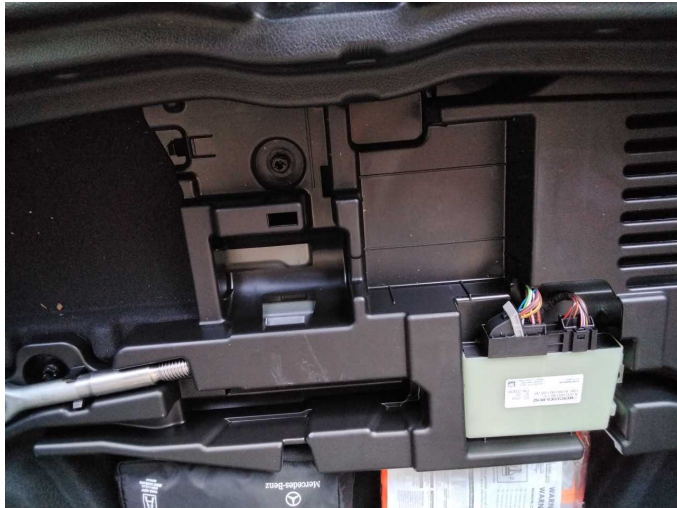
Equipment - Tirefit complete

Missing part 1: Equipment: Tirefit complete - Missing - Replace

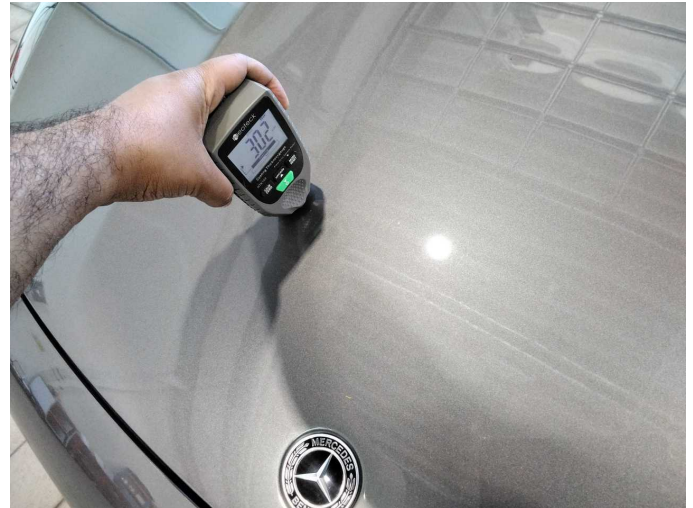
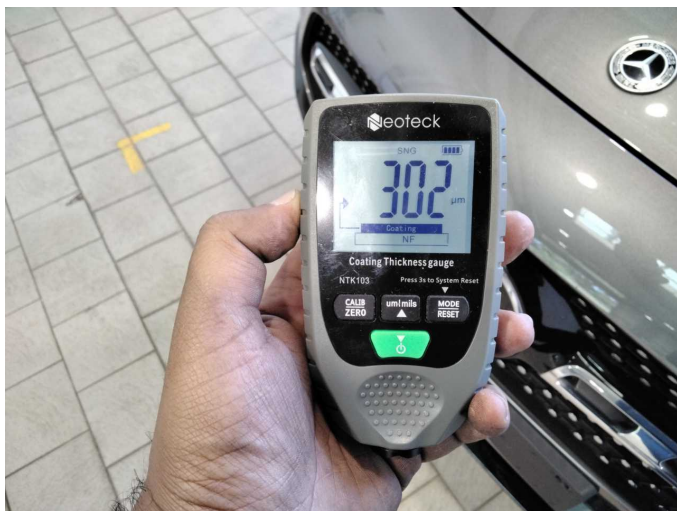
| Bonnet | 302 µm | Side panel - rear left side | 197 µm |

Bonnet: 302 µm

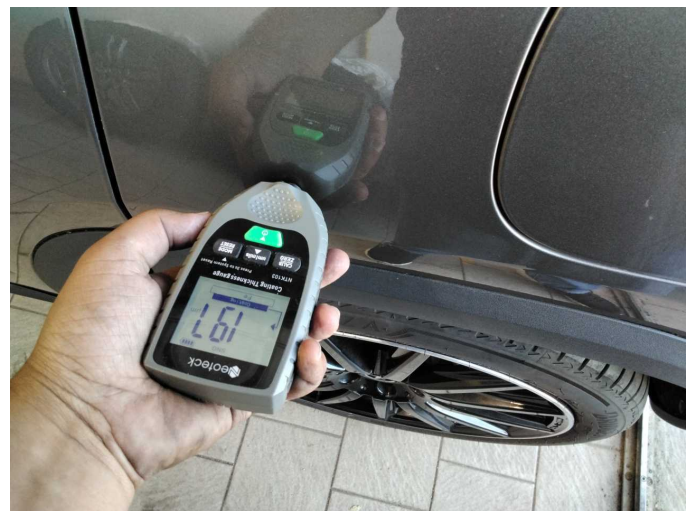
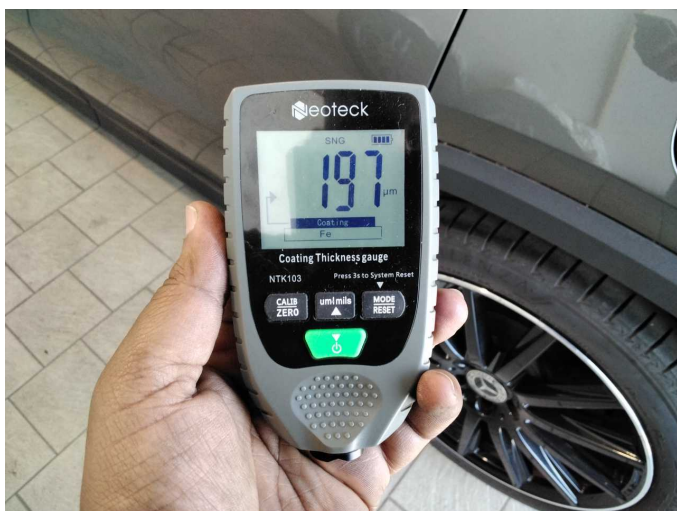
Side panel - rear left side: 197 µm

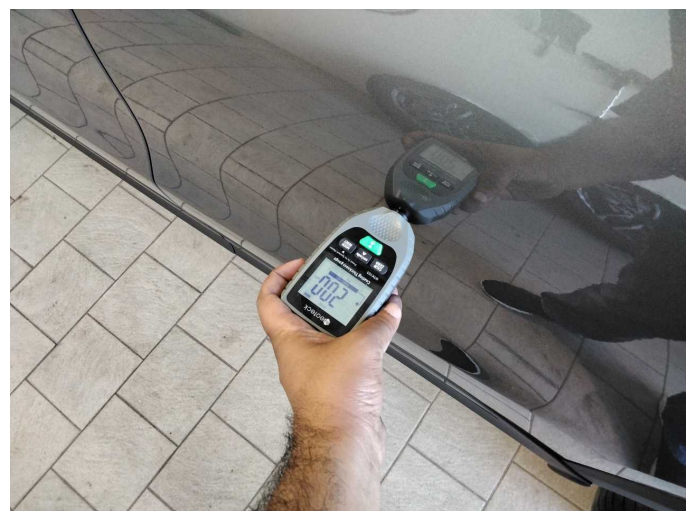
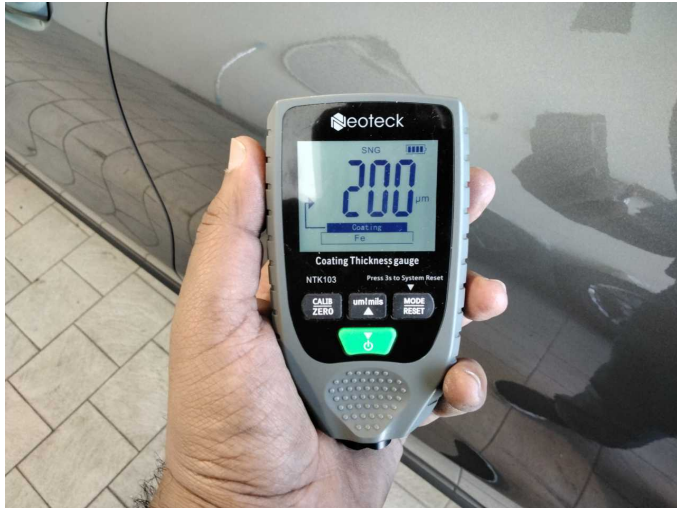
| Door - rear left side | 200 µm | Door - front left side | 248 µm |

Door - rear left side: 200 µm

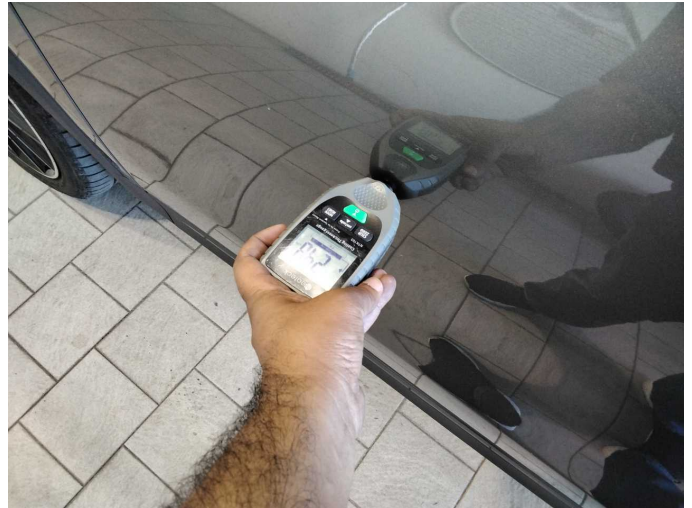
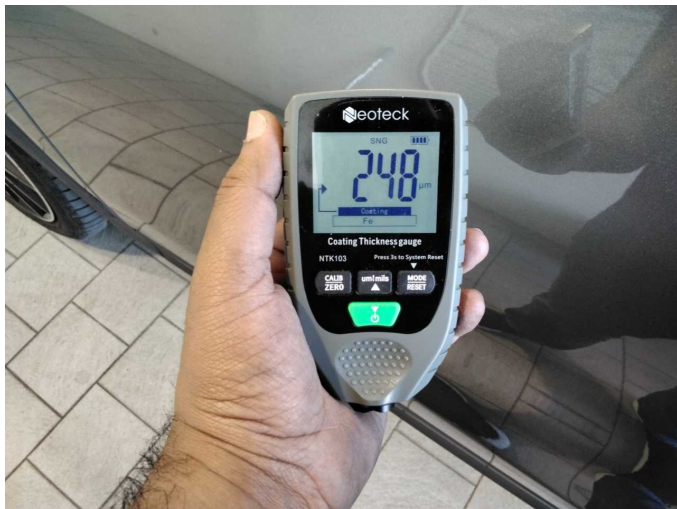
Door - front left side: 248 µm
