Expertise

Protocol number: 46327757  
Order No. / Reference: 26581853  
Inspection date: 6 Jul 2026

Model: Grand Tourneo Connect 1.5 EcoBlue Start/Stop Trend

VIN: WF0UXXWPGUNL49647

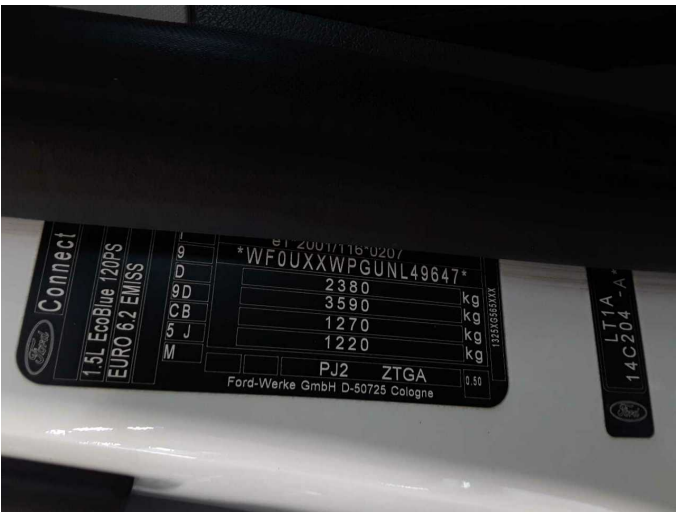
Figure 11: VIN

| VIN comparison | The vehicle identification number (VIN) was read from the vehicle and its conformity with the submitted documents was confirmed by the undersigned during the inspection. |

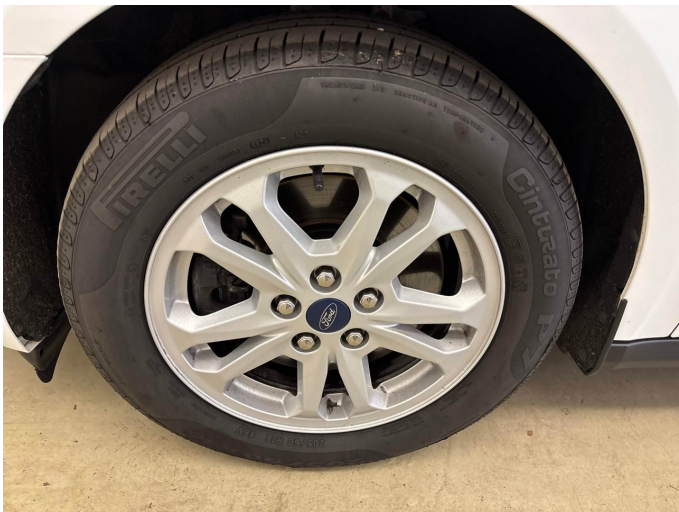
Figure 12: Mounted tyres

| # | Tyre size | Type of tyre | Manufacturer | Tread depth |
|---|---|---|---|---|
| 1) | 205/60 R16 96V | Summer tyres on Light alloy | Pirelli | 4mm / 4mm |
| 2) | 205/60 R16 96V | Summer tyres on Light alloy | Pirelli | 5mm / 5mm |

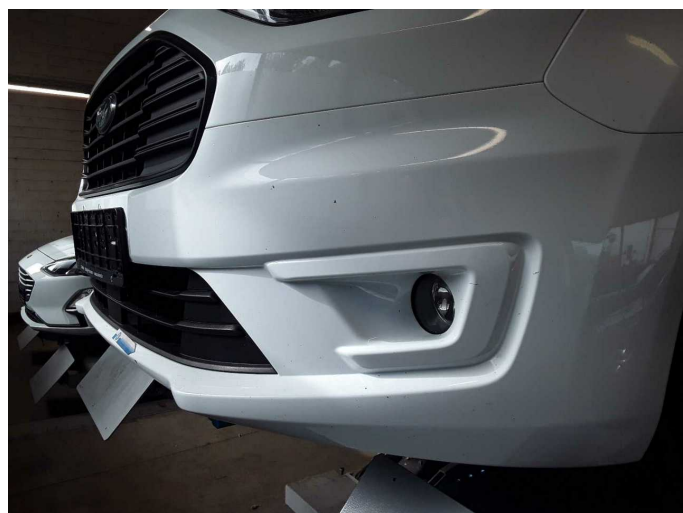
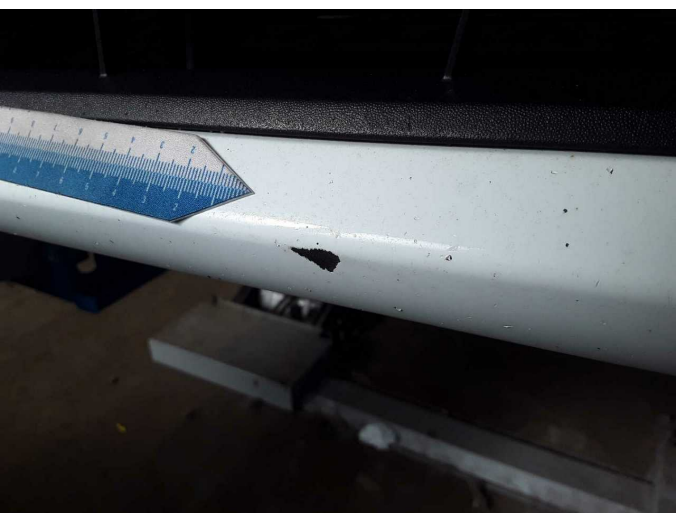
| No. | Component group | Description |
|---|---|---|
| 1 | Front bumper | Front bumper - Scratch(es) - Smart repair |

Damage 1: Front bumper: Front bumper - Scratch(es) - Smart repair

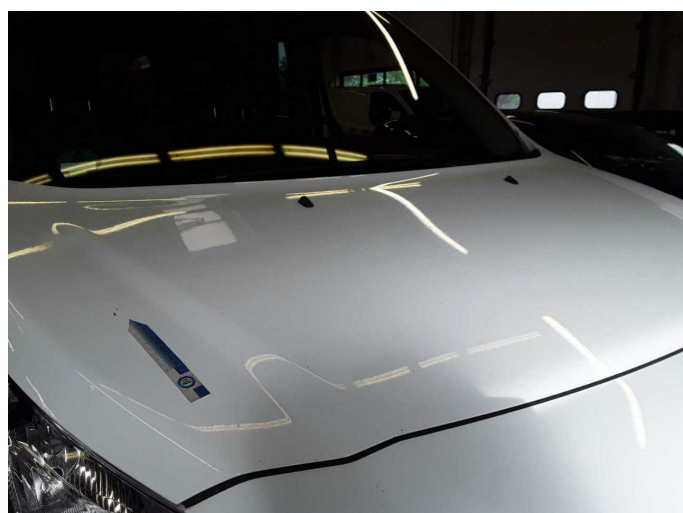
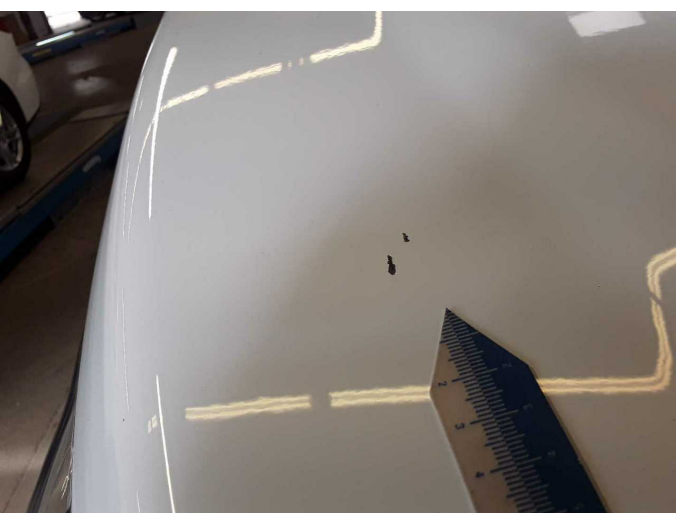
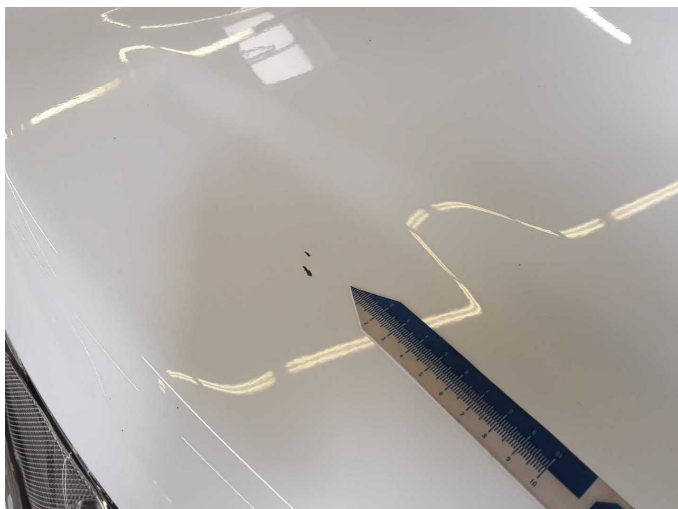
| No. | Component group | Description |
|---|---|---|
| 2 | Bonnet | Bonnet - Scratch(es) - Paint |

Damage 2: Bonnet: Bonnet - Scratch(es) - Paint

**Damage 2:** Bonnet: Bonnet - Scratch(es) - Paint

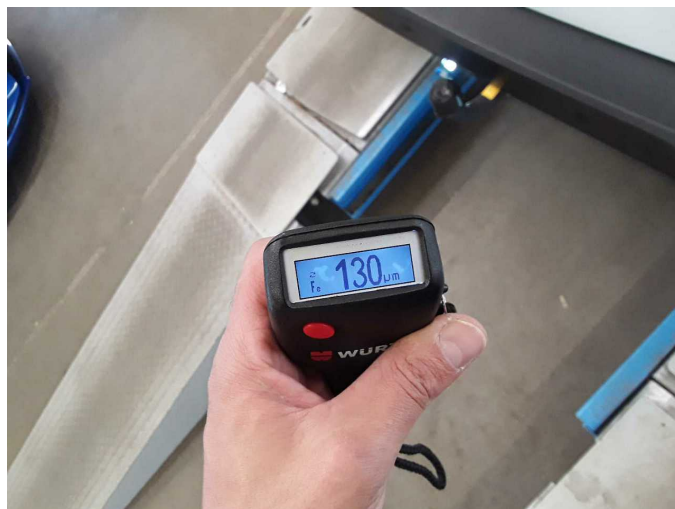
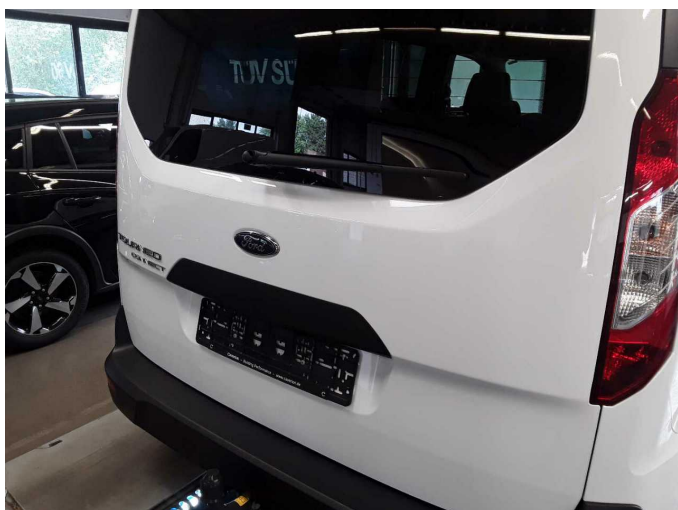
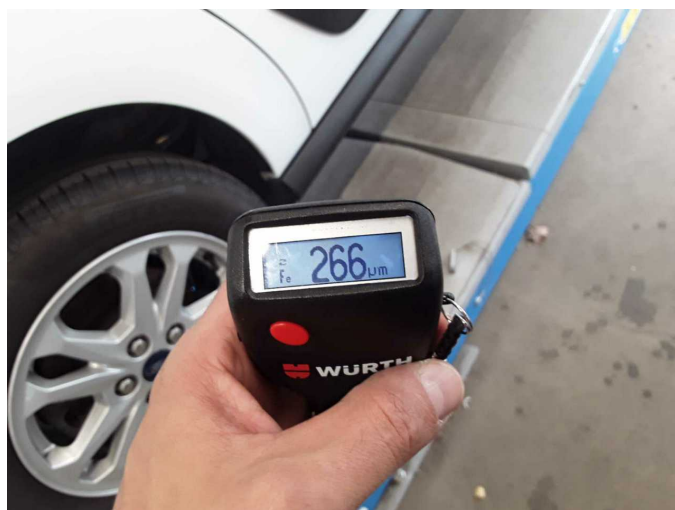
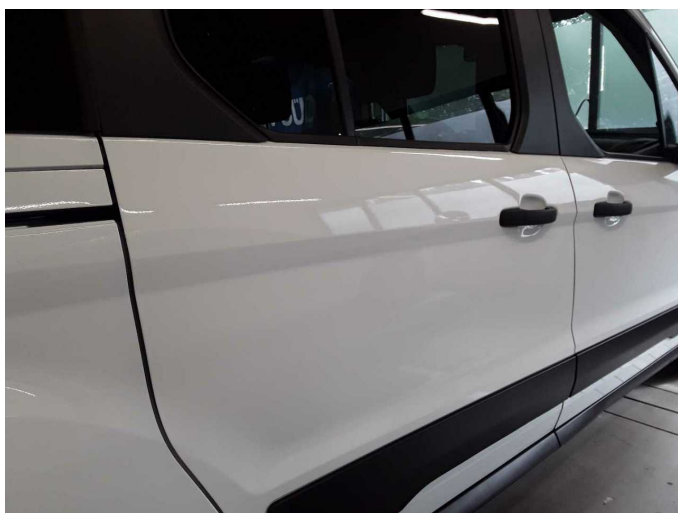
| No. | Repainting |
|---|---|
| 1 | Boot lid / rear door, Side panel - rear right side, Professionally carried out, Invoice of repair done Non-existent |

**Repainting 1:** Boot lid / rear door, Side panel - rear right side
