Expertise

Protocol number: 46531252  
Order No. / Reference: 26652761  
Inspection date: 15 Jul 2026

Manufacturer: Audi

Model: A4 allroad quattro 40 TDI S tronic

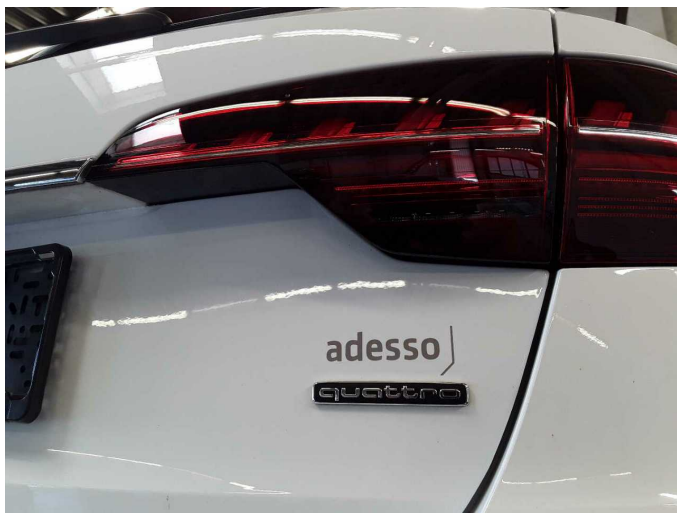
| No. | Component group | Description |
|---|---|---|
| 2 | Boot lid / rear door | Boot lid - Glued / labelled - De-glue / neutralise |

Damage 2: Boot lid / rear door: Boot lid - Glued / labelled - De-glue / neutralise

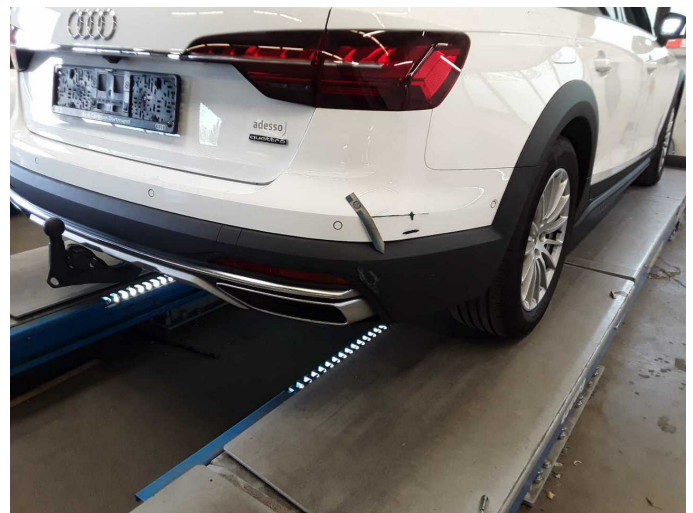
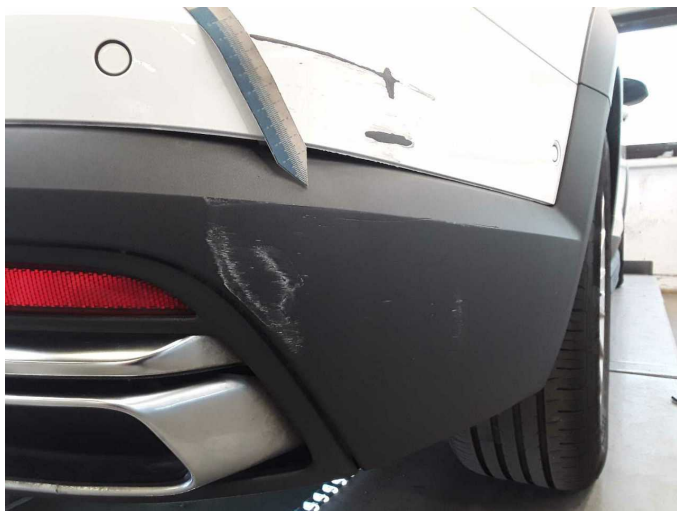
| No. | Component group | Description |
|---|---|---|
| 3 | Rear bumper | Spoiler - Scratched - Smart repair |

Damage 3: Rear bumper: Spoiler - Scratched - Smart repair

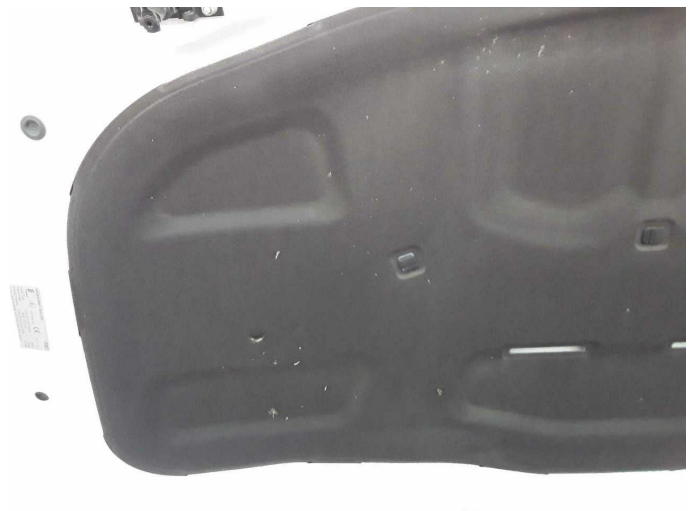
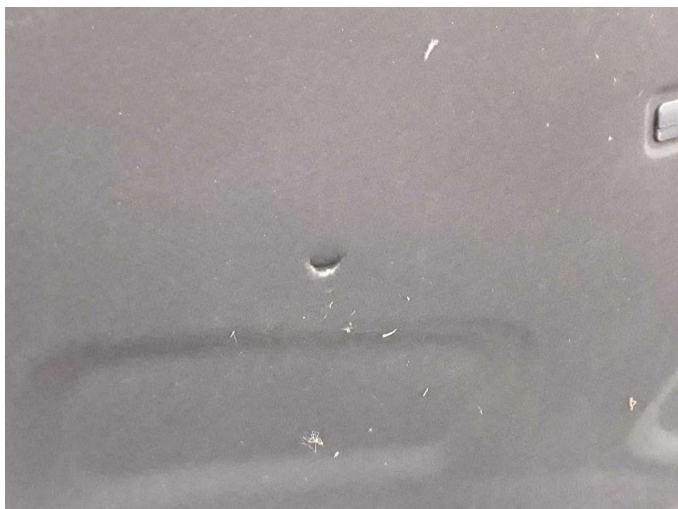
| No. | Component group | Description |
|---|---|---|
| 4 | Engine | Engine cover - Damaged - Replace |

Damage 4: Engine: Engine cover - Damaged - Replace

**Damage 4:** Engine: Engine cover - Damaged - Replace

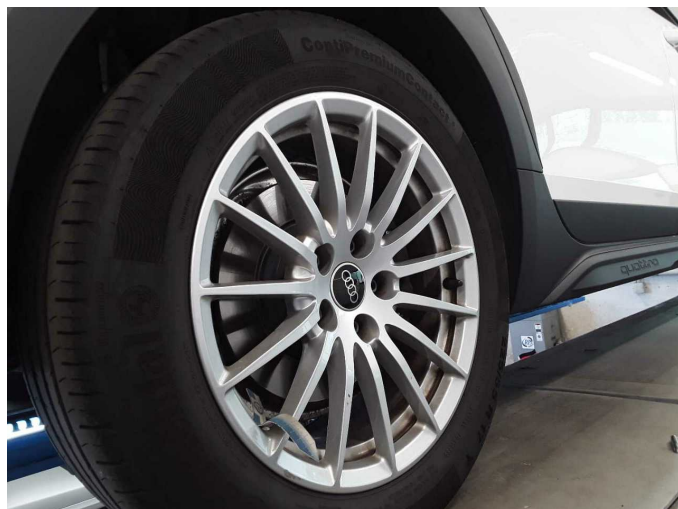
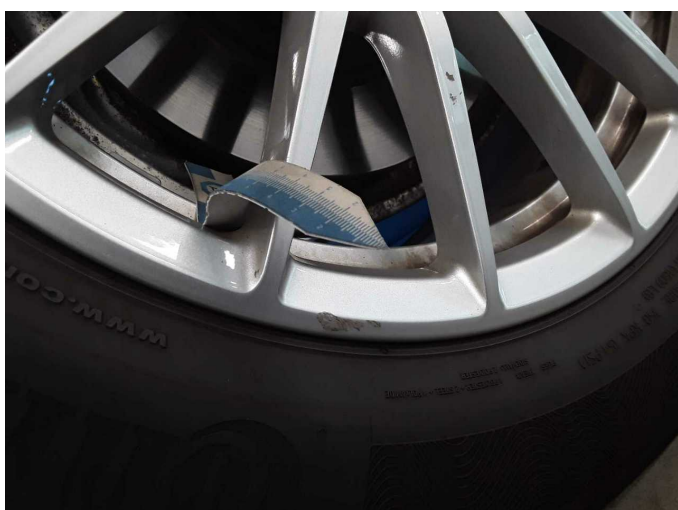
| No. | Component group | Description |
|---|---|---|
| 5 | Wheel / tyres | Alloy rim - rear right side - Scratch(es) - Smart repair |

**Damage 5:** Wheel / tyres: Alloy rim - rear right side - Scratch(es) - Smart repair

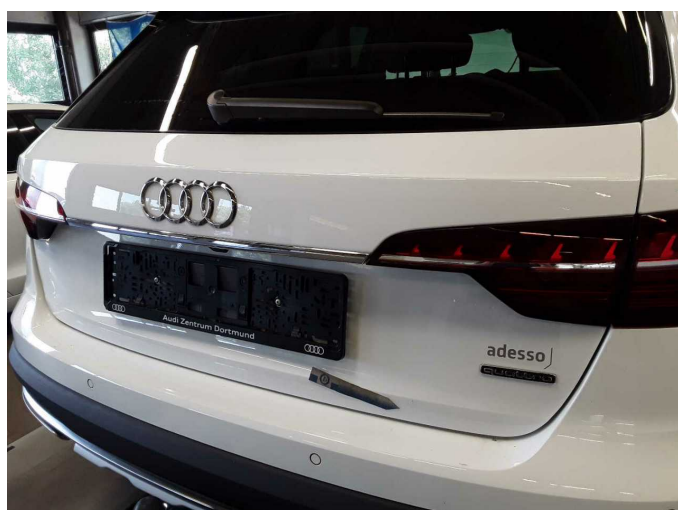
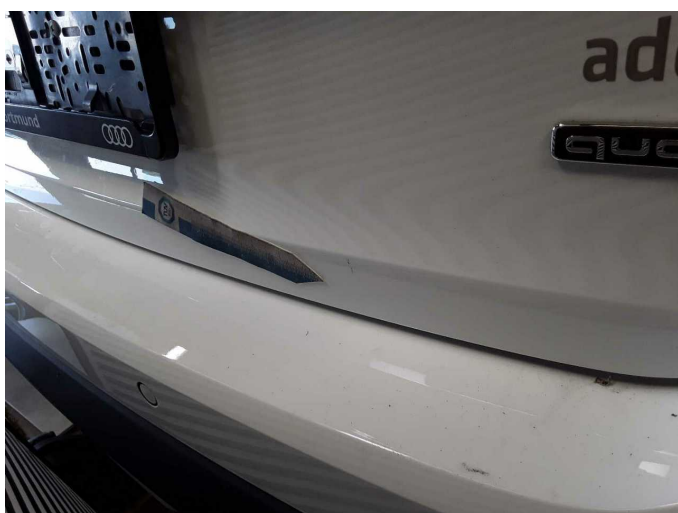
| No. | Component group | Description |
|---|---|---|
| 6 | Boot lid / rear door | Boot lid - Dent / paintcoat damage - Smart repair |

**Damage 6:** Boot lid / rear door: Boot lid - Dent / paintcoat damage - Smart repair

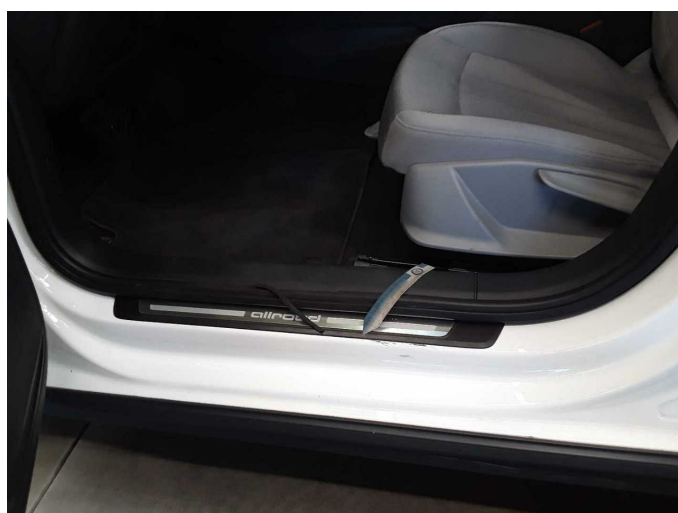
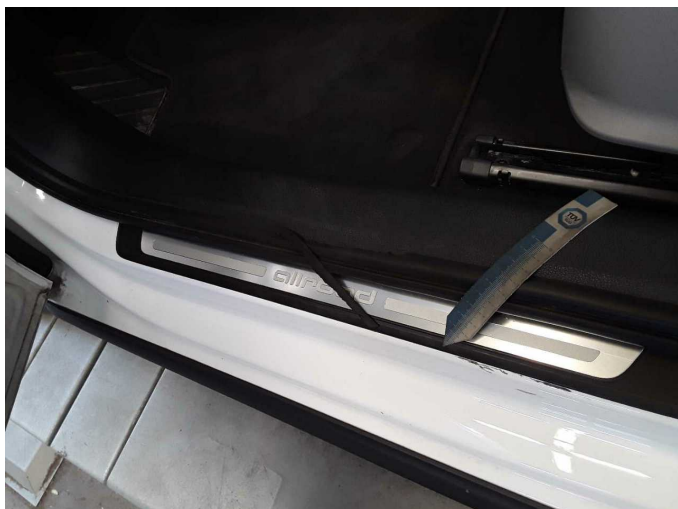
| No. | Component group | Description |
|---|---|---|
| 7 | Cab | Door rubber seal - left side - Damaged - Replace |

**Damage 7:** Cab: Door rubber seal - left side - Damaged - Replace

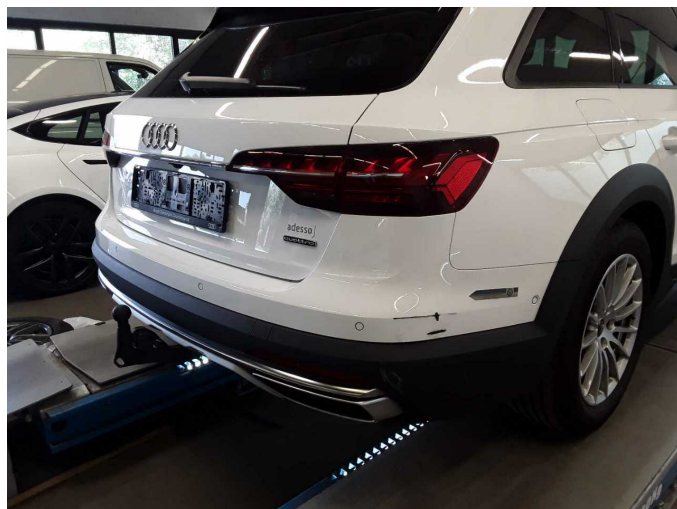
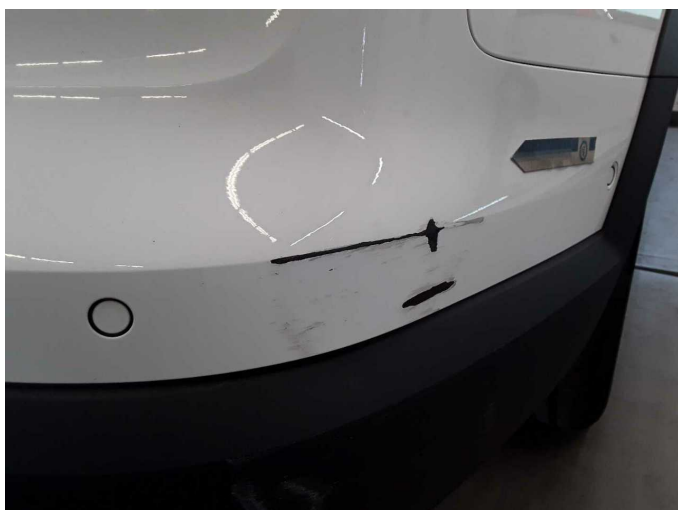
| No. | Component group | Description |
|---|---|---|
| 8 | Rear bumper | Rear bumper - Scratched - Paint |

**Damage 8:** Rear bumper: Rear bumper - Scratched - Paint

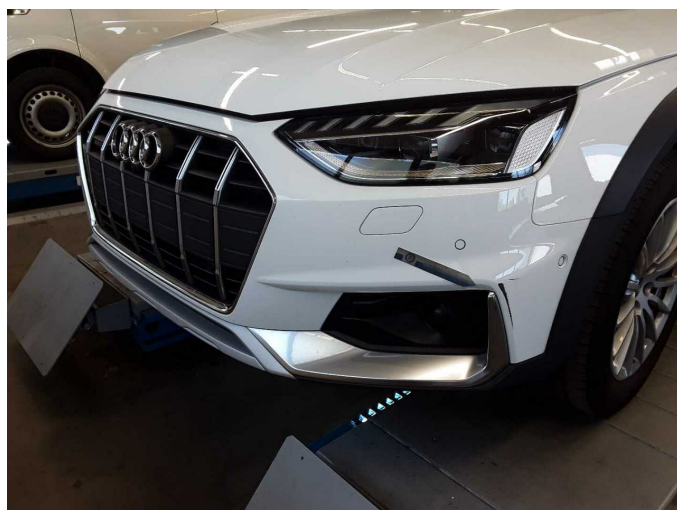
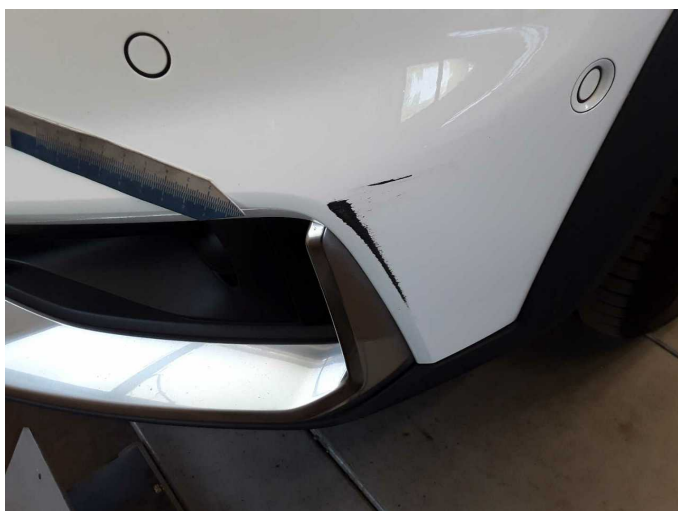
| No. | Component group | Description |
|---|---|---|
| 9 | Front bumper | Front bumper - Scratched - Paint |

**Damage 9:** Front bumper: Front bumper - Scratched - Paint

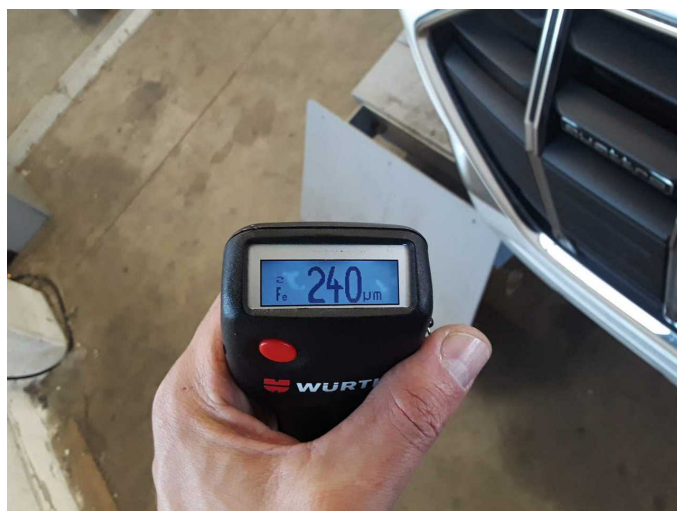
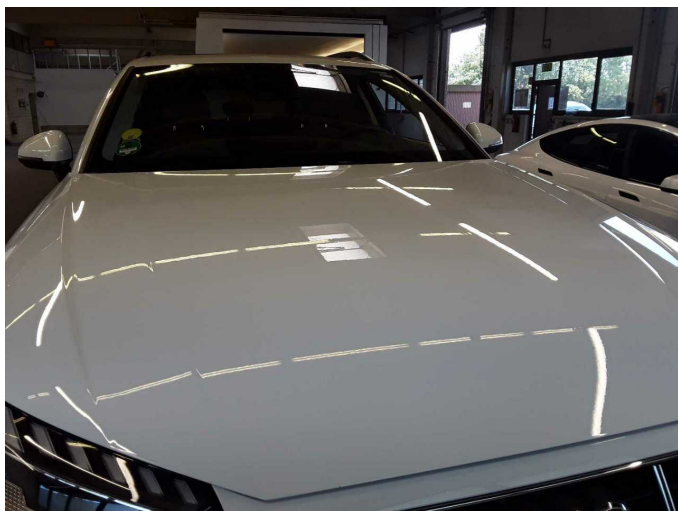
| No. | Repainting |
|---|---|
| 1 | Bonnet, Professionally carried out, Invoice of repair done Non-existent |

Bonnet

240 µm |

**Repainting 1:** Bonnet
