Expertise

Protocol number: 45459646
Order No. / Reference: 26081106-1
Inspection date: 27 Apr 2026

Model: XC60 T6 AWD Recharge Geartronic RDesign

VIN: LYVUZH1V9PB243691

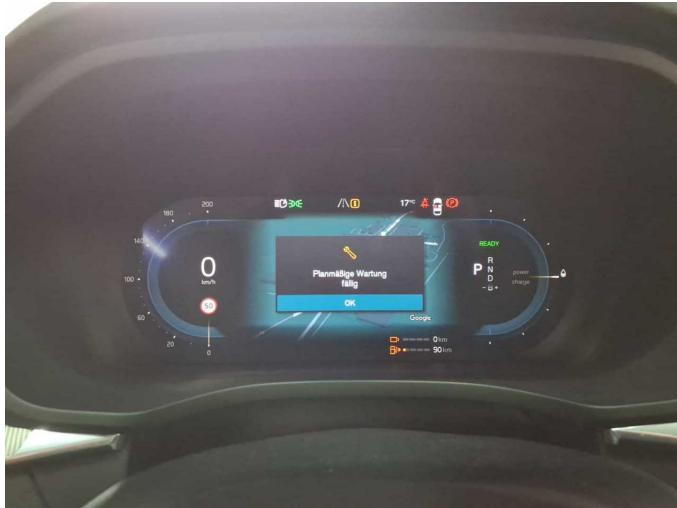
Figure 7: Instrument cluster

Mileage (Read) 49,394 km

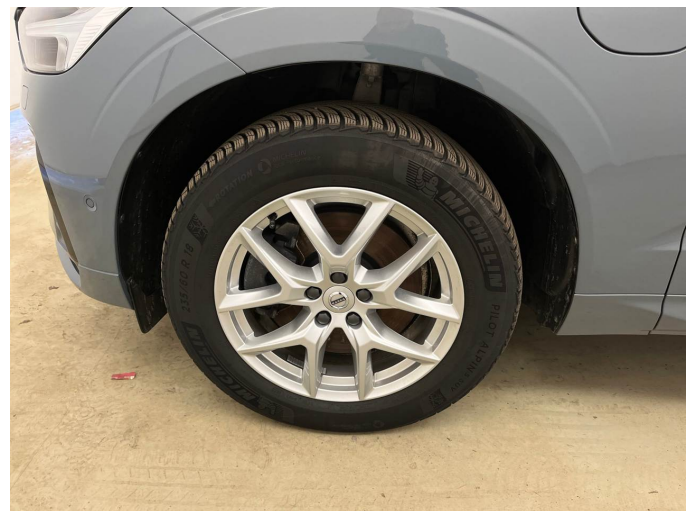
Figure 12: Mounted tyres

#	Tyre size	Type of tyre	Manufacturer	Tread depth
1)	235/60 R18 107H	Winter tyres on Light alloy	Michelin	5mm / 5mm
2)	235/60 R18 107H	Winter tyres on Light alloy	Michelin	5mm / 5mm

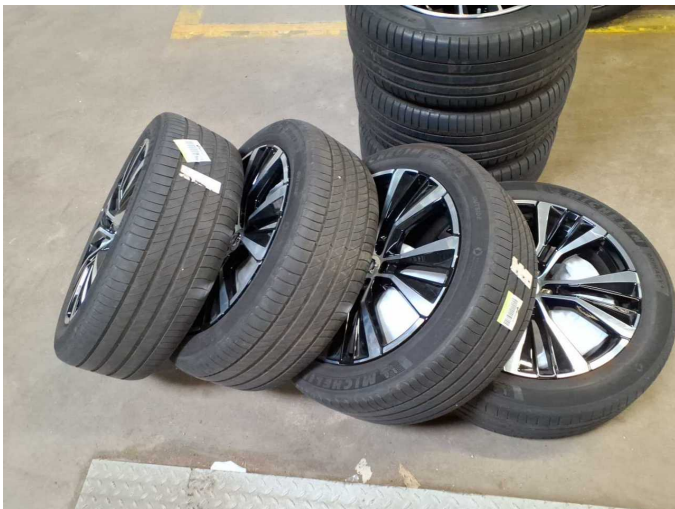
Figure 15: Additional tyres

#	Tyre size	Type of tyre	Manufacturer	Tread depth
1)	255/45 R20 105V	Summer tyres on Light alloy	Michelin	4mm / 4mm
2)	255/45 R20 105V	Summer tyres on Light alloy	Michelin	4mm / 4mm

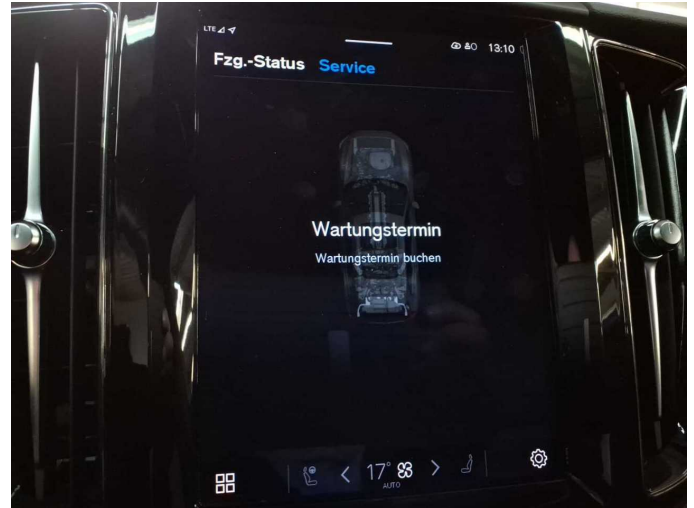
Damage 1: Misc.: Inspection / maintenance - Due - Perform

No.	Component group	Description
1	Misc.	Inspection / maintenance - Due - Perform
2	2nd wheel set	1 alloy rim (Materialabtrag, Grad steht über) - Scratched - Replace

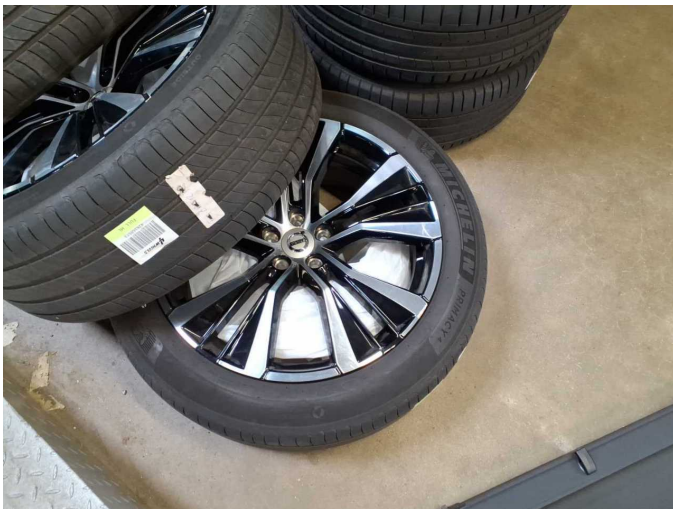
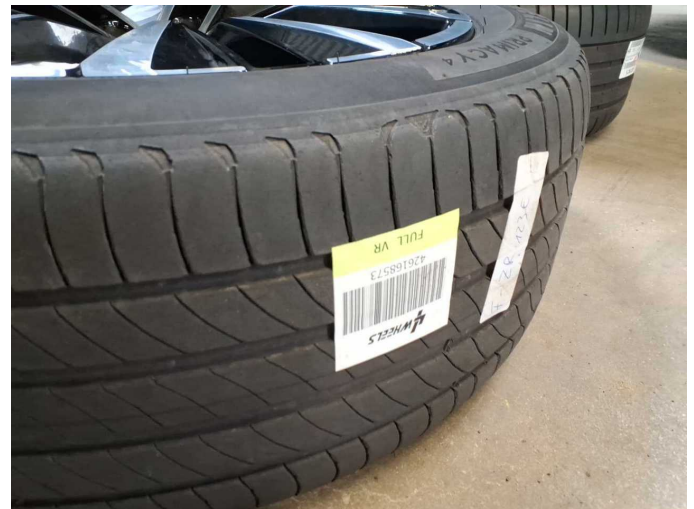
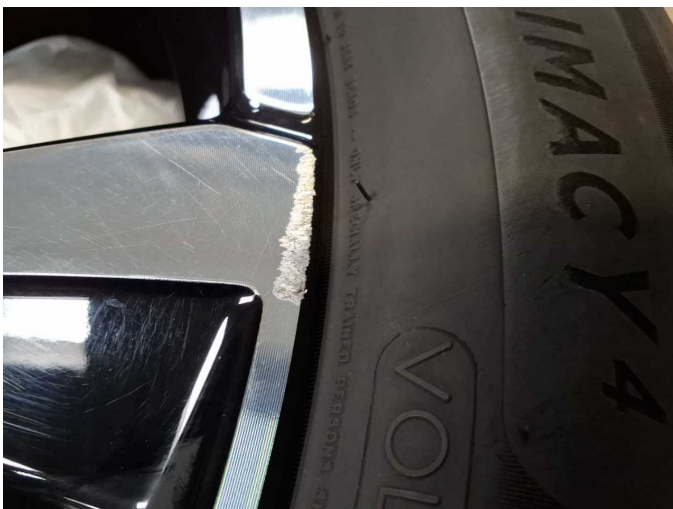
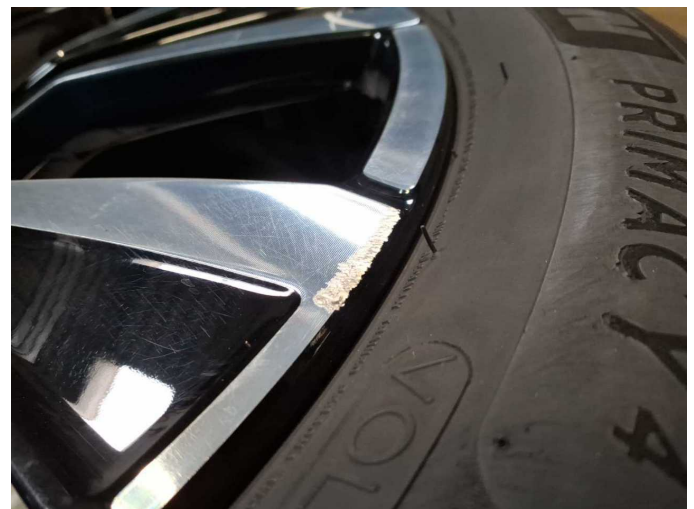
Damage 2: 2nd wheel set: 1 alloy rim (Materialabtrag, Grad steht über) - Scratched - Replace
