Expertise

Protocol number: 46214456  
Order No. / Reference: 26550866  
Inspection date: 30 Jun 2026

Manufacturer: Volkswagen

Model: Passat Variant 2.0 TDI SCR Elegance

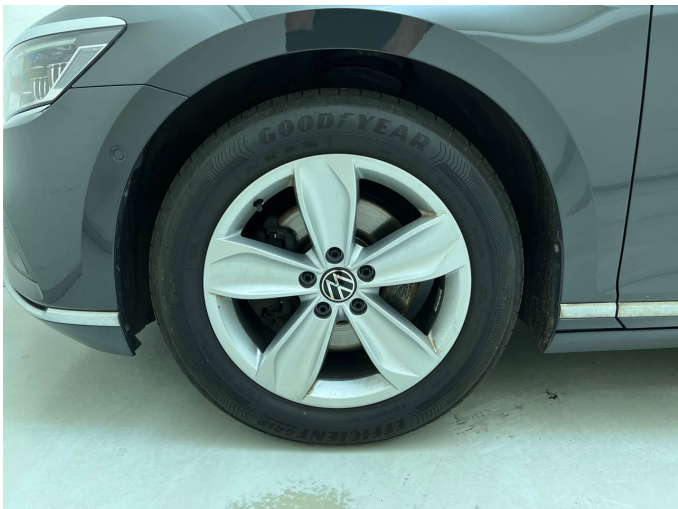
Figure 12: Mounted tyres

| # | Tyre size | Type of tyre | Manufacturer | Tread depth |
|---|---|---|---|---|
| 1) | 215/55 R17 94V | Summer tyres on Light alloy | Goodyear | 6mm / 6mm |
| 2) | 215/55 R17 94W | Summer tyres on Light alloy | Goodyear | 8mm / 8mm |

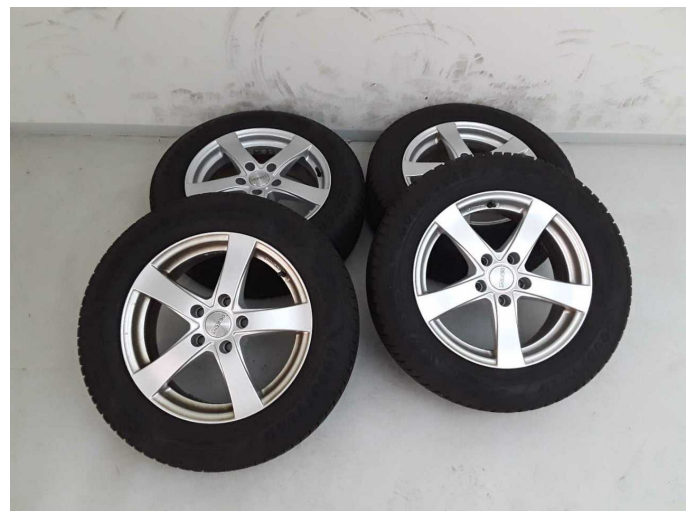
Figure 16: Additional tyres

| # | Tyre size | Type of tyre | Manufacturer | Tread depth |
|---|---|---|---|---|
| 1) | 215/60 R16 99H | Winter tyres on Light alloy | Goodyear | 6mm / 6mm |
| 2) | 215/60 R16 99H | Winter tyres on Light alloy | Goodyear | 7mm / 7mm |

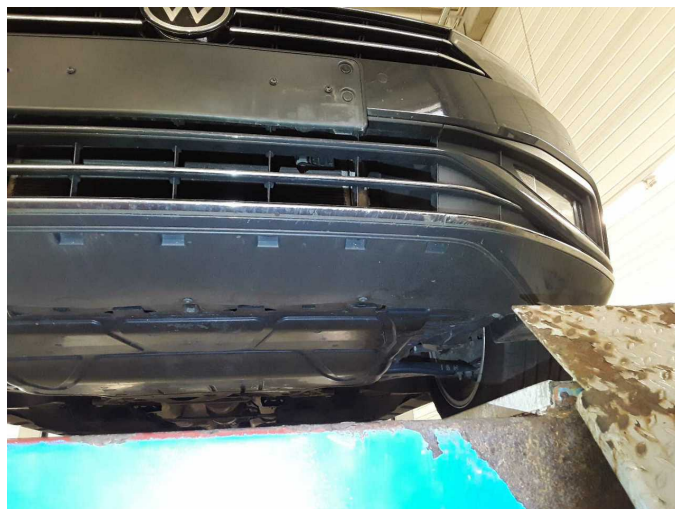
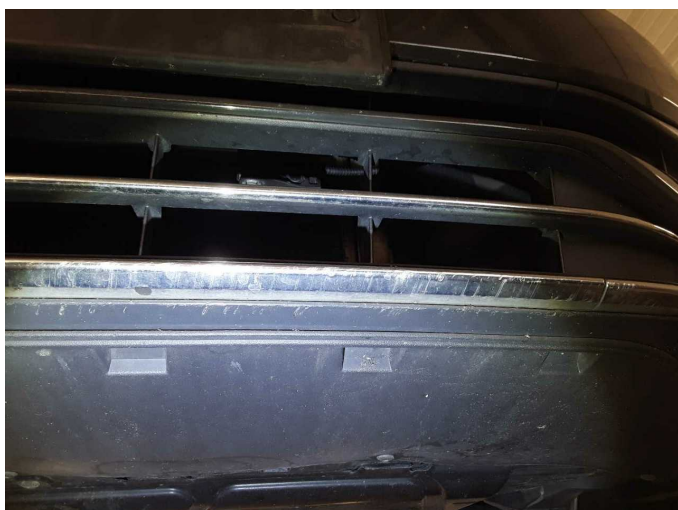
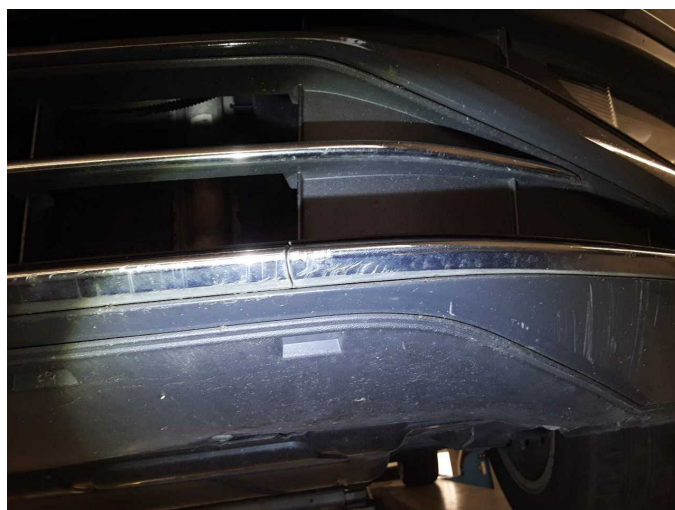
**Damage 1:** Trim / covers: Brightware / decorative strip (Stoßfänger vorn)  
- Scratched - Replace

| No. | Component group | Description |
|---|---|---|
| 1 | Trim / covers | Brightware / decorative strip (Stoßfänger vorn) - Scratched - Replace |

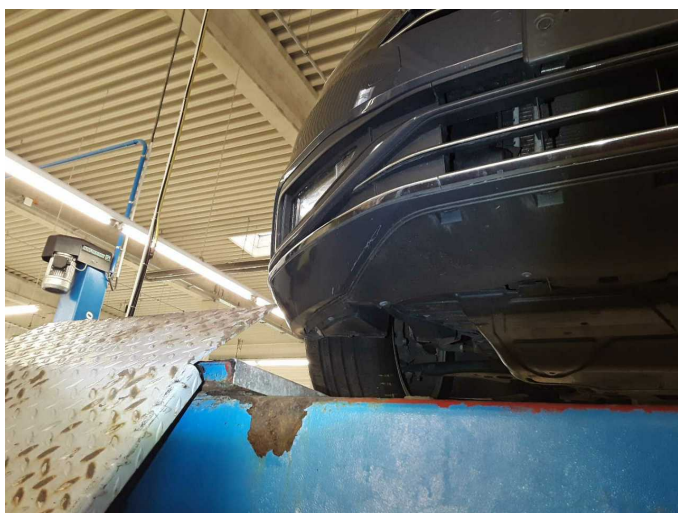
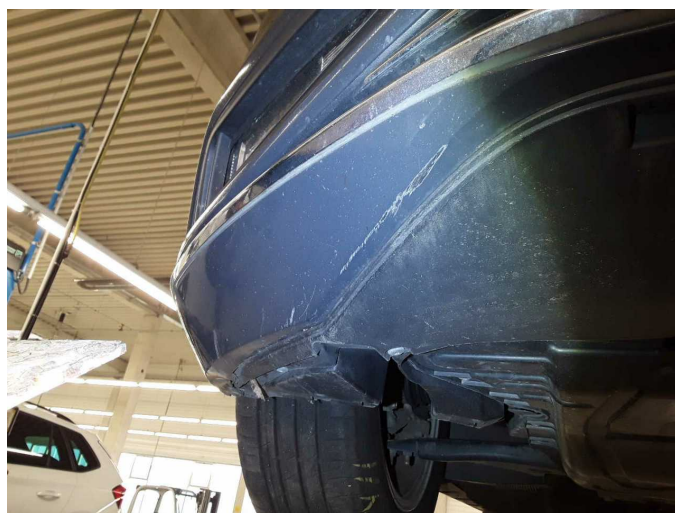
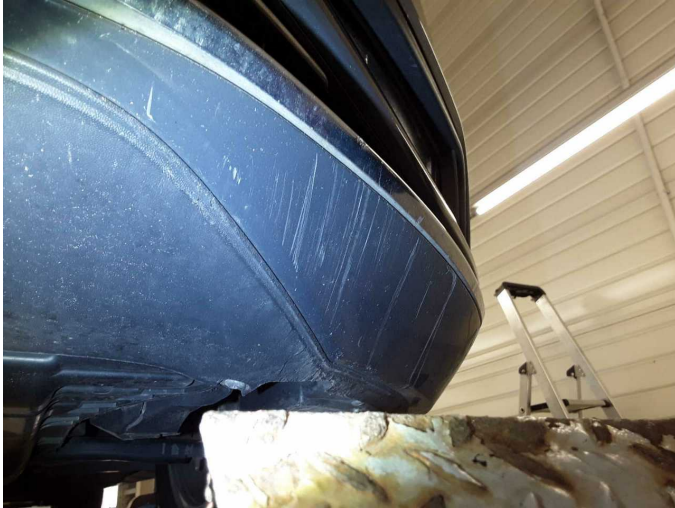
**Damage 2:** Front bumper: Front bumper - Scratch(es) - Paint

| No. | Component group | Description |
|---|---|---|
| 2 | Front bumper | Front bumper - Scratch(es) - Paint |

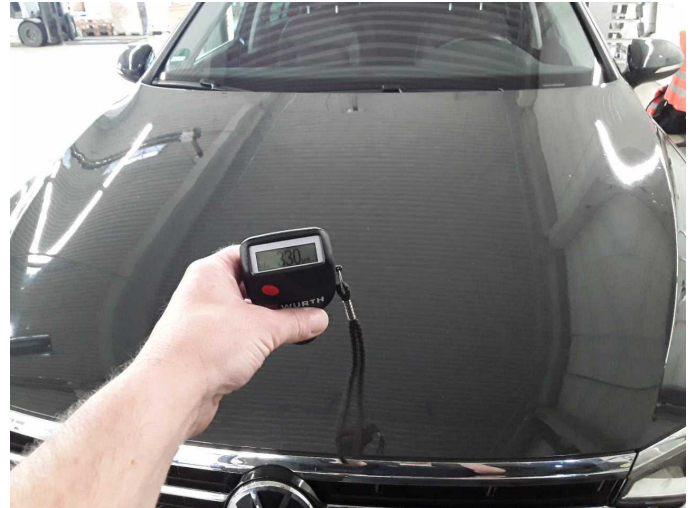
**Bonnet:** 330  $\mu\text{m}$

| No. | Repainting |
|---|---|
| 1 | Bonnet, Side panel - rear left side, Door - rear left side, Professionally carried out |

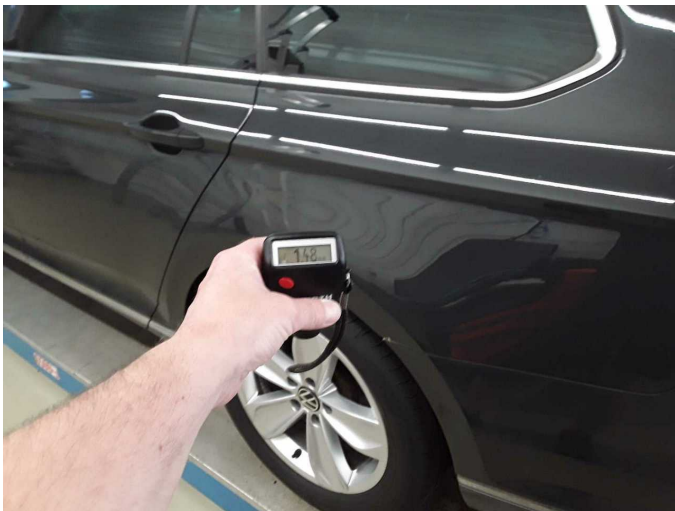
**Side panel - rear left side:** 1,480  $\mu\text{m}$

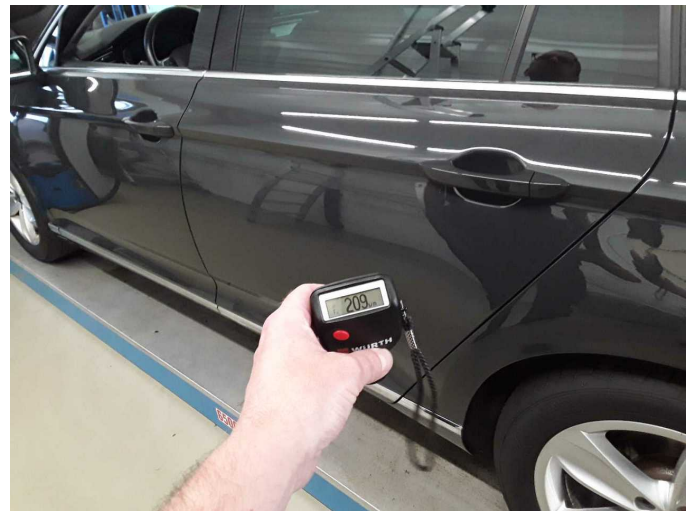
**Door - rear left side:** 209  $\mu\text{m}$
