Expertise

Protocol number: 45877671  
Order No. / Reference: 26574127  
Inspection date: 10 Jun 2026

Manufacturer: Mercedes-Benz

Model: GLC 220 d 4Matic 9G-TRONIC AMG Line Advanced

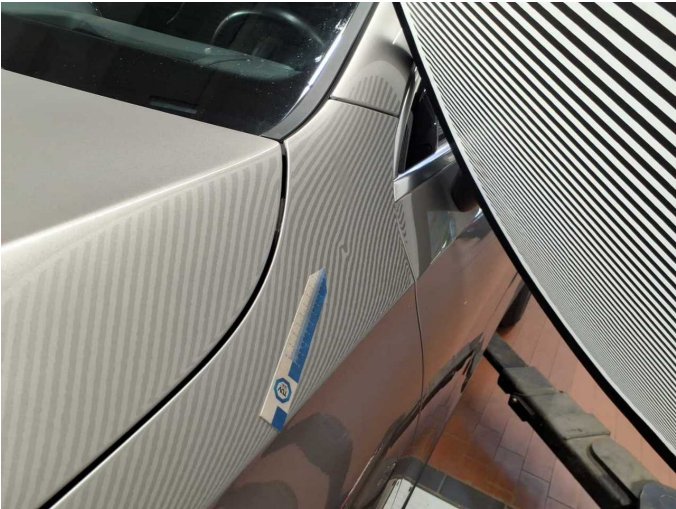
| No. | Component group | Description |
|---|---|---|
| 1 | Mudguard - left side | Mudguard - left side - dent(s) - Smooth repair work |

Damage 1: Mudguard - left side: Mudguard - left side - dent(s) - Smooth repair work

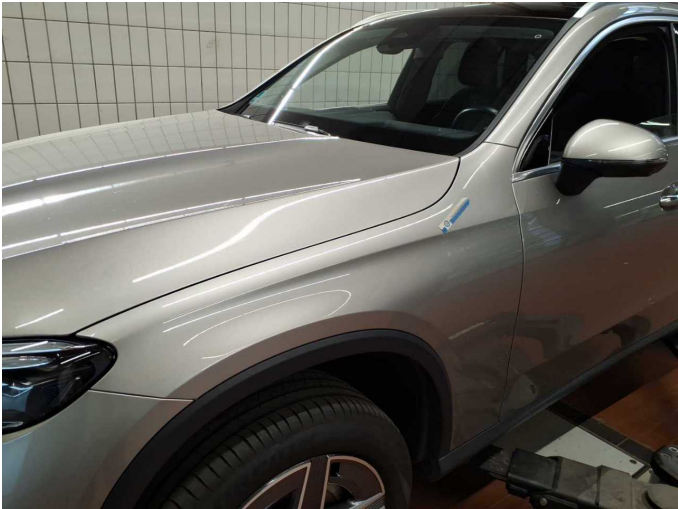
Damage 1: Mudguard - left side: Mudguard - left side - dent(s) - Smooth repair work

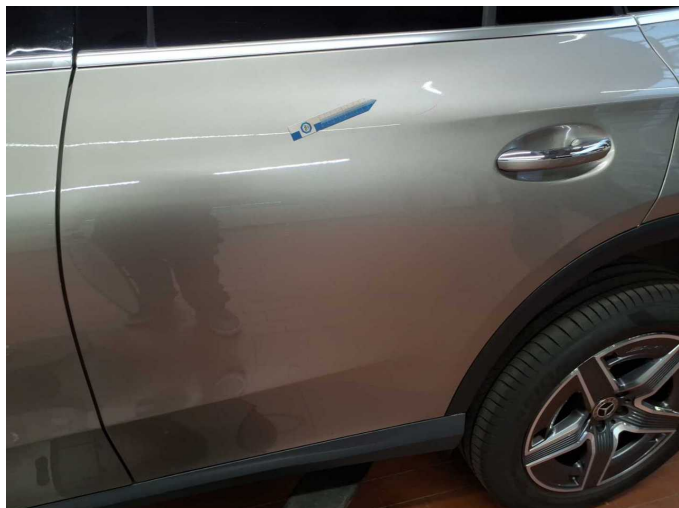
| No. | Component group | Description |
|---|---|---|
| 2 | Door - rear left side | Door - dent(s) - Smooth repair work |

**Damage 2:** Door - rear left side: Door - dent(s) - Smooth repair work

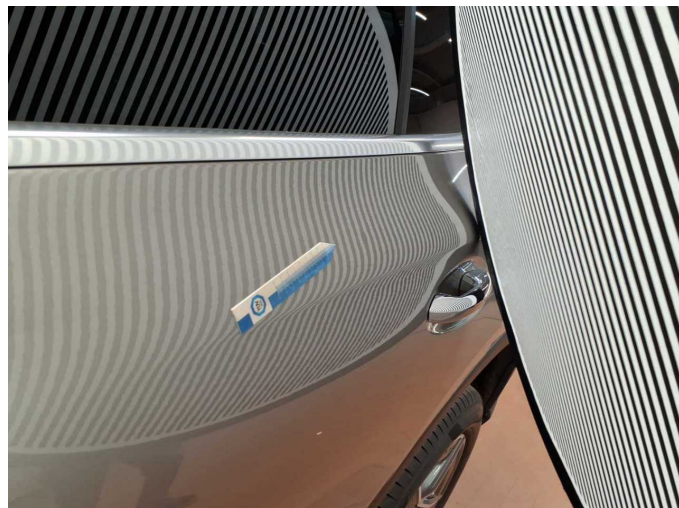
**Damage 2:** Door - rear left side: Door - dent(s) - Smooth repair work

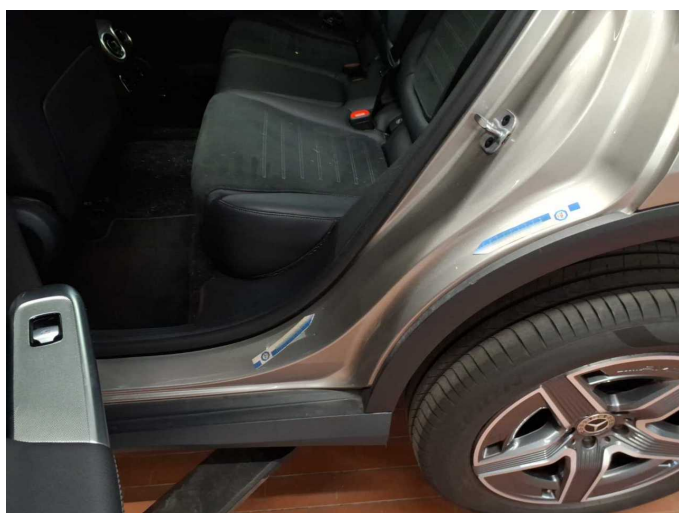
| No. | Component group | Description |
|---|---|---|
| 3 | Side panel - rear left side | Sill - Scratch(es) - Smart repair |

**Damage 3:** Side panel - rear left side: Sill - Scratch(es) - Smart repair

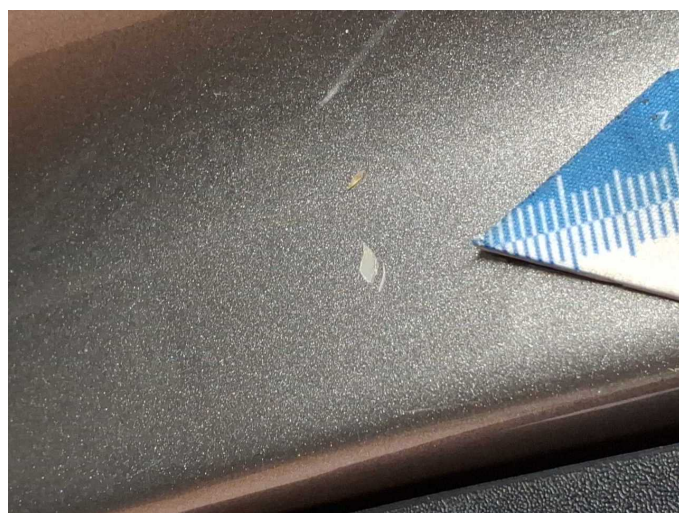
**Damage 3:** Side panel - rear left side: Sill - Scratch(es) - Smart repair

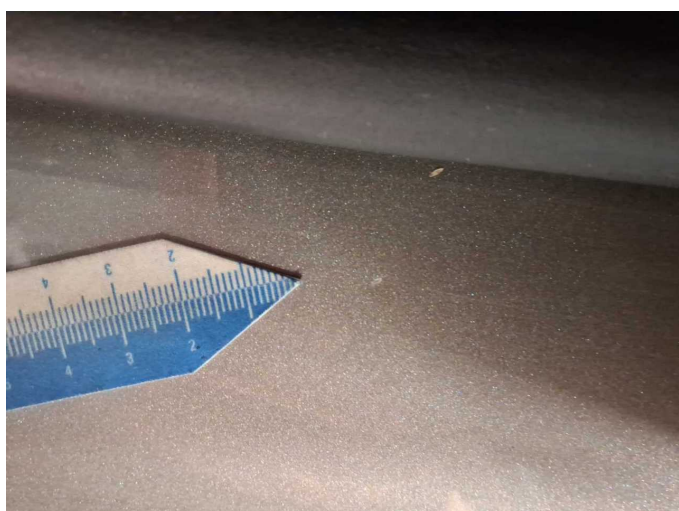
**Damage 3:** Side panel - rear left side: Sill - Scratch(es) - Smart repair

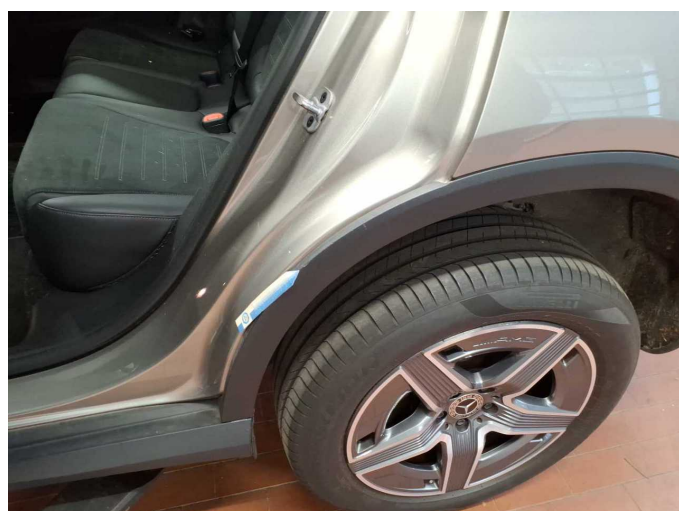
| No. | Component group | Description |
|---|---|---|
| 4 | Side panel - rear left side | Wheel well extension - Scratched - Replace |

**Damage 4:** Side panel - rear left side: Wheel well extension - Scratched - Replace

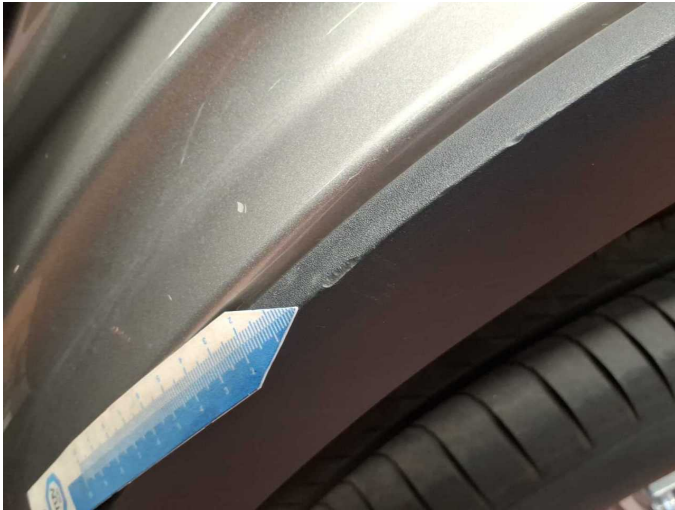
**Damage 4:** Side panel - rear left side: Wheel well extension - Scratched - Replace

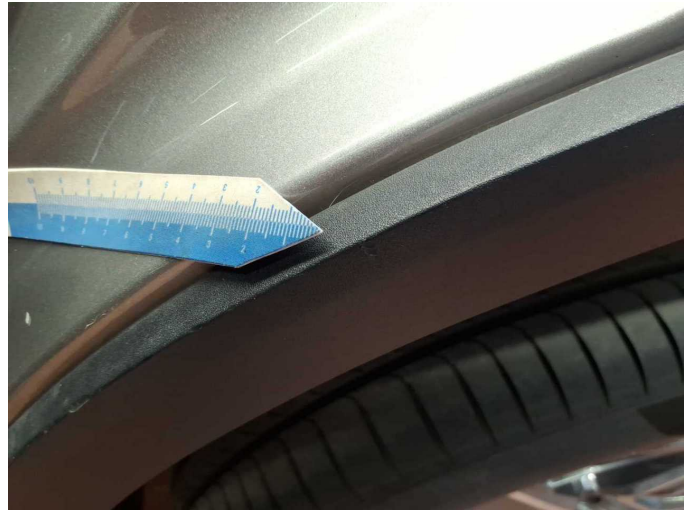
**Damage 4:** Side panel - rear left side: Wheel well extension - Scratched - Replace

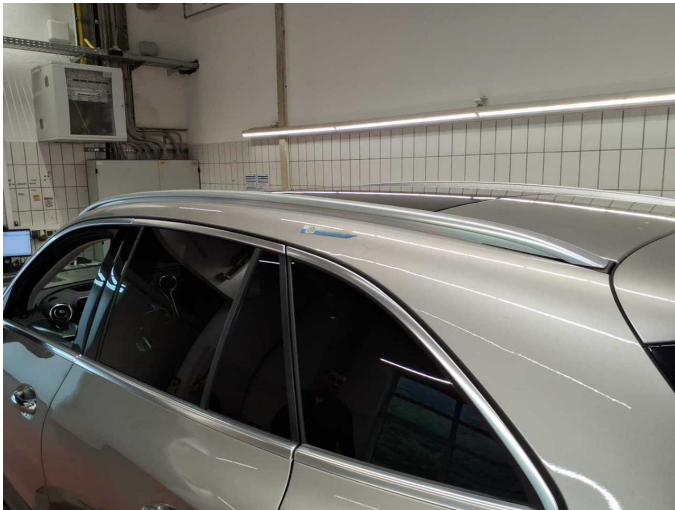
| No. | Component group | Description |
|---|---|---|
| 5 | Roof | Roof rail - left side - dent(s) - Smooth repair work |

**Damage 5:** Roof: Roof rail - left side - dent(s) - Smooth repair work

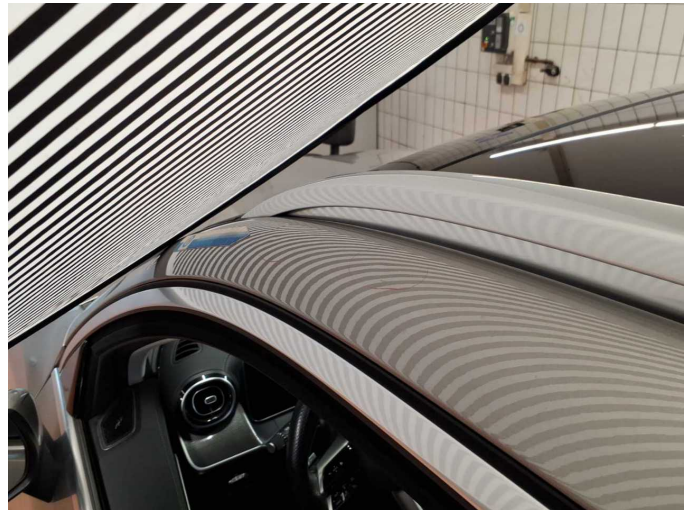
**Damage 5:** Roof: Roof rail - left side - dent(s) - Smooth repair work

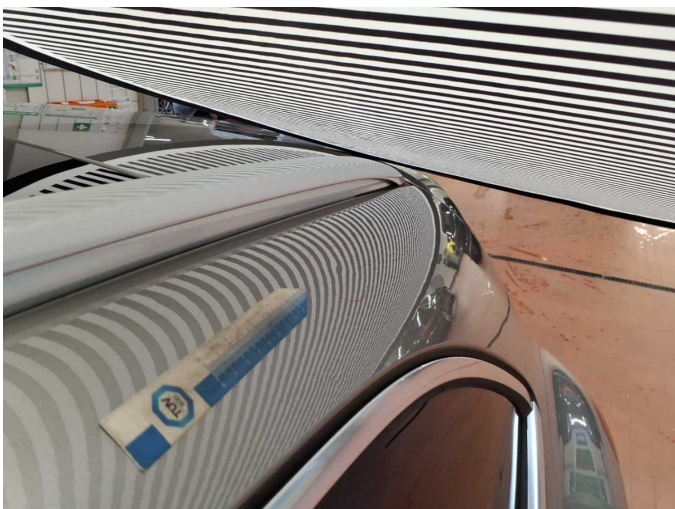
**Damage 5:** Roof: Roof rail - left side - dent(s) - Smooth repair work

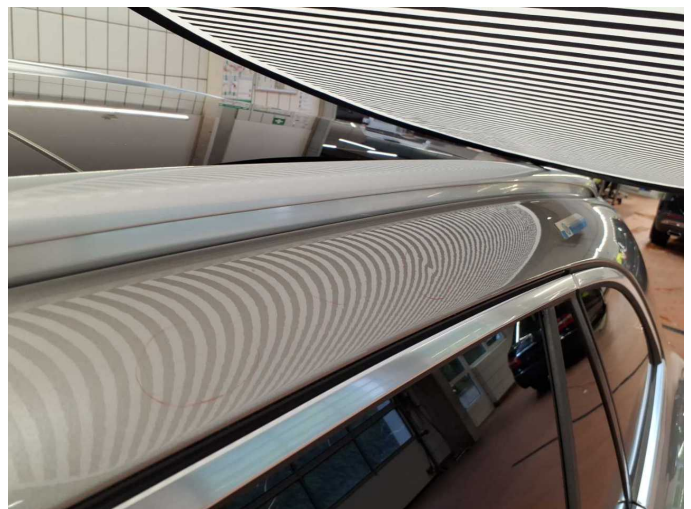
**Damage 5:** Roof: Roof rail - left side - dent(s) - Smooth repair work

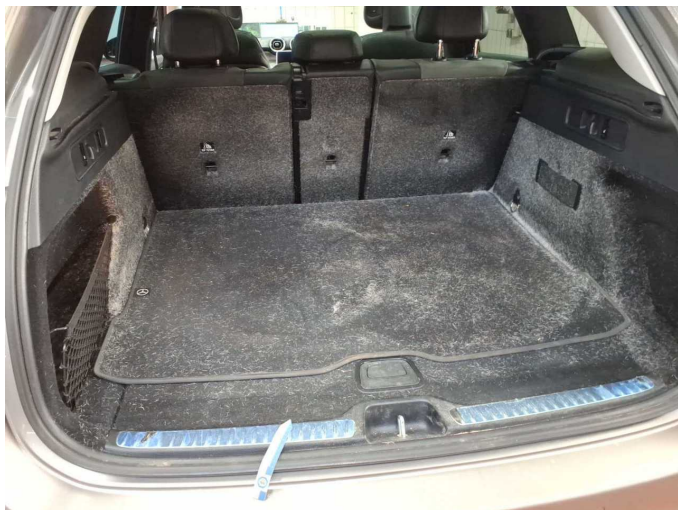
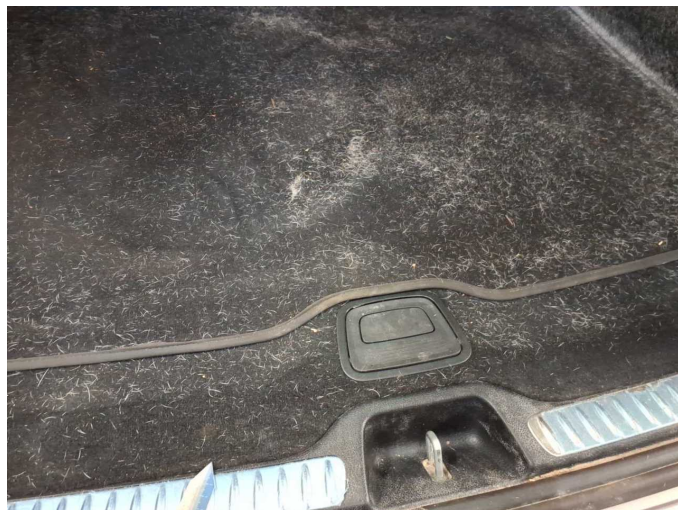
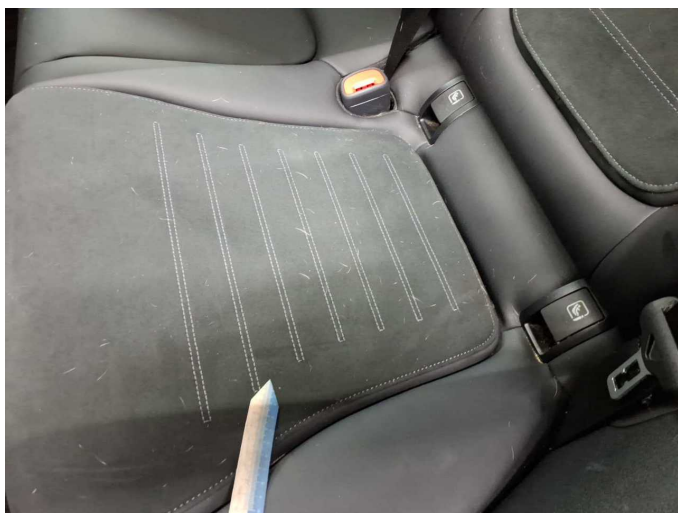
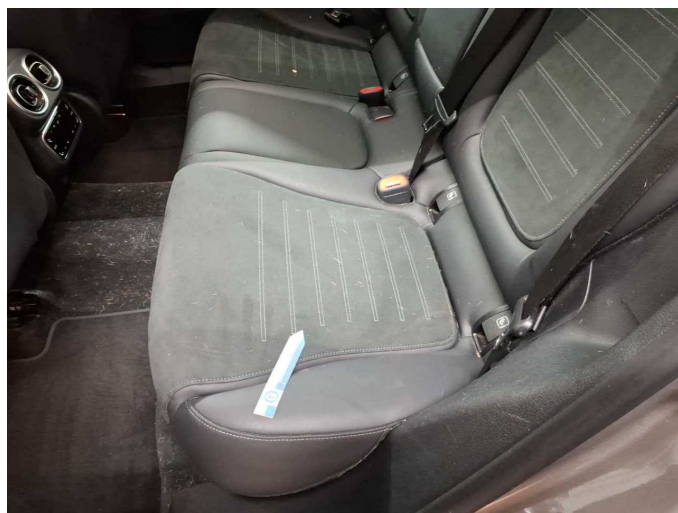
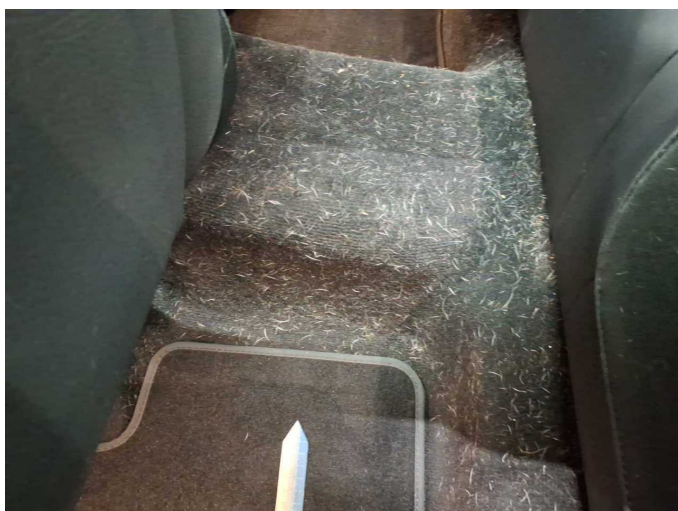
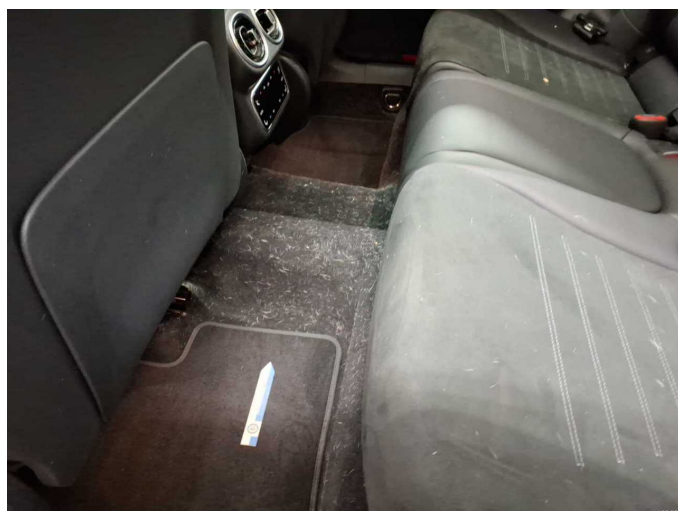
| No. | Component group | Description |
|---|---|---|
| 6 | Interior | Interior (Haare/ Folgekosten möglich) - Soiled - Clean |

**Damage 6:** Interior: Interior (Haare/ Folgekosten möglich) - Soiled - Clean

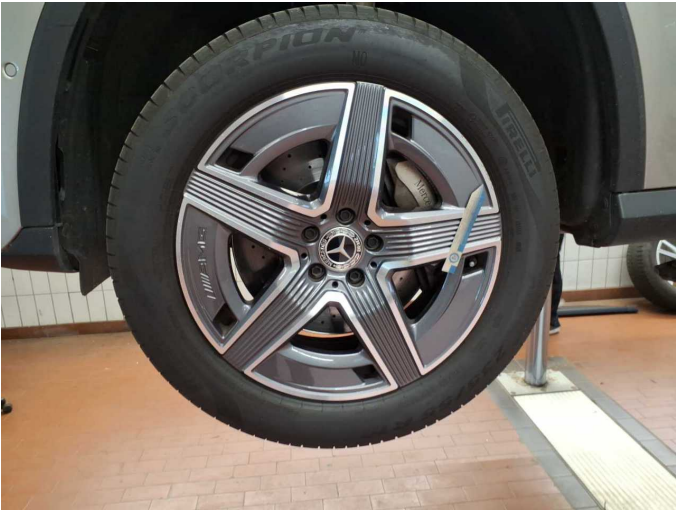
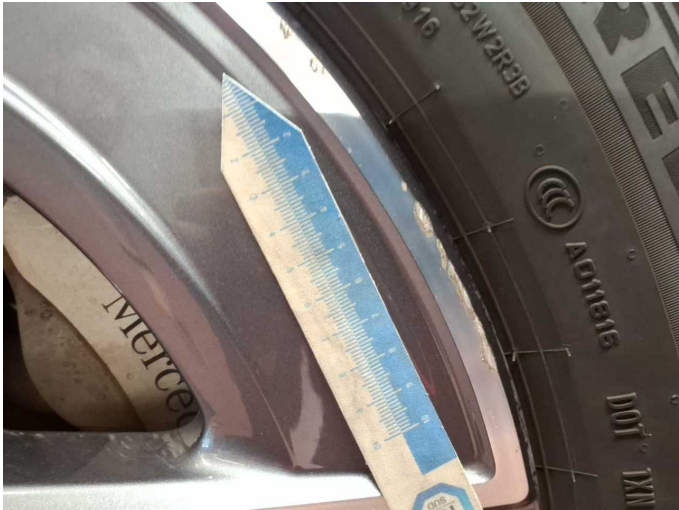
| No. | Component group | Description |
|---|---|---|
| 7 | Wheel / tyres | Alloy rim - front left side - Scratched - Loss in value |

**Damage 7:** Wheel / tyres: Alloy rim - front left side - Scratched - Loss in value

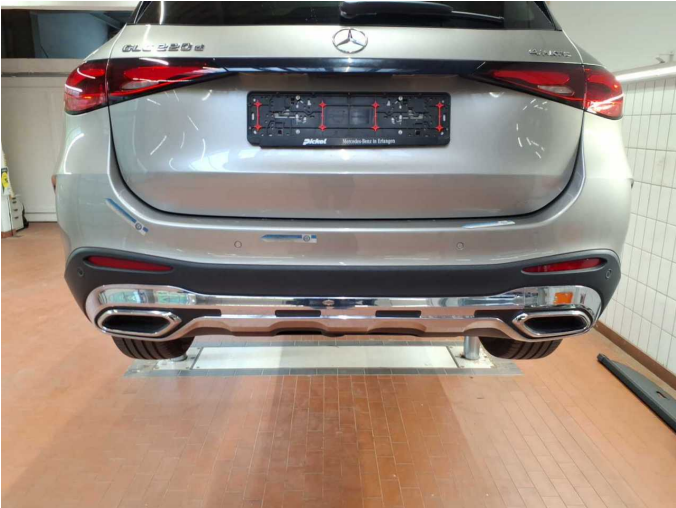
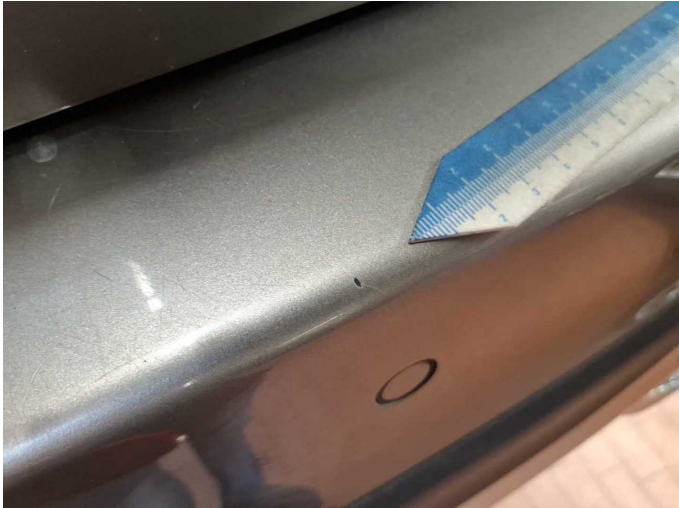
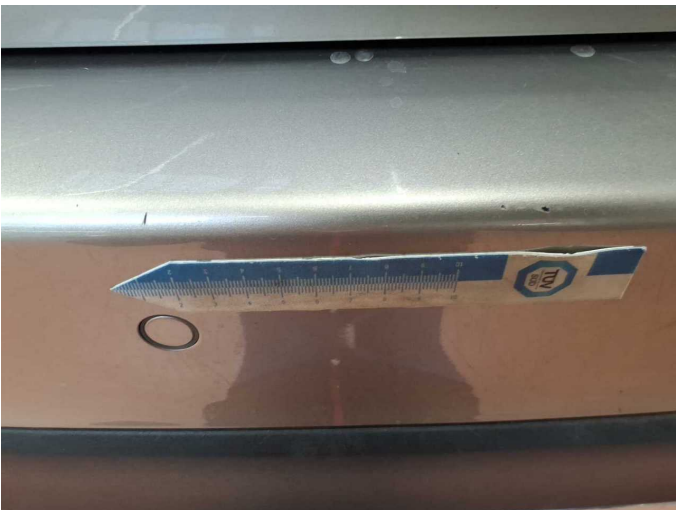
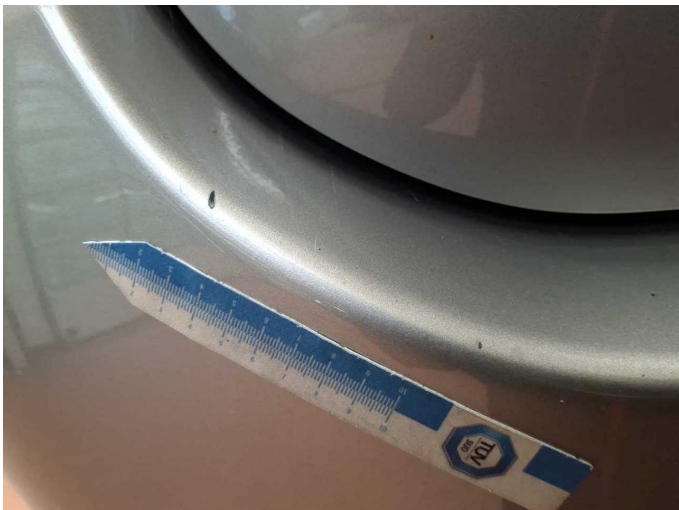
| No. | Component group | Description |
|---|---|---|
| 8 | Rear bumper | Rear bumper - Scratched - Paint |

**Damage 8:** Rear bumper: Rear bumper - Scratched - Paint

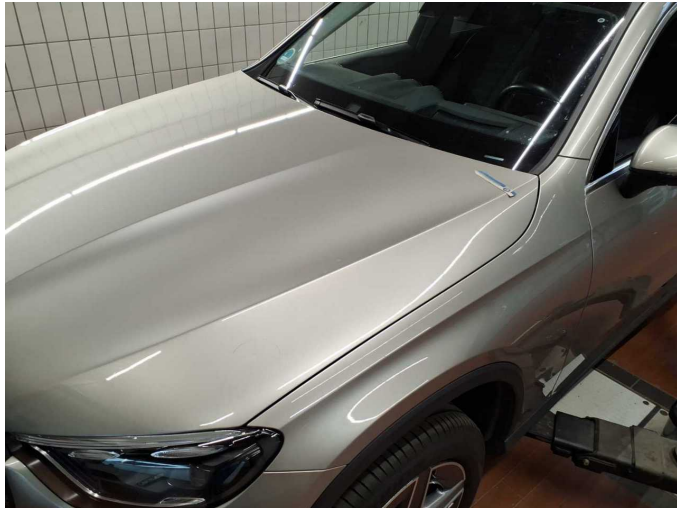
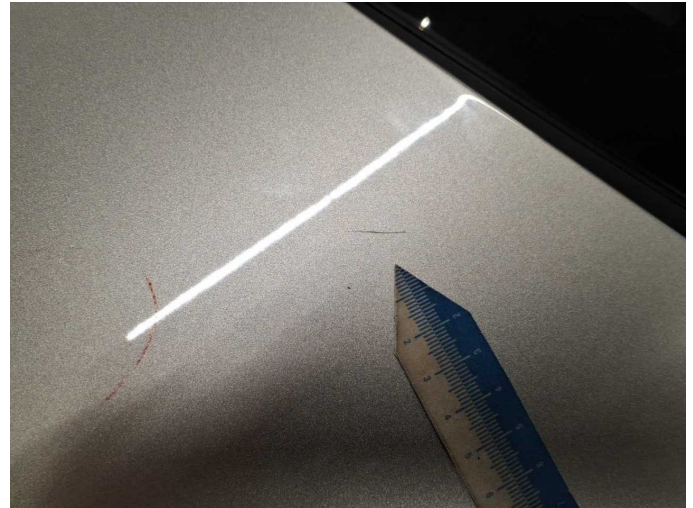
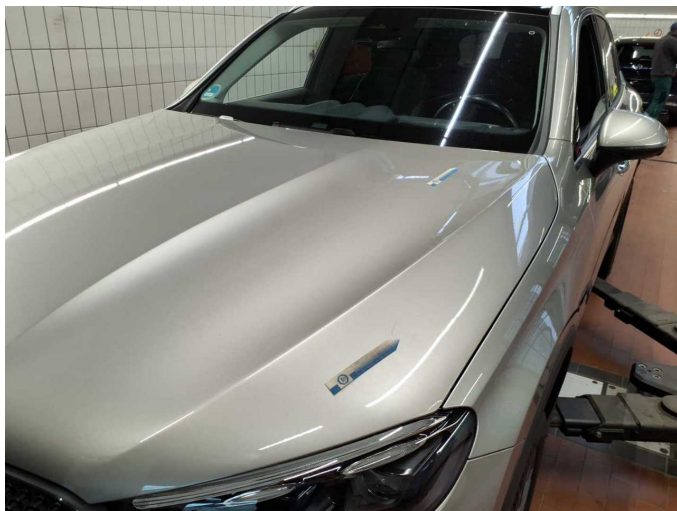
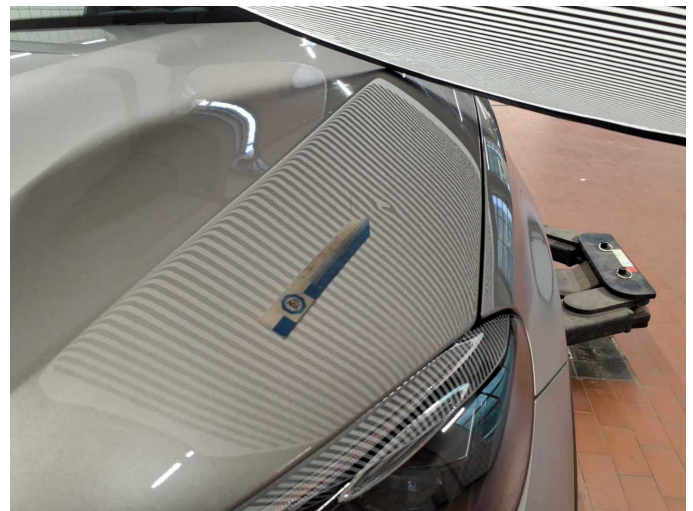
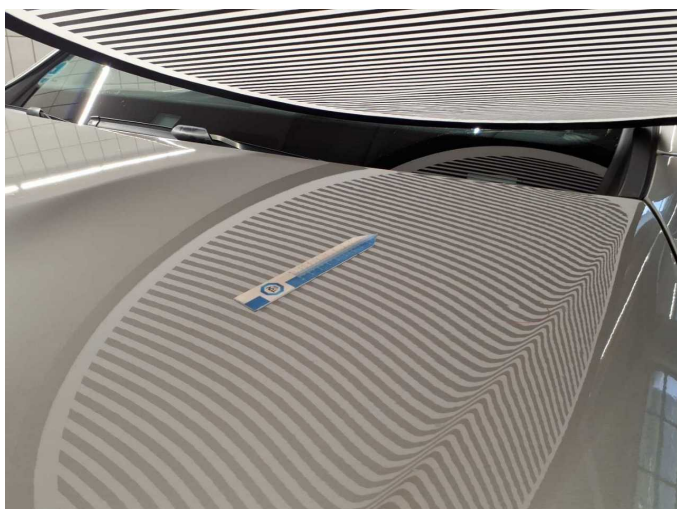
| No. | Component group | Description |
|---|---|---|
| 9 | Bonnet | Bonnet - Scratch(es) - Repair and paint |

**Damage 9:** Bonnet: Bonnet - Scratch(es) - Repair and paint

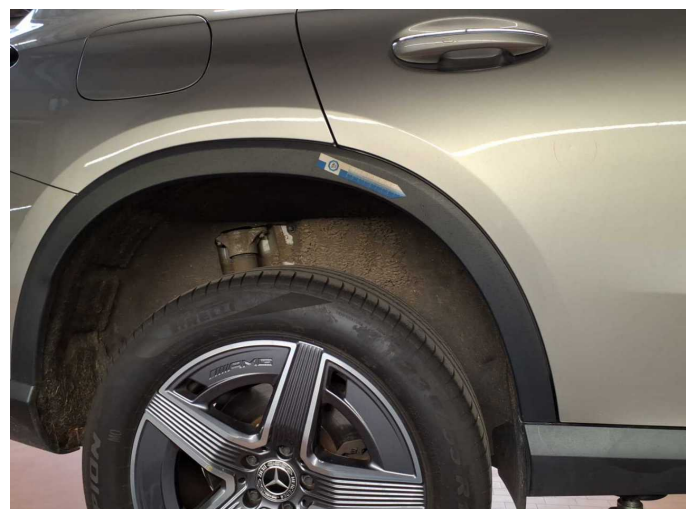
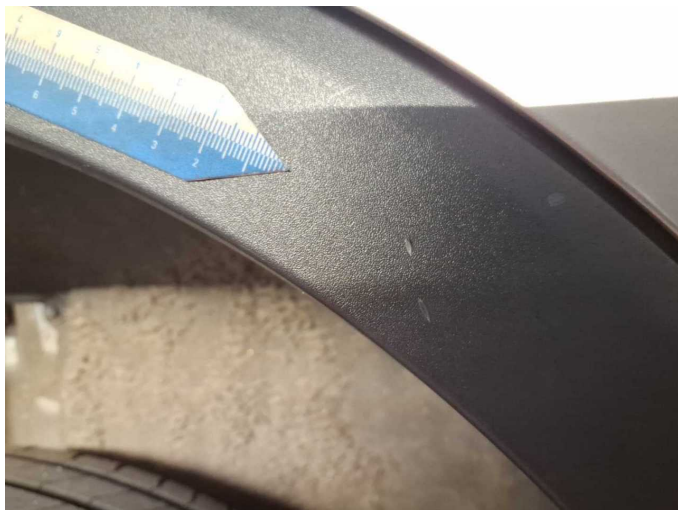
| No. | Component group | Description |
|---|---|---|
| 1 | Side panel - rear right side | Wheel well extension - Scratch(es) - No deduction |

**Wear and tear 1:** Side panel - rear right side: Wheel well extension - Scratch(es) - No deduction

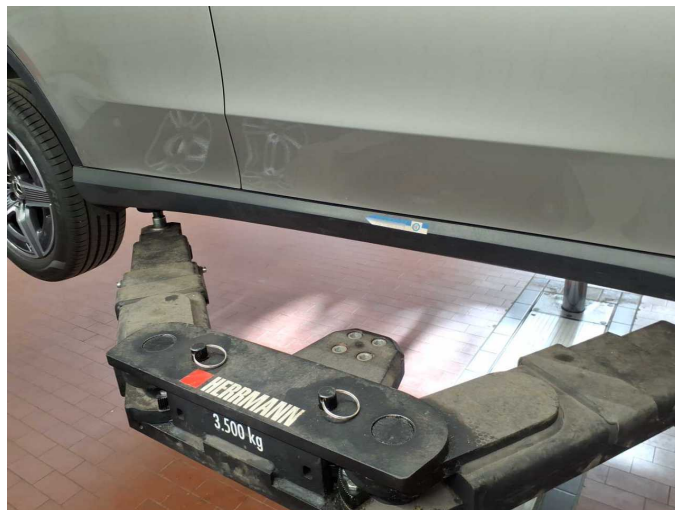
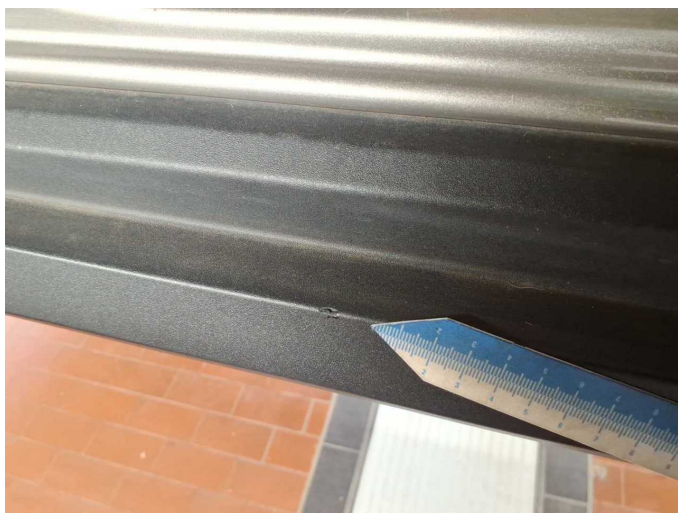
| No. | Component group | Description |
|---|---|---|
| 2 | Sill - right side | Trim - Scratched - No deduction |

**Wear and tear 2:** Sill - right side: Trim - Scratched - No deduction

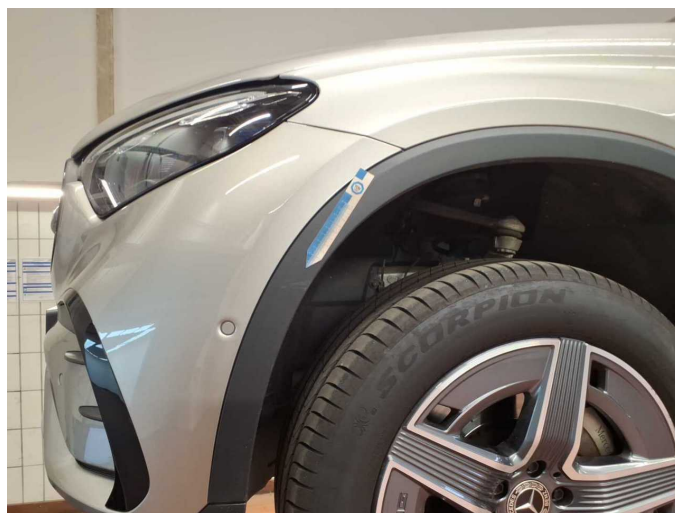
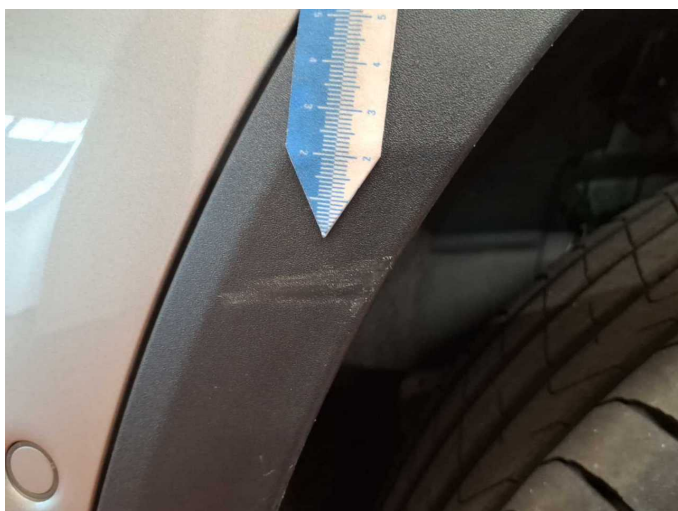
| No. | Component group | Description |
|---|---|---|
| 3 | Mudguard - left side | Wheel well extension - Scratch(es) - No deduction |

**Wear and tear 3:** Mudguard - left side: Wheel well extension - Scratch(es) - No deduction

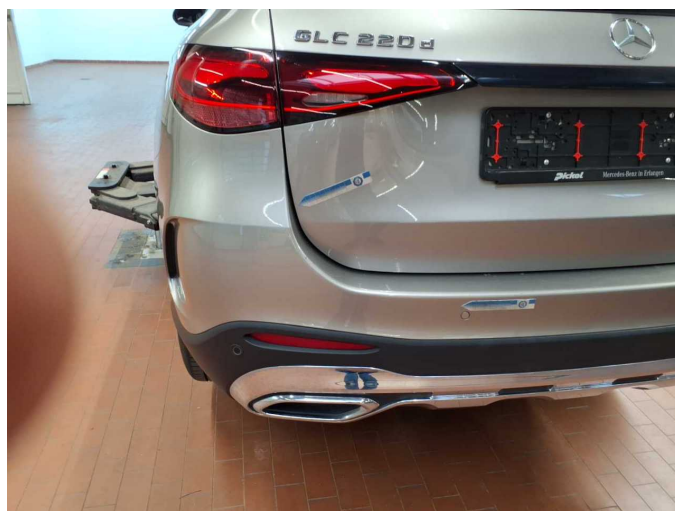
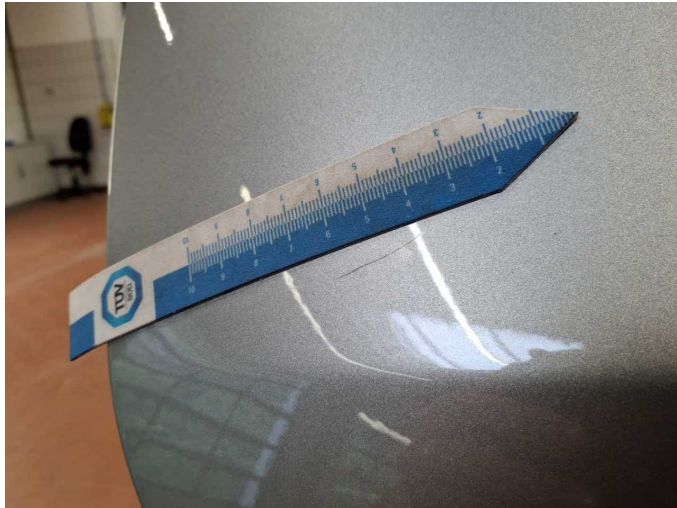
| No. | Component group | Description |
|---|---|---|
| 4 | Boot lid / rear door | Boot lid - Scratch(es) - No deduction |

**Wear and tear 4:** Boot lid / rear door: Boot lid - Scratch(es) - No deduction

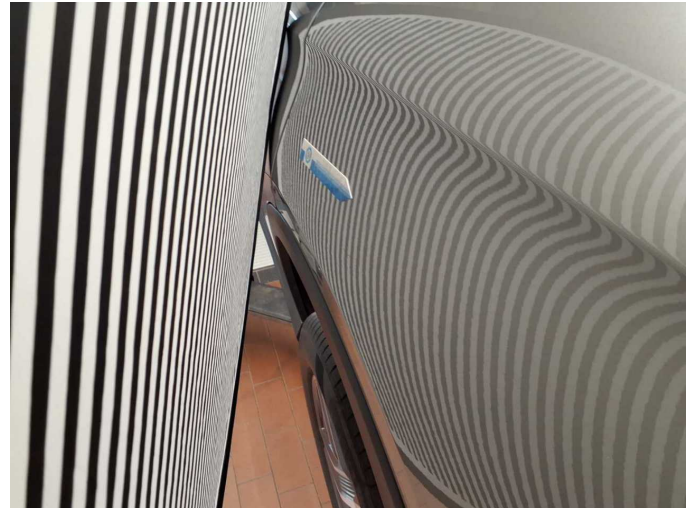
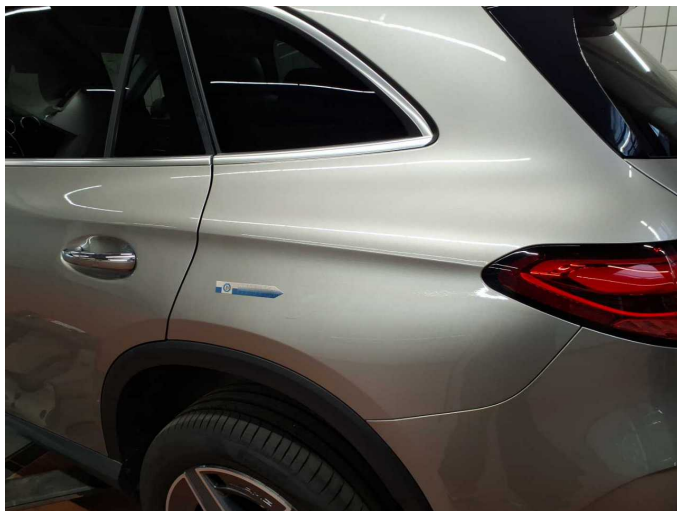
| No. | Component group | Description |
|---|---|---|
| 6 | Side panel - rear left side | Side panel - dent(s) - No deduction |

**Wear and tear 6:** Side panel - rear left side: Side panel - dent(s) - No deduction
