Expertise

Protocol number: 46332650
Order No. / Reference: 26487366
Inspection date: 3 Jul 2026

Model: GLA 180 d 8G-DCT Style

VIN: W1N4N1AB9PJ539111

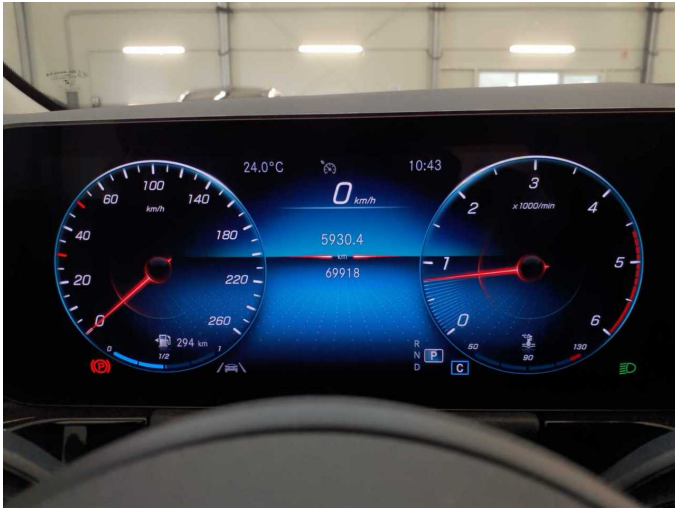
Figure 7: Instrument cluster

Mileage (Read) 69,918 km

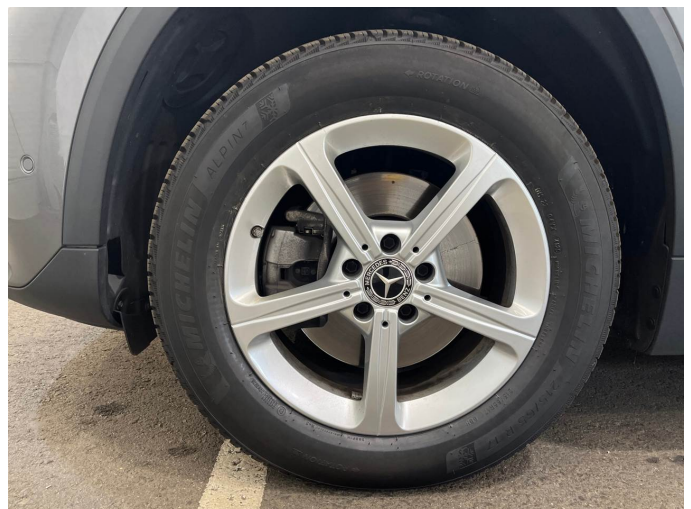
Figure 12: Mounted tyres

Mounted tyres				
#	Tyre size	Type of tyre	Manufacturer	Tread depth
1)	215/65 R17 99H	Winter tyres on Light alloy	Michelin	7mm / 7mm
2)	215/65 R17 99H	Winter tyres on Light alloy	Michelin	6mm / 6mm

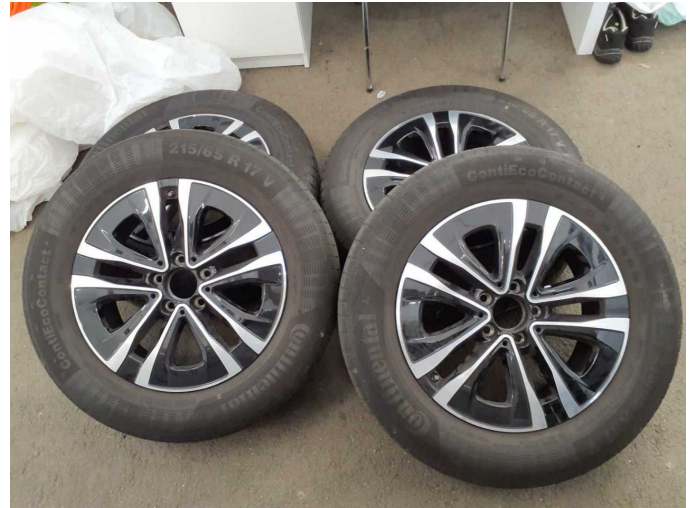
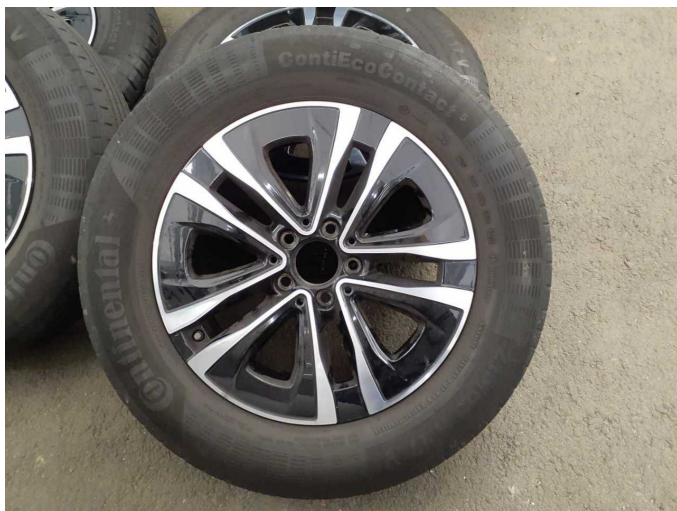
Figure 14: Additional tyres

Additional tyres				
#	Tyre size	Type of tyre	Manufacturer	Tread depth
1)	215/65 R17 99V	Summer tyres on Light alloy	Continental	4mm / 4mm
2)	215/65 R17 99V	Summer tyres on Light alloy	Continental	4mm / 4mm

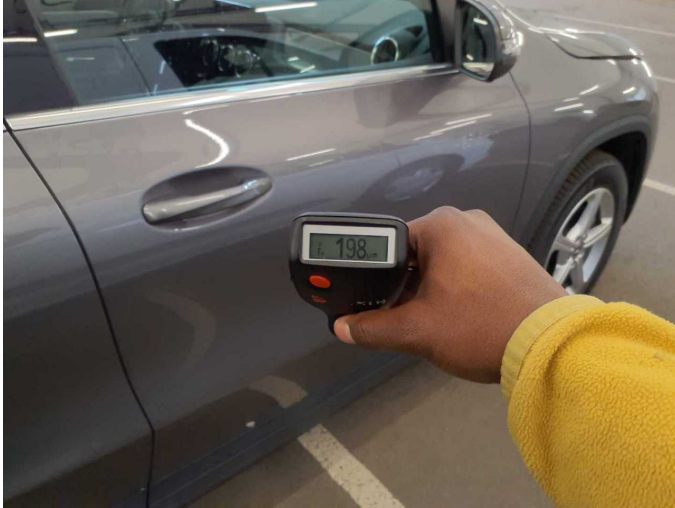
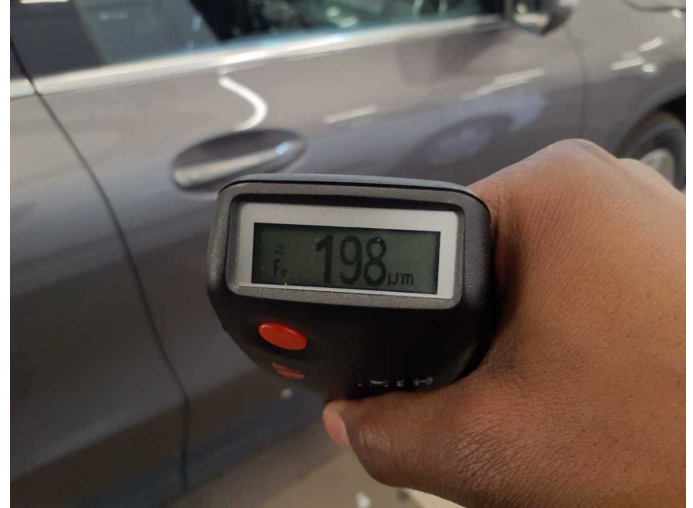
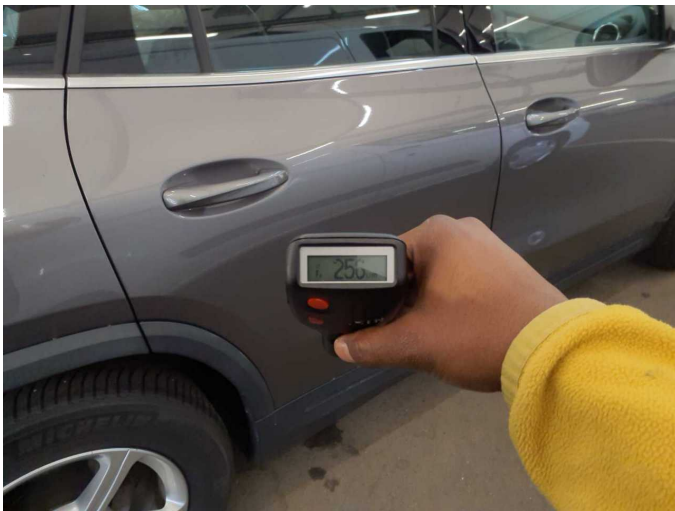
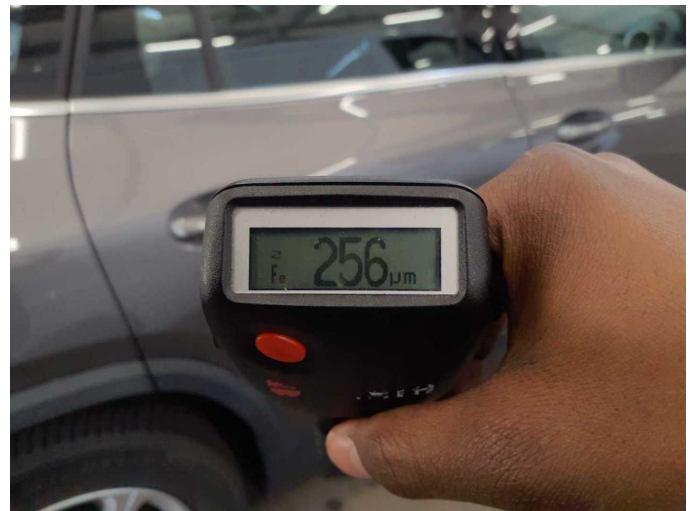
Repainting 1: Door - rear right side, Door - front right side

No.	Repainting
1	Door - rear right side, Door - front right side, Professionally carried out, Invoice of repair done Non-existent

Door - rear right side	256 µm	Door - front right side	198 µm
------------------------	--------	-------------------------	--------
