Expertise

Protocol number: 46495573  
Order No. / Reference: 26711867  
Inspection date: 10 Jul 2026

Manufacturer: Ford

Model: Tourneo Custom 320 L1H1 VA Autm. Trend

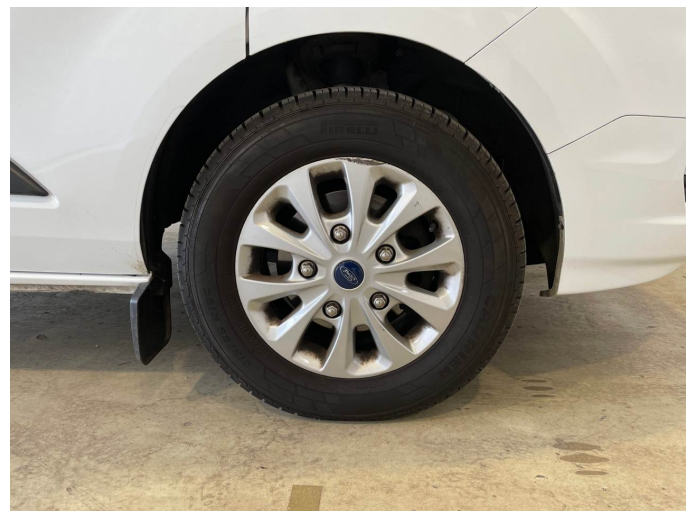
Figure 12: Mounted tyres

| # | Tyre size | Type of tyre | Manufacturer | Tread depth |
|---|---|---|---|---|
| 1) | 215/65 R16 109T | Summer tyres on Light alloy | Pirelli | 7mm / 7mm |
| 2) | 215/65 R16 109T | Summer tyres on Light alloy | Pirelli | 7mm / 7mm |

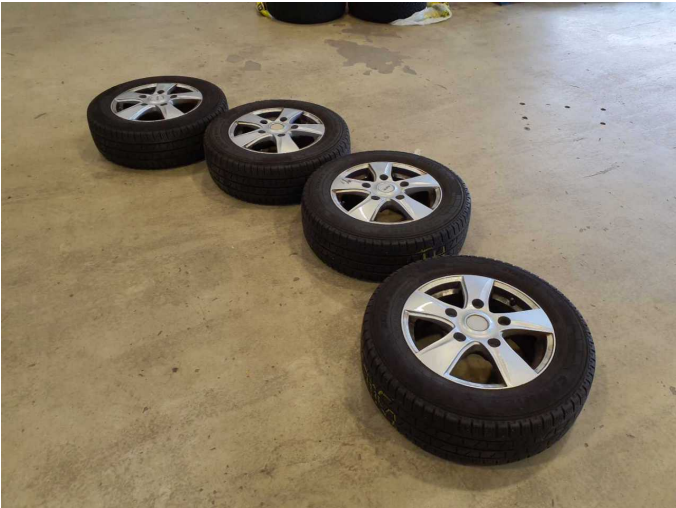
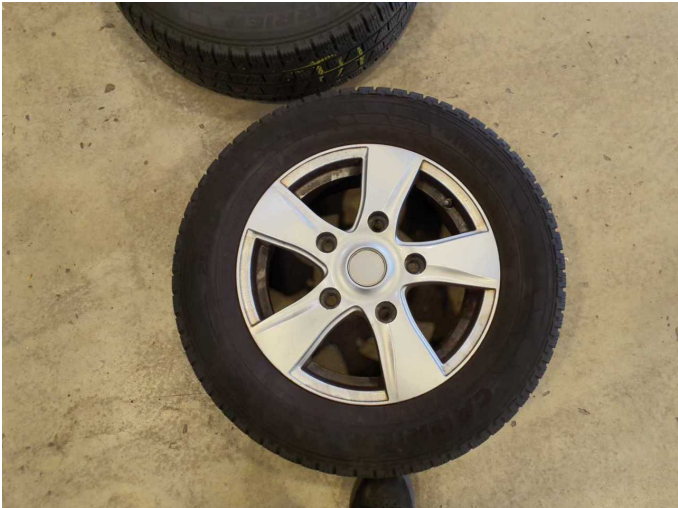
Figure 15: Additional tyres

| # | Tyre size | Type of tyre | Manufacturer | Tread depth |
|---|---|---|---|---|
| 1) | 215/65 R16 109R | Winter tyres on Light alloy | Pirelli | 6mm / 6mm |
| 2) | 215/65 R16 109R | Winter tyres on Light alloy | Pirelli | 6mm / 6mm |

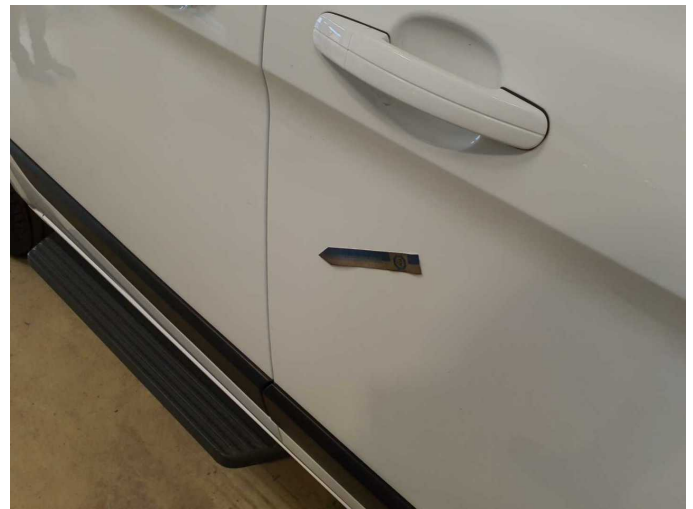
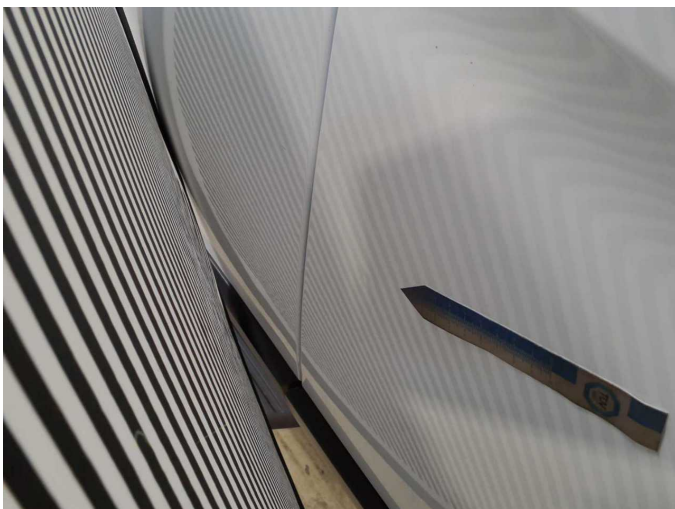
| No. | Component group | Description |
|---|---|---|
| 1 | Door - front right side | Door - dent(s) - Smooth repair work |

**Damage 1:** Door - front right side: Door - dent(s) - Smooth repair work

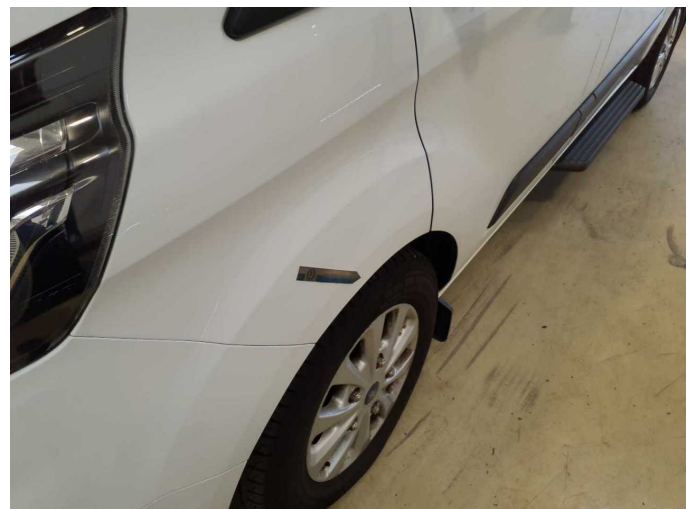
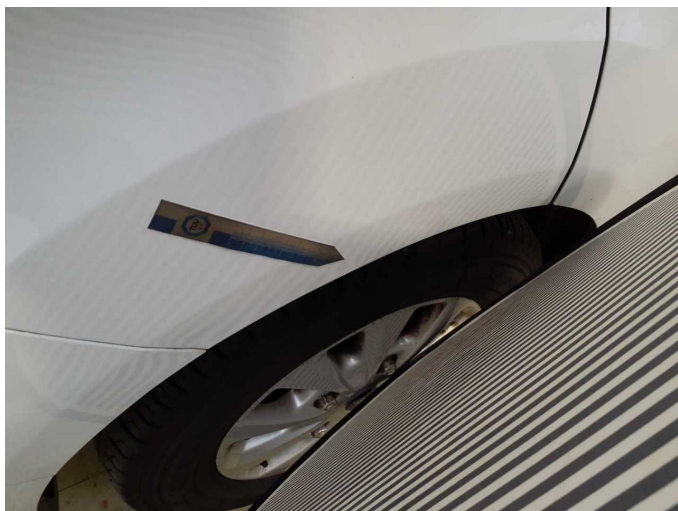
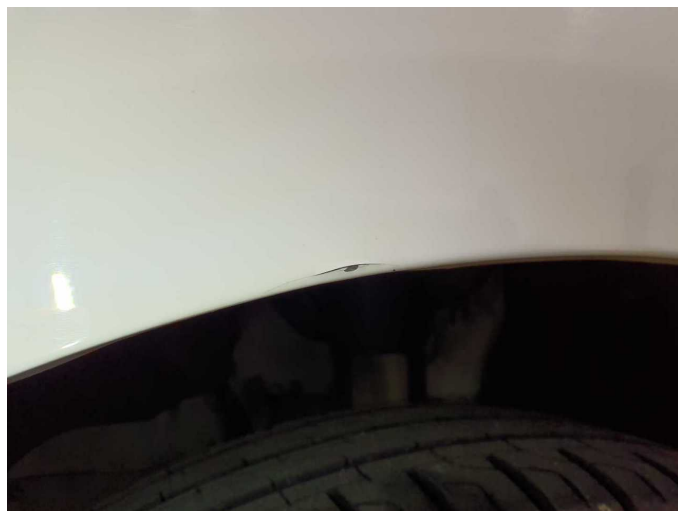
| No. | Component group | Description |
|---|---|---|
| 2 | Mudguard - left side | Mudguard - left side - Dent / paintcoat damage - Smart repair |

**Damage 2:** Mudguard - left side: Mudguard - left side - Dent / paintcoat damage - Smart repair

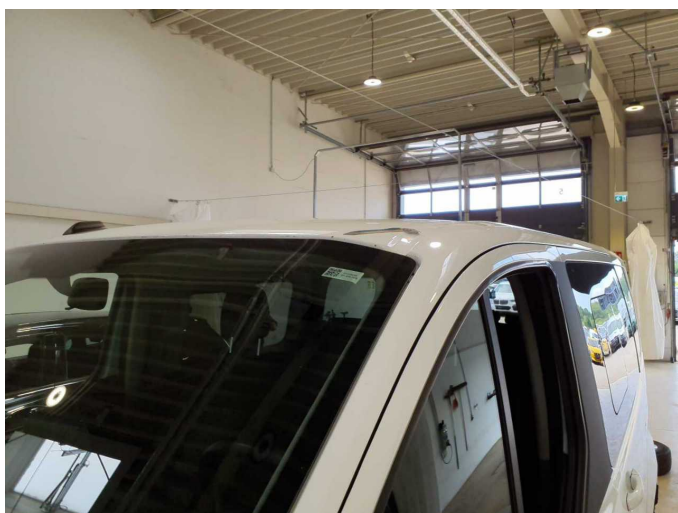
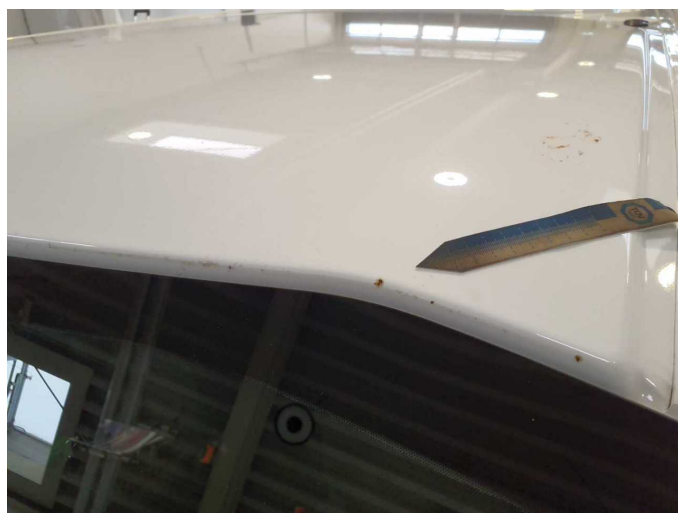
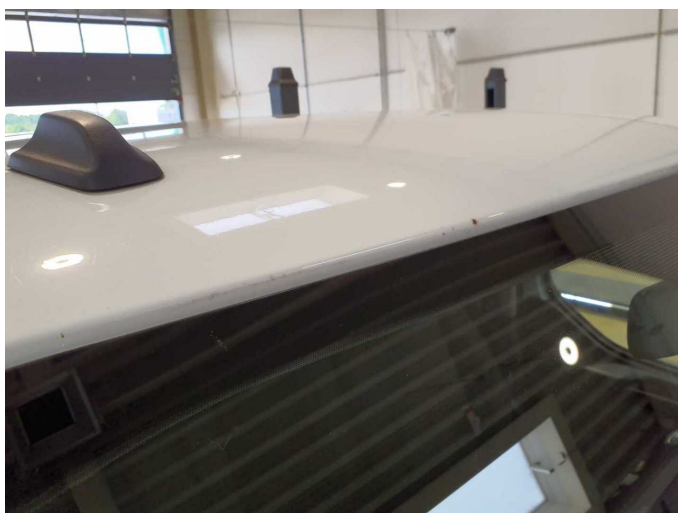
| No. | Component group | Description |
|---|---|---|
| 3 | Roof | Roof - Corrosion - Smart repair |

**Damage 3:** Roof: Roof - Corrosion - Smart repair

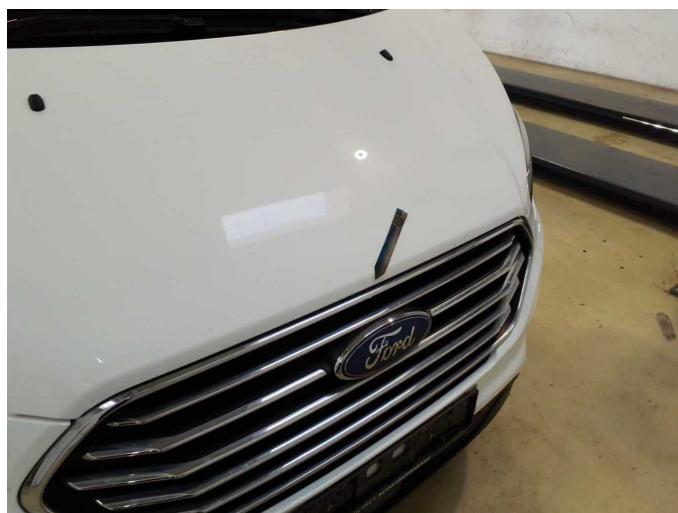
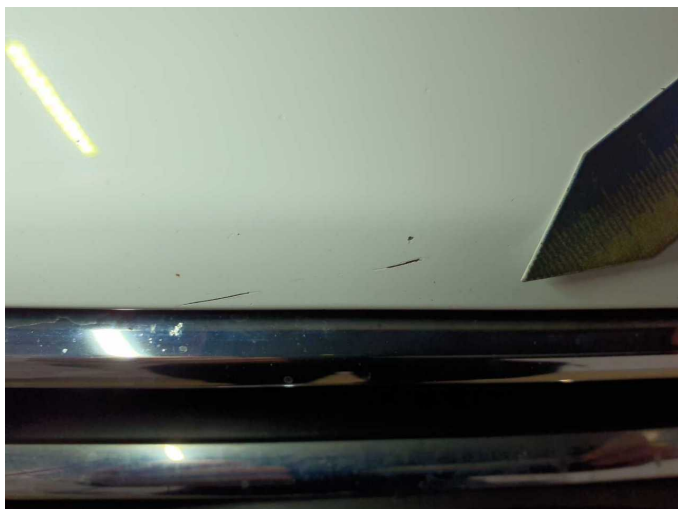
| No. | Component group | Description |
|---|---|---|
| 4 | Bonnet | Bonnet - Scratch(es) - Paint |

**Damage 4:** Bonnet: Bonnet - Scratch(es) - Paint

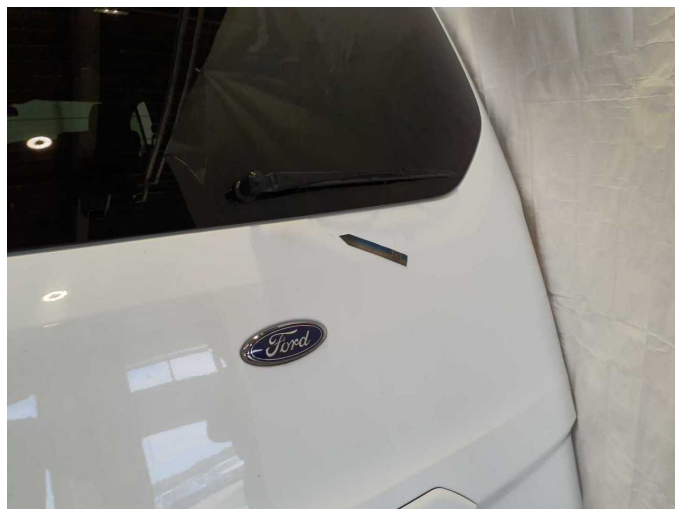
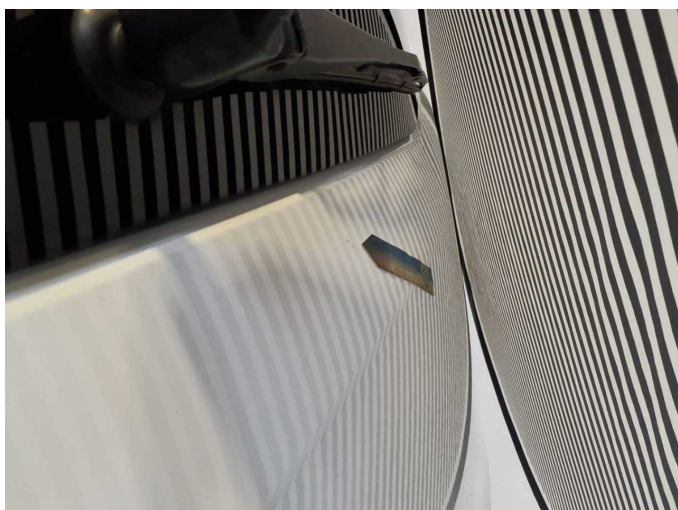
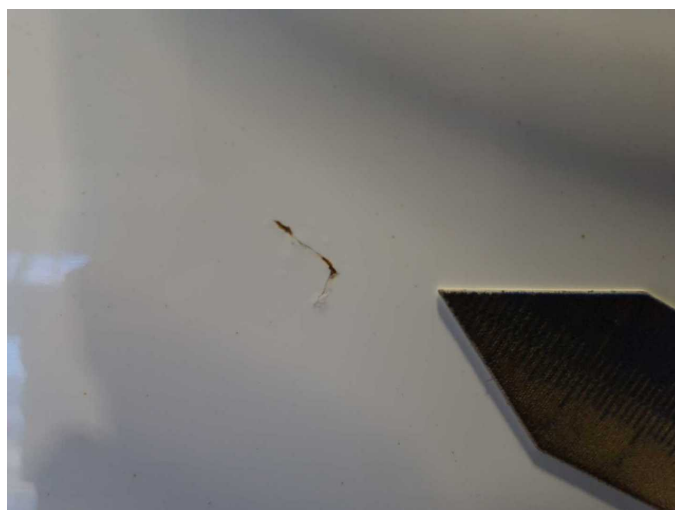
| No. | Component group | Description |
|---|---|---|
| 5 | Boot lid / rear door | Boot lid - Scratch(es) - Paint |

**Damage 5:** Boot lid / rear door: Boot lid - Scratch(es) - Paint

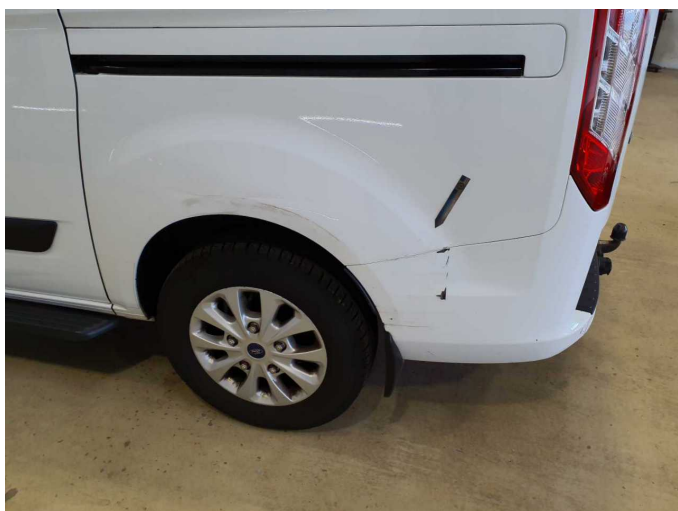
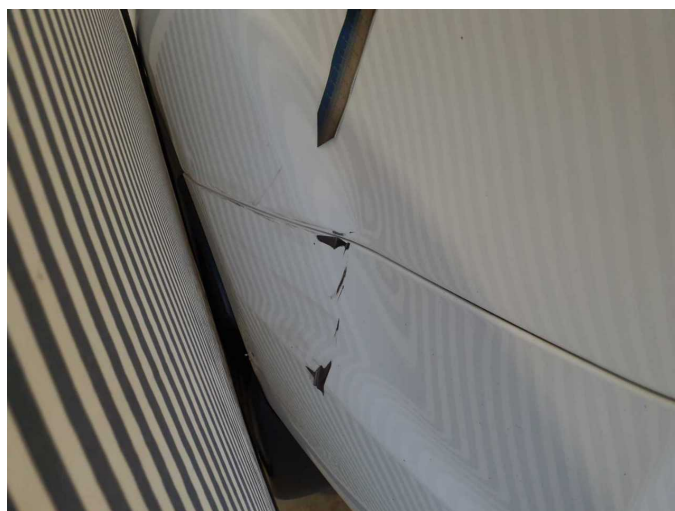
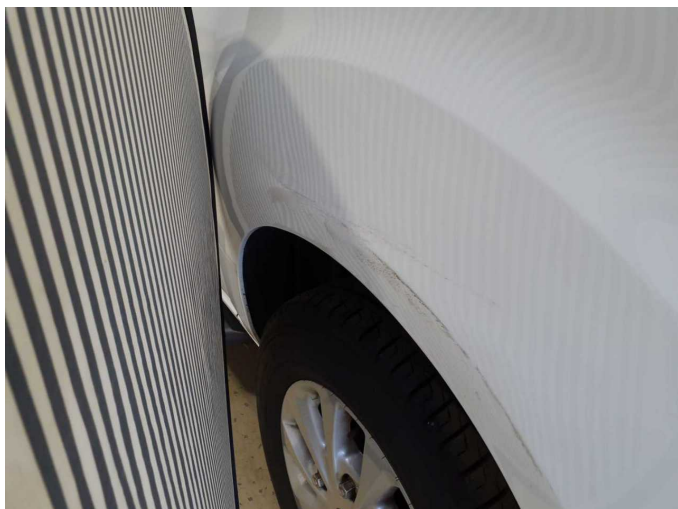
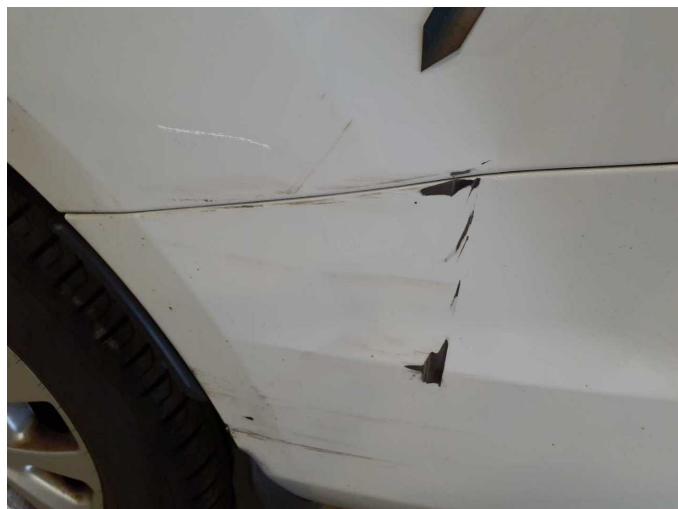
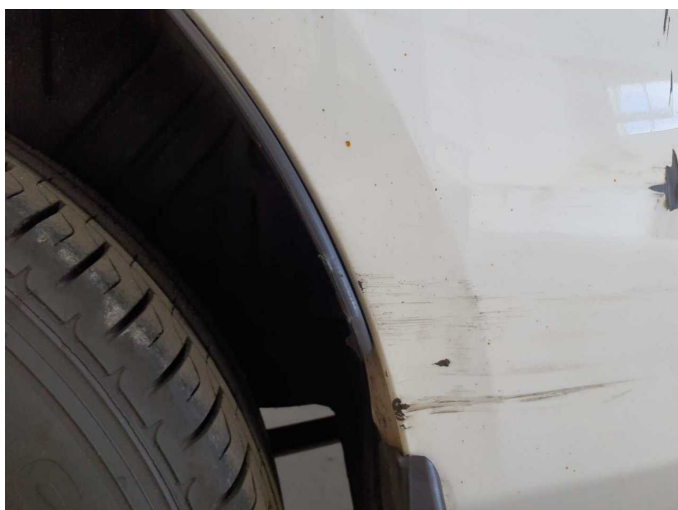
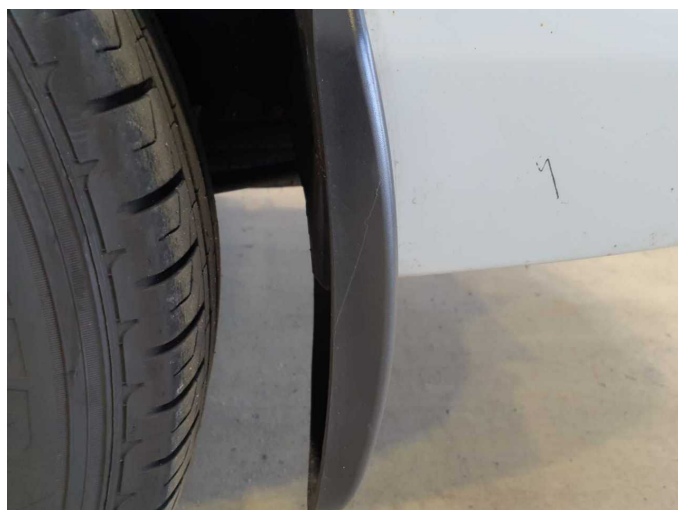
1 Rear, Side - left

Non-repaired previous damages were found at the vehicle. The necessary repair costs are listed in the expert report or if necessary, are listed in detail in a separately enclosed repair cost calculation.

**Accident 1:** Rear, Side - left

**Accident 1: Rear, Side - left**
