Expertise

Protocol number: 46265751  
Order No. / Reference: 26342947  
Inspection date: 1 Jul 2026

Manufacturer: Skoda  
VIN: TMBJC7NY4NF043831

Model: Enyaq iV 80

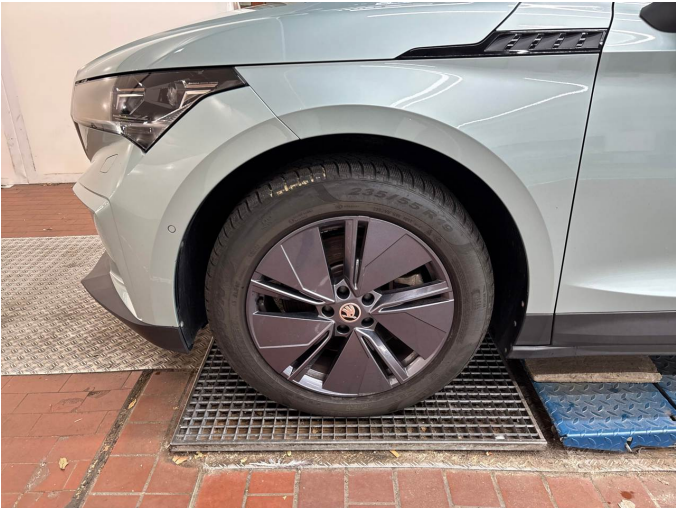
| # | Tyre size | Type of tyre | Manufacturer | Tread depth |
|---|---|---|---|---|
| 1) | 235/55 R19 101T | Winter tires (with run-flat tires) on Light alloy | Pirelli | 7mm / 7mm |
| 2) | 235/55 R19 101T | Winter tires (with run-flat tires) on Light alloy | Pirelli | 7mm / 7mm |

Figure 13: Mounted tyres

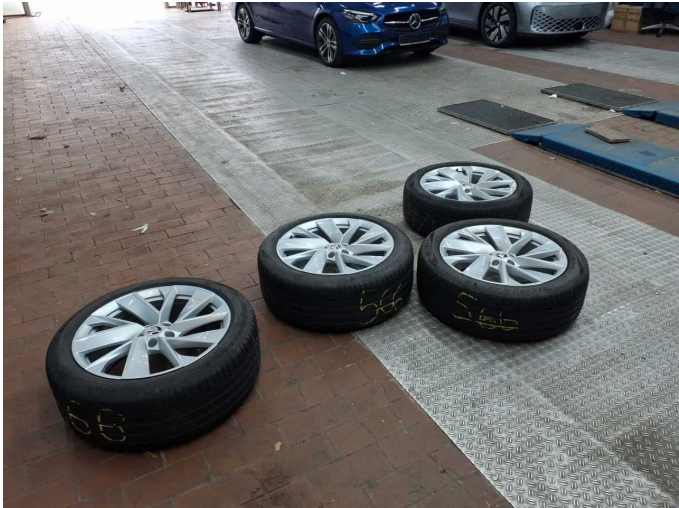
| # | Tyre size | Type of tyre | Manufacturer | Tread depth |
|---|---|---|---|---|
| 1) | 235/50 R20 100T | Summer tires (with run-flat tires) on Light alloy | Pirelli | 3mm / 3mm |
| 2) | 235/50 R20 100T | Summer tires (with run-flat tires) on Light alloy | Pirelli | 4mm / 5mm |

Figure 16: Additional tyres

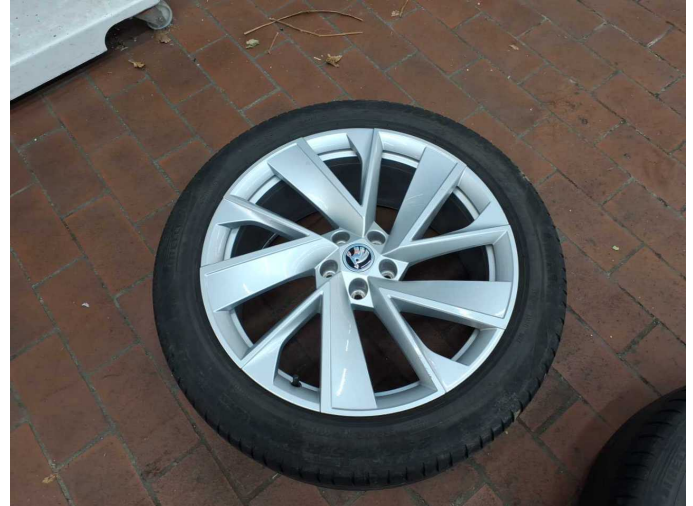
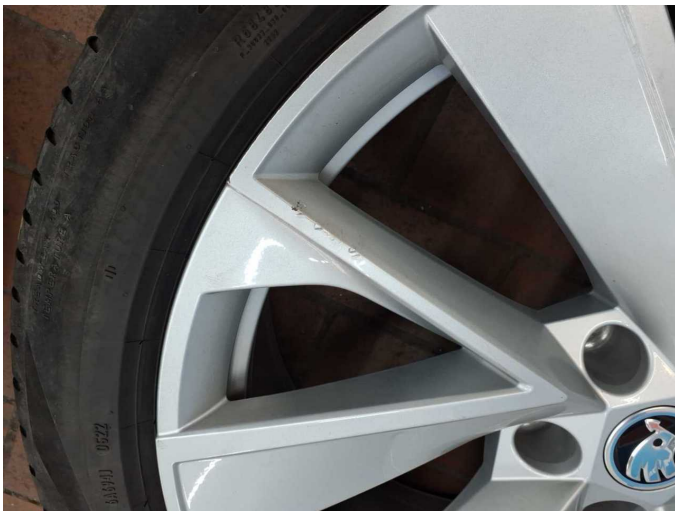
| No. | Component group | Description |
|---|---|---|
| 1 | 2nd wheel set | 1 alloy rim - Scratch(es) - Loss in value |

**Damage 1:** 2nd wheel set: 1 alloy rim - Scratch(es) - Loss in value

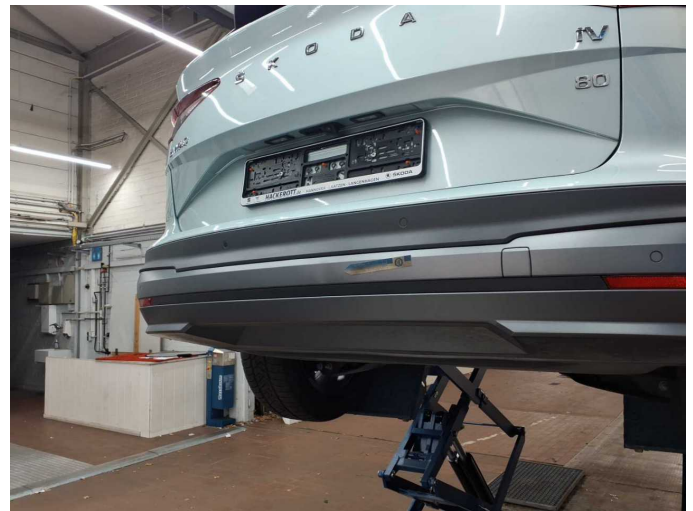
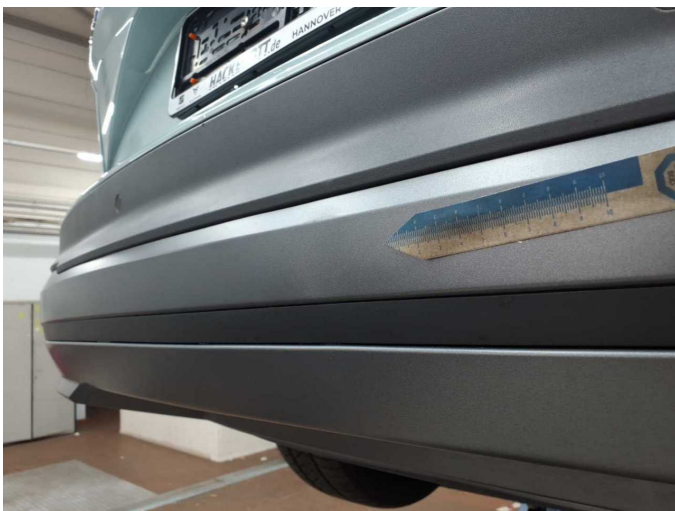
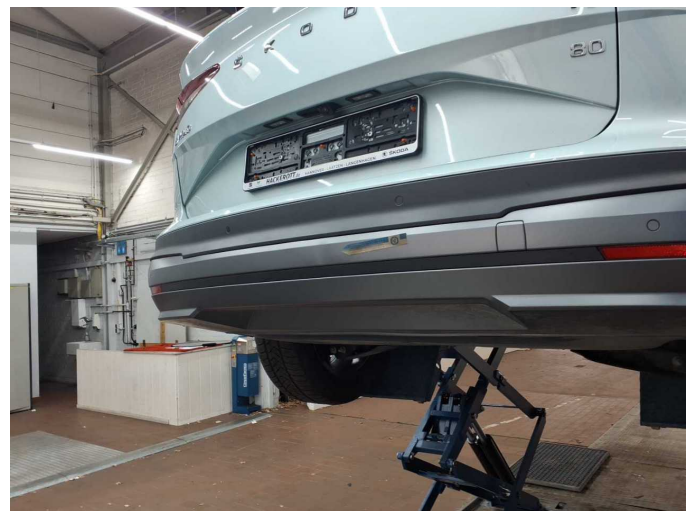
| No. | Component group | Description |
|---|---|---|
| 2 | Rear bumper | Spoiler - Deformed - Replace |

**Damage 2:** Rear bumper: Spoiler - Deformed - Replace

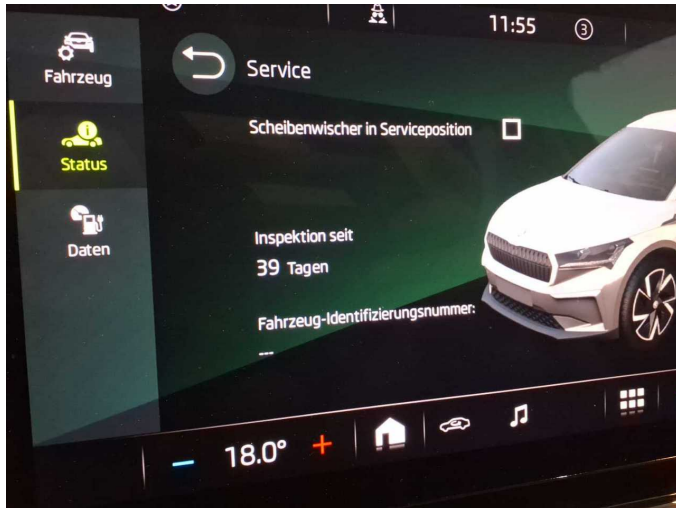
| No. | Component group | Description |
|---|---|---|
| 3 | Misc. | Inspection / maintenance - Due - Perform |

**Damage 3:** Misc.: Inspection / maintenance - Due - Perform

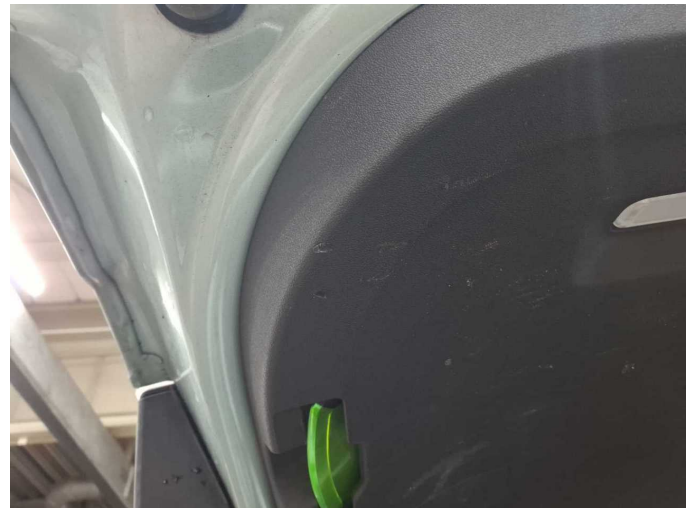
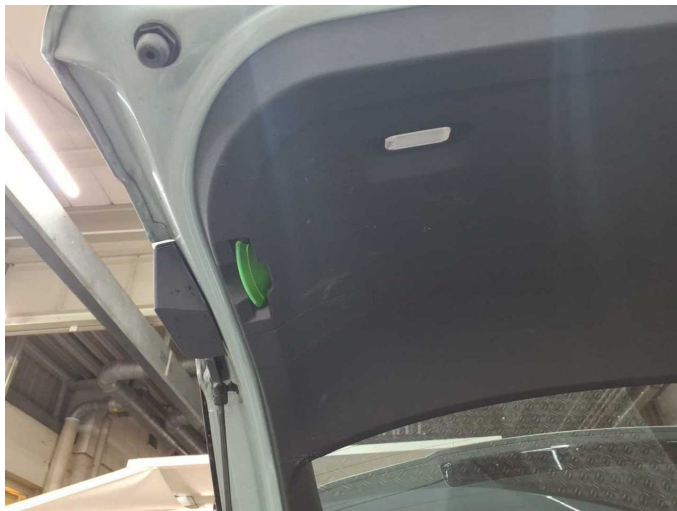
| No. | Component group | Description |
|---|---|---|
| 7 | Trim / covers | Boot lid - interior trim - Scratch(es) - No deduction |

**Wear and tear 7:** Trim / covers: Boot lid - interior trim - Scratch(es) - No deduction
