Expertise

Protocol number: 46668546  
Order No. / Reference: 26681226  
Inspection date: 23 Jul 2026

Manufacturer: Volkswagen

Model: Touran 2.0 TDI SCR DSG UNITED

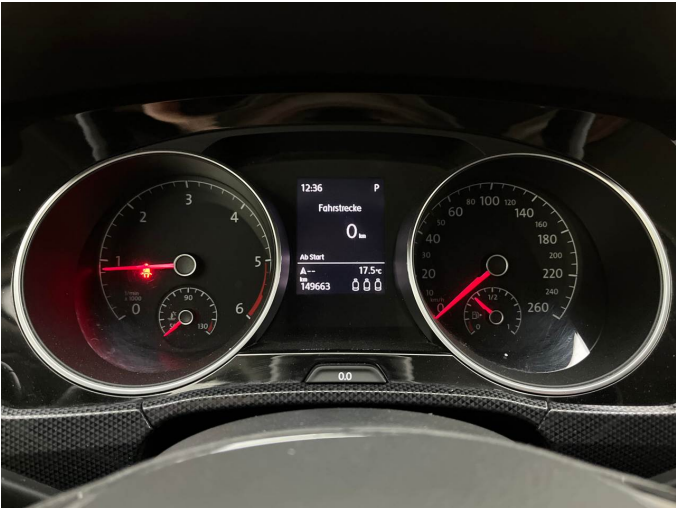
| Vehicle details | |
|---|---|
| Mileage (Read) | 149,663 km |

Figure 7: Instrument cluster

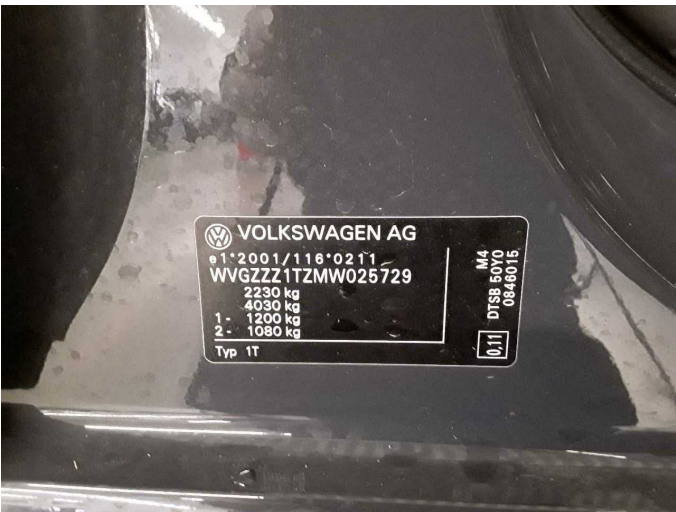
| VIN comparison | The vehicle identification number (VIN) was read from the vehicle and its conformity with the submitted documents was confirmed by the undersigned during the inspection. |

Figure 11: VIN

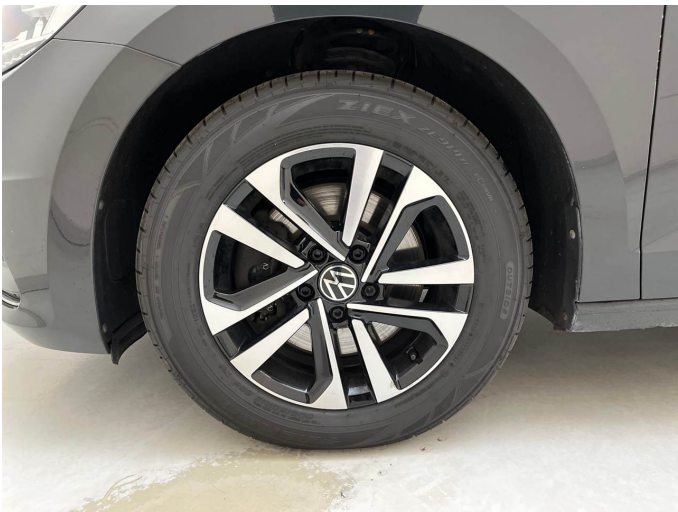
| # | Tyre size | Type of tyre | Manufacturer | Tread depth |
|---|---|---|---|---|
| 1) | 205/60 R16 96V | Summer tyres on Light alloy | Falken | 8mm / 8mm |
| 2) | 205/60 R16 96V | Summer tyres on Light alloy | Pirelli | 6mm / 6mm |

Figure 12: Mounted tyres

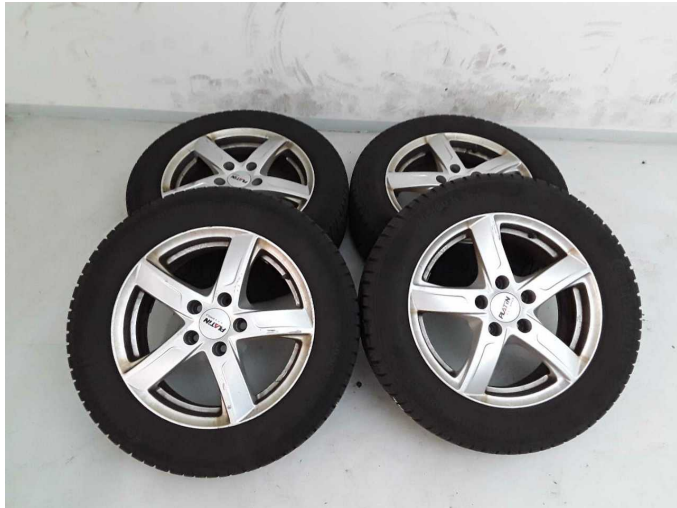
| # | Tyre size | Type of tyre | Manufacturer | Tread depth |
|---|---|---|---|---|
| 1) | 205/60 R16 96H | Winter tyres on Light alloy | Continental | 6mm / 6mm |
| 2) | 205/60 R16 96H | Winter tyres on Light alloy | Continental | 7mm / 7mm |

Figure 19: Additional tyres

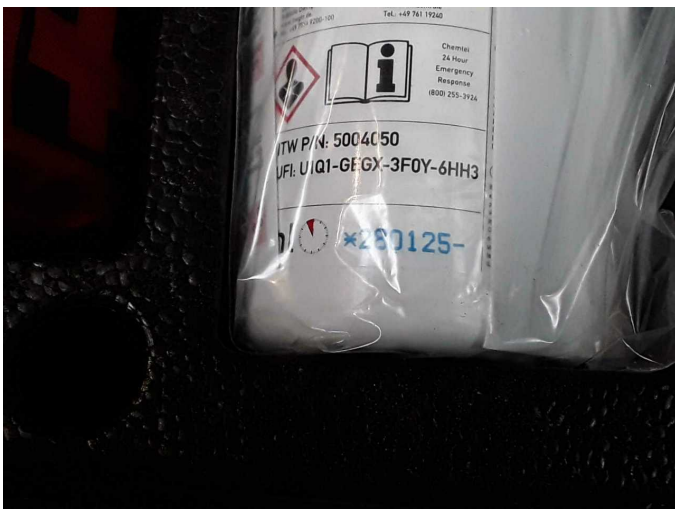
**Damage 1:** Equipment: Tirefit filler - Expired - Replace

| No. | Component group | Description |
|---|---|---|
| 1 | Equipment | Tirefit filler - Expired - Replace |

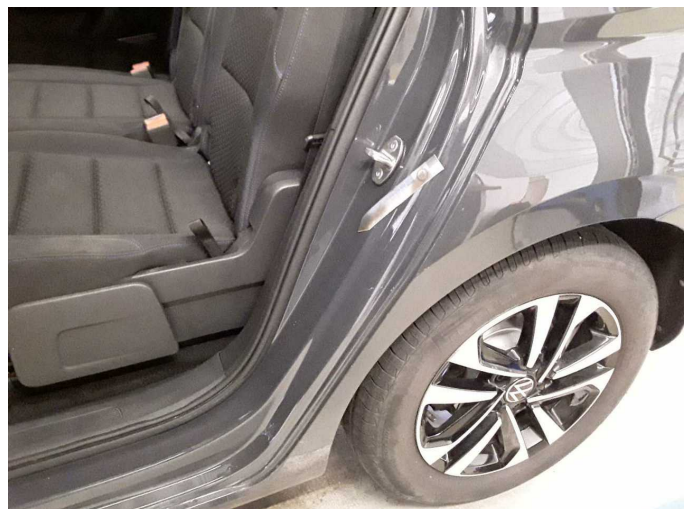
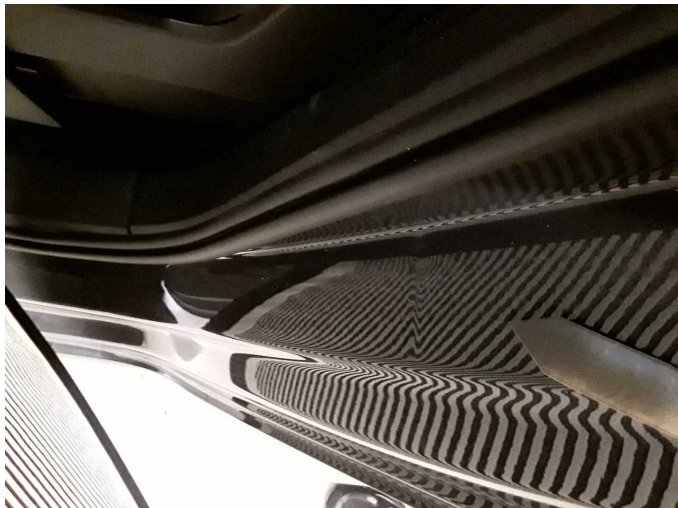
**Damage 2:** Body: C-pillar - left side - dent(s) - Smart repair

| No. | Component group | Description |
|---|---|---|
| 2 | Body | C-pillar - left side - dent(s) - Smart repair |

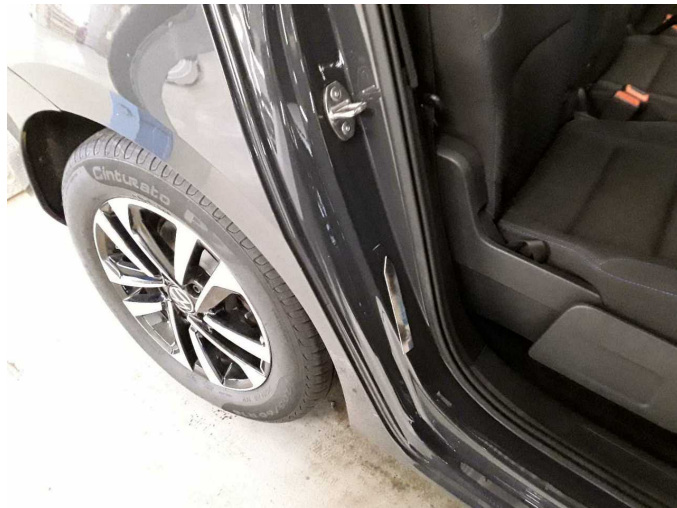
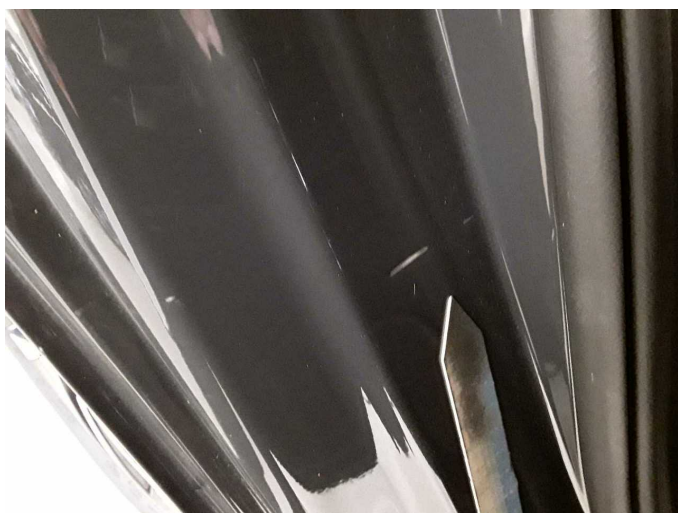
**Damage 3:** Body: C-pillar - right side - Scratch(es) - Smart repair

| No. | Component group | Description |
|---|---|---|
| 3 | Body | C-pillar - right side - Scratch(es) - Smart repair |

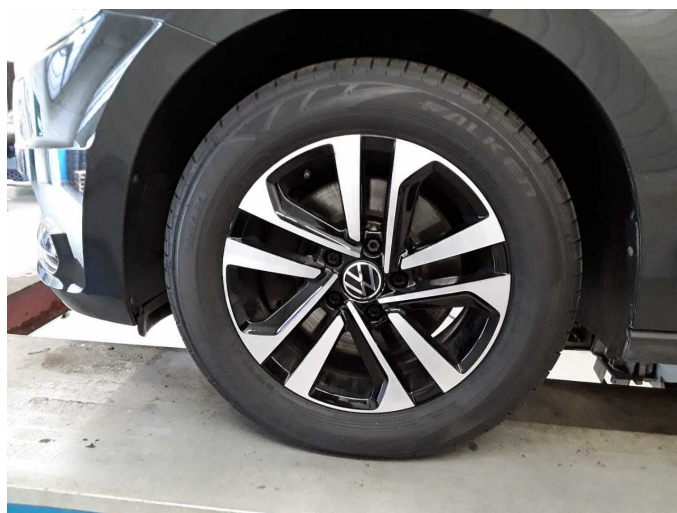
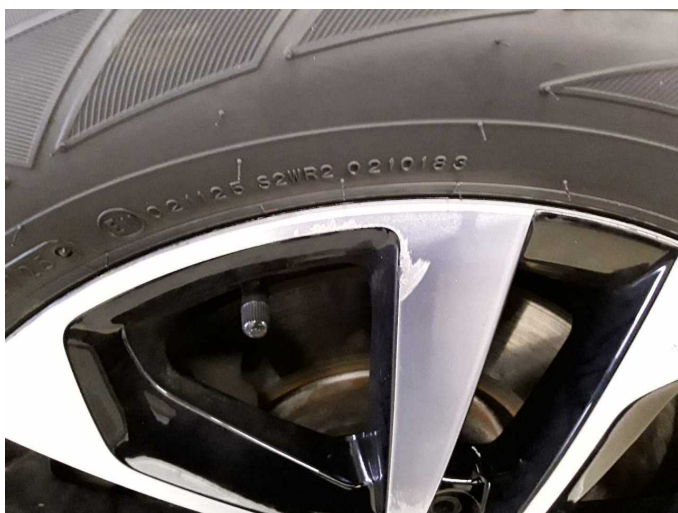
**Damage 4:** Wheel / tyres: Alloy rim - front left side - Scratch(es) - Loss in value

| No. | Component group | Description |
|---|---|---|
| 4 | Wheel / tyres | Alloy rim - front left side - Scratch(es) - Loss in value |

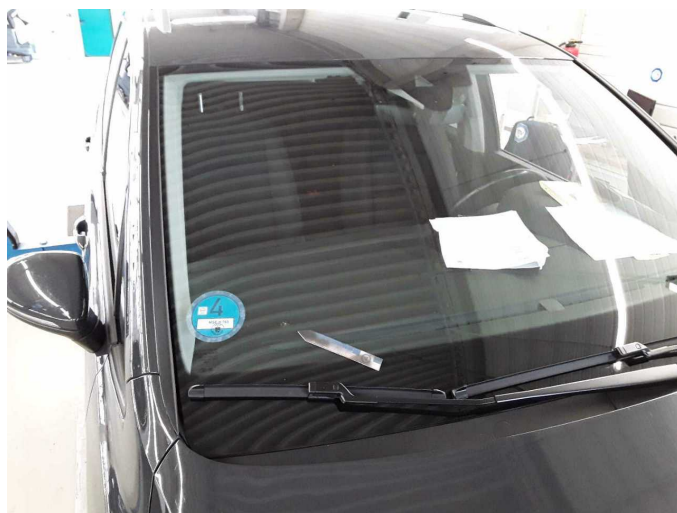
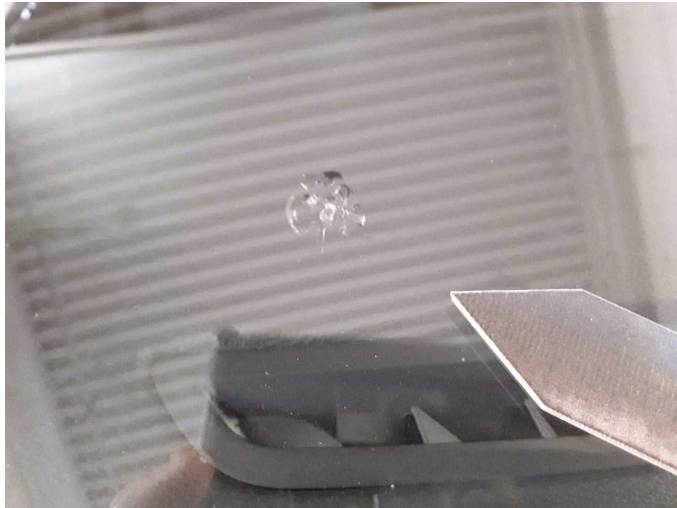
**Damage 5:** Vehicle glazing: Windscreen with lane departure assistant - Stone chips - Replace

| No. | Component group | Description |
|---|---|---|
| 5 | Vehicle glazing | Windscreen with lane departure assistant - Stone chips - Replace |

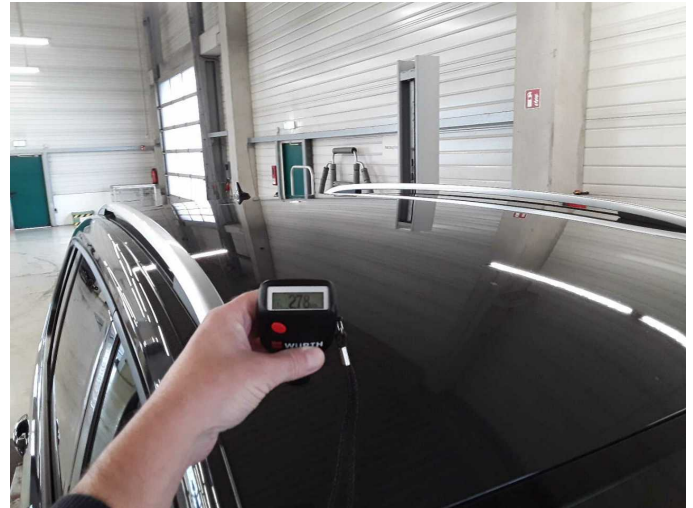
| Roof | 278 µm | Boot lid / rear door | 186 µm |

**Roof:** 278  $\mu\text{m}$

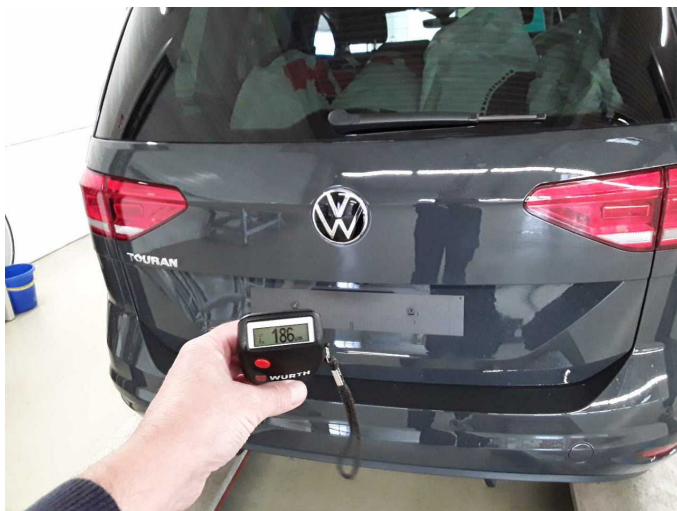
**Boot lid / rear door:** 186  $\mu\text{m}$

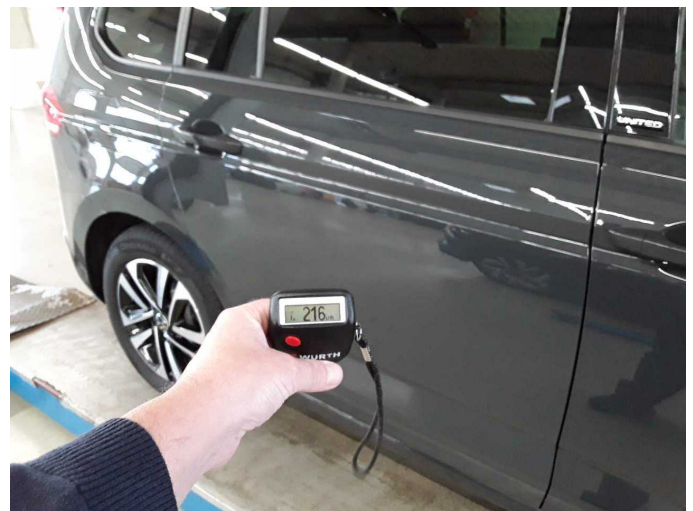
| Door - rear right side | 216 µm | | |

**Door - rear right side:** 216  $\mu\text{m}$
