Expertise

Protocol number: 46286290  
Order No. / Reference: 26673640  
Inspection date: 1 Jul 2026

Manufacturer: MAN  
VIN: WMA03VUY1P9019802

Model: TGE 3.140 4X2F SB (03V)

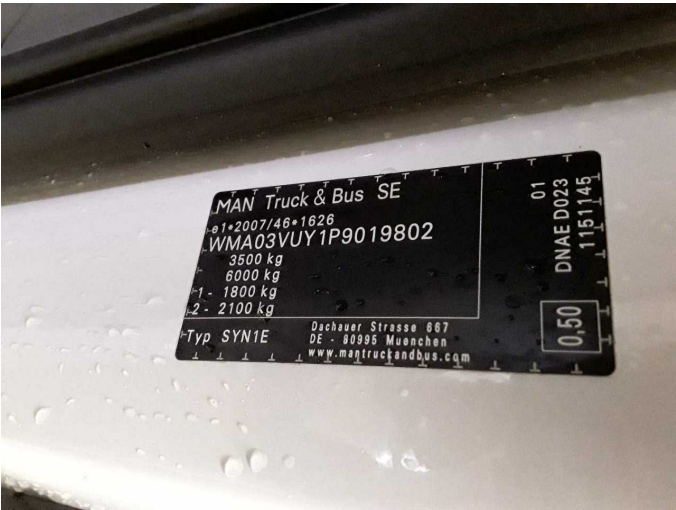
Figure 11: VIN

| VIN comparison | The vehicle identification number (VIN) was read from the vehicle and its conformity with the submitted documents was confirmed by the undersigned during the inspection. |

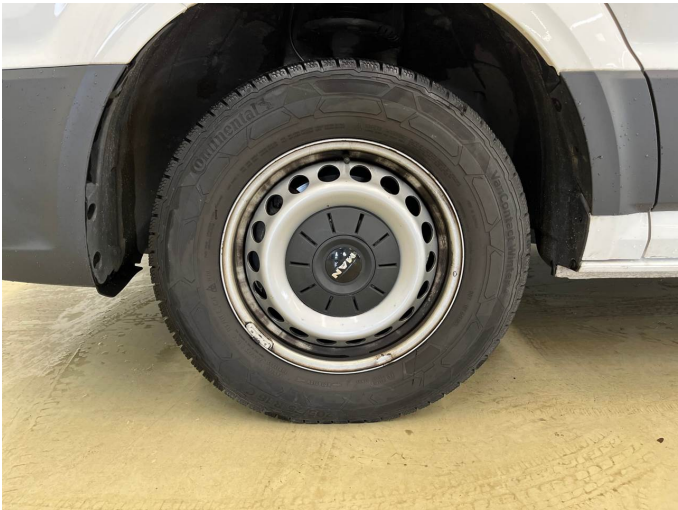
Figure 12: Mounted tyres

| # | Tyre size | Type of tyre | Manufacturer | Tread depth |
|---|---|---|---|---|
| 1) | 205/75 R16 113R | Winter tyres on Steel rim with wheel cover | Continental | 4mm / 4mm |
| 2) | 205/75 R16 113R | All-season tyres on Steel rim with wheel cover | Continental | 6mm / 6mm |

| No. | Component group | Description |
|---|---|---|
| 1 | Wheel / tyres | Tyre - front - Differs from the original configuration - No deduction |

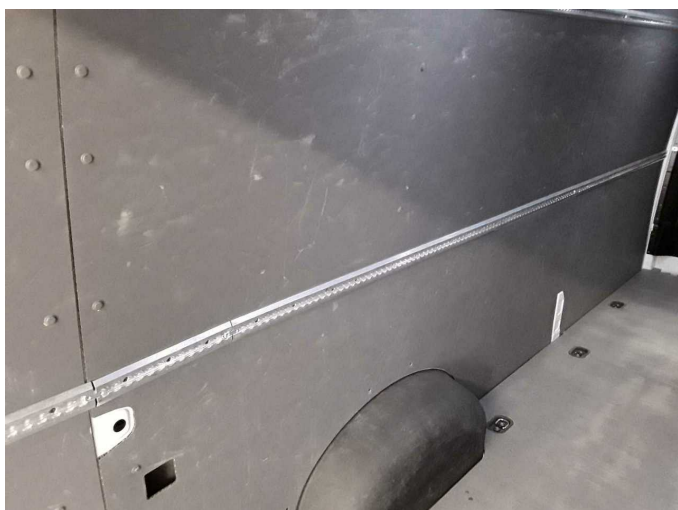
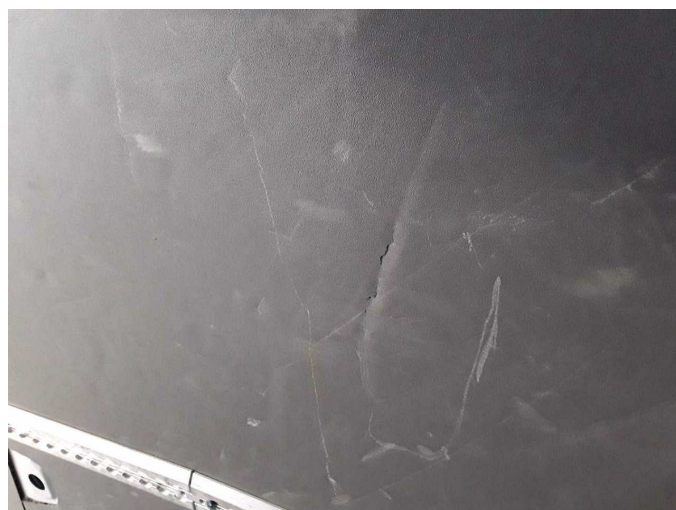
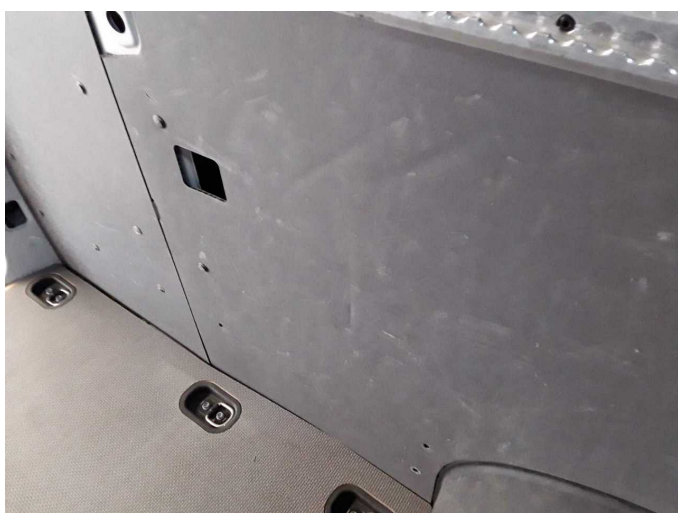
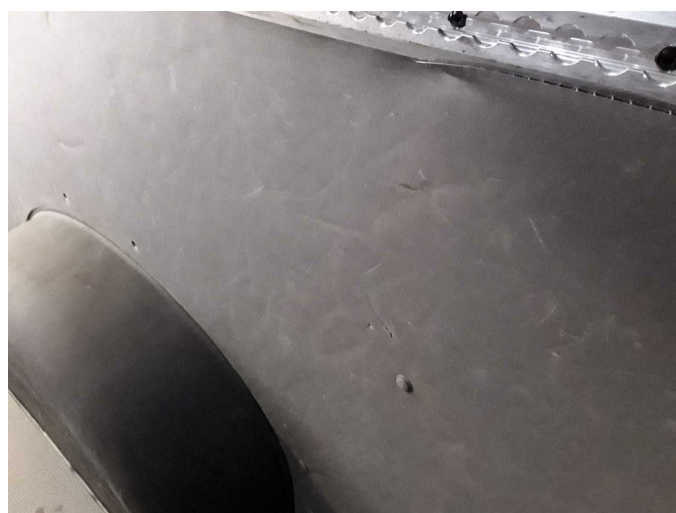
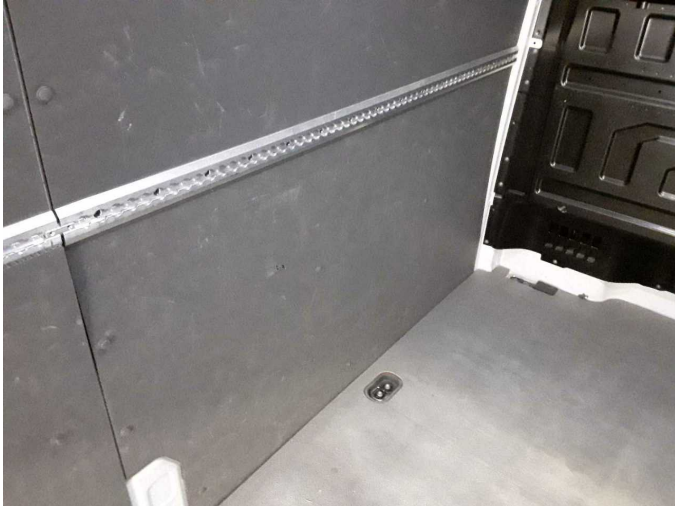
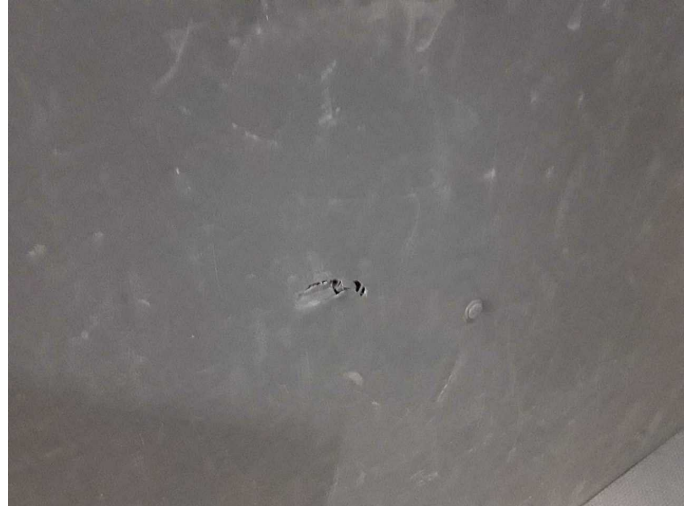
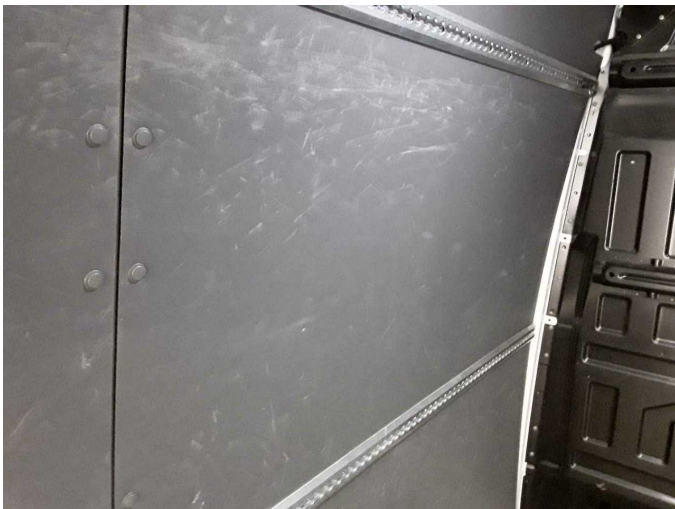
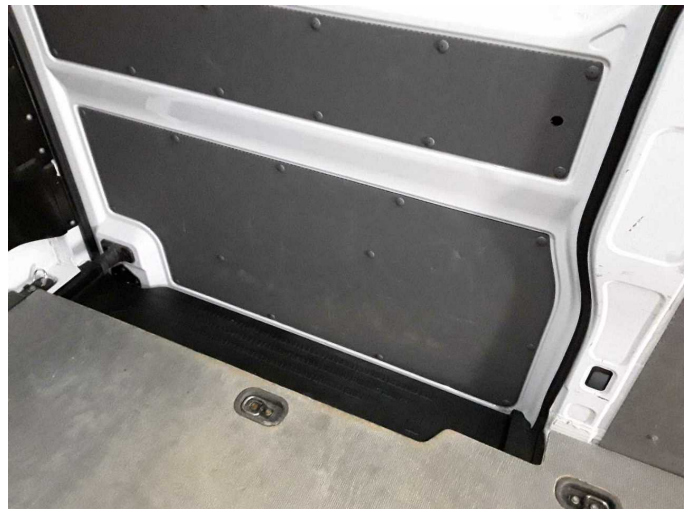
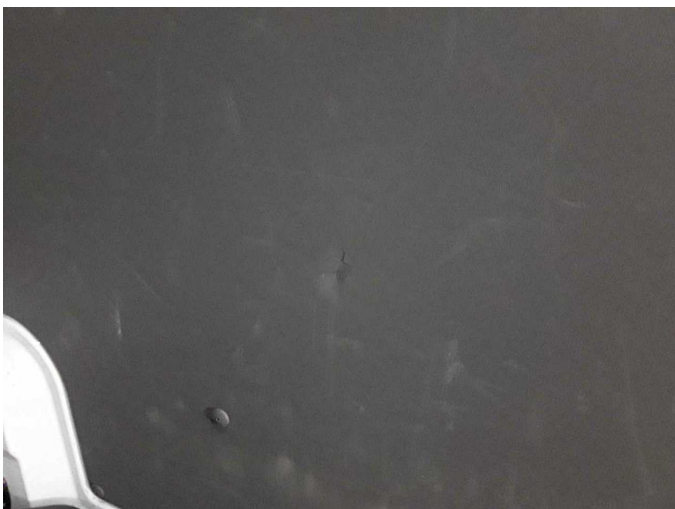
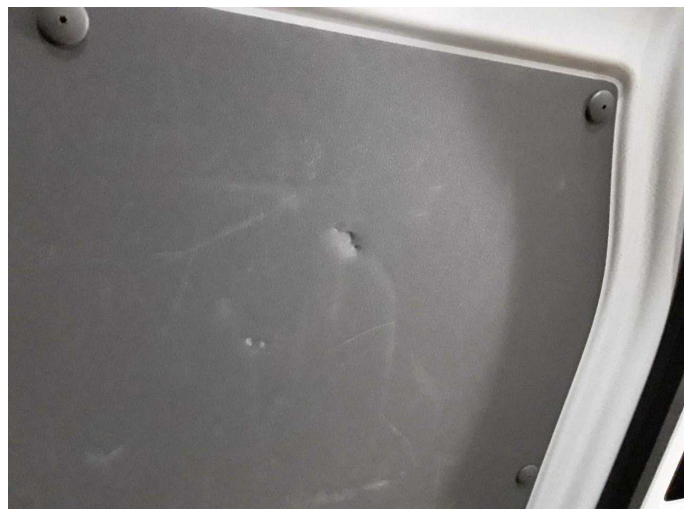
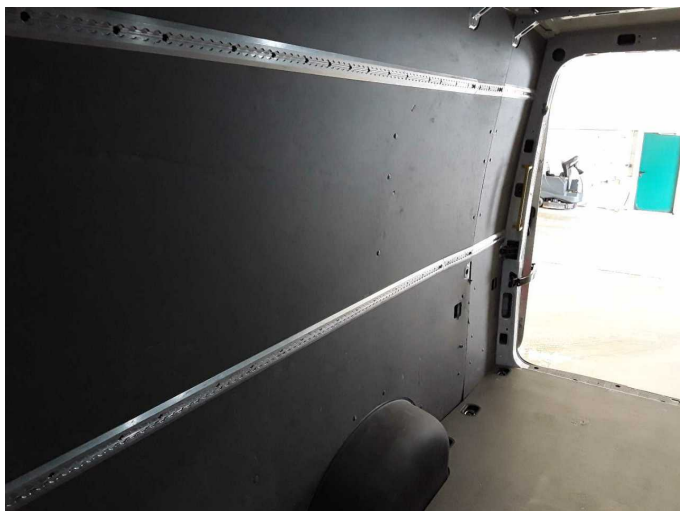
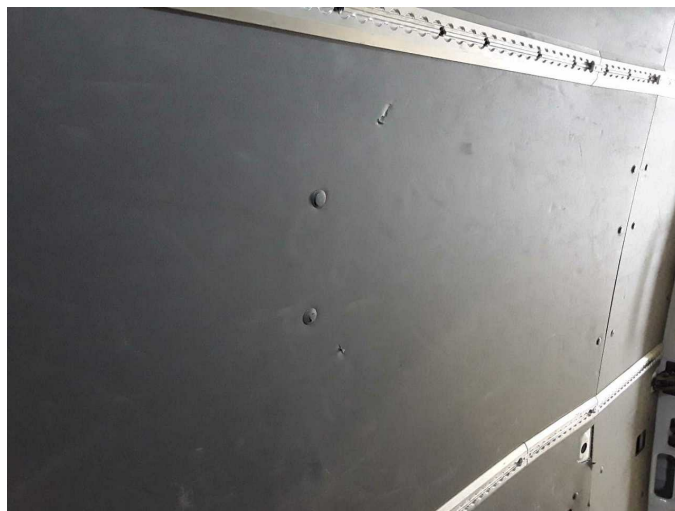
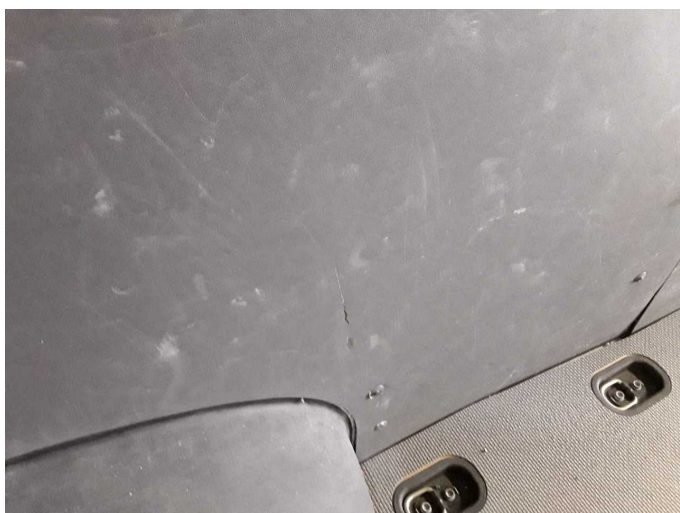
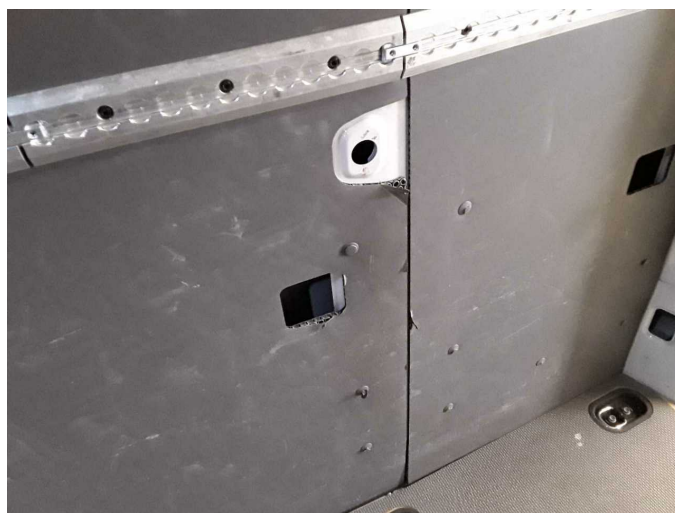
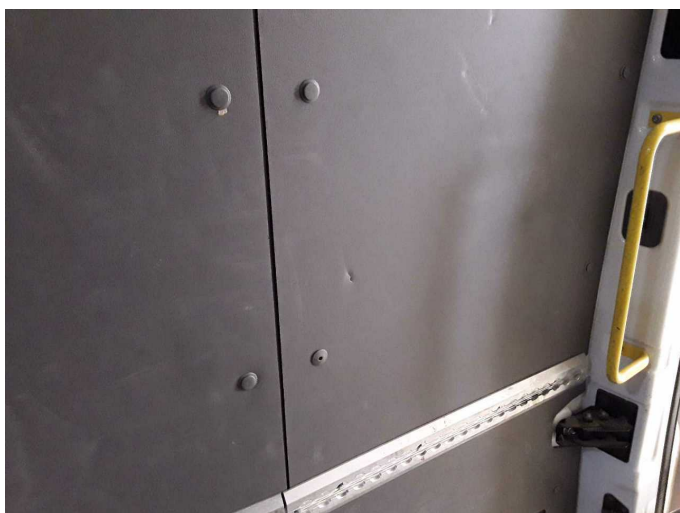
| No. | Component group | Description |
|---|---|---|
| 2 | Interior | Interior (Laderaumverkleidungen) - Scratched - Loss in value |

**Damage 2:** Interior: Interior (Laderaumverkleidungen) - Scratched - Loss in value
